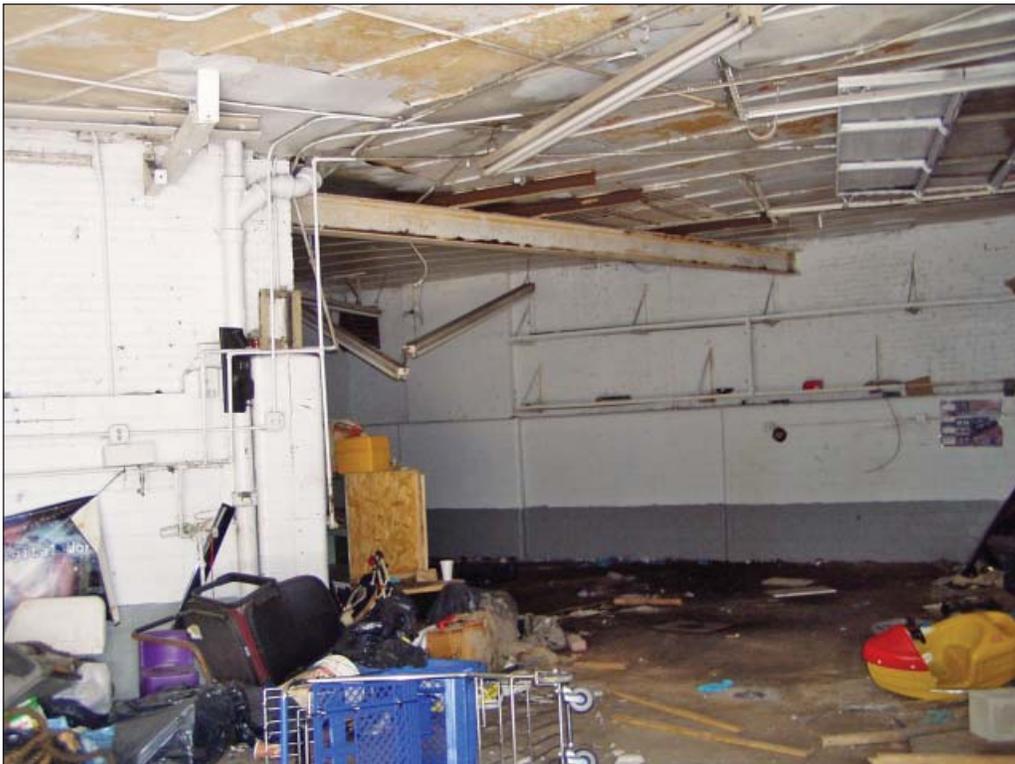
Photograph 1118-I-B

As shown in Photographs B through D, the interior of the building is in poor condition. Part of the ceiling cover has been torn, exposing the wood beams supporting the roof. Other areas of the building have chipped paint on the ceiling, rusted metal pipes, and lighting fixtures hanging from exposed electrical wires. Garbage debris, chairs, and old boxes litter the floor throughout the structure.

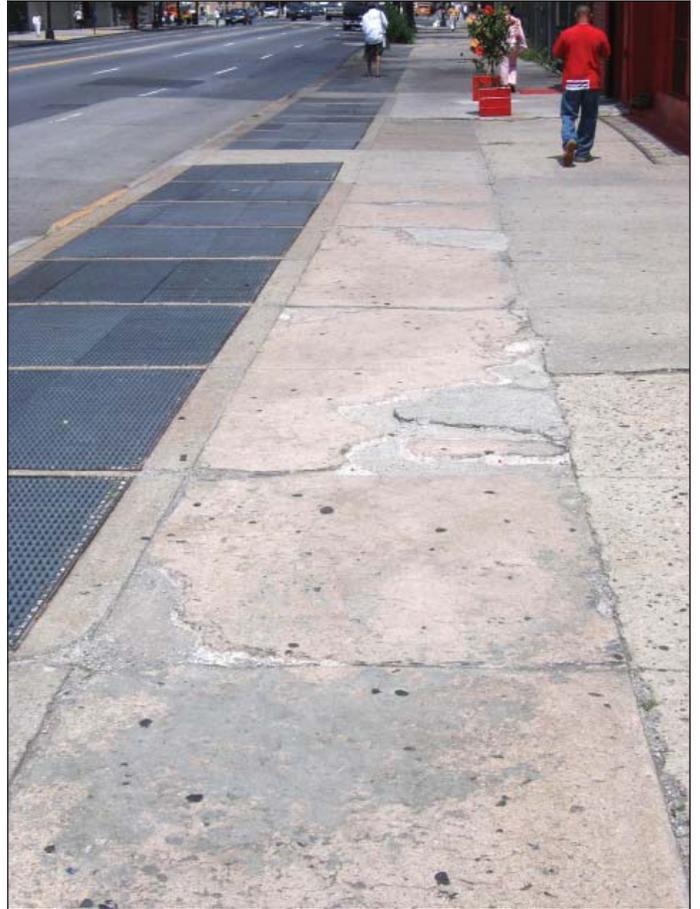
Photograph 1118-I-E

The sidewalk surrounding the building is cracked and crumbling (see Photograph E). The exterior of the building appears to be in fair condition with the exception of some cracks between the concrete tiles along the façade fronting 5th Avenue. The façade of one of the garage entryways is cracked and deteriorated, exposing the concrete block wall below (see Photograph F). It may be noted that the façade of the building on lot 1 is colored differently in some of the pictures. During the summer of 2005, AYDC permitted a temporary licensee access to this property, who painted the exterior of the building and the fence surrounding the parking lot.

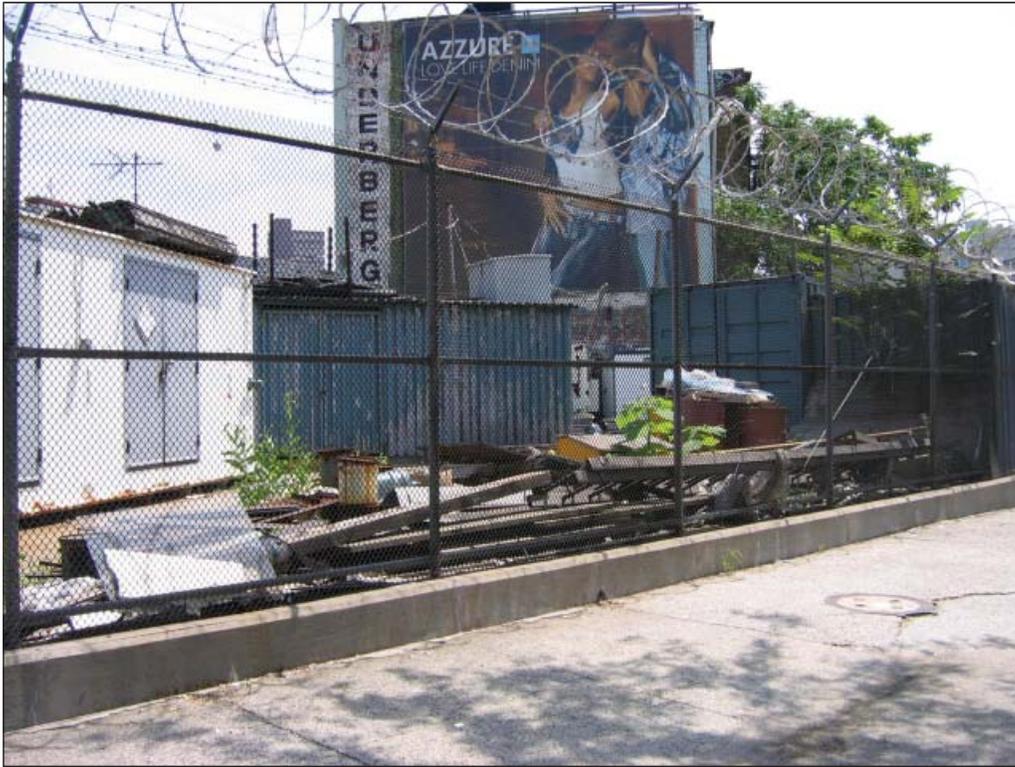
Photograph 1118-6-A

As shown in Photographs A through E, lot 6 is strewn with debris including metal beams, broken Plexiglas, rusted barrels, and wooden crates. The sign shown in Photograph C indicates that hazardous materials are being stored in some of the containers located on the property. The lot is surrounded by a chain-link fence topped in barbed wire. The concrete surface that covers the lot is cracked and uneven, and tall weeds are growing through the cracks across much of the lot. As shown in Photograph D, the sidewalk surrounding the lot is also in poor condition.

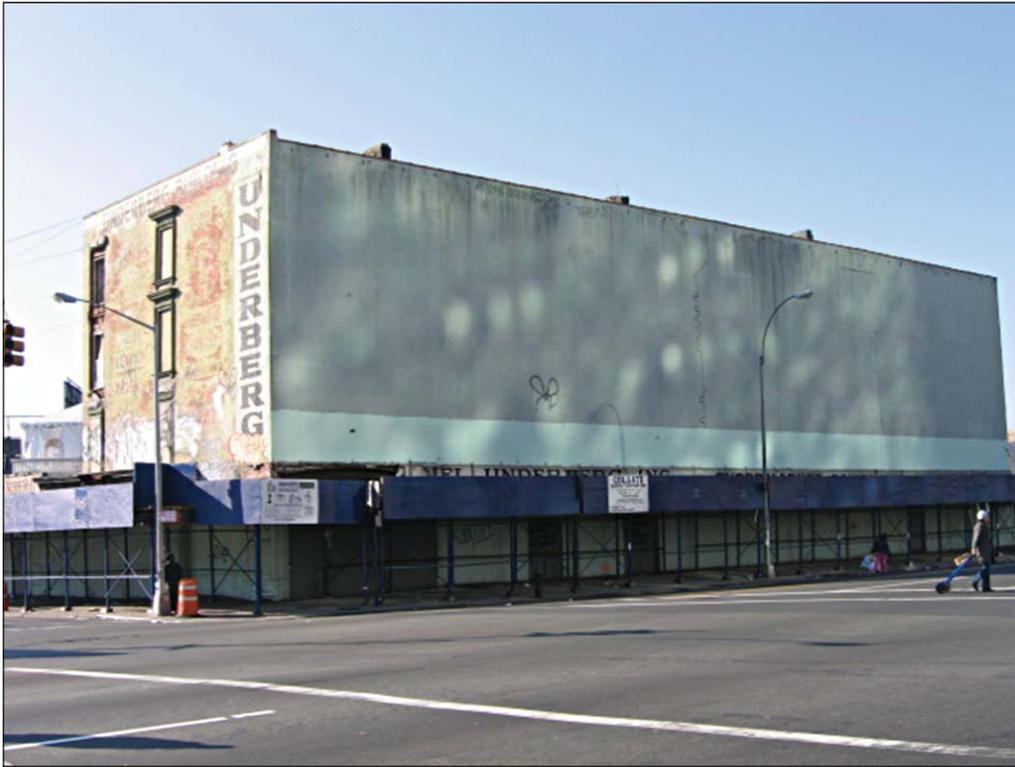
Photograph 1118-21/27-A

Prior to their demolition, the exteriors of the buildings located on lots 21-25 and 27 were in extremely poor condition and a sidewalk bridge was in place for several years to protect pedestrians walking adjacent to the building. The brickwork was crumbling on several portions of the façade, and graffiti was painted on eastern and rear façades of the building (see Photographs A through C); of particular concern was the east brick masonry-bearing wall of the building on lot 27: the brick around several windowsills was loose, and there was the possibility of bricks falling to the sidewalk. The sidewalks and curbs surrounding the lots along Atlantic and 5th Avenues are also in poor condition. As illustrated in Photograph D, the sidewalks have cracked and settled in many areas.

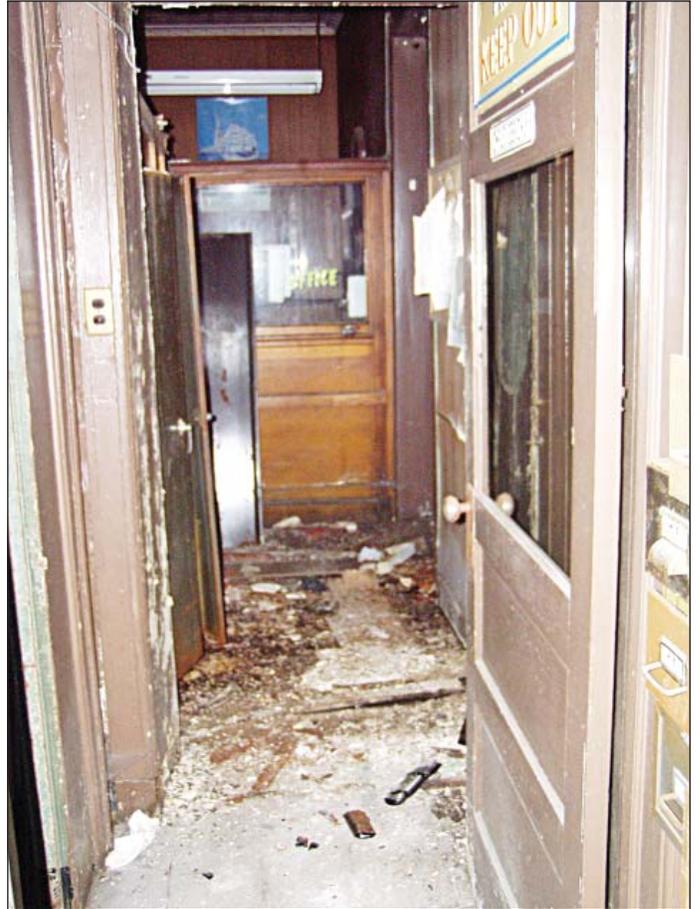
Photograph 1118-21/27-E

The building interiors also posed serious safety concerns. The hallways were strewn with fallen building materials from the ceiling and walls (see Photograph E). In some areas of the building, parts of the ceiling were hanging or completely fallen, exposing electrical wiring and the wood lath underneath (see Photographs F and G) and portions of the roof on the eastern portion of the block had collapsed, exposing the building's interior to the outside elements (see Photograph H).
