## Block I 127, Lot 20

### Location, Use, Zoning, and Ownership

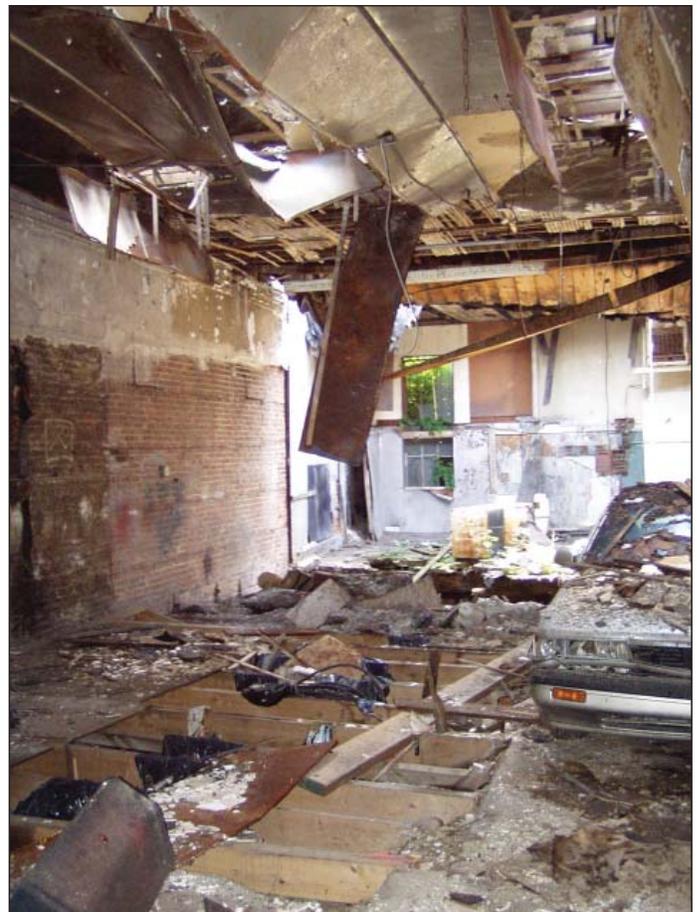
**Photograph I 127-20-B**

As indicated above, the building on lot 20 was demolished in Spring 2006. Similar to the adjacent building on lot 19, the exterior of the building on lot 20 was in fair physical condition but, as shown in Photographs B through D, the interior was in a state of severe disrepair. Part of the floor was missing, revealing the wooden joists underneath, and in other locations, the floor was in danger of collapsing. Throughout the building, the ceiling was either completely torn away or on the verge of collapse. Metal sheets, perhaps used as ceiling material, and electrical wiring hung from the ceiling. Concrete was missing, flaking or crumbling from most of the interior walls. Throughout the interior, the floor was filled with construction debris and garbage.

According to a structural due diligence report completed by LZA Technology in October 2005 (see Appendix A), the building on lot 20 had experienced severe structural deterioration and was unsafe. As shown in Photographs B and C, there were holes in the roof of the building, exposing the interior to the outside elements. The LZA report indicated that the interior of the structure was in a serious state of disrepair from water damage and exposure to the elements, and that portions of the timber floor framing would continue to collapse due to the water damaged floor structure. The report also indicated that the building's roof membrane was deteriorated and no longer existed in many locations. A partial collapse at the southern end of the roof, numerous holes across the roof area, and broken and open windows all exposed the building to further water damage. Overall, LZA Technology deemed the building unsafe, and recommended that it be demolished.

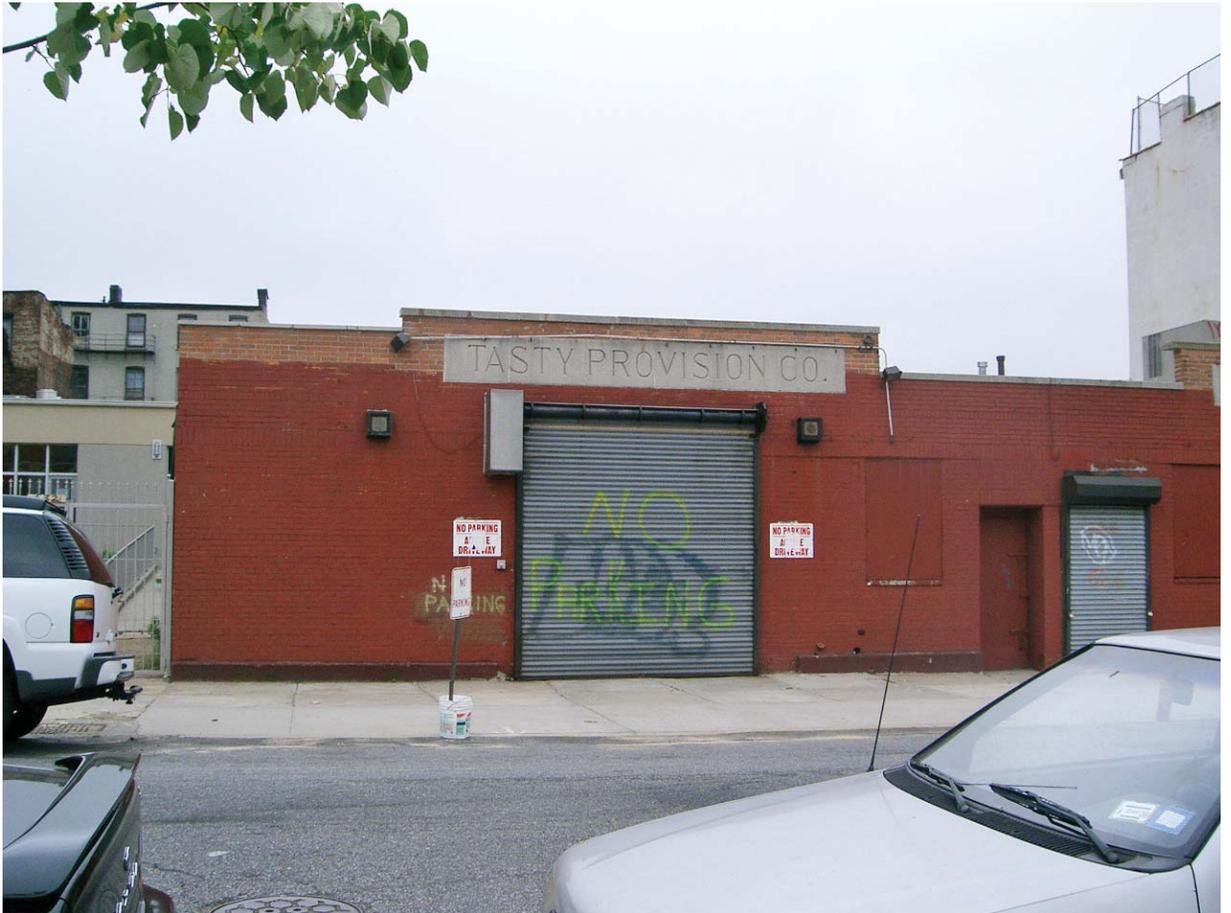
**Photograph I 127-22-A**

Apart from some graffiti on the façade of the building on lot 22 and some cracks in the sidewalk, no unsanitary or unsafe conditions were identified as part of the visual assessment.

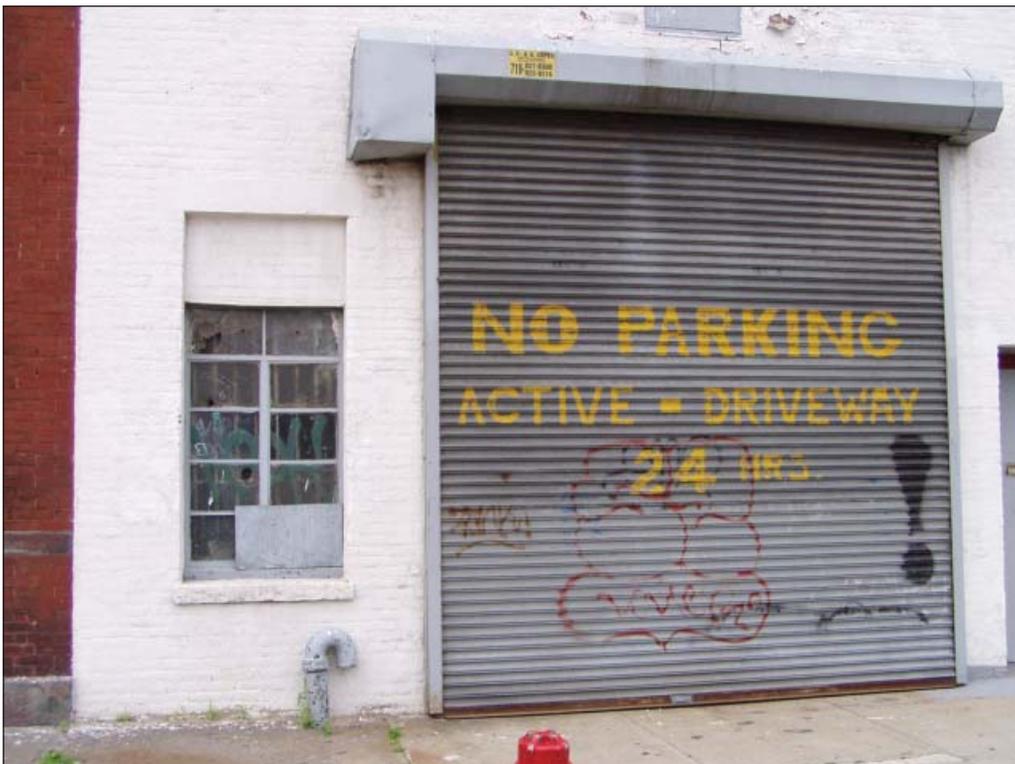
**Photograph I 127-30-B**

The façade of the building on lot 30 is generally in fair condition. However, the building's garage door and adjacent window are painted with graffiti, one of the building's windows is cracked, and the paint is flaking off portions of the building's façade (see Photographs B and C). In addition, as shown in Photograph D, the sidewalk in front of the building is heavily cracked, the curb is deteriorating, and weeds grow through many of the cracks.

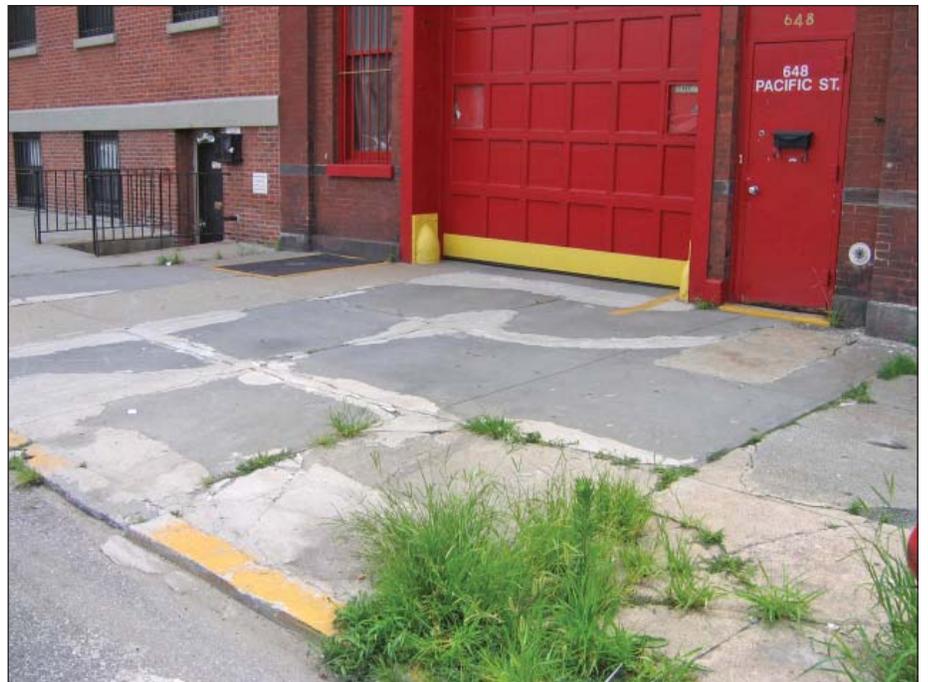
**Photograph I 127-33-B**

Aside from the cracks and weeds in the sidewalk of lot 33 (see Photograph B), no unsanitary or unsafe conditions were identified as part of the visual assessment.

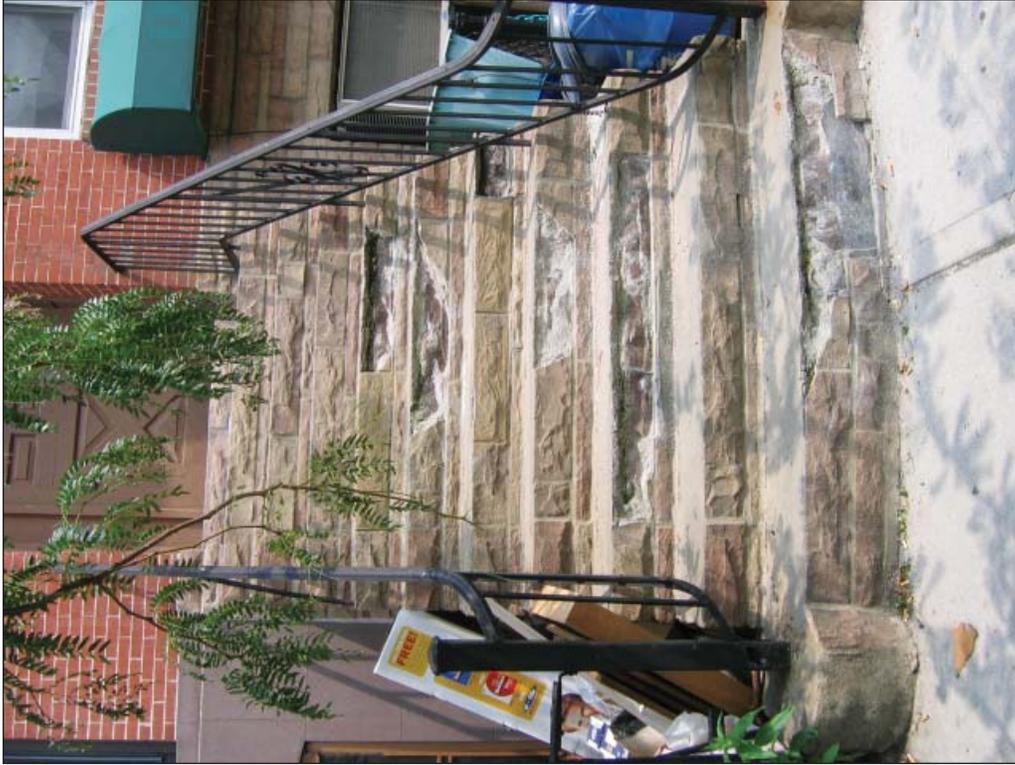
**Photograph I 127-45-B**

Apart from some deterioration of the stone on the building's front steps (see Photograph B), no unsanitary or unsafe conditions were identified as part of the visual assessment.
