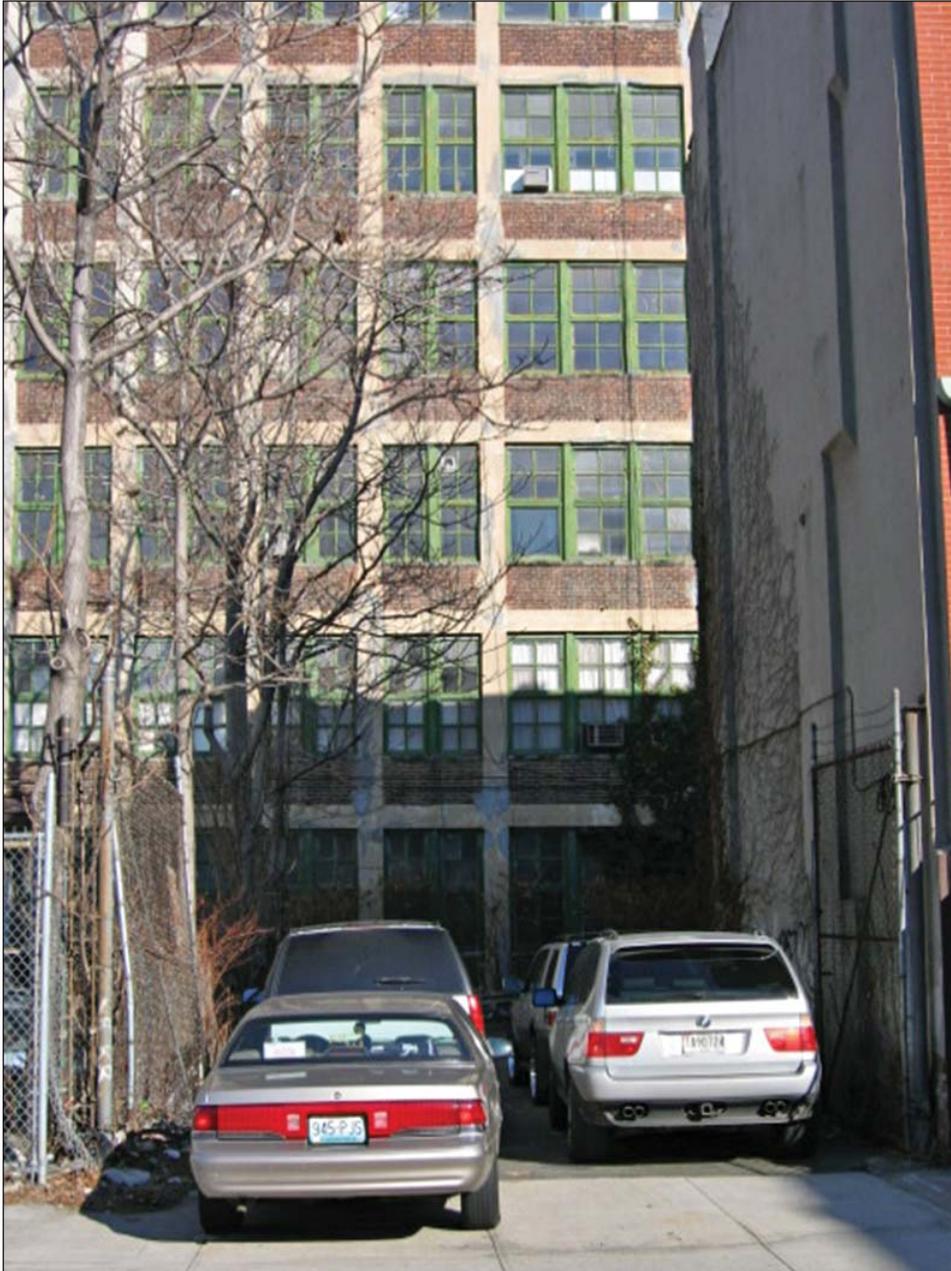
Photograph I 127-47-A

As shown in Photograph A, there are some weeds and trash lining the fence on lot 47, and the fence itself is topped in barbed wire. Apart from these conditions, no unsanitary or unsafe conditions were identified as part of the visual assessment.

As indicated above, lot 47 is currently used for parking. The lot is owned by Bergen Tile Paint and Linoleum Company, a flooring and tile store located on Flatbush Avenue between Bergen and Dean Streets, and appears to be used by store employees. Although used for parking, the lot is not properly configured for use as a parking lot. There are no parking guide lines on the pavement and as illustrated in Photograph A, parked cars often protrude out onto the sidewalk.

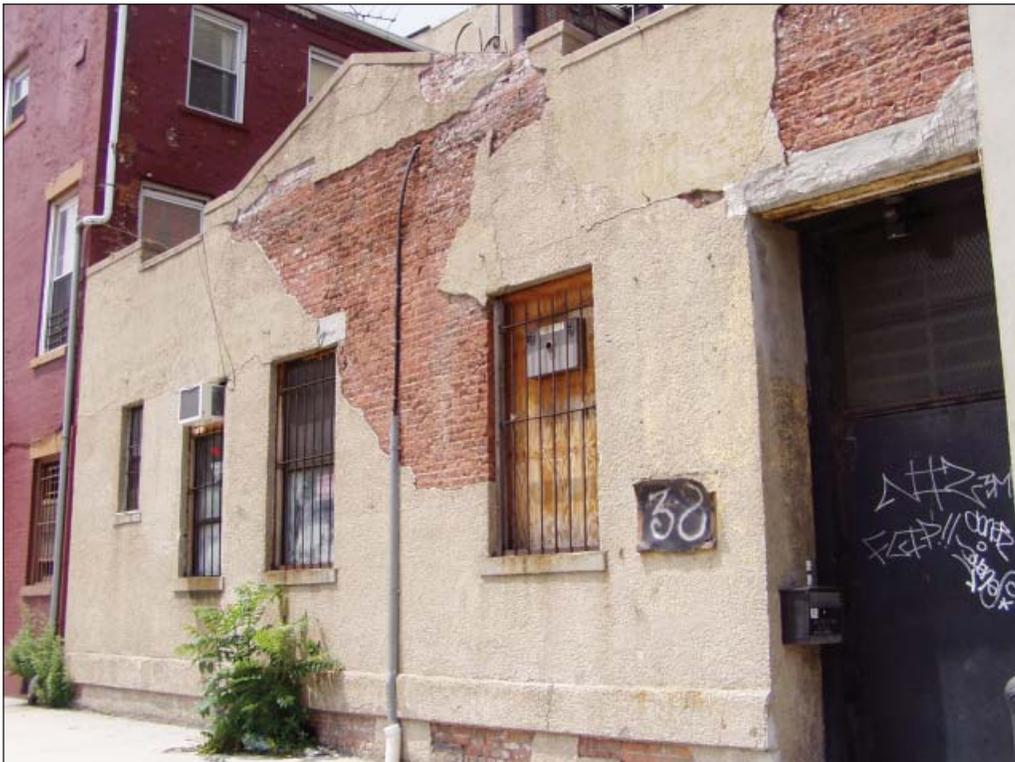
Photograph I 127-48-B

The façade of the one-story building on the eastern portion of lot 48 is in poor condition. As shown in Photograph B, large segments of the building's stucco coating have fallen off, exposing the brickwork below. Bricks along the upper portions of the façade appear to be crumbling, and the lintels that are visible are chipped. There is graffiti painted on the building's front door and one of the windows has been boarded up.

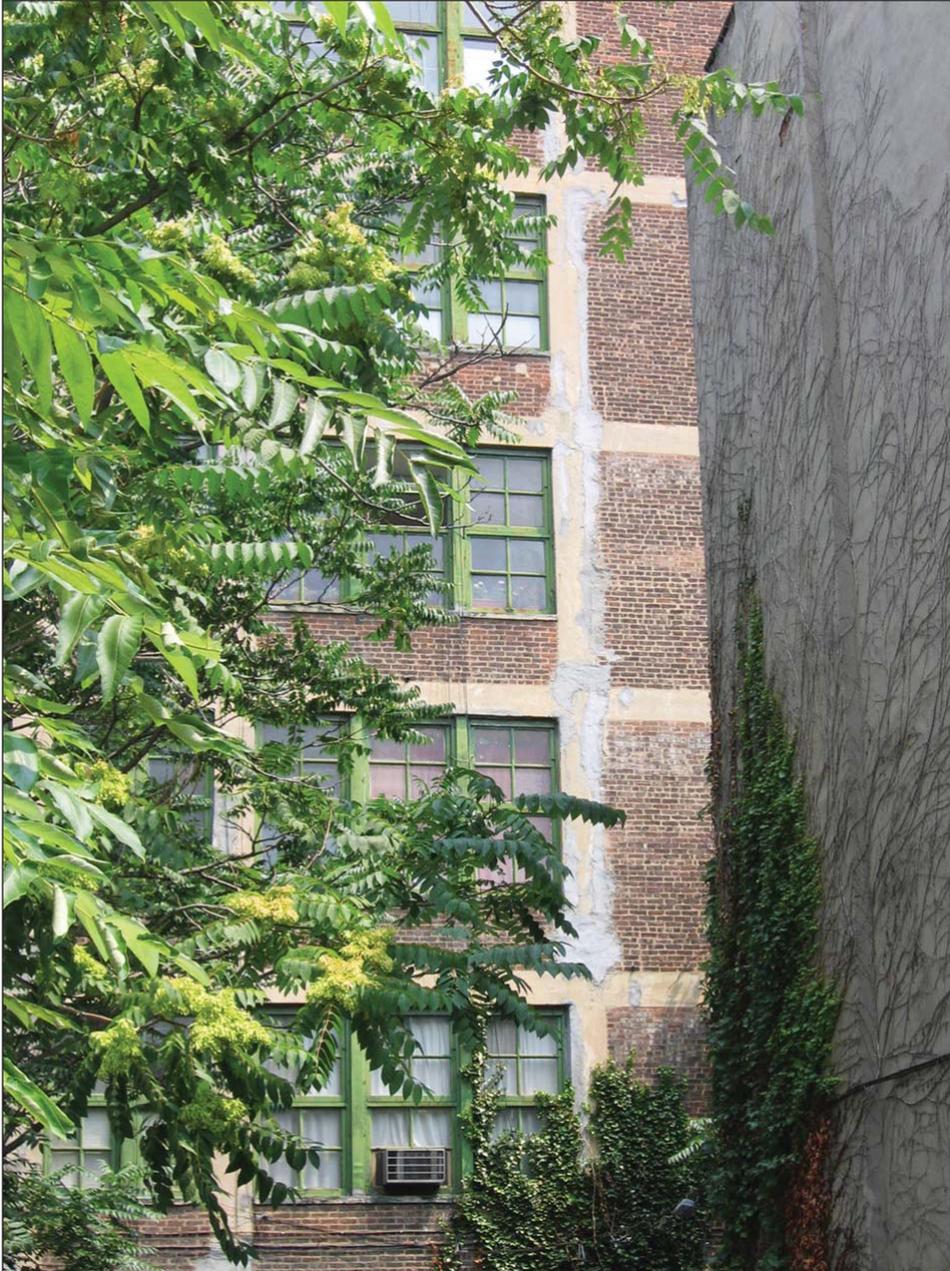
Photograph I 127-48-C

The six-story condominium building on lot 48 appears to be in fair condition. However, the patched concrete shown in Photograph C may be indicative of spalling.

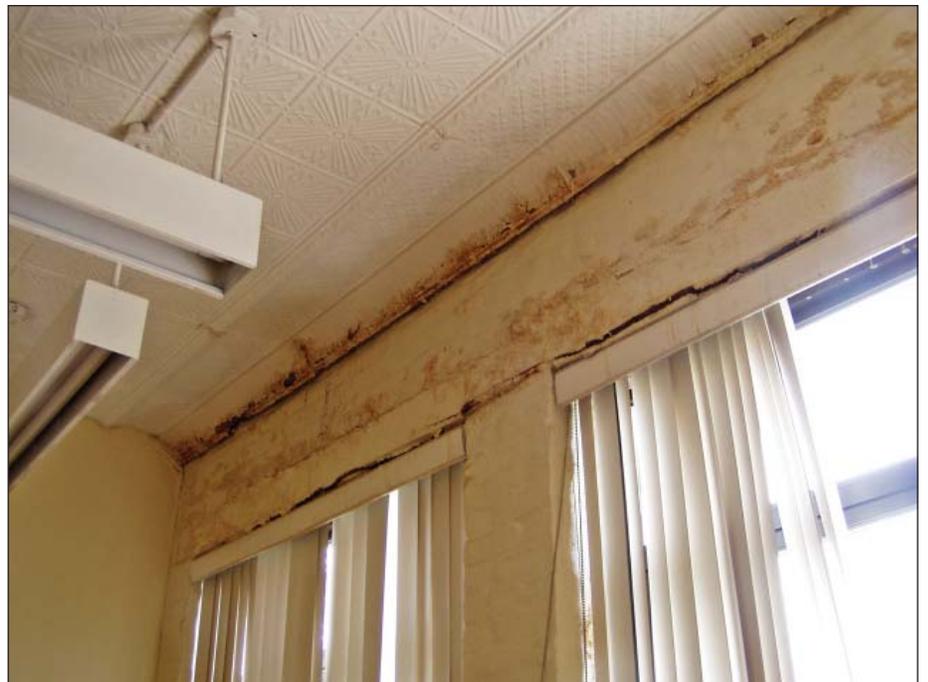
Photograph I 127-54-B

With the exception of some graffiti above the second-floor windows and on the front doorway, the building exterior is in fair condition. The building's interior has suffered water damage in several areas. For example, as shown in Photographs B and C, leaking water has caused the paint to peel away from the walls above the second-floor windows and has damaged the underlying brickwork.

As described above, water leaks have caused cracking and spalling of the interior brickwork. This damage may lead to degradation of the building's structure. However, a structural due diligence survey has not been conducted for this lot and the visual assessment did not indicate that the building structure is substantially compromised.

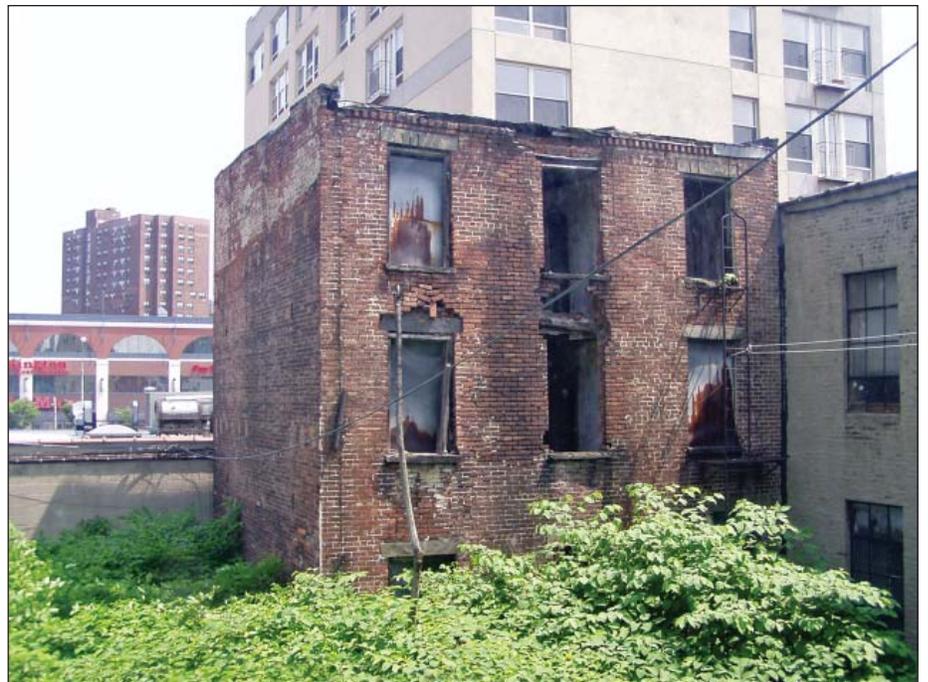
Photograph I 127-55-B

Both the exterior and interior of the three-story building on the rear portion of the lot were in critical condition. As shown in Photograph B, the building no longer had windows and some of the window openings were covered with metal sheeting. In many areas, the brickwork had either fallen off or was loose and/or severely damaged. A portion of the south masonry wall had collapsed and other portions appeared to be on the verge of collapse. Some of the building's window openings were no longer framed, which left the bricks surrounding the windows without any support (see Photograph F). Below a second-floor window, some of the brick buckled and bowed inward. According to a structural due diligence report prepared by LZA Technology in November 2005, the timber floor framing on the interior of the building was severely deteriorated and appeared on the verge of collapse due to the water-damaged floor structure.

The unbuilt portion of the lot was also unsanitary and unsafe. The yard was overgrown with vegetation that grew to the second story of the building (see Photograph B) and there was evidence of vermin living on the property.

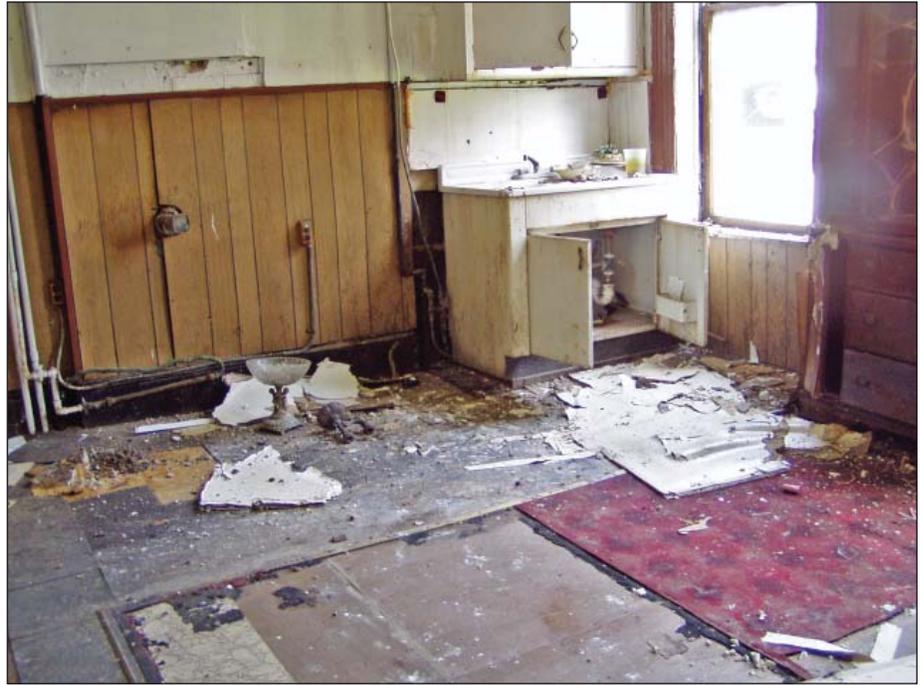
Photograph I 127-55-E

As indicated above, the buildings on lot 55 were demolished in Spring 2006. The exterior of the four-story building facing Dean Street appeared to be in fair physical condition. However, the interior was in a state of severe disrepair. The ceiling was damaged in several areas and parts of the ceiling had fallen, exposing the wooden beams and the subfloor above (see Photographs C and D). The floors of the building were littered with debris and all of the floors were sagging severely to the center-most point of the building (see Photograph E).

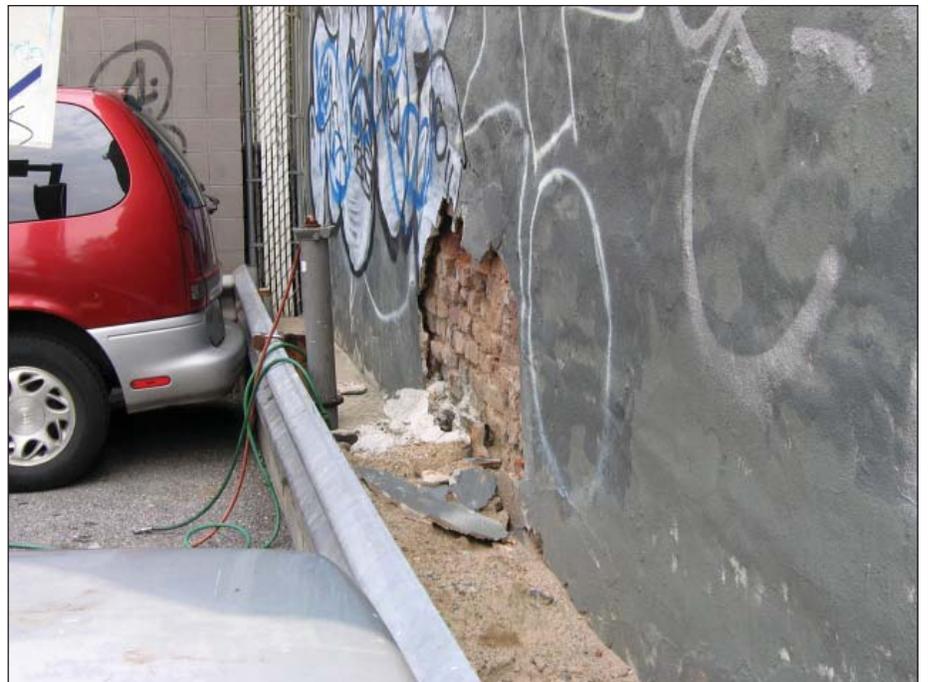
Photograph I 127-56-B

As indicated above, the building on lot 56 was demolished in Spring 2006. The exterior of the building on lot 56 appeared to be in fair physical condition. However, there was graffiti painted on the building's western façade, and a portion of the stucco coating on that façade had crumbled, revealing the underlying brick, which also appeared to be crumbling (see Photograph B).

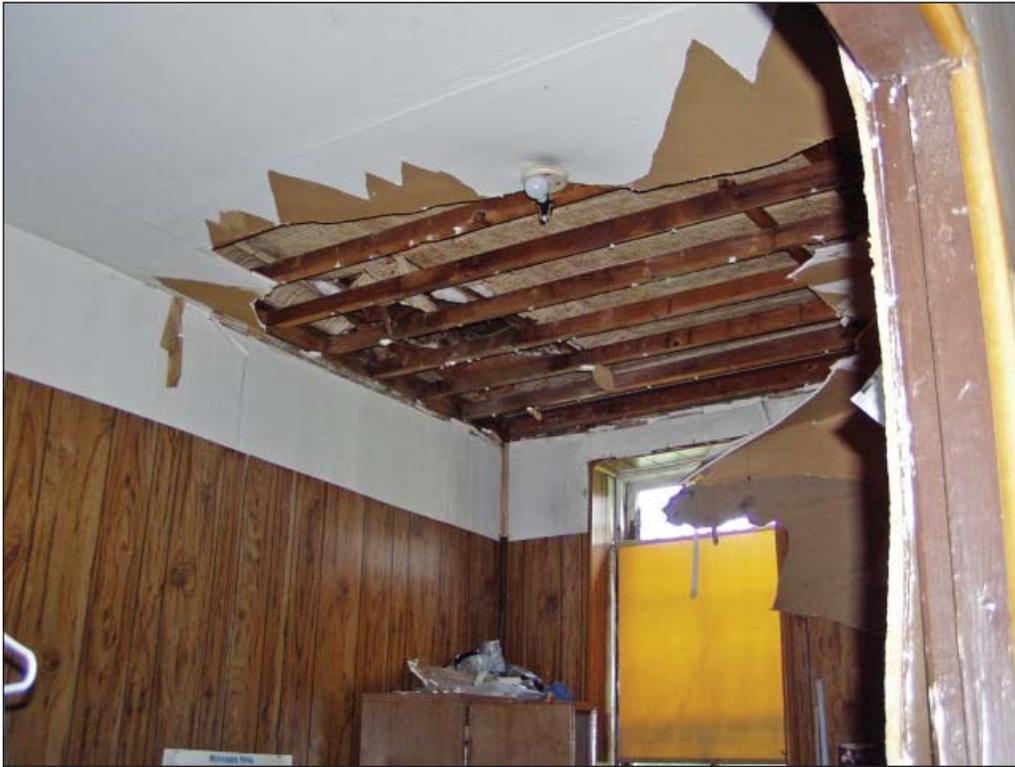
Photograph I 127-56-C

The interior of the building on lot 56 was in a severe state of disrepair. The ceiling is damaged in several areas and parts of the ceiling had fallen, exposing the wooden beams and lath and the subfloor above (see Photographs C and D). The floors in the building were sagging severely to the center-most point of the building and many floors were littered with debris from the falling ceilings and crumbling walls (see Photograph E). Water damage was evident throughout the building and mold was discovered on the back wall of one of the building's closets (see Photograph F).

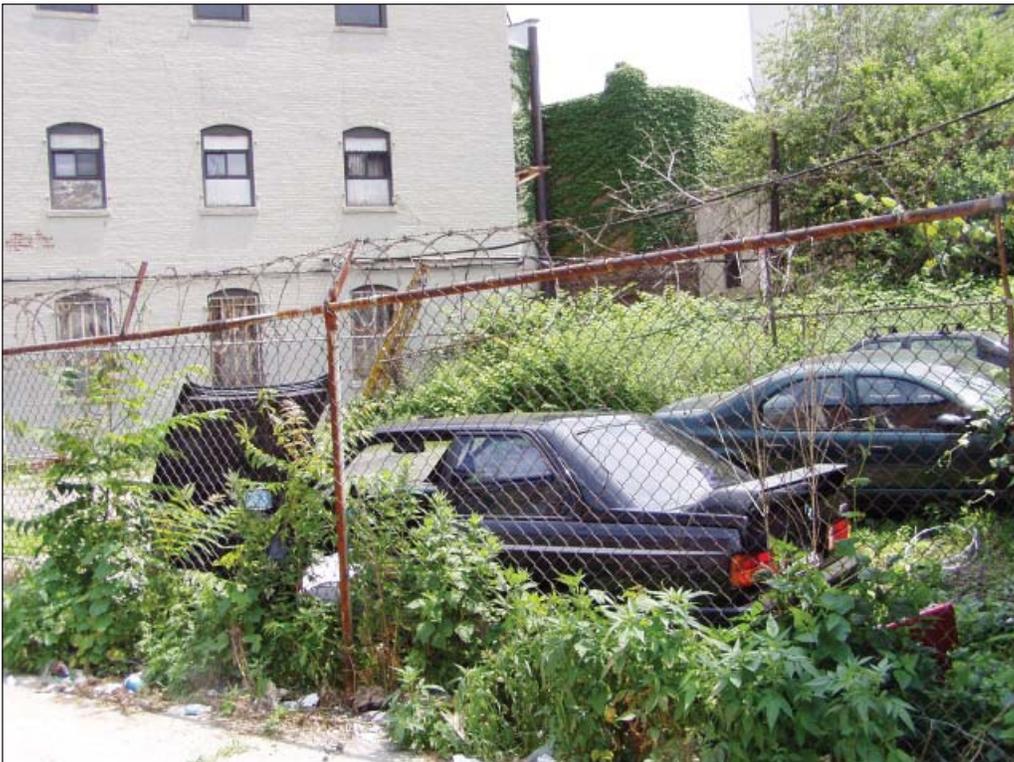
Photograph 1128-1,2-B

As shown in Photograph B, lots 1 and 2 are surrounded by a chain-link fence topped with barbed wire. Weeds grow on both the inside and outside of the fence. The weeds on the outside of the fence encroach onto the sidewalk. As shown in Photograph C, the lots themselves are partially paved with weeds growing in unpaved areas and through cracks in the pavement. The sidewalk bordering lots 1 and 2 is cracked in many places, and weeds grow along the curb and through some of the sidewalk cracks (see Photograph D).
