EXECUTIVE SUMMARY

The Manhattanville Neighborhood Conditions Study was commissioned by the Empire State Development Corporation to evaluate physical conditions in a study area approximately coterminous with the area proposed for the development of a new campus by Columbia University. Analysis of neighborhood conditions for this study was begun in September 2006 and continued through April 2007.

Manhattanville Neighborhood Conditions Study

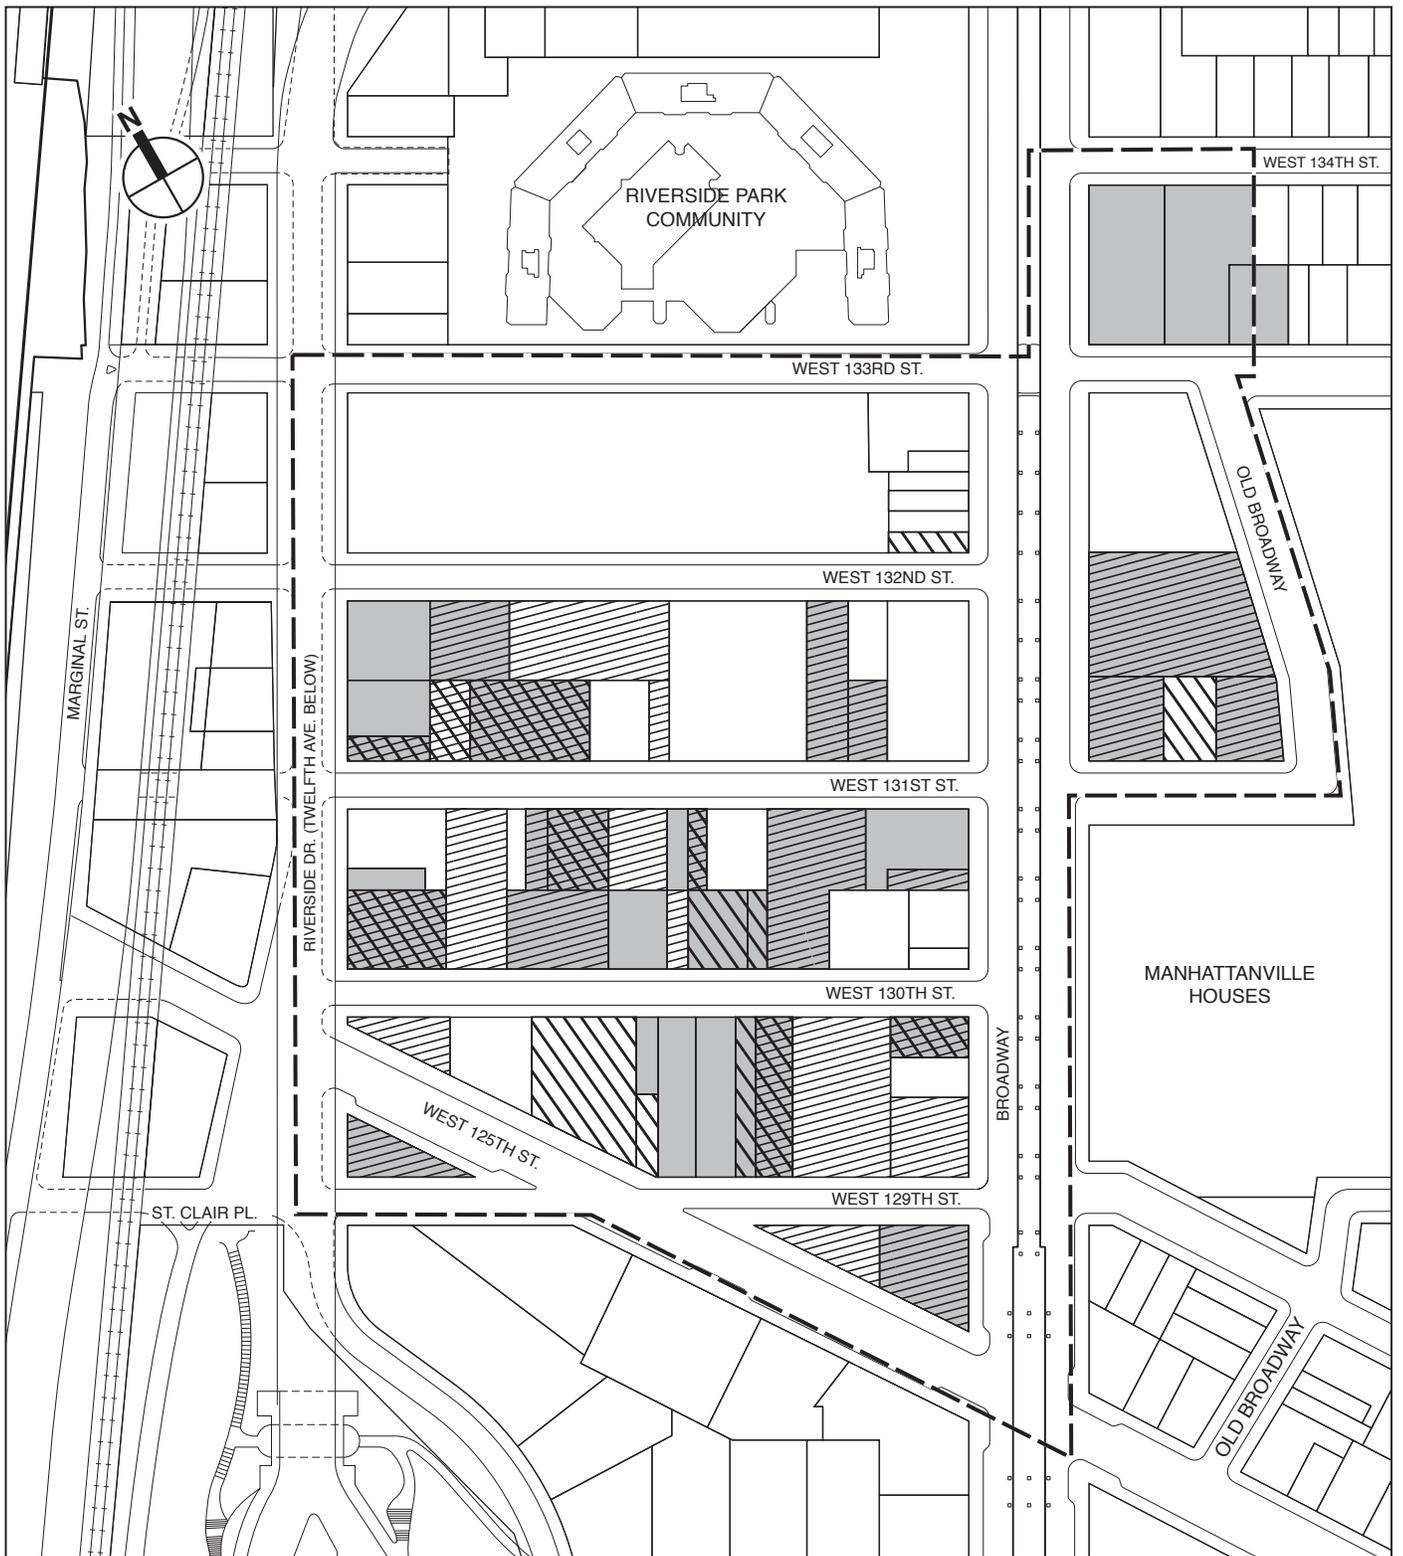
Cumulatively, these adverse conditions make the study area as a whole substantially unsafe, unsanitary, substandard, and deteriorated. As illustrated in Figure 2, 48 of the 67 lots in the study area (or 72 percent of the total lots) have one or more substandard condition, including poor or critical physical

lot conditions, a vacancy rate of 25 percent or more, or site utilization of 60 percent or less. Based on physical conditions alone, 34 of the 67 lots in the study area (or 51 percent of the total lots) were assessed as being in poor or critical condition. The presence of such a high proportion of properties with multiple substandard conditions suggests that the study area has been suffering from a long-term trend of poor maintenance and disinvestment, leading to the overall condition of deterioration that exists today.

As illustrated in Figure 2, the Manhattanville Neighborhood Conditions Study identified 48 of the 67 lots in the study area (or approximately 72 percent) as substantially deteriorated or substandard as a result of poor or critical structural conditions; other unsafe, unsanitary, and/or unhealthy building conditions; underutilization; and high vacancy. In addition, the advanced age and small size of many of the structures in the study area render a substantial portion of the existing building stock functionally obsolete for many types of community facilities, retail and other commercial uses, amusement uses, and some light manufacturing uses permitted under the existing zoning. The current preponderance of automotive service establishments in the study area, as well as other types of general service establishments (such as vehicle storage, warehousing, and moving and storage companies), are among a limited array of businesses that could use these properties without undue expense for necessary renovations. Finally, the effective isolation of the study area by large-scale transportation facilities, such as the NYCT bus garage and the Manhattan Valley IRT viaduct, casts a bleak pall and unsafe image on the study area that limits integration with and connectivity to the surrounding neighborhoods, dampens pedestrian activity and urban street life found in surrounding neighborhoods, and creates opportunities for graffiti, which only adds to the sense of deterioration and disinvestment in the study area.
