Block 1986 Lot 65

SITE CONDITION:	FAIR
------------------------	-------------

Manhattanville Neighborhood Conditions Study

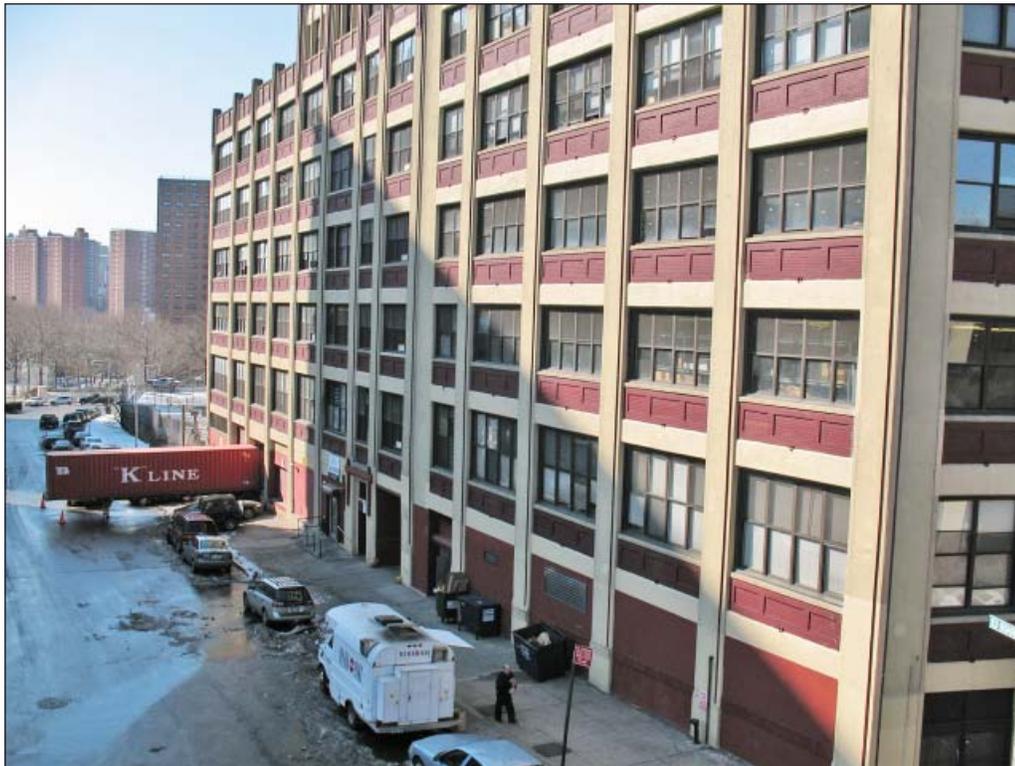
Photograph 1986-65-A

All four of the building's exterior walls were undergoing renovations during the course of Thornton Tomasetti, Inc.'s various site visits (see Photograph M), likely to address the building code violation described below. The walls are now in good condition (see Photographs A and B).

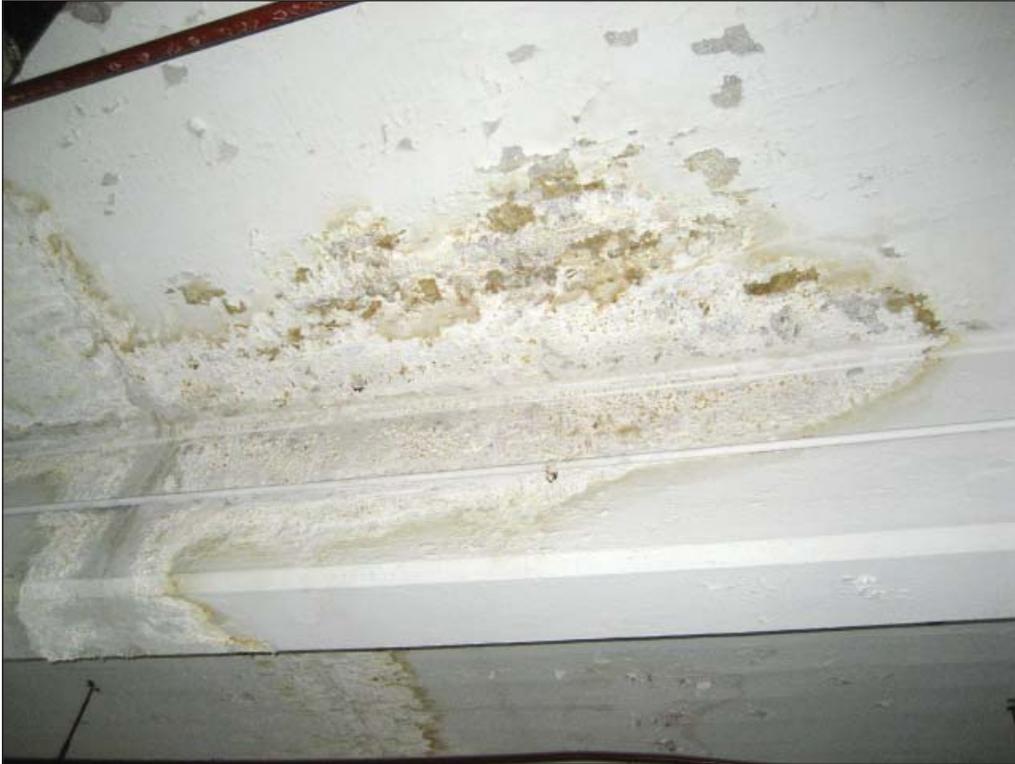
Photograph 1986-65-C

Water infiltration has caused local deterioration of several structural and non-structural elements, including water damage on the underside of the floor slab (see Photograph C); corrosion on the underside of a metal deck (see Photograph D); and cracks, efflorescence, and peeling paint on the walls (see Photographs E and F). Potential causes of water infiltration include holes, cracks, and air pockets on the roofing membrane (see Photograph G); damaged flashing and drains on the roof; deteriorated window sills and headers; damaged waterproof coatings on the window frames (see Photograph H); and a wide crack on the chimney (see Photograph I). There is peeling paint on the walls and ceiling in the parking garage on the first floor, which was likely caused by humidity from standing water in the garage or from low-quality paint (see Photograph J).

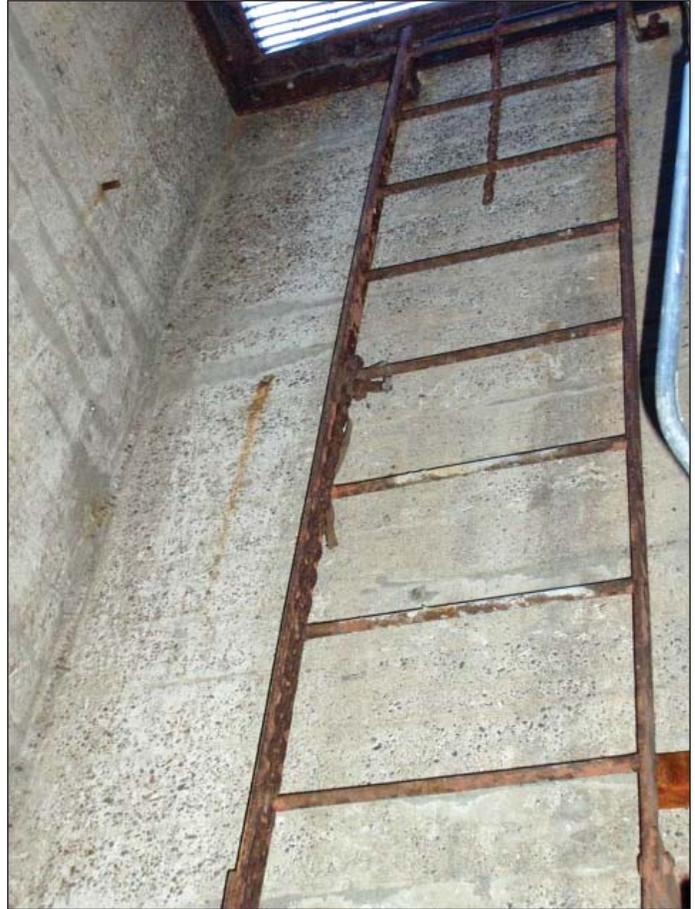
Photograph 1986-65-K

The emergency ladder from the boiler room to the sidewalk is corroded (see Photograph K). Although the sidewalks on Broadway, West 133rd Street, and Old Broadway are in fair condition overall, there are local wide cracks and spalling on the Broadway sidewalk (see Photograph L).

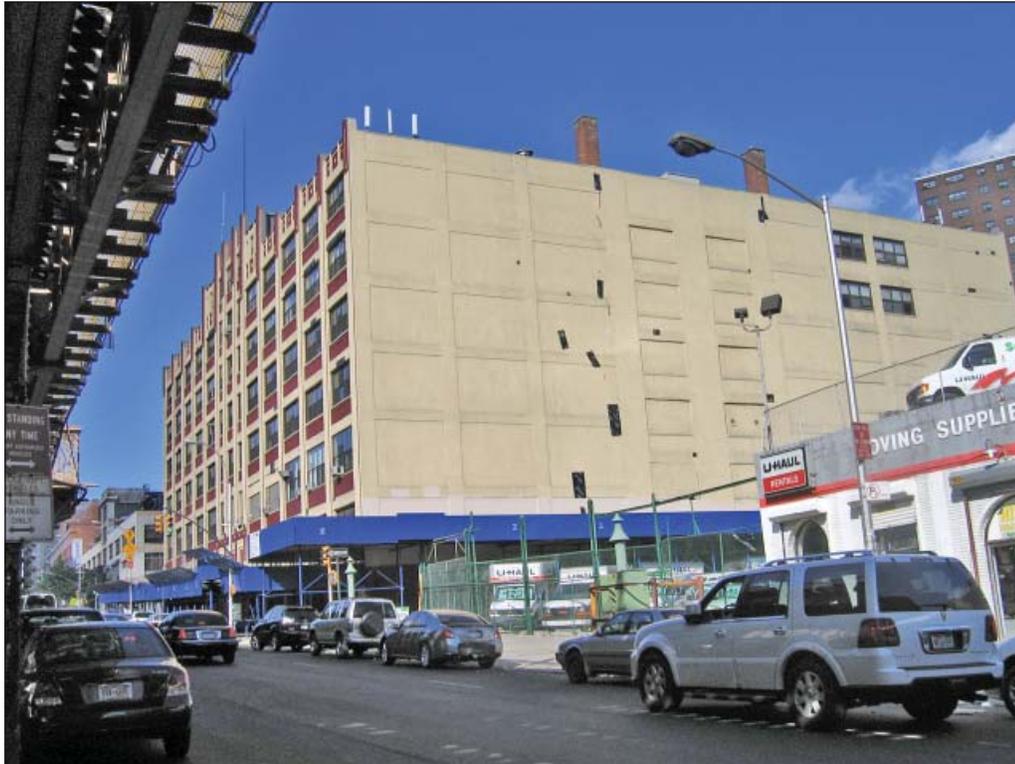
Photograph 1986-65-M

Six building code violations were issued for Lot 65. One violation issued in 2005, for failure to maintain an exterior wall, is considered hazardous and of high severity by ECB though it appears to have been recently repaired as mentioned above. It refers to a piece of concrete that broke off from the fifth floor and hit the sidewalk below. Additional cracks at various locations are also cited with the potential to break loose and fall. Four violations were issued by DOB in 2006, for the boiler and one in 2005, for the elevator; however, no additional information is available in the DOB Building Information System. Based on the site visit, the boiler had been recently repaired, which may have been in response to the boiler violations.

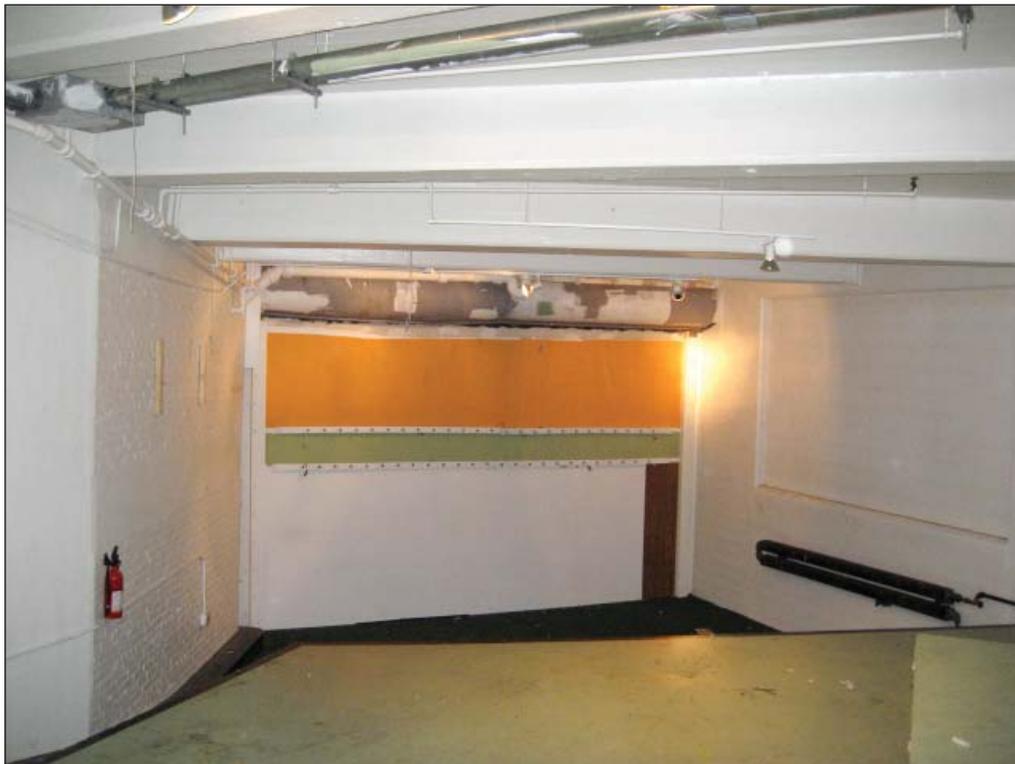
Photograph 1986-65-N

Although these units are not currently occupied, unsafe conditions appear to exist in several units within the former circular parking ramp that appear to have been illegally constructed. As shown in Photograph N, these rooms appear to be unsafe for tenants because they lack proper ventilation,

electrical systems, or means of egress. They also have uneven floors and do not appear to meet building code standards. These units are now vacant, but the unsafe conditions would have to be addressed if this area of the building were to be leased. Also, a former owner or tenant added concrete to the ramp's floor slab to level it with the fifth floor (see Photograph O). There is a repair patch on the underside of the ramp in this location, an addition that may not have been designed by a licensed New York State professional engineer with consideration to the ramp's load capacity.
