Block 1987 Lot 9

SITE CONDITION:	POOR
-----------------	------

Manhattanville Neighborhood Conditions Study

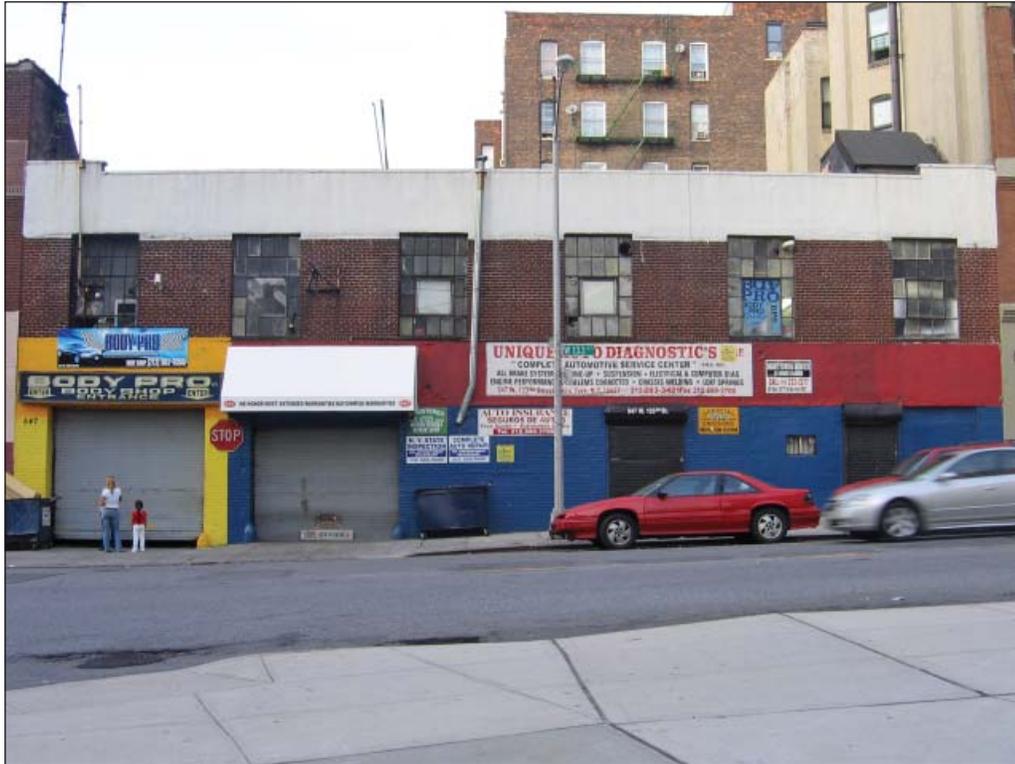
Photograph 1987-9-A

Acquired by the Trustees of Columbia on June 30, 2006, Block 1987 Lot 9 is located at 547 West 133rd Street between Broadway and Amsterdam Avenue. A two-story, 14,238-gsf brick masonry building occupied by automotive repair shops comprises the lot (see Photograph A). The structure’s estimated build year is 1970; however, the building’s presence on a historical Sanborn Map from 1939 indicates that the building was likely constructed prior to 1939. Although the building encompasses the entire lot, only about 45 percent of Lot 9 is within the study area; this western portion is in an M1-2 zoning district. The eastern portion of the building, which is not part of the study area, is in an R7-2 zoning district. The physical evaluation was performed for the entire building and not just the portion of the building

Distress is largely the consequence of active, long-term water infiltration resulting in: water and corrosion stains on the first floor ceiling, rotted timber joists and roof sheathing (see Photograph B), and severe staining and microbial growth on the ceiling and walls (see Photograph C). A mezzanine level on the second floor used for storage (see Photograph D) is subject to localized collapse, as it is suspended from the roof framing that is compromised due to active water infiltration (see Photograph E). Also, there is a significant stepped crack on the north brick masonry wall, which was likely due to long-term water infiltration (see Photograph F). Water damage was likely caused by poor roof conditions, such as ponding water (see Photograph G) and the severe deterioration of the waterproof coating at a portion of the parapet (see Photograph H); and by windows that are in poor condition with a few cracked window panes and some corrosion on the window frames (see Photograph A).

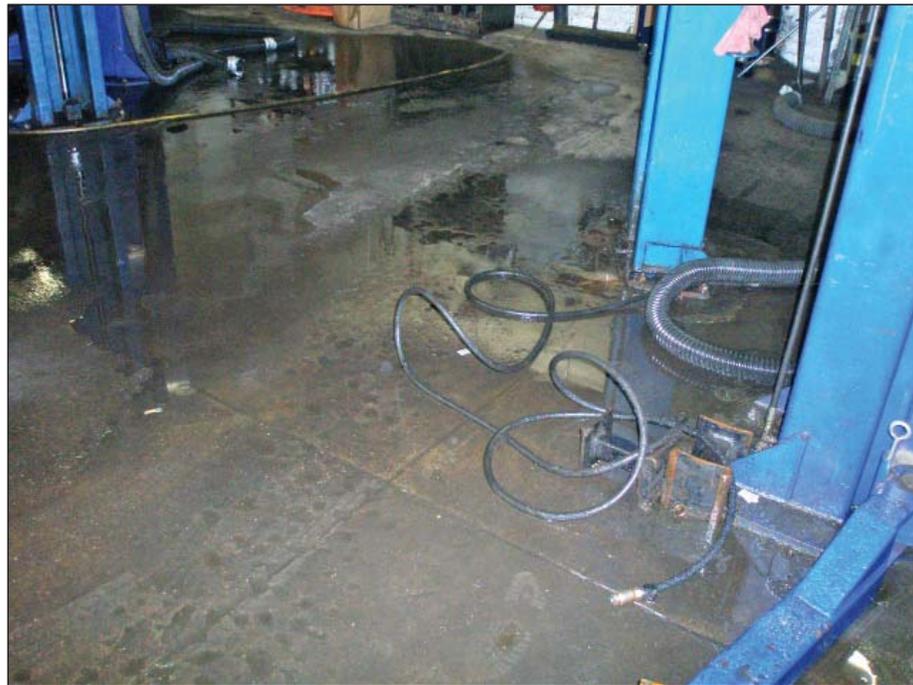
Photograph 1987-9-I

The concrete surfaces on both floors exhibit evidence of long-term automotive repair shop operations, such as cracks, spalling, and deterioration from exposure to motor oil and other chemicals (see Photographs I and J). The top surface of the concrete vehicular ramp has cracks and spalling from long-term use (see Photograph K). Signs of deterioration are also on the underside of the ramp, such as advanced efflorescence and spalling (see Photograph L), as well as black residue likely caused by emissions from machinery on the first floor (see Photograph M). As shown in Photograph M, a reinforcing bar is exposed at one location on the underside of the ramp and is corroded.

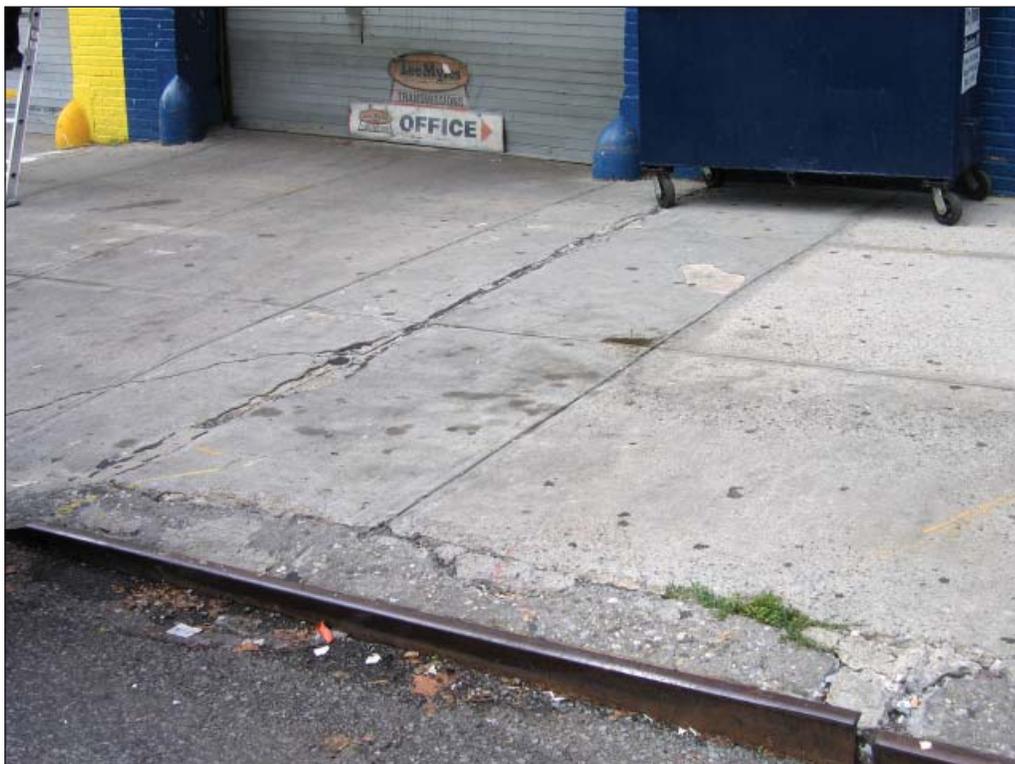
Photograph 1987-9-N

The sidewalks and curb cuts are in fair to poor condition, with cracks and uneven joints (see Photograph N).
