Block 1998 Lot 57

SITE CONDITION: POOR

Manhattanville Neighborhood Conditions Study

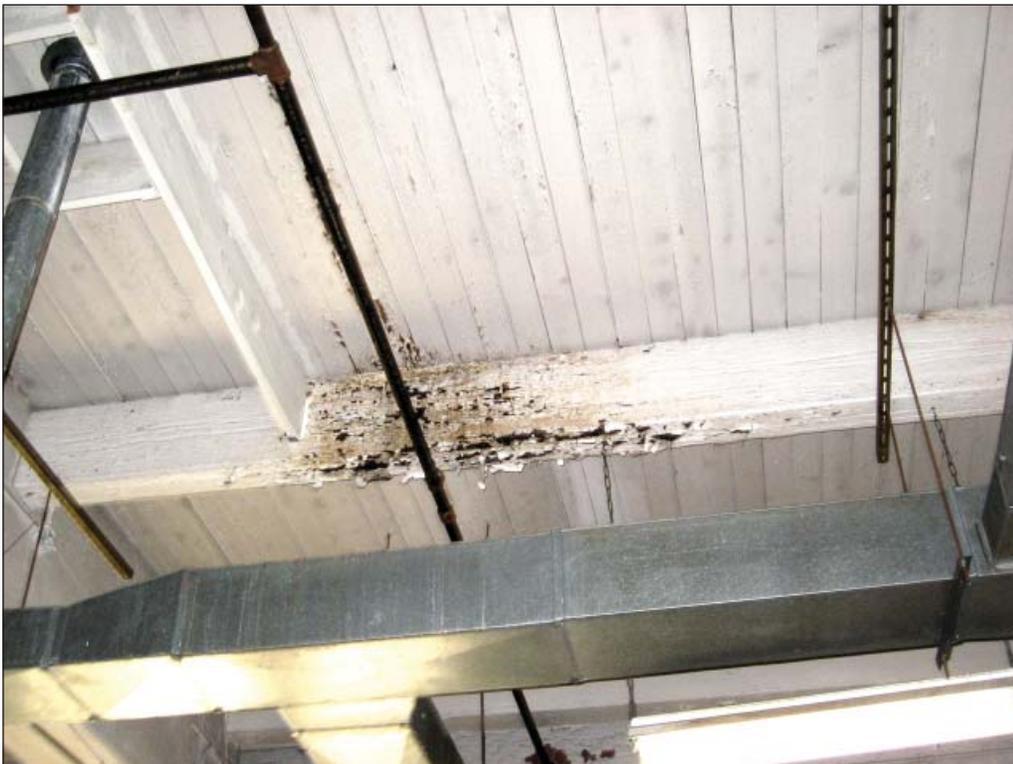
Photograph 1998-57-B

Long-term water infiltration has caused deterioration of several structural and non-structural components of the building. The timber roof joists and timber planks have signs of water damage, including peeling paint, discoloration, and cracks (see Photographs B and C). Water infiltration has also caused damage to the brick masonry walls, which have widespread cracks and flaking paint (see Photograph D and E). Wide cracks on the exterior brick wall are likely causing water damage in the building. The roofing membrane is in fair condition; however, ponding was observed in several locations.

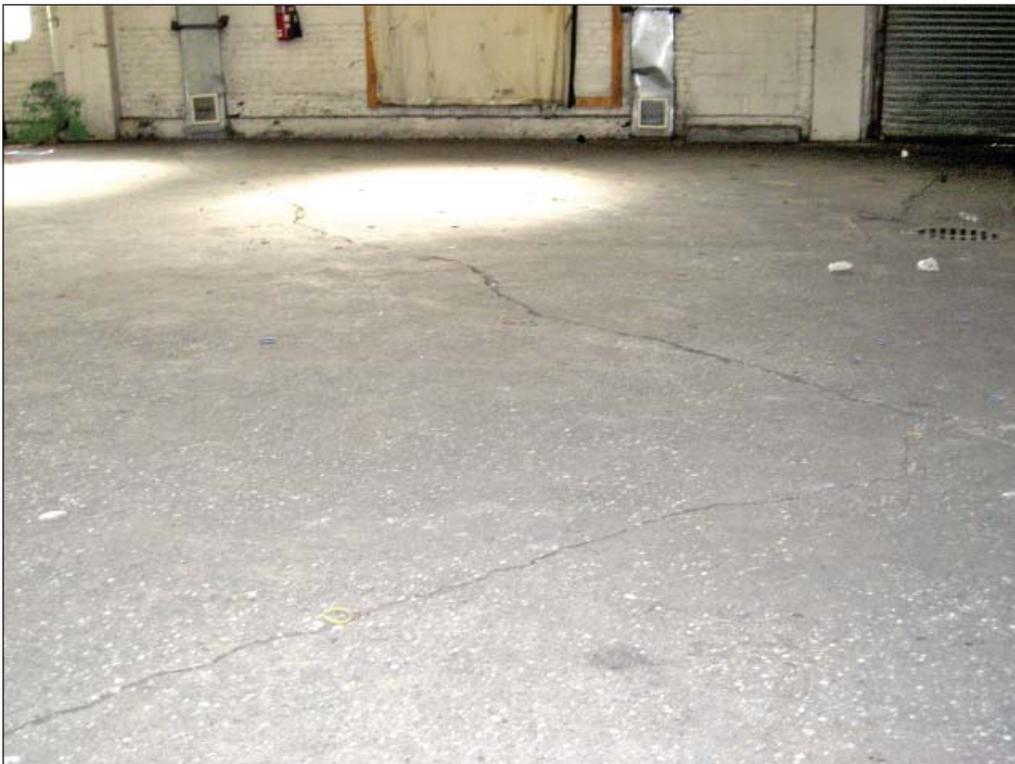
Photograph 1998-57-F

The concrete slab-on-grade is cracked and spalling, the result of its long-term use as a parking garage (see Photograph F). Corrosion stains on the retaining wall of the adjacent Lot 49 suggest that water from this lot has been draining onto Lot 57 (see Photograph G). This could lead to further deterioration of the slab on Lot 57.
