Atlantic Yards Arena and Redevelopment Project: Blight Study

## **Atlantic Yards Arena and Redevelopment Project—Blight Study**

## Block 1121, Lot 1

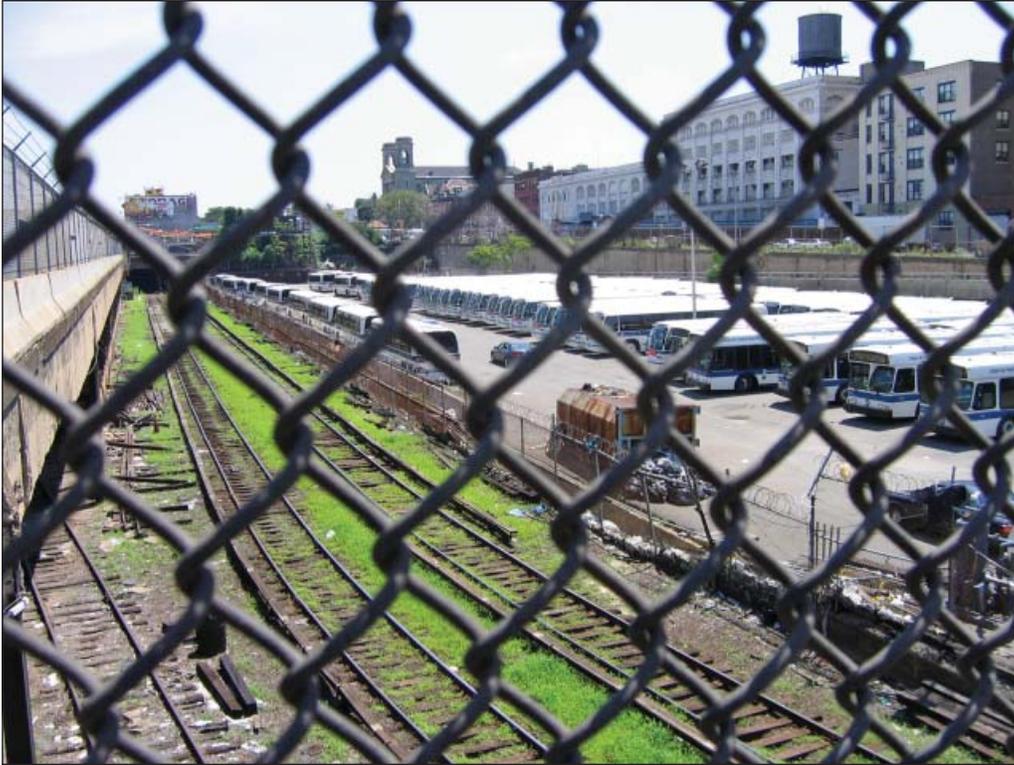
Photograph 1121-I-A

Current conditions on lot 1 are depicted in Photographs A through K. As shown in Photograph A, the entire lot is below grade and is surrounded by a chain link fence, most of which is topped in barbed wire. Portions of the lot are overgrown with weeds and littered with trash and debris (see Photographs B, E, and G) and a chain link fence topped in barbed wire separates the tracks from the storage yard (see Photograph D). As shown in Photograph E, a containing wall abutting adjacent lot 47 is deteriorating. A chain link fence at the top of that wall holds back a large pile of debris, but appears to be bowing inward towards the rail yard under pressure from the debris. The sidewalks surrounding lot 1 are in various states of disrepair. As shown in Photographs H and I, portions of the sidewalk along Pacific Street are so cracked, uneven, and overgrown with weeds that they are almost impassable. In addition, several large slabs of concrete, which appear to be pieces of a dismantled portion of the slab wall shown in Photograph H, are precariously balanced against the chain-link fence facing the sidewalk (see Photograph J). As shown in Photograph K, the concrete sidewalk slabs along Atlantic Avenue are cracked and crumbling, and portions of the sidewalk area are unpaved.

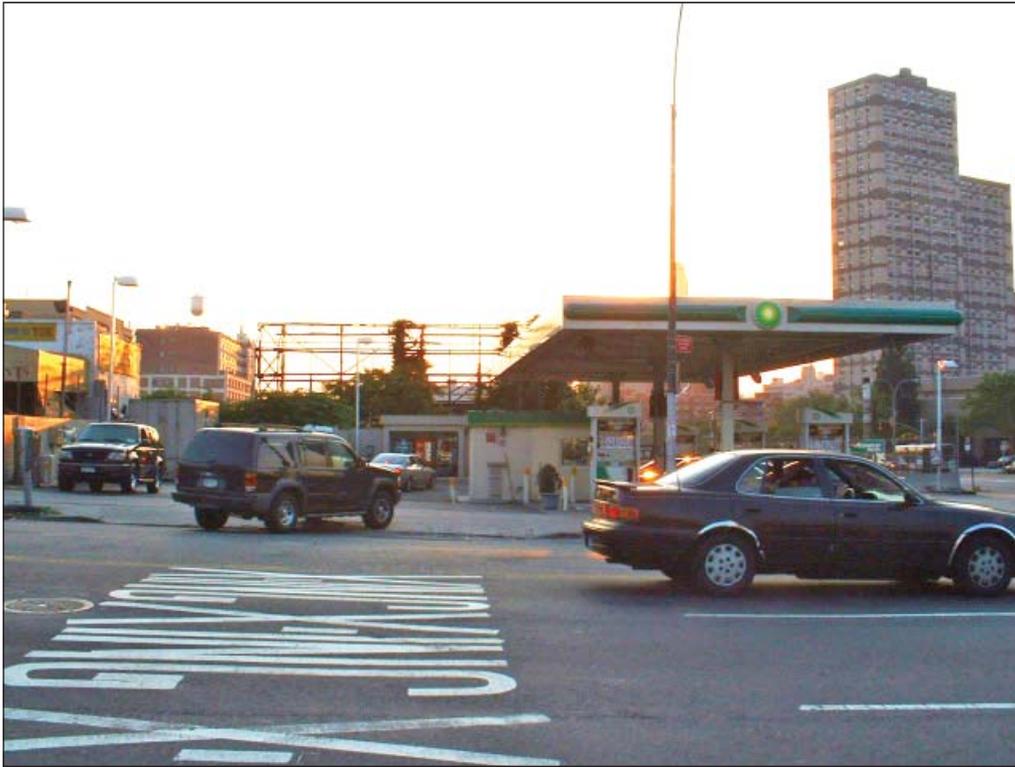
**Photograph 1121-42-A**

Lot 42 is located at 516 Vanderbilt Avenue, at the corner of Vanderbilt and Atlantic Avenues. The lot is occupied by a BP Amoco gas station (see Photograph A). Lot 42 is located in an M1-1 zoning district. M1 districts allow high-performance light manufacturing uses and often serve as buffers to adjacent residential or commercial districts. M1-1 districts have an FAR of 1.0. According to the New York City Department of Finance, lot 42 is owned by Heron Real Estate Company.

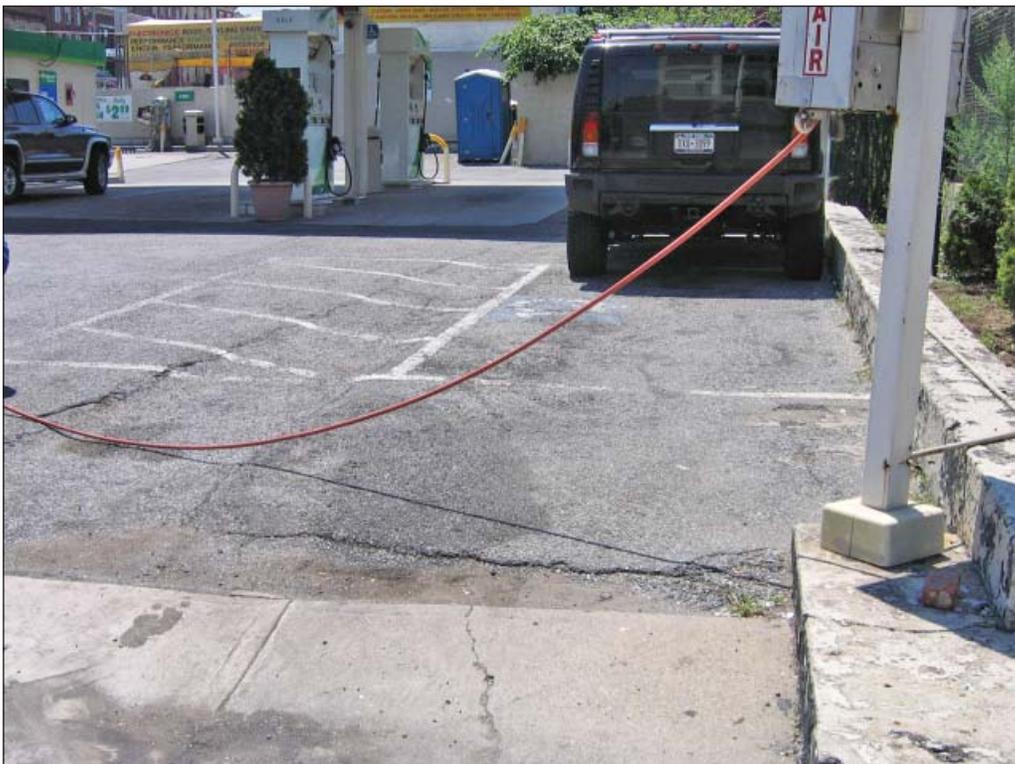
**Photograph 1121-42-B**

There are some cracks in the lot's asphalt surface and the sidewalk surrounding the lot is cracked and uneven in places (see Photograph B).
