Block I 128, Lot 4

Location, Use, Zoning, and Ownership

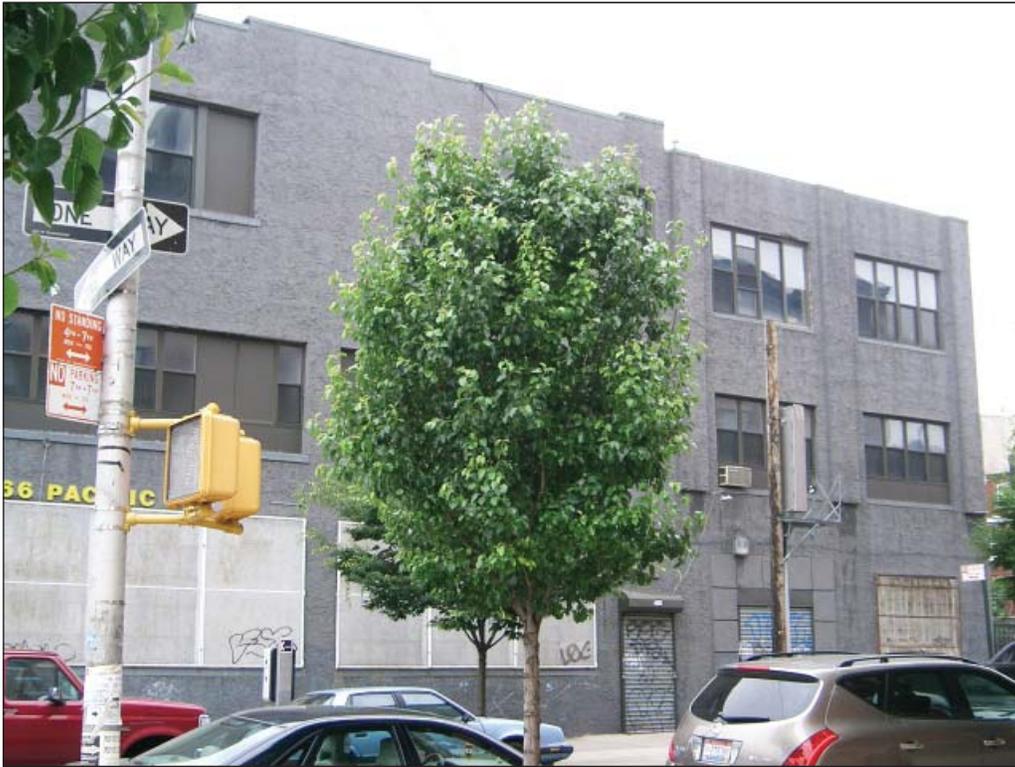
Photograph I 128-4-A

Lot 4 is located at 25 6th Avenue, on the corner of Pacific Street and 6th Avenue. It is an irregularly shaped lot, currently occupied by two attached three story commercial buildings which together contain 6,820 gsf of space (see Photograph A).

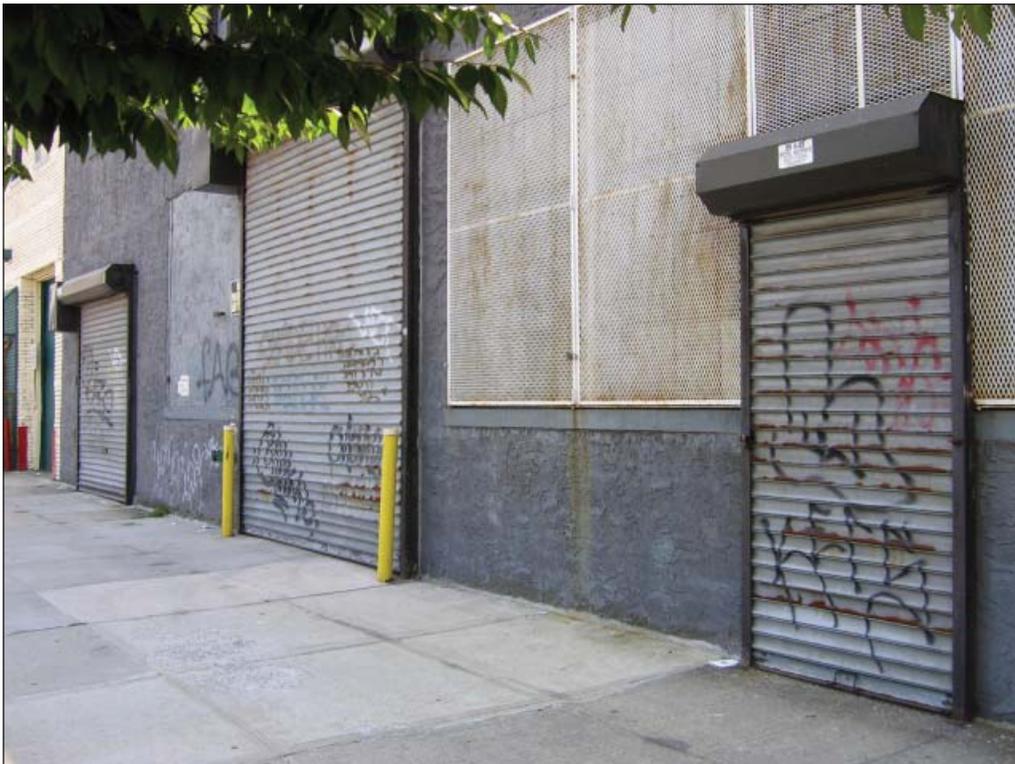
Photograph I 128-4-B

As shown in Photograph B, graffiti has been painted on the walls and garage doors of the building and the metal grating covering the windows has rusted. No other unsanitary or unsafe conditions were identified as part of the visual assessment.

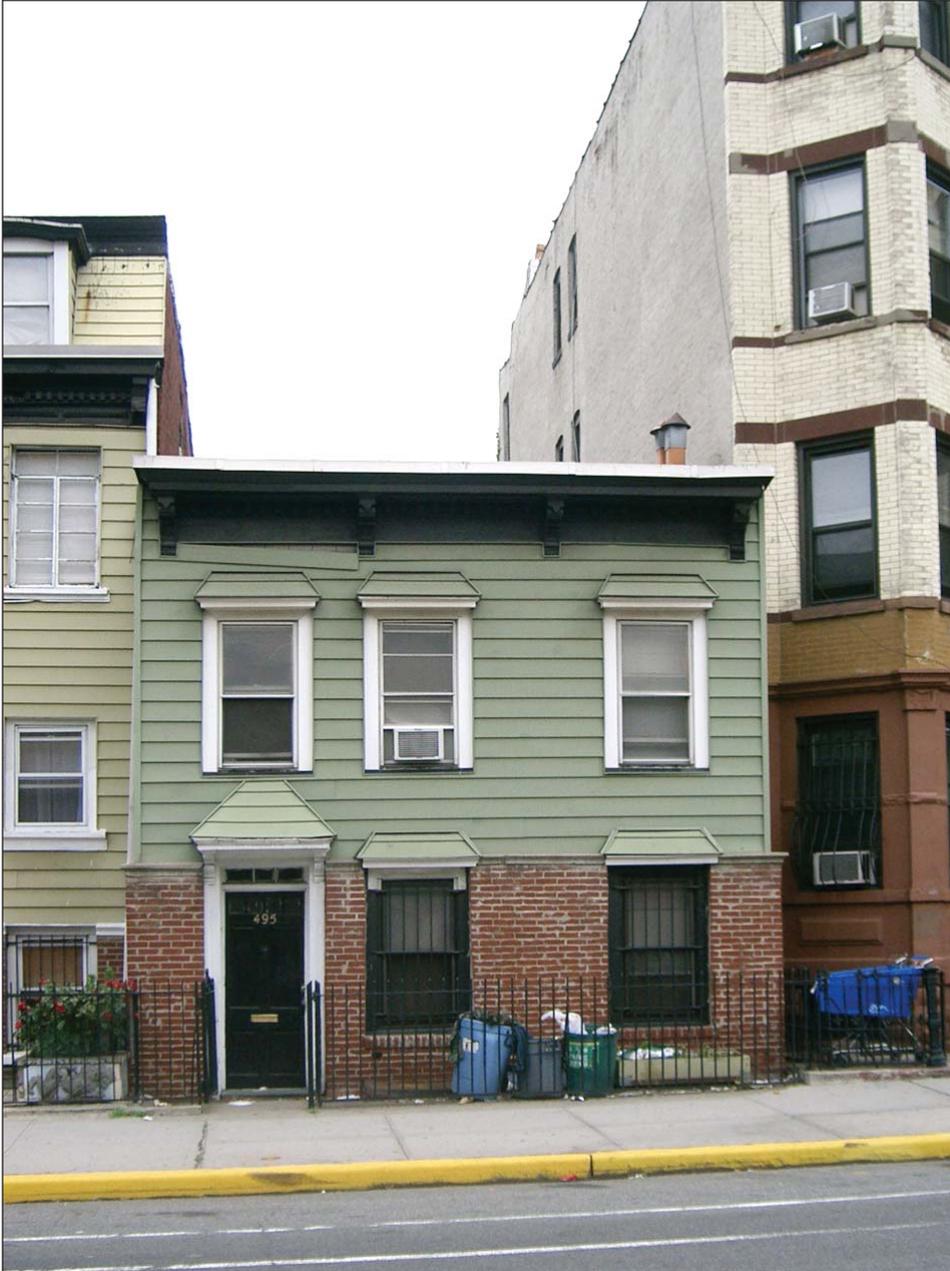
Photograph 1128-85-A

Lot 85 is located at 495 Dean Street between 6th and Carlton Avenues. The lot is occupied by a 1,200 gsf two-story single family home (see Photograph A). Lot 85 is located in an R6B zoning district (see Figure 6 and Table A-1). With an FAR of 2.0, R6B districts are generally characterized by shorter, four-story rowhouses or apartment buildings. According to the New York City Department of Finance, lot 85 is owned by Stewart Oliver.

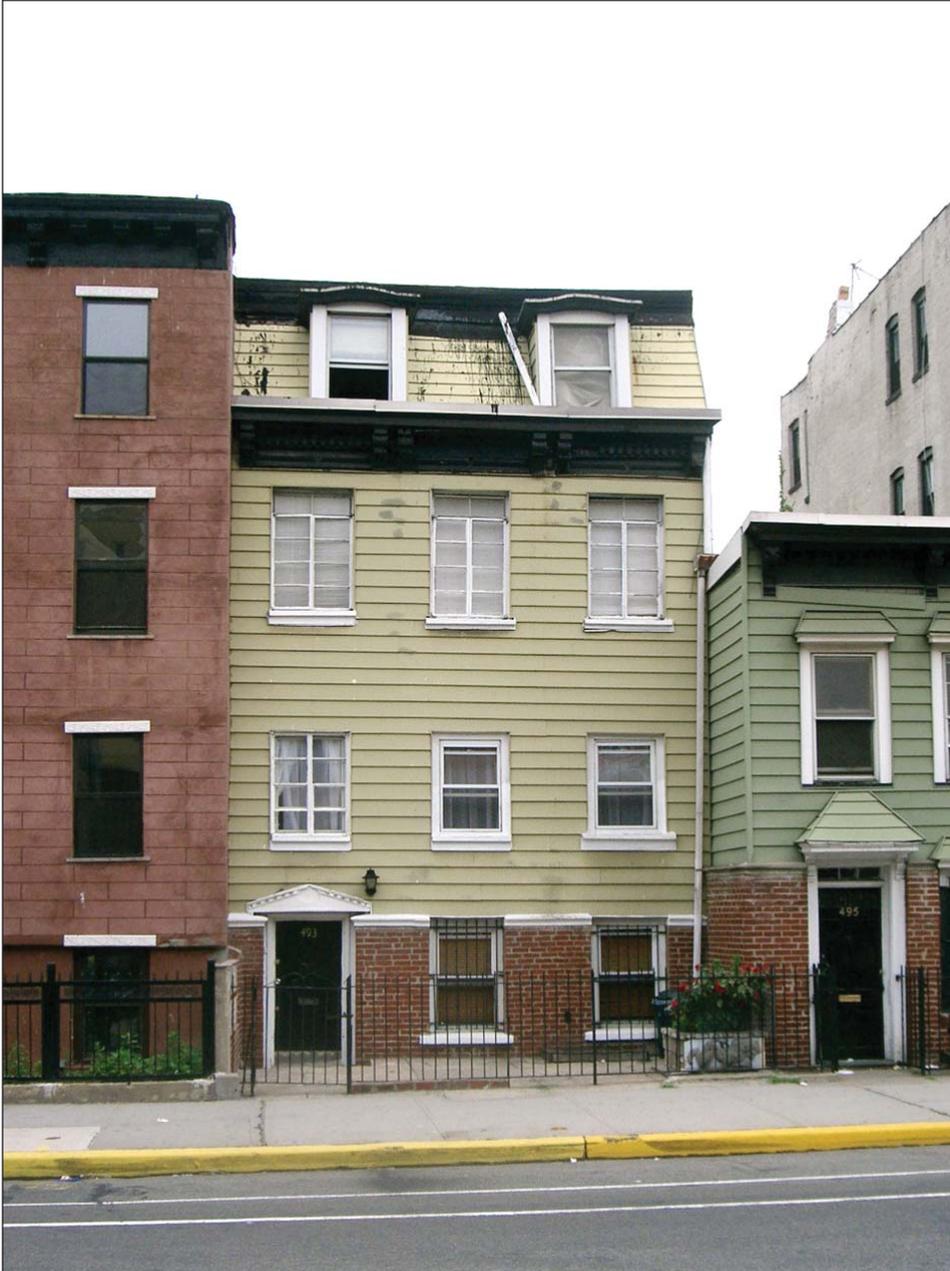
Photograph I 128-86-A

Lot 86 is located at 493 Dean Street between 6th and Carlton Avenues. The lot is occupied by a 2,200 gsf three-story single family home (see Photograph A). Lot 86 is located in an R6B zoning district (see Figure 6 and Table A-1). With an FAR of 2.0, R6B districts are generally characterized by shorter, four-story rowhouses or apartment buildings. According to the New York City Department of Finance, lot 86 is owned by Stewart Oliver Sinclair.

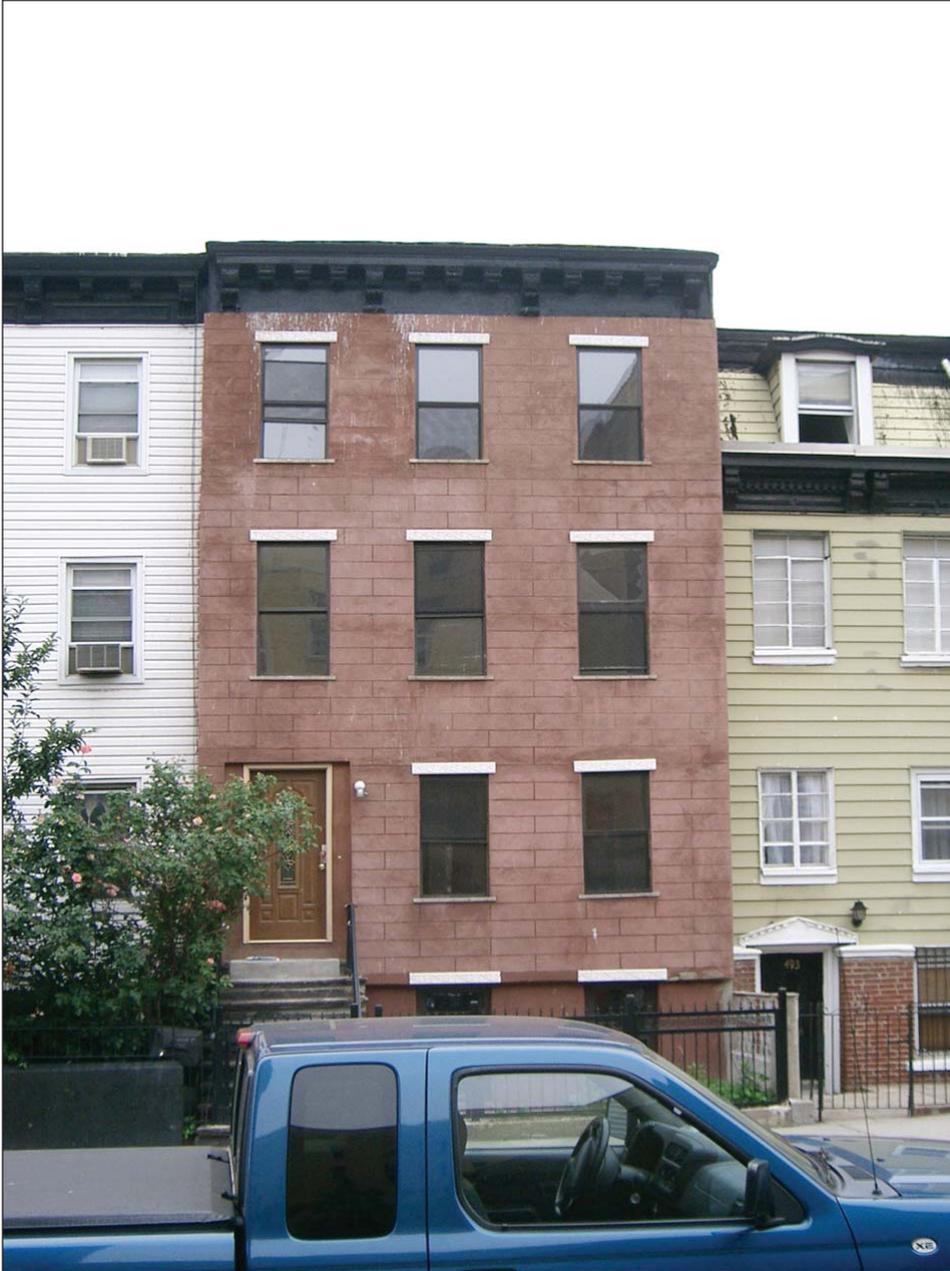
Photograph I 128-87-A

Lot 87 is located at 491 Dean Street between 6th and Carlton Avenues. The lot is occupied by a vacant 2,700 gsf, three-story residential building (see Photograph A). Lot 87 is located in an R6B zoning district (see Figure 6 and Table A-1). With an FAR of 2.0, R6B districts are generally characterized by shorter, four-story rowhouses or apartment buildings. According to the New York City Department of Finance, lot 87 is owned by Jurist Razvan.

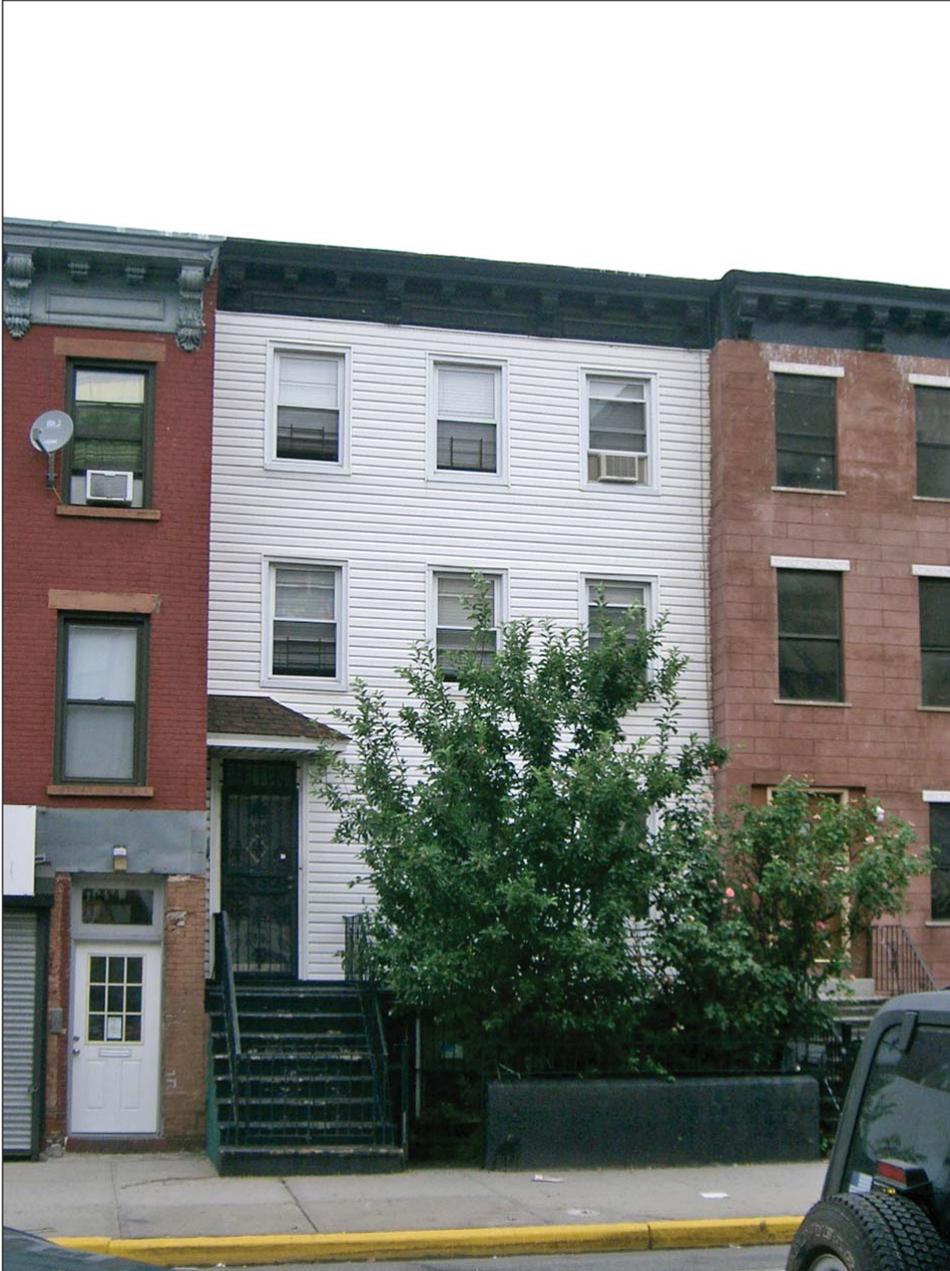
Photograph I 128-88-A

Lot 88 is located at 489 Dean Street between 6th and Carlton Avenues. The lot is occupied by a three-story, 2,000 gsf residential building (see Photograph A). Lot 88 is located in an R6B zoning district (see Figure 6 and Table A-1). With an FAR of 2.0, R6B districts are generally characterized by shorter, four-story rowhouses or apartment buildings. Lot 88 is currently owned by AYDC, which purchased the property in September 2005.

No Phase I or Phase II ESA was performed on this lot. A tank fill port was observed outside the property, indicating that a fuel oil storage tanks was currently or historically present on lot 88.

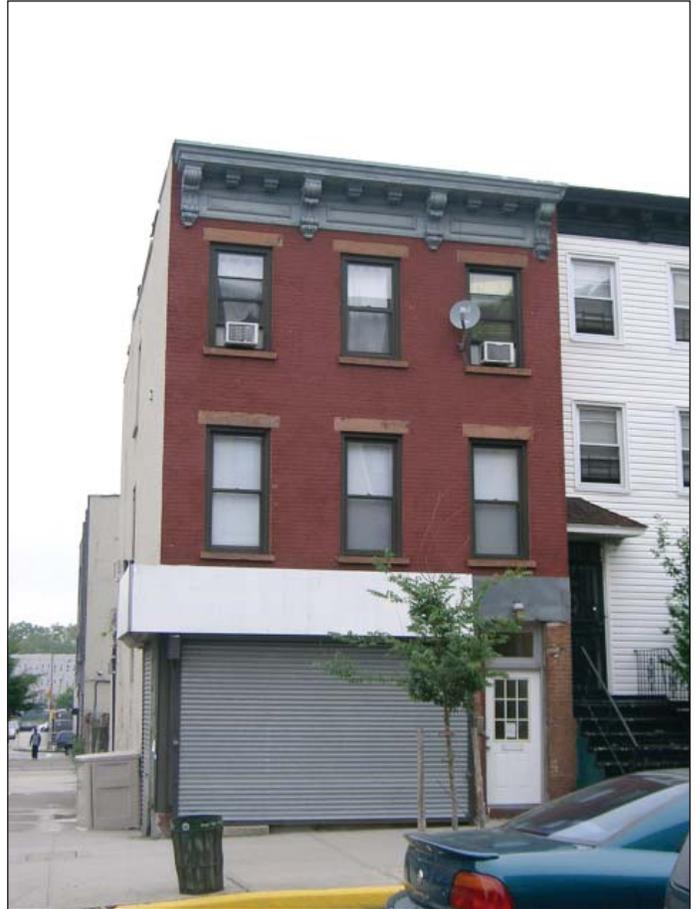
Photograph 1128-89-A

Lot 89 is located at 487 Dean Street on the corner of 6th Avenue and Dean Street. The lot is occupied by a three-story, 2,610 gsf residential building with ground floor commercial space (see Photograph A). Lot 89 is located in an R6B zoning district (see Figure 6 and Table A-1). With an FAR of 2.0, R6B districts are generally characterized by shorter, four-story rowhouses or apartment buildings. According to the New York City Department of Finance, lot 89 is currently owned by Mott and Chloe. LLC.

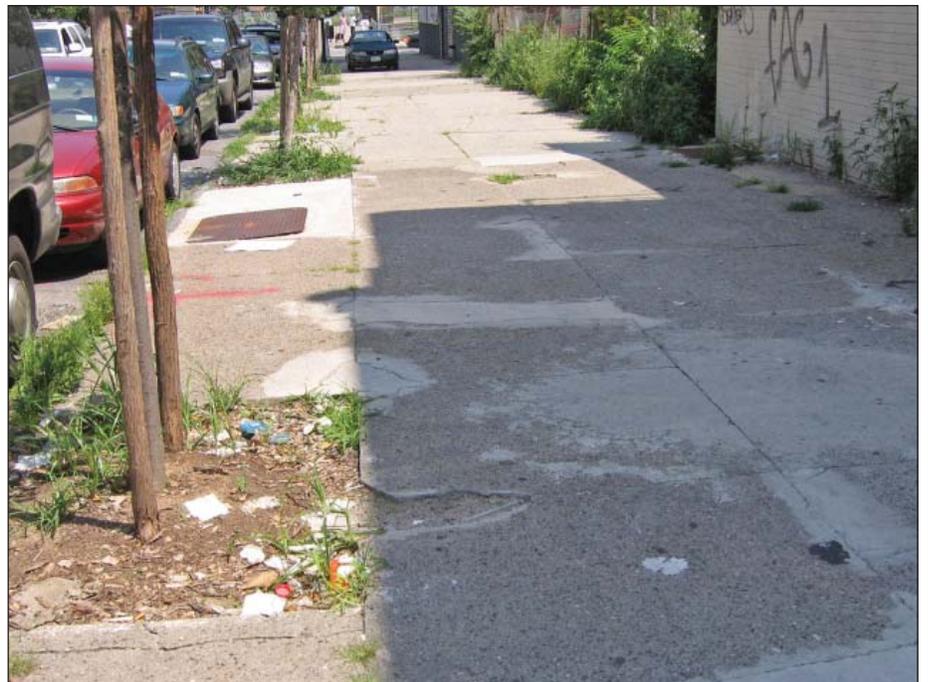
Photograph 1128-89-B

The sidewalk along the 6th Avenue side of lot 89 is in poor condition. In some places, the sidewalk is cracked and crumbling and in others, it is poorly patched (See Photograph B). Weeds grow along the curb for the length of the lot. In addition, as shown in Photographs C and D, graffiti has been painted on the western façade of the building, which faces 6th Avenue.

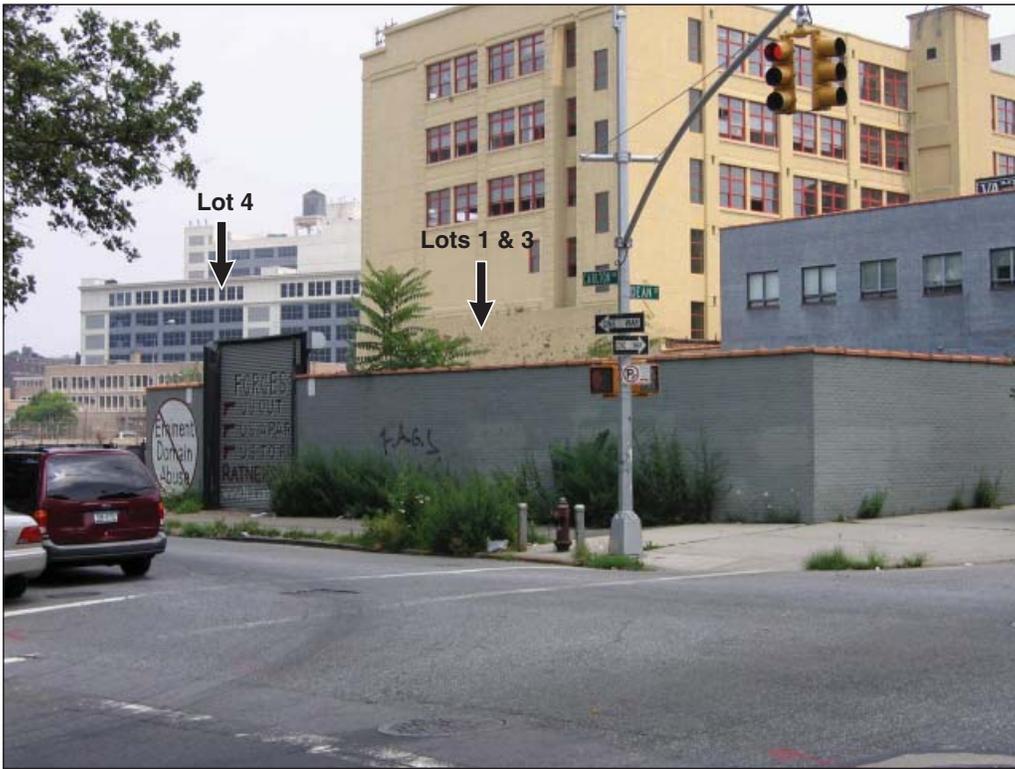
Photograph I 129-1/3-A

Lots 1 and 3 comprise the fenced vacant property attached to the vacant industrial building located on lot 81 (see Photograph A). The lots are located at 551 Carlton Avenue (lot 1) and 549 Carlton Avenue (lot 3), with lot 1 occupying the corner of the Block. Lots 1 and 3 are located in an M1-1 zoning district with an FAR of 1.0. M1 districts allow high-performance light manufacturing uses and often serve as buffers to adjacent residential or commercial districts. Lots 1 and 3 are currently owned by AYDC, which purchased them, along with the building on adjacent lot 81, in May 2004.

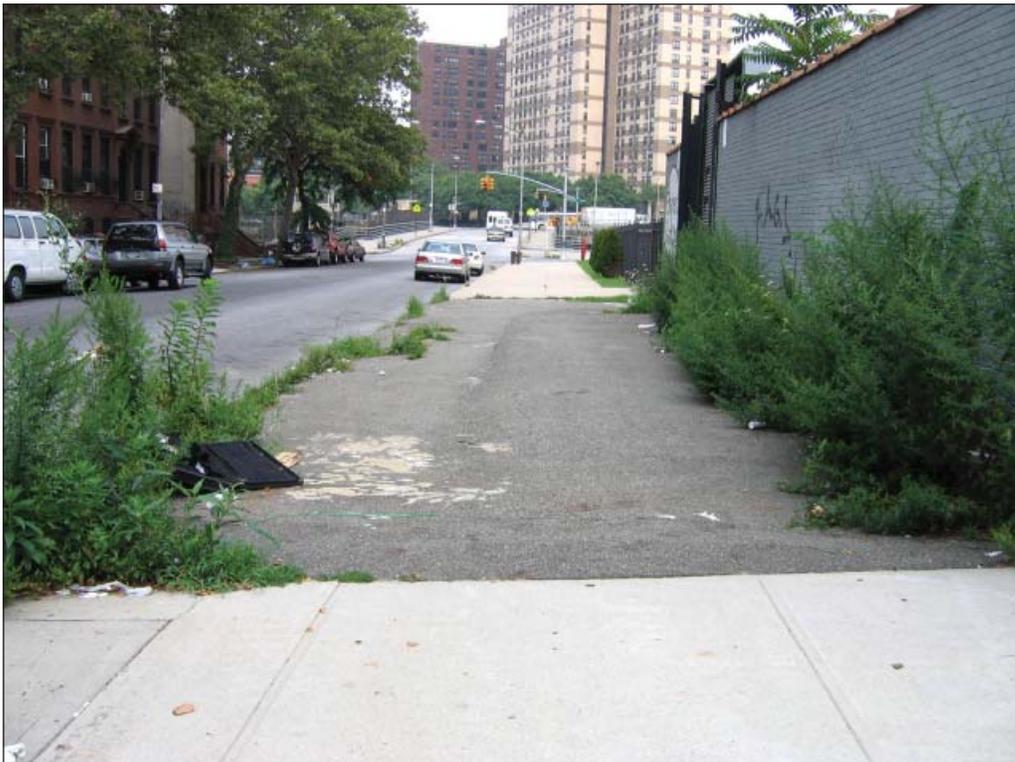
Photograph I 129-1/3-B

As shown in Photograph B, the asphalt sidewalk surrounding lots 1 and 3 is overgrown with weeds along both the interior and curbside portions of the sidewalk, and some graffiti has been painted on the wall of lot 3. No other unsanitary or unsafe conditions were identified as part of the visual assessment for lots 1 or 3. However, as described later in this document, the building on lot 81—which was adjacent to lots 1 and 3 and is functionally attached to lots 1 and 3 by a concrete masonry unit wall that was attached to the building on lot 81—was in such a state of serious disrepair that it was demolished by AYDC in Spring 2006, with approval from ESDC.

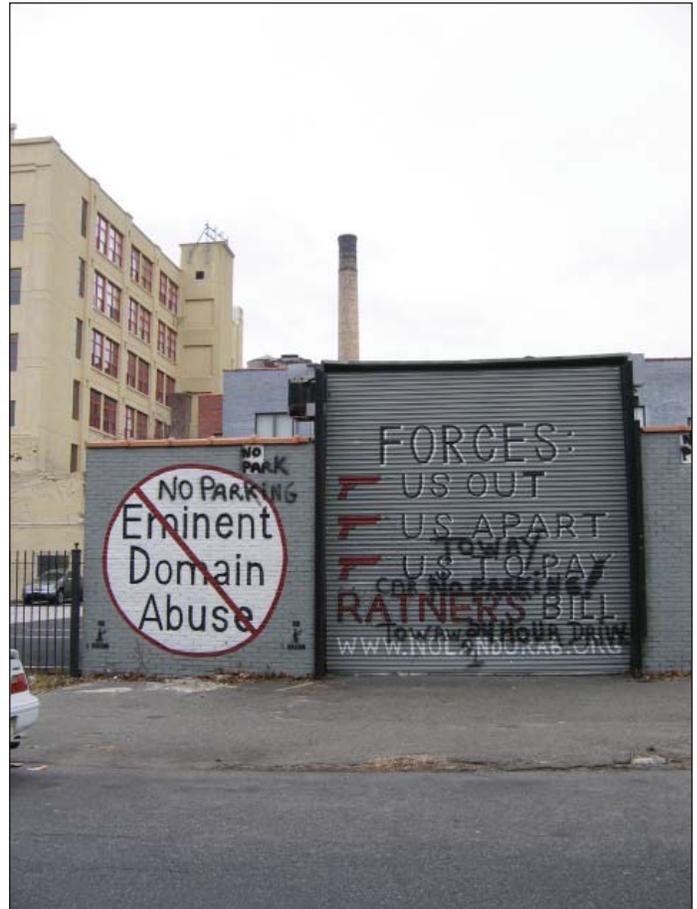
Photograph I 129-4-A

Lot 4 is a vacant 2,600 sf lot located at 547 Carlton Avenue. As shown in Photograph A, the lot has the appearance of being connected to the adjacent lot to its south (lot 3), but it is in fact a separate lot under separate ownership. Lot 4 is located in an M1-1 zoning district with an FAR of 1.0. M1 districts allow high-performance light manufacturing uses and often serve as buffers to adjacent residential or commercial districts. According to the New York City Department of Finance, the lot is currently owned by 535 Carlton Avenue Realty Corporation.

As shown in Photograph A, there are some weeds growing along the interior and curbside portions of the asphalt sidewalk in front of lot 4 and the metal door and wall to its left have messages painted on them. As shown in Photographs B through D, the lot is being used to store broken down cars and car parts and is littered with debris. Legal papers posted on the property gate as of May 2006 indicate that the tenant is being evicted by the owner.

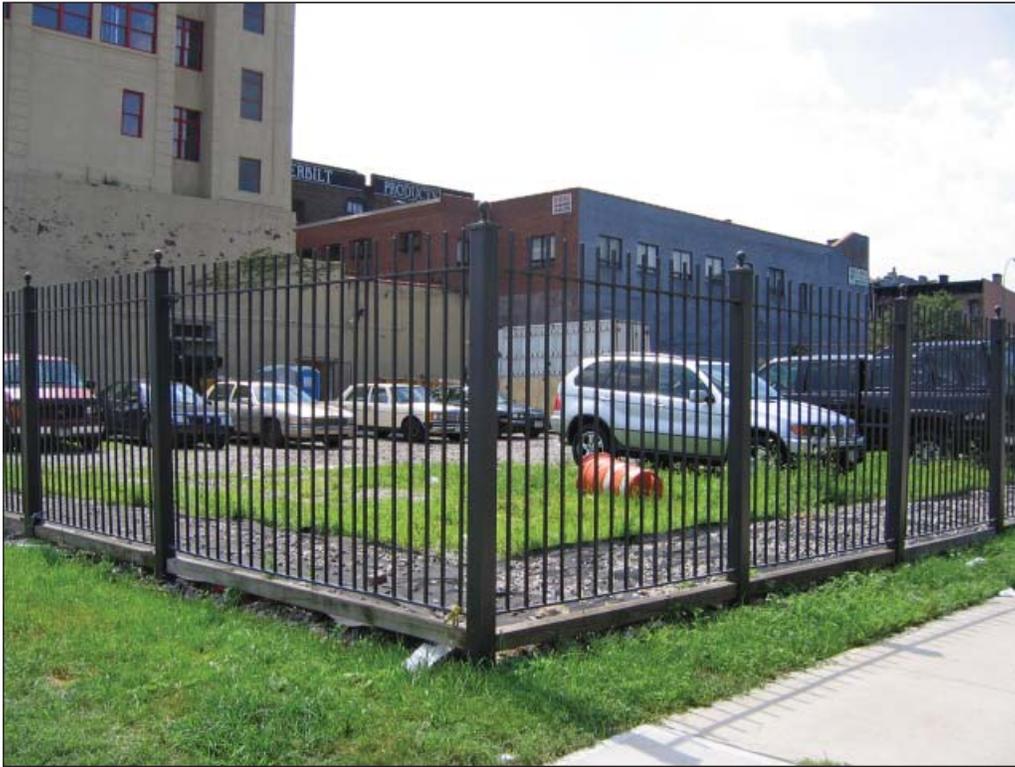
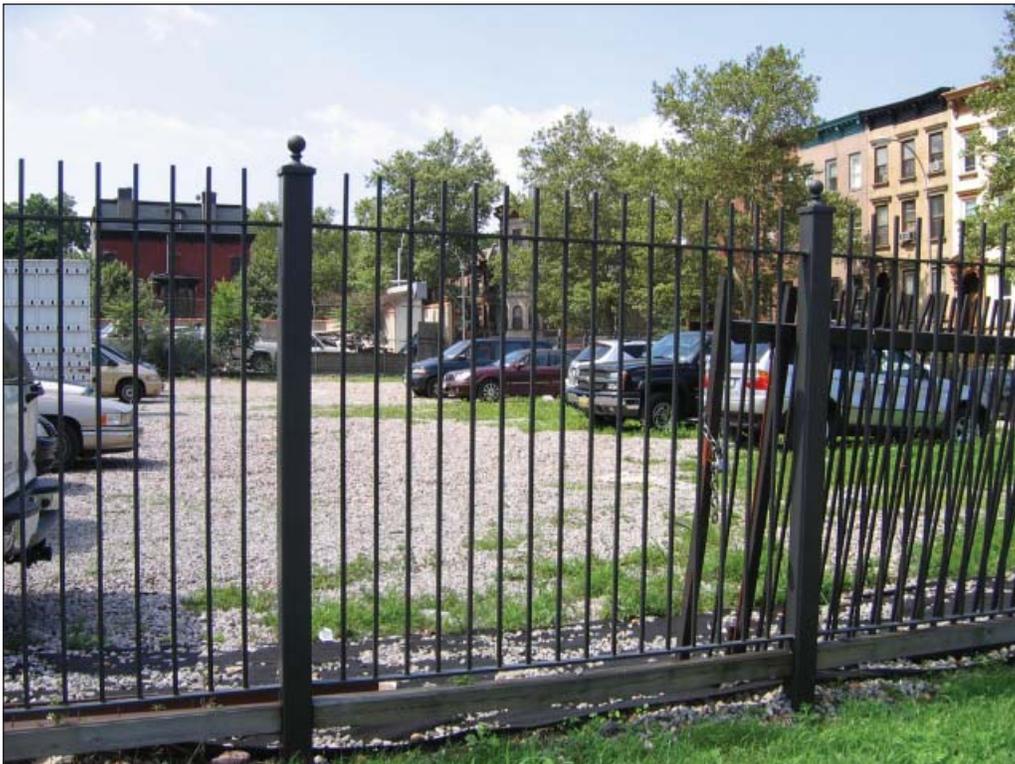
Lots 5 and 6 comprise a parking lot that serves the six story industrial building located on adjacent lot 13 (see Photographs A and B). The lots are located at 545 Carlton Avenue (lot 5) and 543 Pacific Street (lot 6), with lot 6 occupying the northwest corner of the Block. Lots 5 and 6 are located in an M1-1 zoning district with an FAR of 1.0. M1 districts allow high-performance light manufacturing uses and often serve as buffers to adjacent residential or commercial districts. According to the New York City Department of Finance, lots 5 and 6 are owned by 535 Carlton Avenue Realty Corporation. The lots are leased by Pacific Street Park Corporation. AYDC entered into an option to take by assignment the tenant's interest in the ground lease for the lots, subject to the fee owner's consent to such assignment, which consent cannot be unreasonably withheld. The closing of that assignment occurred in March 2006, but the fee owner has disputed the validity of the assignment.

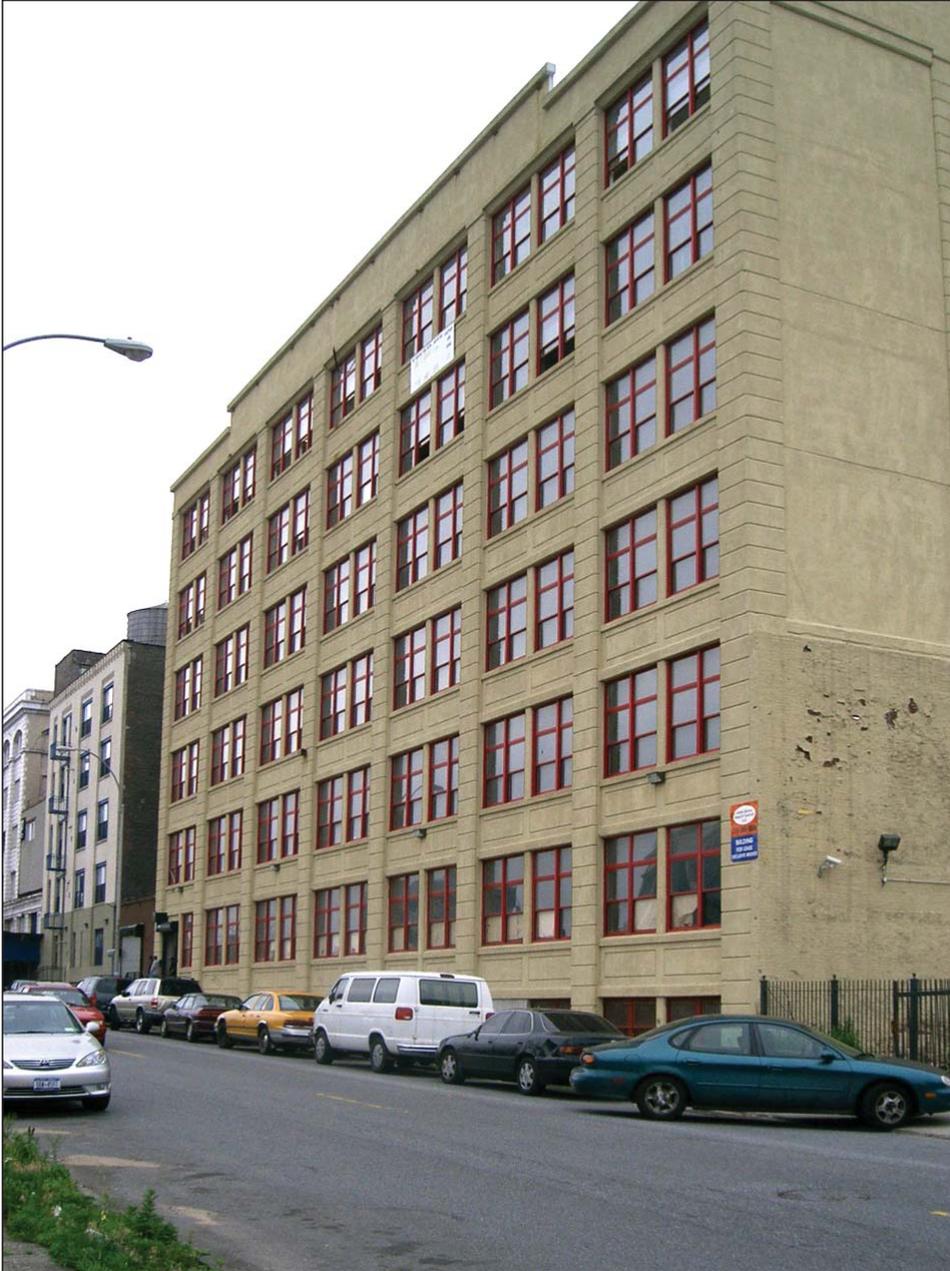
Photograph I 129-13-A

Lot 13 is located at 752-766 Pacific Street between Carlton and Vanderbilt Avenues. The lot is occupied by a six story 83,200 gsf industrial building (see Photograph A). Lot 13 is located in an M1-1 zoning district with an FAR of 1.0. M1 districts allow high-performance light manufacturing uses and often serve as buffers to adjacent residential or commercial districts. According to the New York City Department of Finance, lot 13 is owned by Pacific Carlton Development Corporation. The lots are leased by 752 Pacific, LLC (“752 Pacific”). AYDC entered into an option to take by assignment the tenant’s interest in the ground lease for the property, subject to the fee owner’s consent to assignment, which consent cannot be unreasonably withheld. The closing of that assignment occurred in March 2006, but the fee owner has disputed the validity of the assignment.

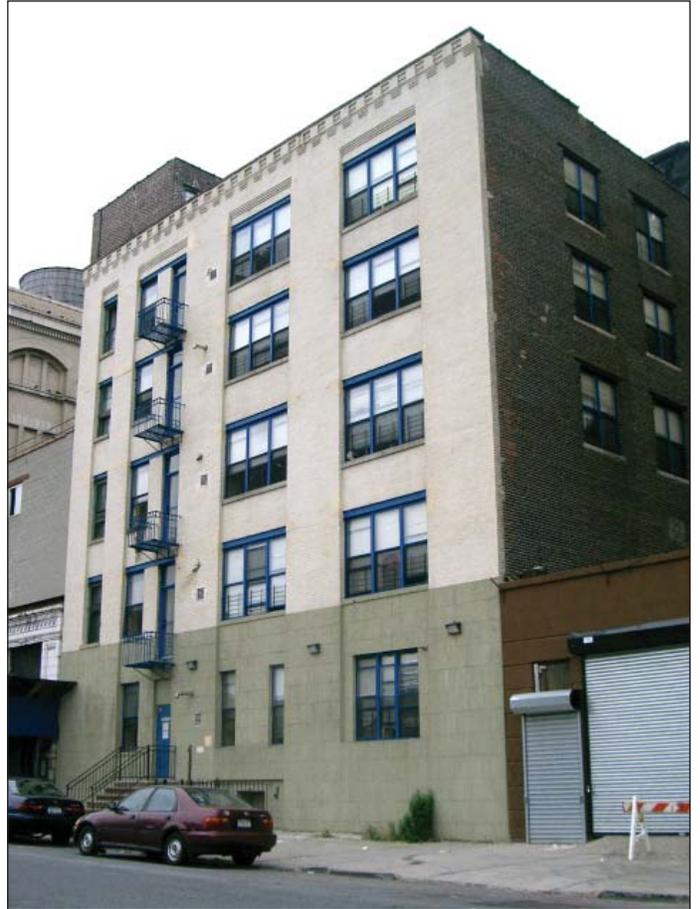
Photograph 1129-21-A

Lot 21 is located at 768 Pacific Street between Carlton and Vanderbilt Avenues. The lot is occupied by a five story 25,000 gsf building that is currently used, along with the building on adjacent lot 76, to provide temporary housing for homeless families (see Photograph A). Lot 21 is located in an M1-1 zoning district with an FAR of 1.0. M1 districts allow high-performance light manufacturing uses and often serve as buffers to adjacent residential or commercial districts. According to the New York City Department of Finance, lot 21 is owned by Pacific Dean Realty. It is leased by Specific Street, LLC.

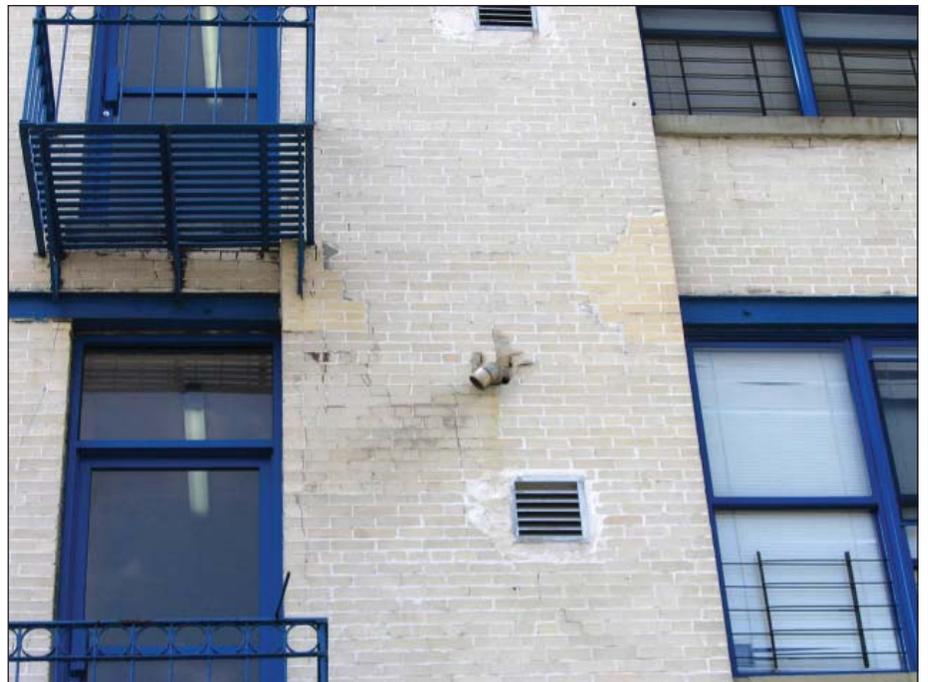
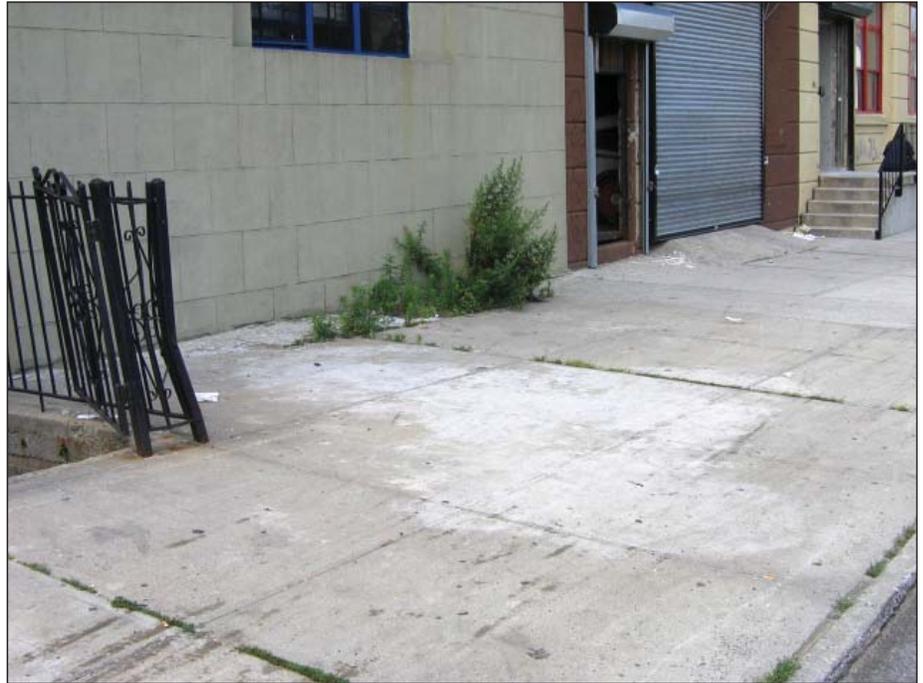
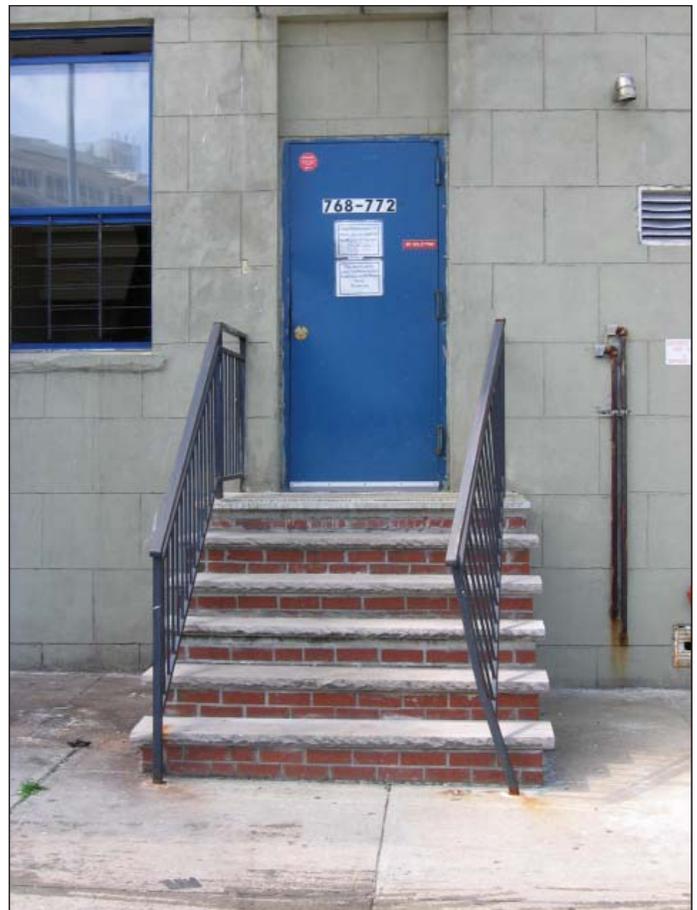
There are some small cracks running through portions of the building's façade and it appears as though some of the brickwork surrounding some windows degraded and has been replaced recently (see Photograph B). As shown in Photograph C, the sidewalk in front of lot 21 is in fair condition, but weeds grow through some of the cracks—particularly against the building's façade. As shown in Photograph D, the stair railing leading up to the building entrance is bent.
