## Block 1998 Lot 26

<b>SITE CONDITION:</b>	<b>POOR</b>
------------------------	-------------

Manhattanville Neighborhood Conditions Study

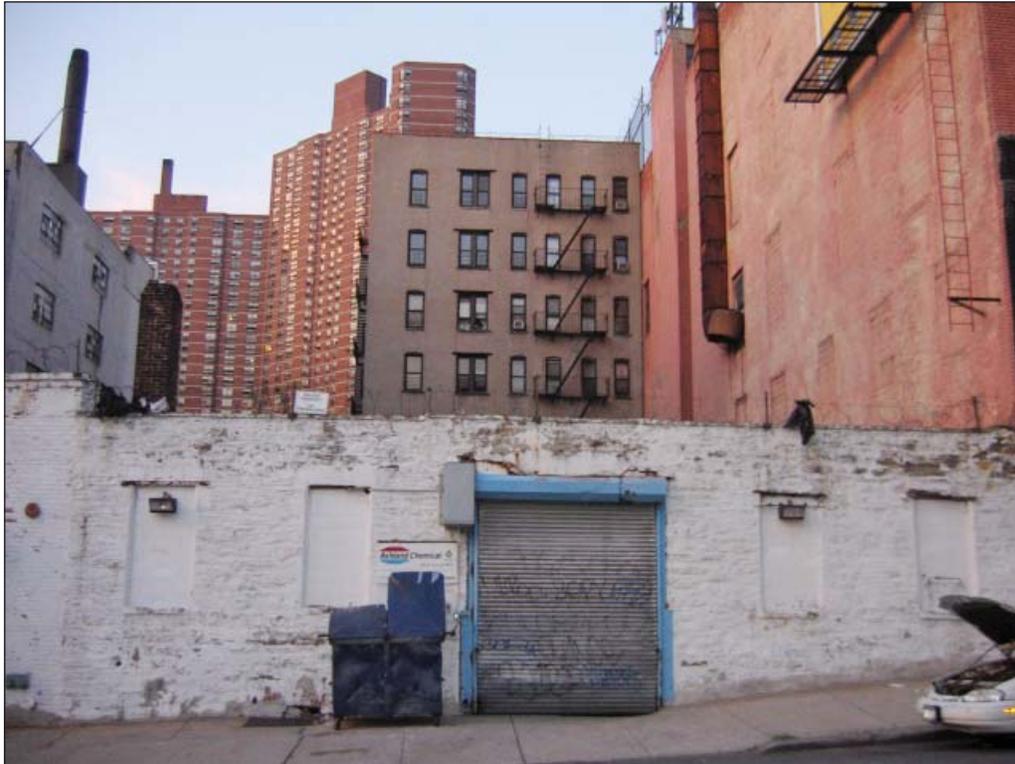
**Photograph 1998-26-A**

Lot 26, which is in an M1-2 zoning district, is located at 605 West 131st Street between Twelfth Avenue and Broadway (see Photograph A). Like Lot 24, the one-story 4,996-gsf building was acquired by Ashland Chemical, Inc. circa September 1990, which occupies the lot as well. The property is under contract by the Trustees of Columbia University. DOB records list the estimated build year as 1910; however its presence on a historic Sanborn map from 1909 indicates that it was likely constructed prior to 1909. No renovations have been recorded.

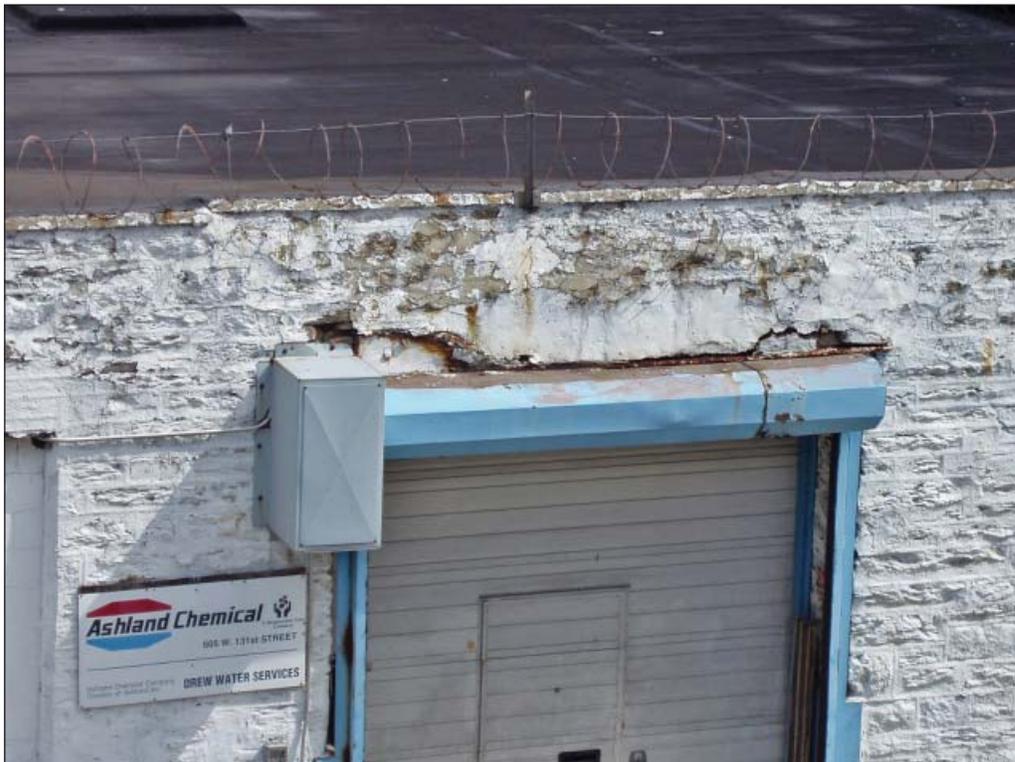
**Photograph 1998-26-B**

The exterior wall along West 131st Street, which is topped with razor wire, appears to be in critical condition with widespread cracks and severe deterioration, including a wide crack above the roll-up door (see Photograph B); damage to the brick masonry facing and mortar joints (see Photographs C and D); deteriorated lintels above the bricked-in windows (see Photograph C); and a hole in the masonry at the sidewalk-façade interface, which could allow rainwater or ground water runoff to enter the building (see Photograph E). The entryway's concrete slab-on-grade is broken and severely spalling (see Photograph F). The roof membrane appears to be in fair condition, however, ponding water, water staining, and debris accumulation was observed (see Photograph G).

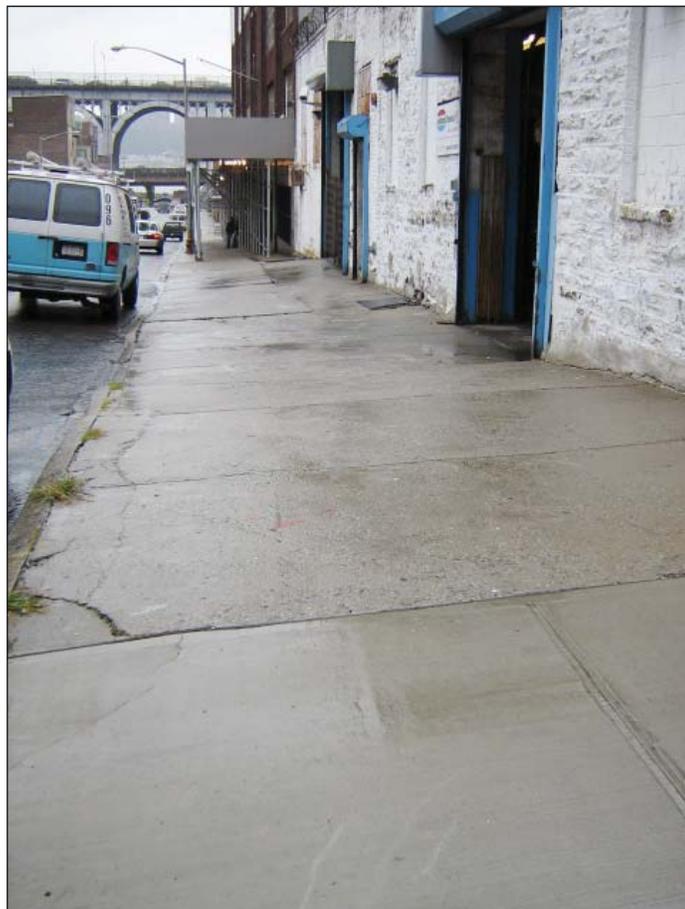
**Photograph 1998-26-H**

As shown in Photograph H, the sidewalk along West 131st Street is in poor condition with some wide cracks and vegetation observed, while the curbs cuts appear to be in fair condition.
