# Environmental Site Assessment

*Monterey Correctional Facility  
2150 Evergreen Hill Road  
Beaver Dams, New York*

**December 26, 2013**

OGS Contract # S5339, Project SA363, Work Order # 48, HRP Job #NEW7427.P1

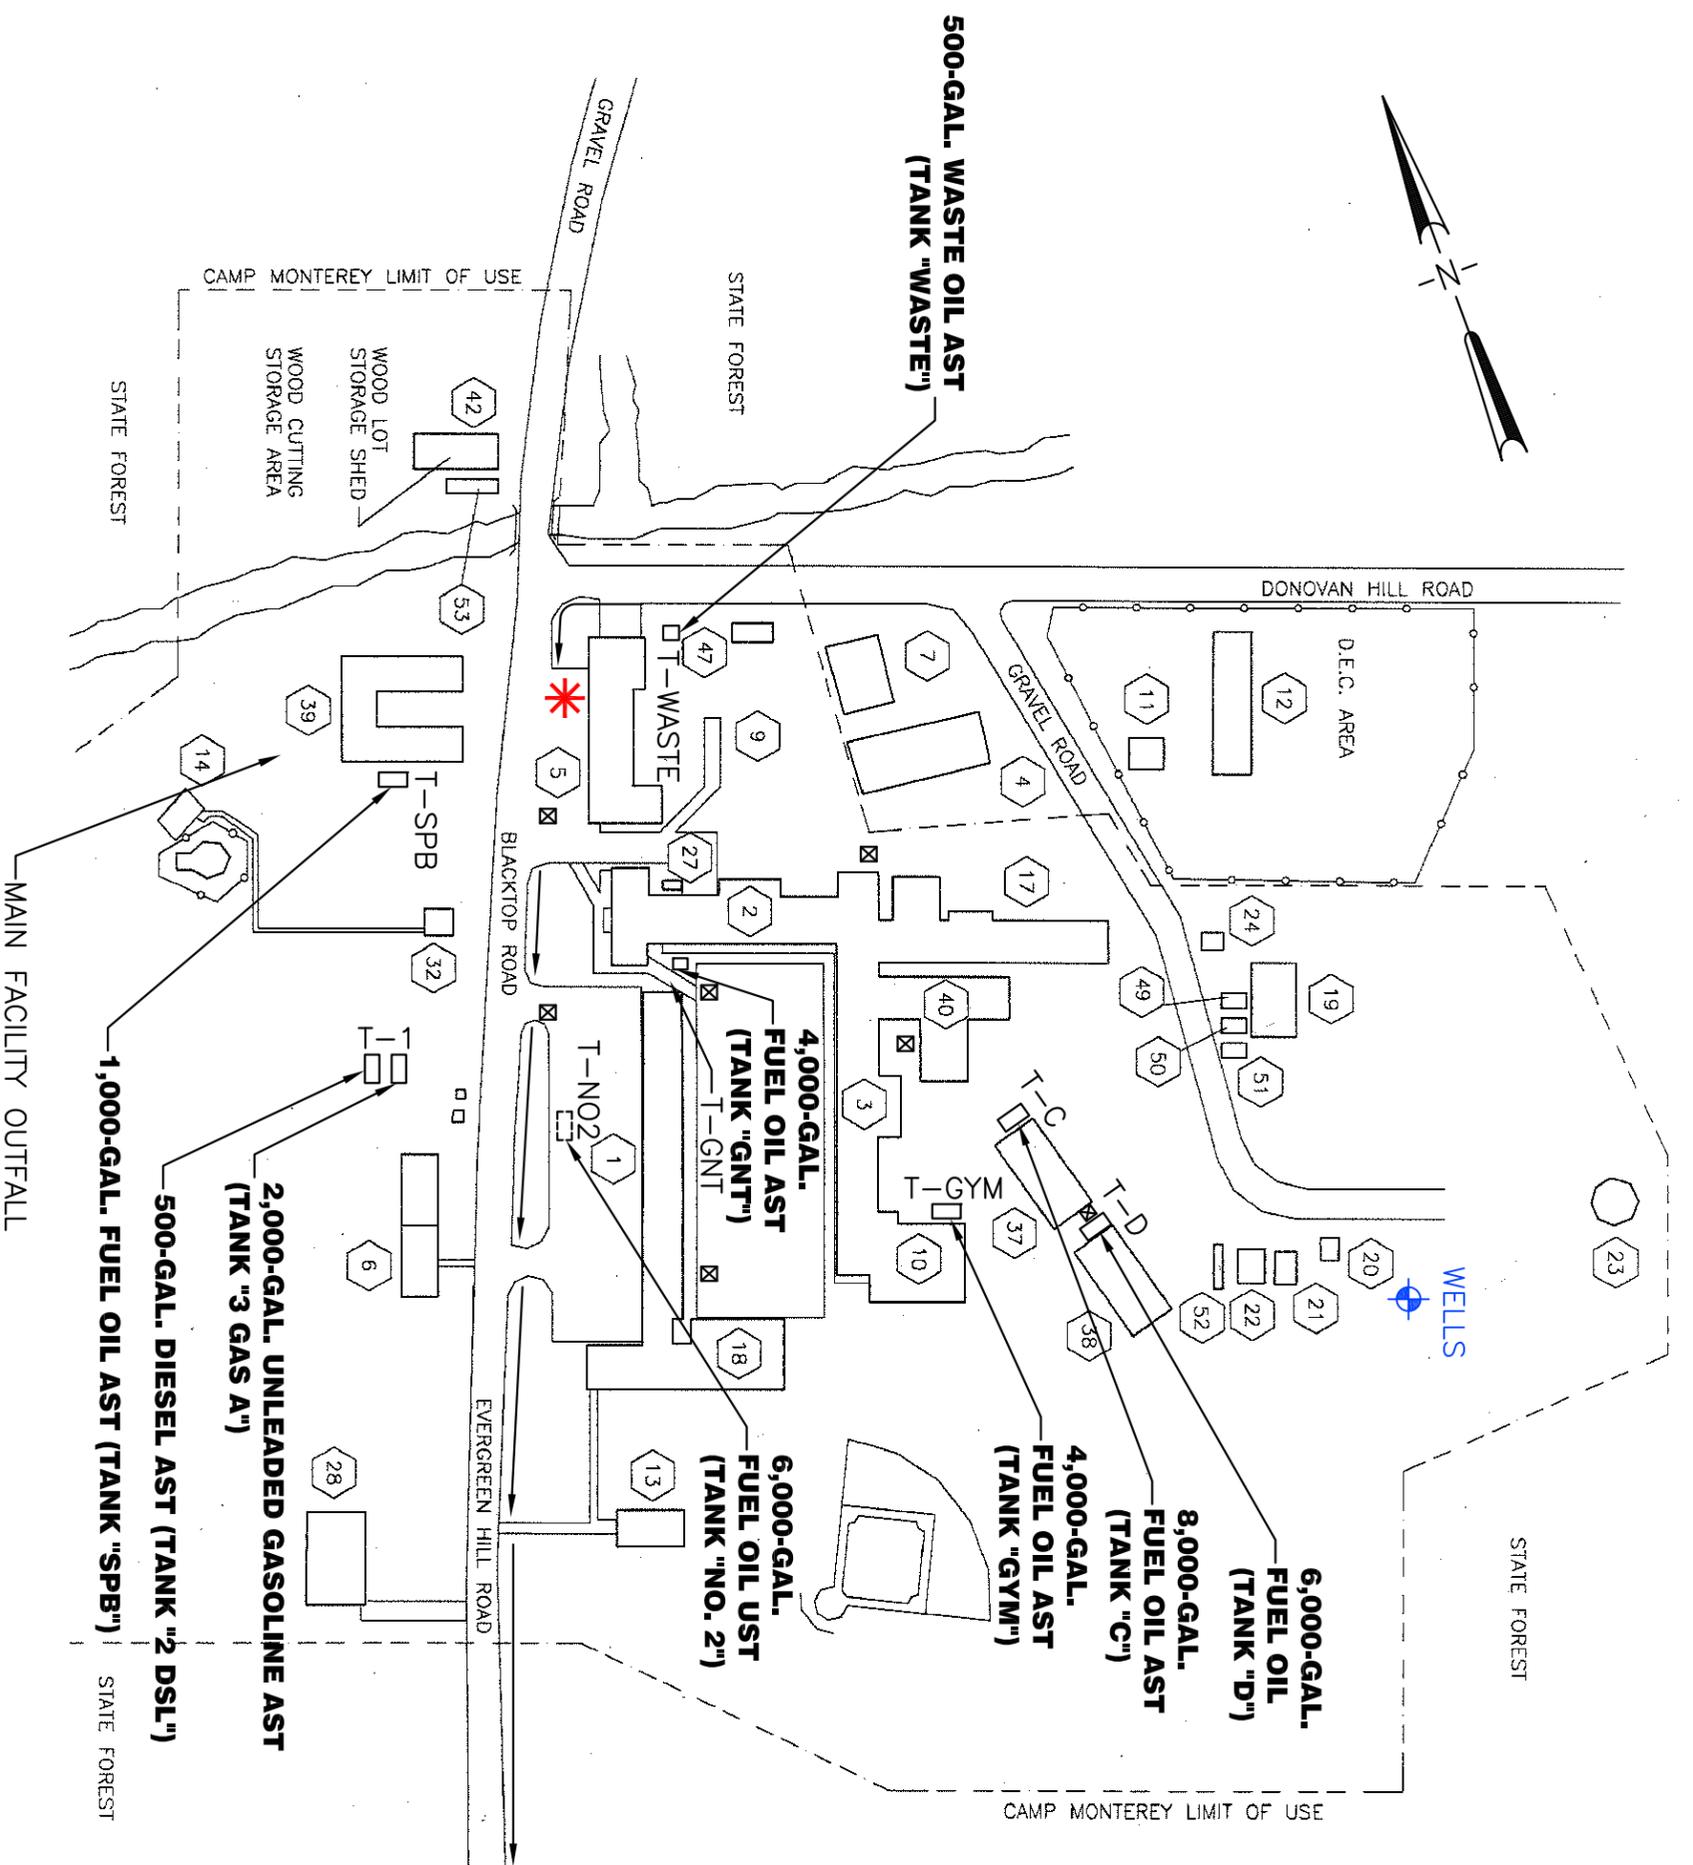
**FIGURE 2**  
**SITE PLAN**  
**MONTEREY SHOCK**  
**INCARCERATION FACILITY**  
**MONTEREY, NY**  
**HRP # NEW7427.P1**  
**NOT TO SCALE**

Based on HRP's review of information provided by DOCCS and site observations, the following description of the current site buildings is offered. The site is improved by 45 buildings (comprising approximately 86,814 square feet) which are listed in Appendix B along with their approximate date of construction, type of construction, number of stories, use, heating source, and past hazardous substance storage. The buildings reportedly range in date of construction from the 1958 to 2010.

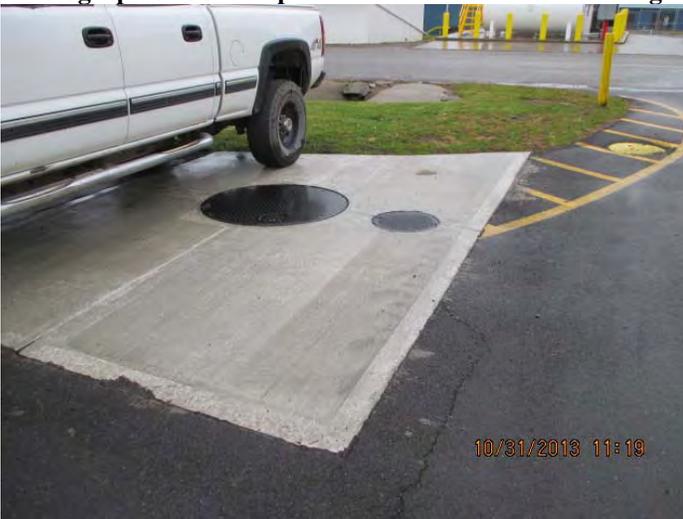
**Photograph of UST fill pad near Administration Building.**

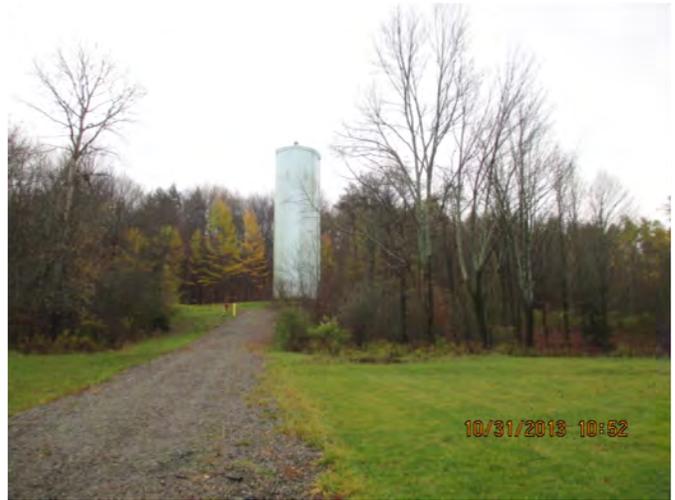
**Photograph of water storage tower.**

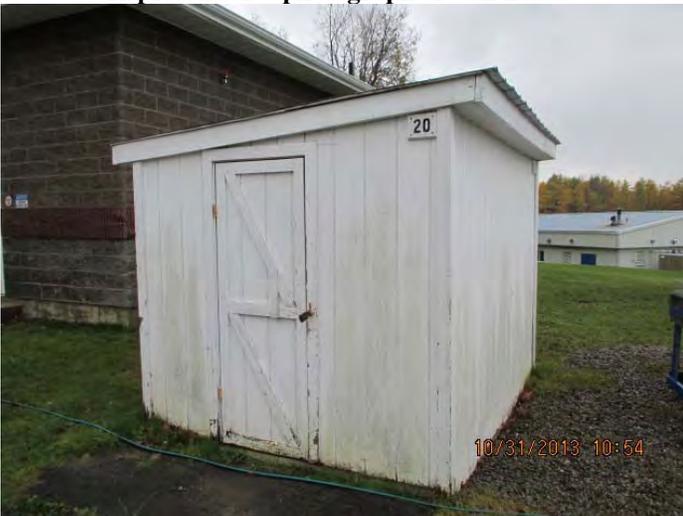
The facility's drinking water is supplied by three onsite drinking water wells. Spill # 0510294 was called in on November 30, 2005 as a result of a toluene detection in one of the onsite drinking water wells at 7.6 parts per billion (ppb). The detection was caused by electrical tape used in well casing repair. The tape was removed and sample results from April 13, 2006 were non-detect for toluene. The onsite drinking water is monitored on a semi-annual basis and no exceedences of toluene have been detected. However, the spill was closed not meeting DEC standards on May 3, 2006.

**Representative photograph of well house.**

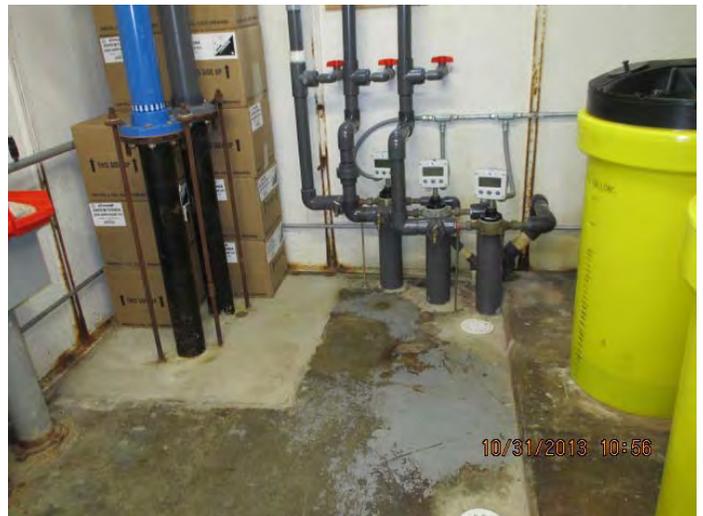
Generally, chemicals stored were in small quantities or the stored materials had been removed due to the facility closure. Approximately 10 boxes of chlorine were observed in the Pump House (Building 21) for potable water treatment for the onsite wells.

**Photograph inside water treatment building.**

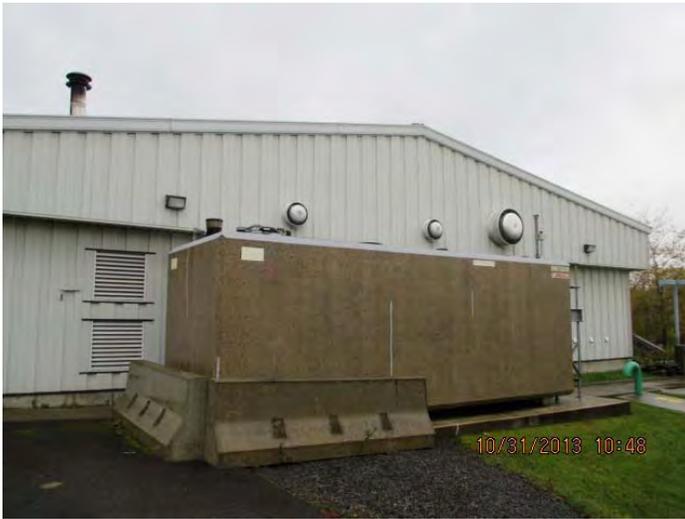
Eight primary ASTs and five day tanks containing fuel oil, diesel, gasoline, and motor oil were observed onsite and are listed in Section 6.12. The ASTs present are used for automotive refueling, heating, and an emergency generator. No staining was observed near these ASTs, which were observed to be properly numbered, labeled, and located in secondary containment units. Exterior observations and conversations with the site contacts indicate that each of these ASTs are double walled tanks; however, HRP was not able to observe the surface immediately below the tanks. No staining was observed in the vicinity of these ASTs.

**Representative photograph of aboveground storage tank.**

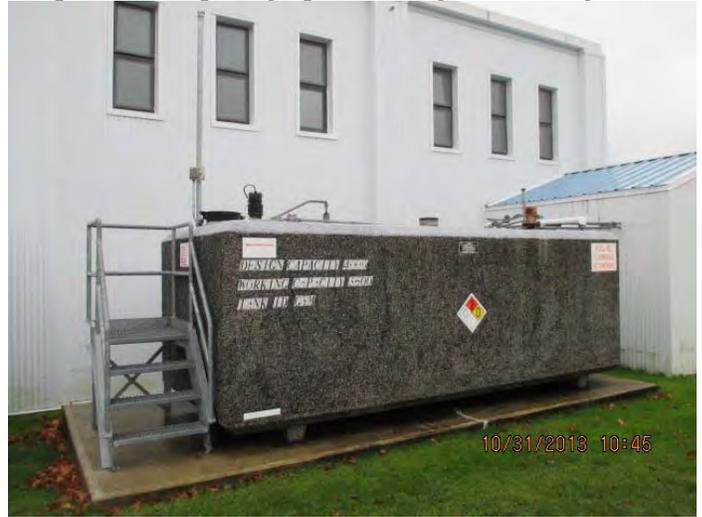
**Representative photograph of aboveground storage tank.**

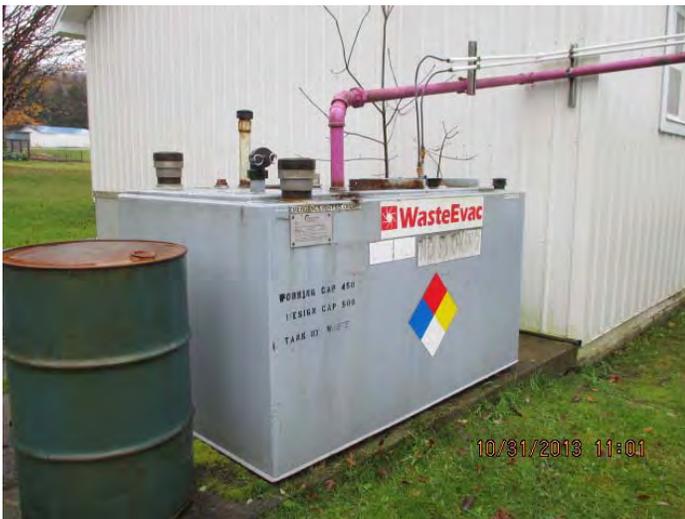
**Photograph of waste oil AST.**

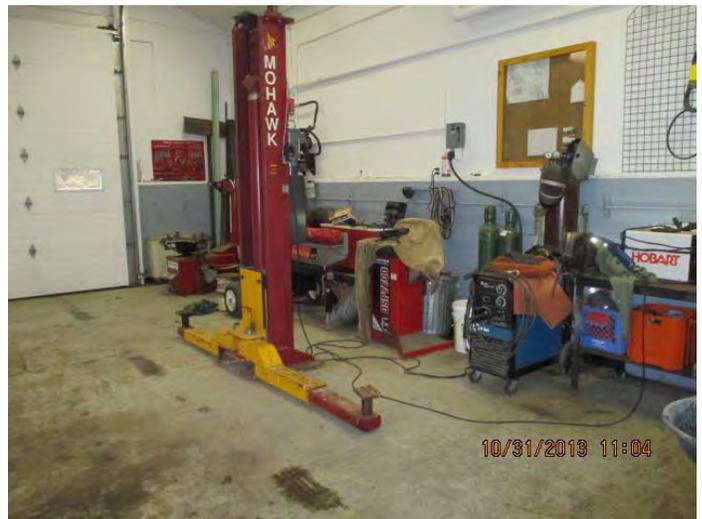
**Photograph of interior of maintenance building.**

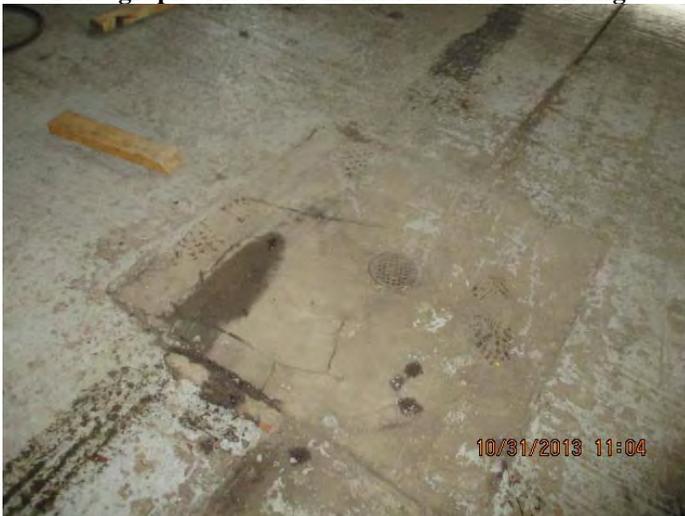
ITEM	Observed?
Septic System	No evidence of septic systems was observed onsite.
Drains/Sumps	Floor drains were noted in several buildings, all reportedly directly connected to the WWTP with the exception of three floor drains in the maintenance building (Building 5). Three floor drains within the vehicle maintenance shop reportedly discharge to an oil/water separator prior to discharge to the wastewater treatment plant. No petroleum sheens, odors, or staining was noted in or near any of the drains.
Pits, Ponds, Lagoons	No evidence of pits, ponds, or lagoons was observed onsite.

**Photograph of floor drain in maintenance building.**

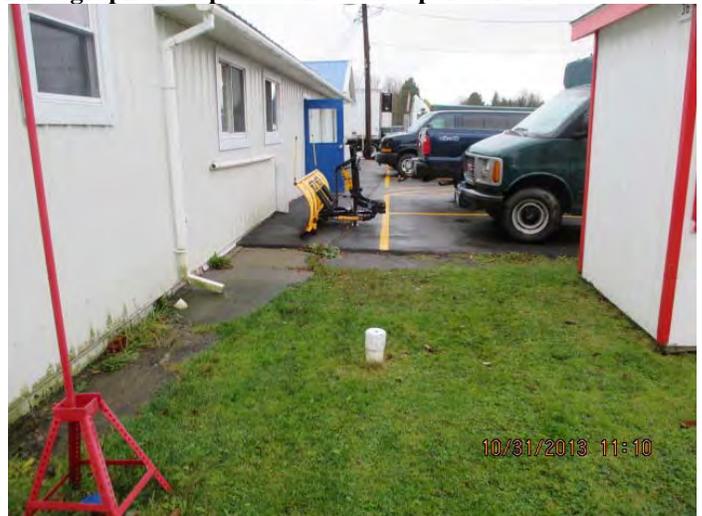
additional information was available regarding the suspected oil/water separator. No staining was observed within the vehicle maintenance shop or near these floor drains. No records regarding the oil/water separator service schedule were available for review.

**Photograph of suspected oil/water separator area.**

<b>Issue</b>	<b>Environmental Concern Identified? (Y/N)</b>	<b>Recommendation</b>	<b>Estimated Cost</b>
Facility Operations	Y	A limited Phase II Investigation, including a geophysical survey, should be conducted to confirm the location of the oil/water separator and determine if it's use has impacted the environmental quality of the subject site.	Costs included in USTs/ASTs section below
USTs/ASTs	Y	A Phase II Investigation should be conducted to determine if the USTs have impacted the environmental quality of the subject site.	\$20,000-\$25,000
Septic System	N		
Drains/Drywells	N		
Stains	N		
PCBs	N		
Asbestos	N		
Radon	N		
Lead-based paint	N		
Lead in drinking water	N		
Adjoining Properties	N		
Historical Use	N		
Regulatory Review	N		
Other	N
