Atlantic Yards Arena and Redevelopment Project: Blight Study

## **Atlantic Yards Arena and Redevelopment Project—Blight Study**

## Block 1121, Lot 1

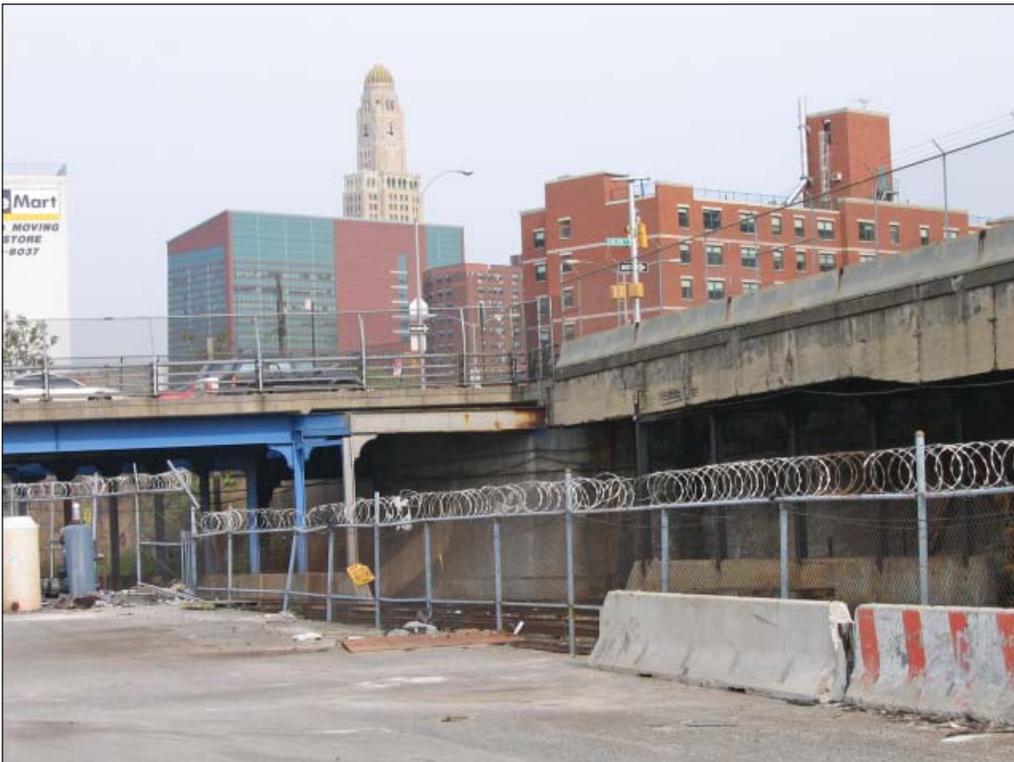
Photograph 1121-I-D

Lot 1 occupies approximately 90 percent of the block bounded by Atlantic Avenue on the north, Vanderbilt Avenue on the east, Pacific Street on the south, and Carlton Avenue on the west. The lot accommodates the eastern portion of the 8-acre below-grade rail yard, which is used for the storage and servicing of LIRR commuter rail trains, and by an NYCT storage yard for retired buses (see Photographs A through K).
