## Block 927, Lot 1

### Location, Use, Zoning, and Ownership

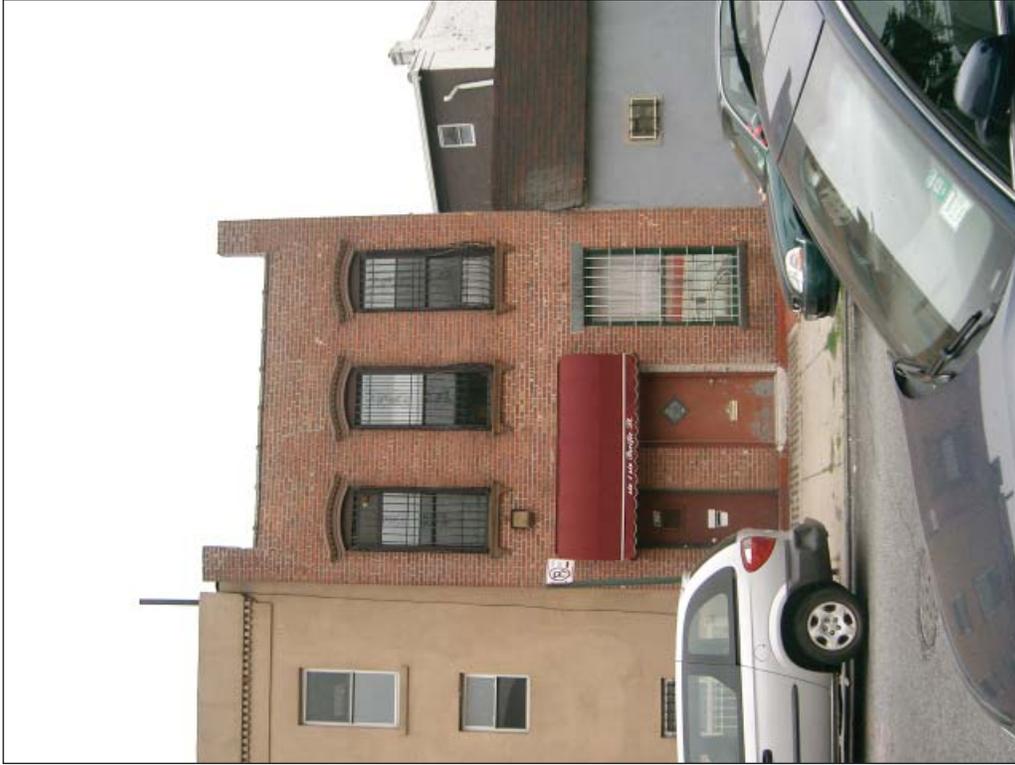
**Photograph I 127-11-B**

As shown in the map above, lot 11 runs across the narrow western end of Block 1127 and fronts on both Flatbush Avenue and Pacific Street. The southern portion of the lot hosts a two-story mixed-use residential and commercial building located at 191 Flatbush Avenue (see Photograph A) and the northern portion of the lot hosts a two-story mixed use residential and commercial building located at 616 Pacific Street (see Photograph B). The buildings contain a combined 6,092 gsf of space.
