Block I 129, Lot 25

Location, Use, Zoning, and Ownership

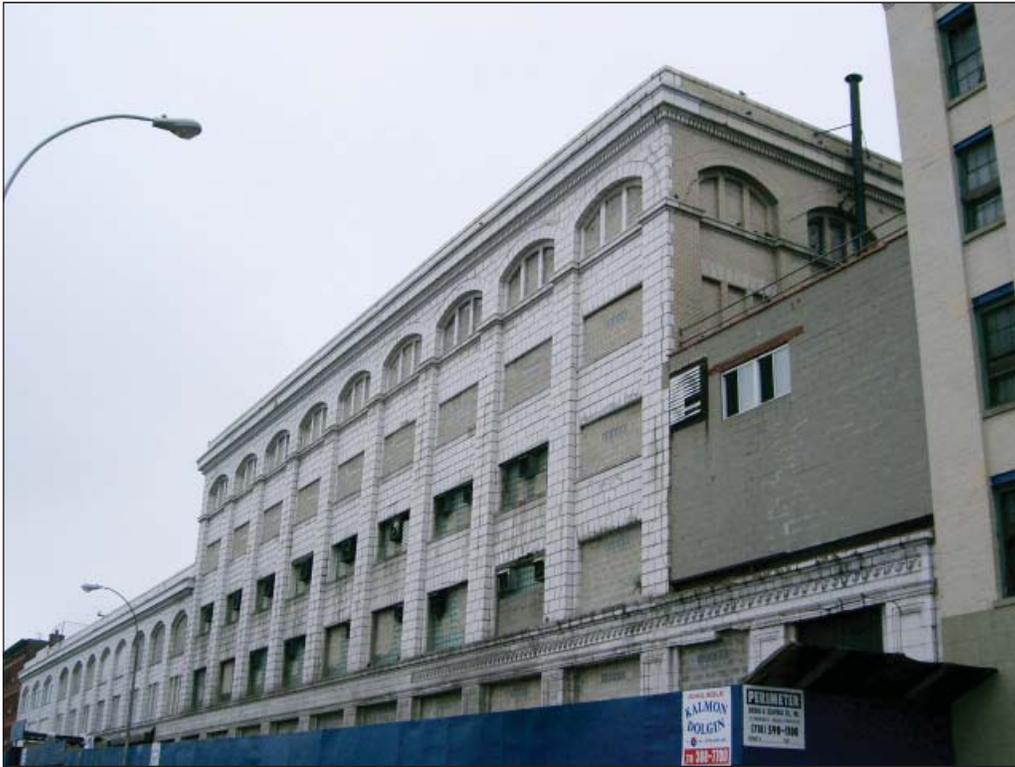
Photograph I 129-25-A

Lot 25 is located at 800 Pacific Street between Carlton and Vanderbilt Avenues. The lot is occupied by a three to six story 143,060 gsf industrial building that spans the width of the block, fronting both Pacific Street (Photograph A) and Dean Street (Photograph B). Lot 25 is located in an M1-1 zoning district with an FAR of 1.0. M1 districts allow high-performance light manufacturing uses and often serve as buffers to adjacent residential or commercial districts. Lot 25 is owned by AYDC, which purchased the property in March 2006.

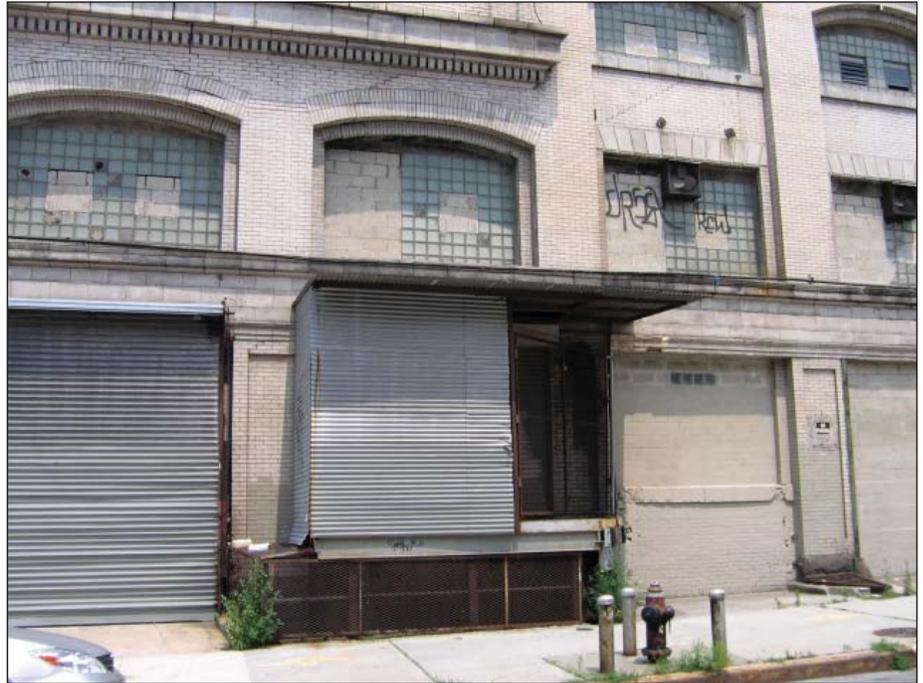
Photograph I 129-25-C

AYDC has maintained lot 25 in substantially the same condition it was in when the property was purchased in March 2006. All of the windows in the building on lot 25 have been partially or wholly filled in with cement blocks (see Photograph B). Graffiti has been painted onto the building's façade in several locations (see Photographs B and C) and large cracks are visible on portions of the façade around the base of the building (see Photograph D). The building's location across from the eastern portion of the rail yard, coupled with the scaffolding that surrounds the building, create a feeling of isolation. As shown in Photographs E and F, it appears that homeless persons have used the recessed area between the building's façade and the sidewalk on the Pacific Street side of the building for shelter. The tarp, plastic sheeting, and personal belongings (e.g., clothing, soda bottles) shown in Photographs E and F were present on lot 25 over the course of multiple visits to the site during the Summer and Fall of 2005.

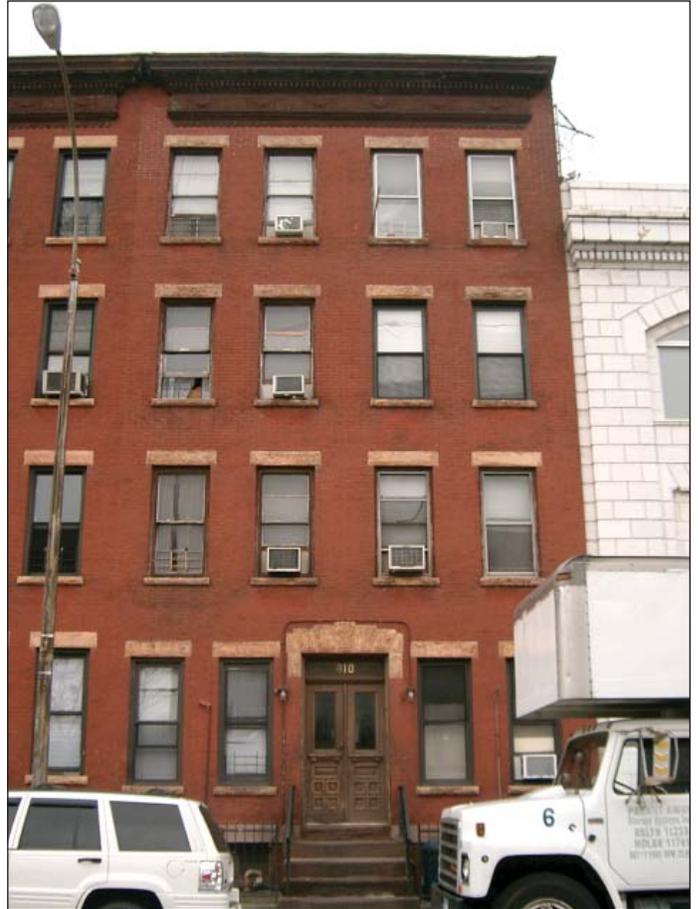
Photograph 1129-43-A

Lot 43 is located at 810 Pacific Street between Carlton and Vanderbilt Avenues. The lot is occupied by a four story 6,000 gsf multi-family residential building (see Photograph A). Lot 43 is located in an M1-1 zoning district with an FAR of 1.0. M1 districts allow high-performance light manufacturing uses and often serve as buffers to adjacent residential or commercial districts. Lot 43 is owned by AYDC, which purchased the property in April 2005.

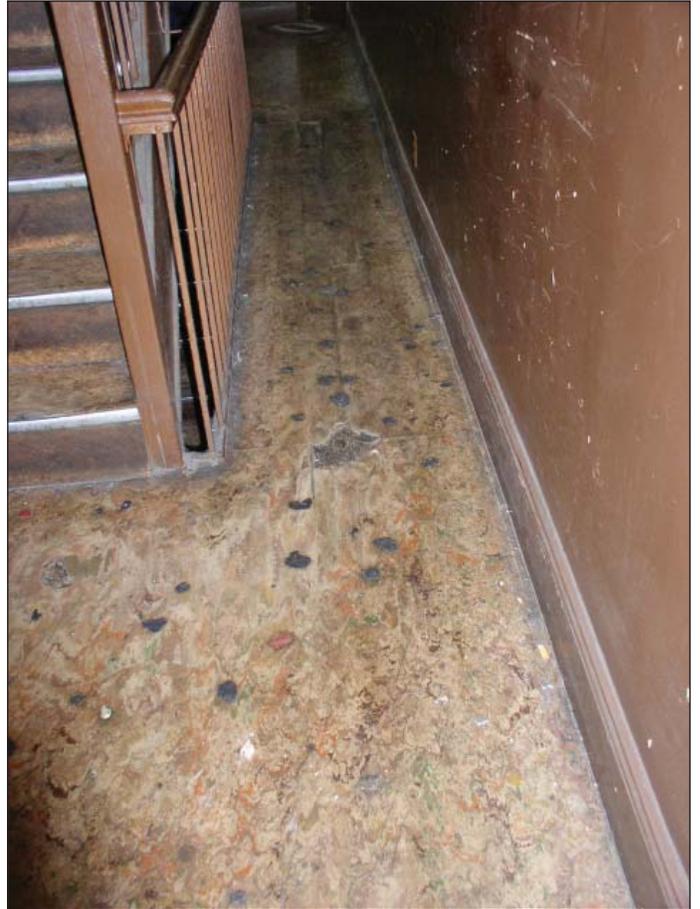
Photograph I 129-43-C

AYDC has maintained lot 43 in substantially the same condition it was in when the property was purchased in April 2005. The exterior of the building on lot 43 is in generally fair condition. As shown in Photograph B, the building's wooden door is dented and chipped, and the steps leading to the door are chipped and worn down in places, but overall the façade appears to be in fair condition. However, the interior of the building shows signs of many years of disrepair. As shown in Photographs C and D, the hallways floors and stairwells are severely worn and dirty. And as illustrated in Photographs E through H, which were taken in one of the ground floor vacant apartment units, the building's walls and ceilings have suffered from water damage. The paint and plaster on the walls is bubbling, peeling, and falling off in several areas, and as shown in Photograph G, plaster has fallen from the ceiling along some of the window frames. Graffiti has been painted inside the cupboard near the sink and on the brick fill in the fireplace.

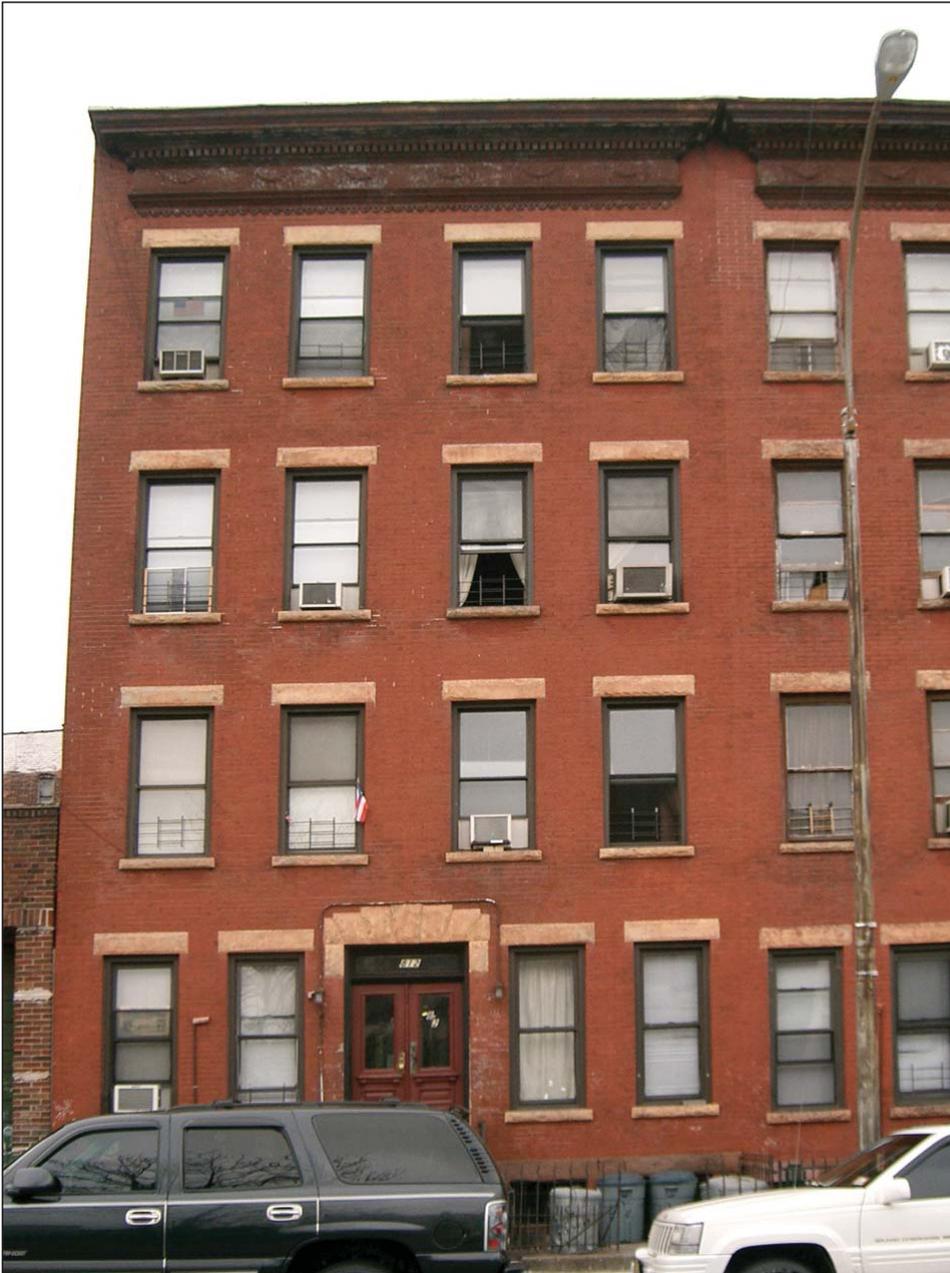
Photograph I 129-44-A

No unsanitary or unsafe conditions were identified as part of the visual assessment for lot 44. However, as shown in Photograph A, the building on lot 44 is attached to the building on lot 43, which has suffered from water damage and general neglect for many years. It is possible that water infiltration may have occurred in the buildings on lot 44 as well. Lot 44 is privately owned and the building was not accessible for viewing; the building's interior conditions are currently unknown, but are likely to be similar to conditions in the building on lot 43.

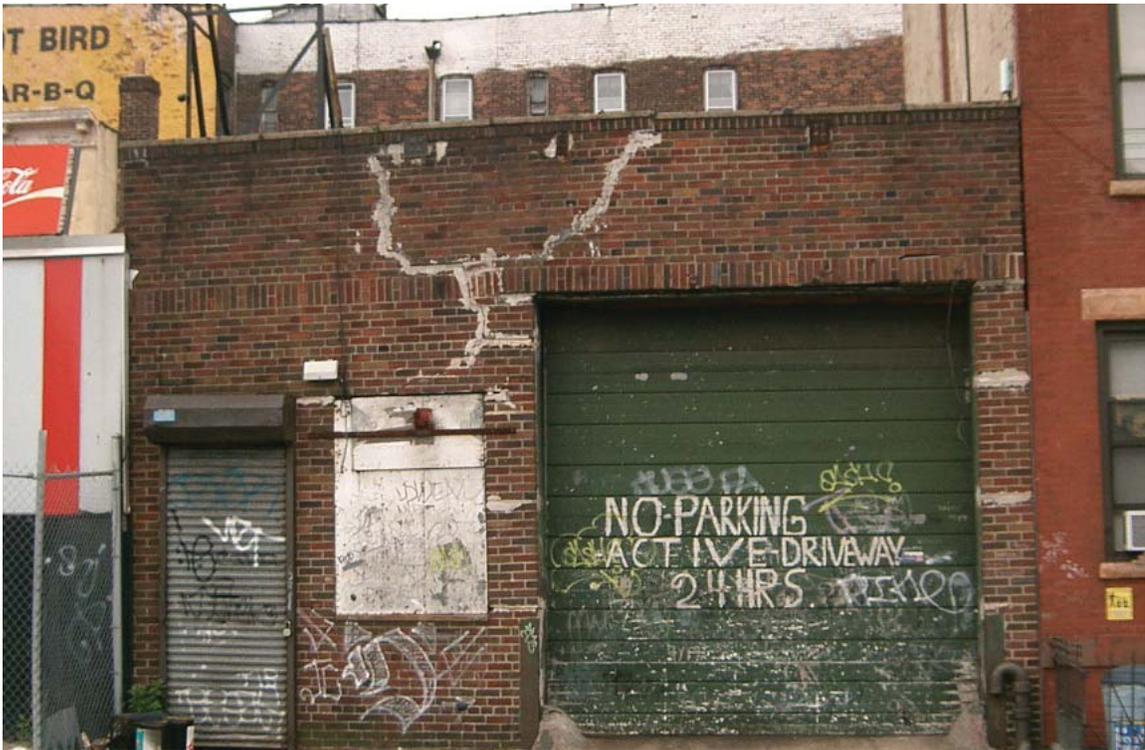
Photograph I 129-45-A

Lot 45 is located at 814 Pacific Street, between Carlton and Vanderbilt Avenues. The lot is occupied by a vacant single-story 2,400 gsf building, which was formerly a pump repair and fabrication shop (see Photograph A). As shown in Figure 6 and Table A-1, lot 45 is located in an R7A zoning district, with a C1-4 overlay. R7A districts permit medium-density housing with a maximum FAR of 4.0. C1-4 districts accommodate retail and personal service shops needed in residential neighborhoods. When mapped in R7 districts, the maximum commercial FAR in C1-4 districts is 2.0. Lot 45 is currently owned by AYDC, which purchased the property in June 2005.

AYDC has maintained lot 45 in substantially the same condition it was in when the property was purchased in June 2005. The exterior of the building on lot 45 is in poor condition from many years of neglect. There is a large, poorly patched crack in the brickwork on the façade of the building. Graffiti marks the garage entry, window, and front doorway. Deterioration is also evident in the building's interior. There are holes in parts of the ceiling exposing electrical outlets and wiring. Elsewhere, the ceiling and walls have been seriously damaged by water, causing ceiling tiles to fall, exposing electrical wires (see Photograph B.)

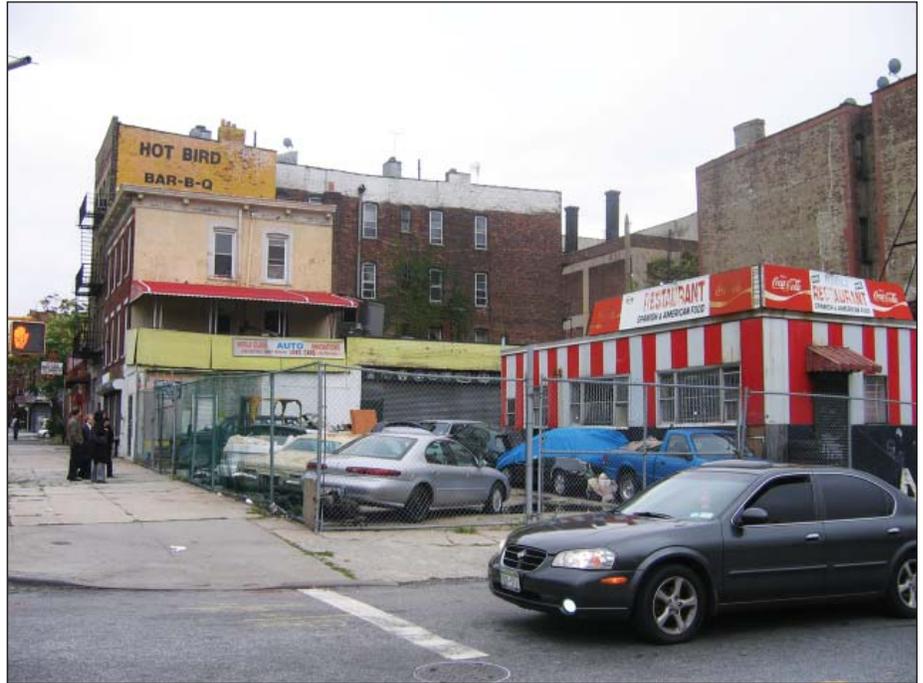
Photograph I 129-46-A

Lot 46 is located at 818 Pacific Street between Carlton and Vanderbilt Avenues (see Photograph A). The lot hosts a single story vacant diner building on the northern portion of the lot (see Photograph B) and a three story residential building with an attached single story auto garage on the southern portion of the lot (Photograph D shows the residential building). Together, the three buildings contain approximately 3,600 gsf of space. Between these structures, there is a parking lot used for auto storage and repair.

AYDC has maintained lot 46 in substantially the same condition it was in when the property was purchased in April 2006. As shown in Photographs A through M, all three buildings on the lot are in states of disrepair. The vacant diner building is painted with graffiti and its metal siding is rusting. The ceiling and walls inside the building are water damaged and peeling (see Photograph C). Weeds and trash occupy the space between the building's northern façade and the fence separating the property from the sidewalk (see Photograph B). The roof of the auto garage connected to the residential building on the southern portion of the lot is sagging and the brickwork appears to be degrading in areas (see Photograph E). There are cracks in the façade of the residential building, and the area above the ground floor windows facing Vanderbilt Avenue appears to have been damaged by water and rust (see Photographs C and D). As shown in Photograph E, the drainage pipe running down the façade of the residential portion of the building ends at the garage rooftop, draining down the side of the garage building and directly onto the parking lot.

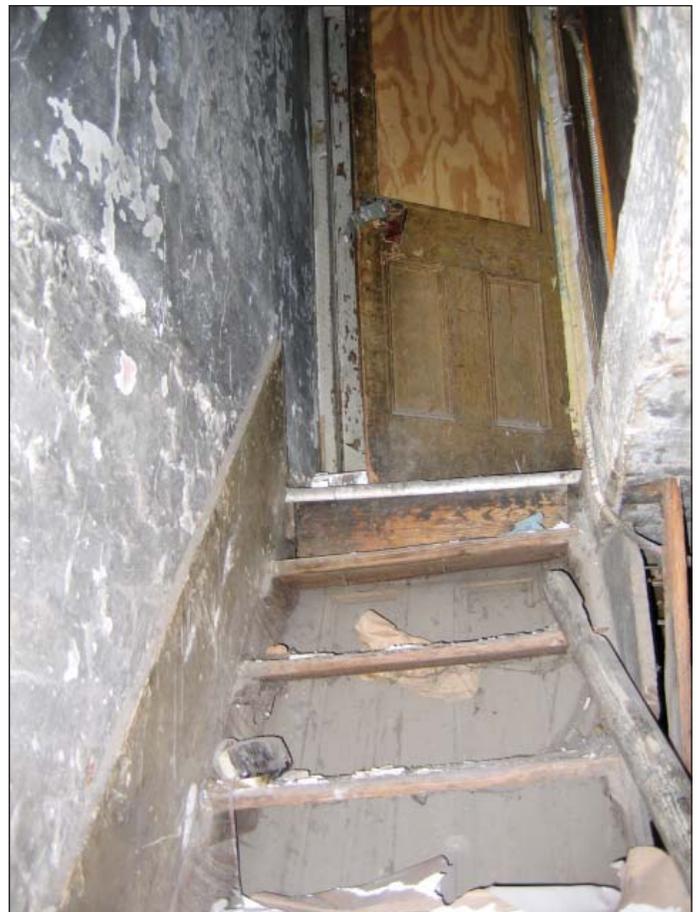
Photograph I 129-46-J

The interiors of the buildings on lot 46 are also in disrepair. As shown in Photographs G through I, the ceilings and walls in the residential building are severely damaged and insulation is falling from the ceiling in some areas. The wooden steps leading to the basement are falling down and the plaster wall in the stairwell is crumbling (see Photograph J). The basement itself is littered with debris and the walls and ceiling are in poor condition (see Photographs K and L). The second story balcony facing the northern portion of the lot is also in poor condition. As shown in Photograph M, the bricks under the window opening are crumbling and the surfacing on the brick wall on the right is cracked and has begun to fall off.
