Block 1986 Lot 1

SITE CONDITION: POOR

Manhattanville Neighborhood Conditions Study

Block 1986 Lot 6

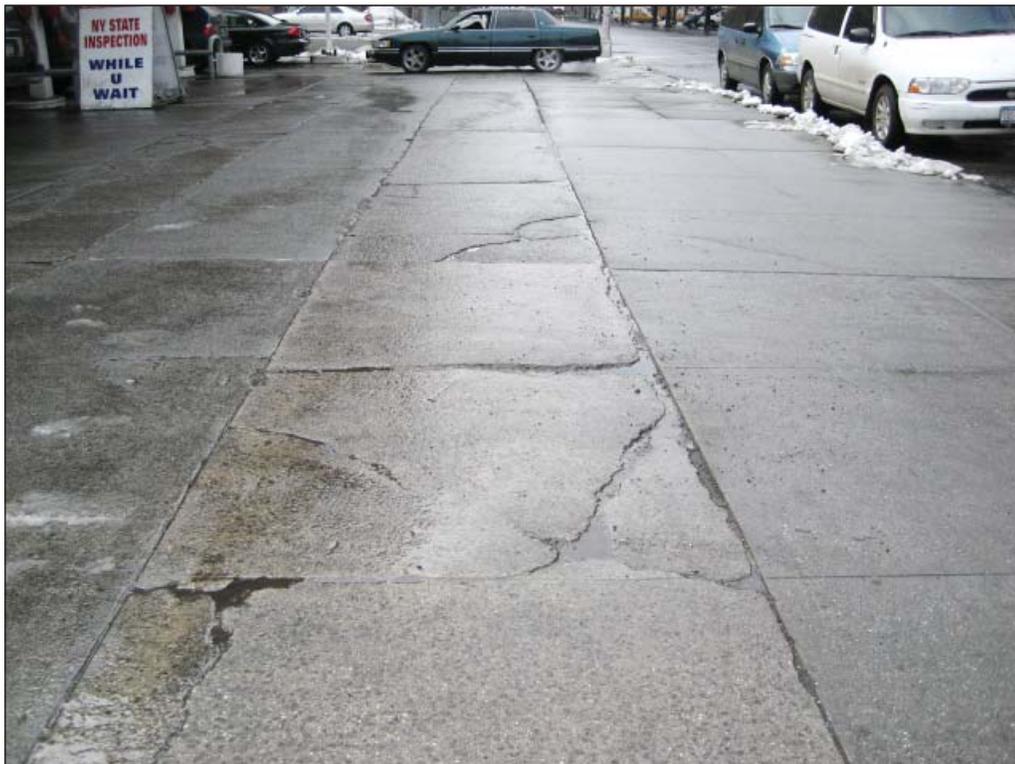
Photograph 1986-I-H

Interior and exterior slabs have several signs of damage. The interior concrete slab in the automotive service shop has cracks and chemical stains due to the nature of its long-term use (see Photograph F). The slab in the parking lot is covered with asphalt and has local spalling (see Photograph G). The sidewalks along West 131st Street and Broadway are in poor condition overall, with several wide cracks and spalling at the corner of Broadway and West 131st Street (see Photographs H and I, respectively). Curb cuts along West 131st Street and at the southwest corner appear to be in poor to critical condition with several wide cracks and spalling; however they are in fair condition near the north side of the lot along Broadway.

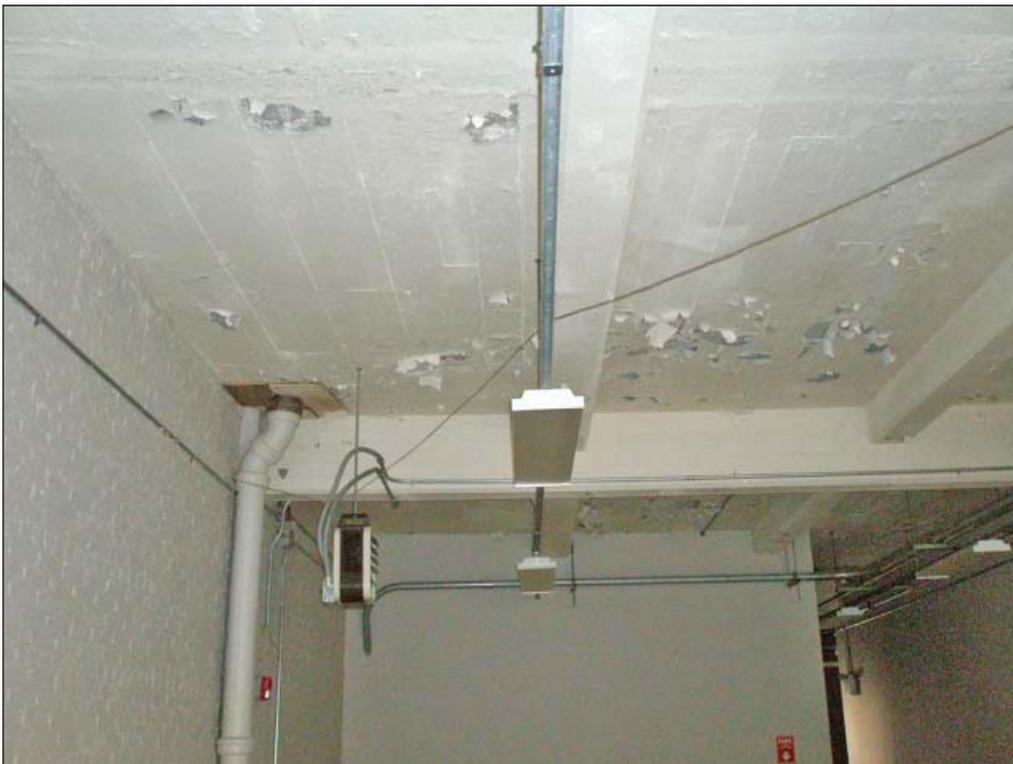
Photograph 1986-6-D

A wide diagonal crack, indicating significant structural distress, was observed in the northeast corner of the roof and floor slabs on all levels, as well as in the load-bearing exterior masonry walls, possibly the result of differential settlement of the building’s slab-on-grade (see Photographs B and C). Prolonged water infiltration has caused deterioration of the roof and floor framing (see Photographs D and E), corrosion of the façade’s steel lintels (see Photograph F), localized deterioration of brick masonry walls (see Photograph G), and microbial growth on the fourth-floor walls (see Photograph H). Portions of the building’s roofing membrane are billowing, segments of the sheet metal flashing are not properly connected (see Photograph I), and water ponding is likely a concern in the roof’s northeastern quadrant. In addition, a skylight on the roof of the elevator bulkhead is in poor condition, with broken glass panes and corroded framing (see Photograph J). As a result, signs of water intrusion from the skylight are evident on all elevator shaft walls. If left unchecked, this water intrusion will eventually lead to local failure of the skylight framing.

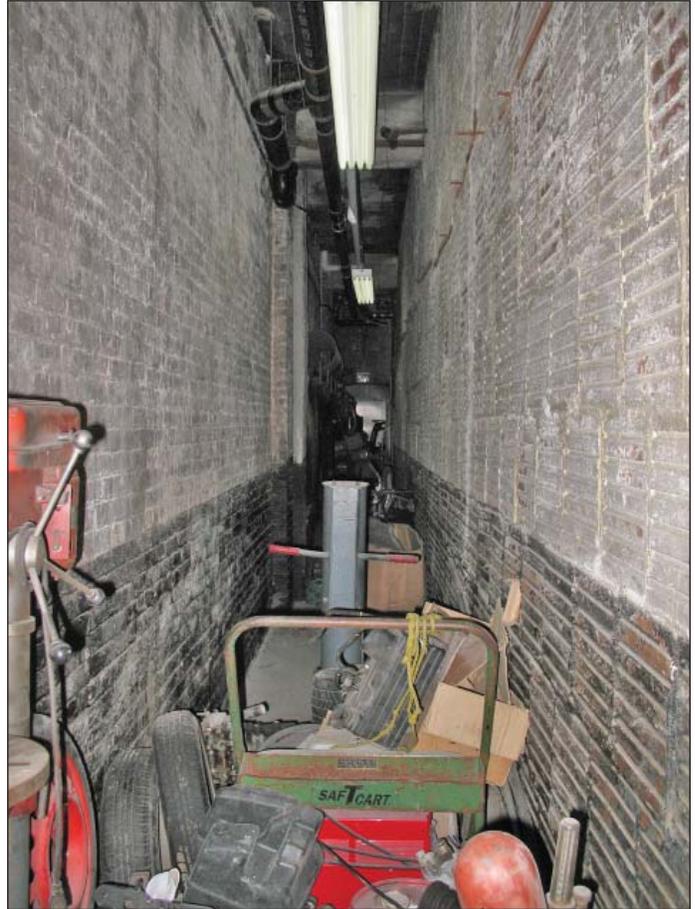
Photograph 1986-6-M

Between the fourth floor and the roof, the stair tread and riser dimensions are non-uniform, which poses a safety hazard (see Photograph L). In addition, an exit corridor along the west wall that connects the fire escape with the stairwell is blocked by storage items, creating a potential fire hazard (see Photograph M). The roll-up door on the north side of Block 1986 Lot 1 is closed in the evening, blocking egress from the emergency exit from this building and from the gas station on Block 1986 Lot 1, which is an unsafe condition (see Photograph N).
