Block 1986 Lot 10

Manhattanville Neighborhood Conditions Study

Block 1986 Lot 30

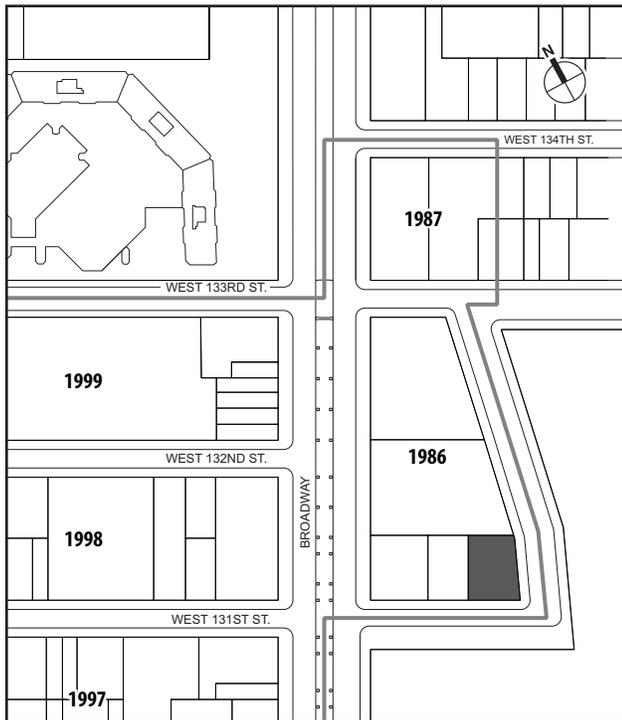
SITE CONDITION: POOR

Due to localized structural distress and some substandard exterior, interior, and site conditions, this site was evaluated by Thornton Tomasetti, Inc. to be in poor condition overall. The first-floor slab-on-grade appears to be in generally poor condition, with large cracks and spalling concrete (see Photograph B). In

addition, portions of the slab are uneven as a result of differential settlement. The sagging lintel and severely cracked masonry above the center roll-up door on the south wall are indicative of significant local structural distress (see Photographs C and D) and has the potential to lead to local structural failure. Sections of the roof membrane that extend onto the parapets are damaged at various locations due to delamination and tears (see Photograph E).

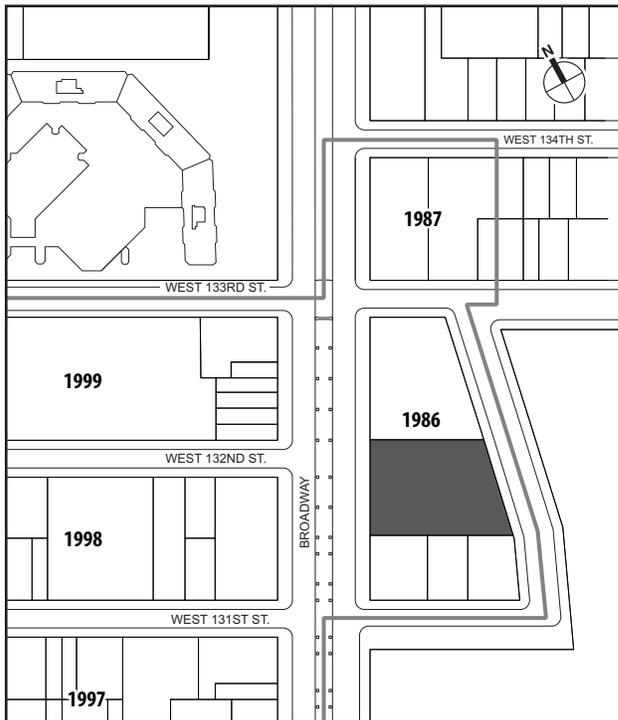
SITE CONDITION: CRITICAL

Overall, this site was evaluated by Thornton Tomasetti, Inc. to be in critical condition due

to a combination of significant localized structural distress, some deficient interior and exterior building conditions, and other hazardous site conditions.
