## Block 1995 Lot 31

**SITE CONDITION: CRITICAL**

Manhattanville Neighborhood Conditions Study

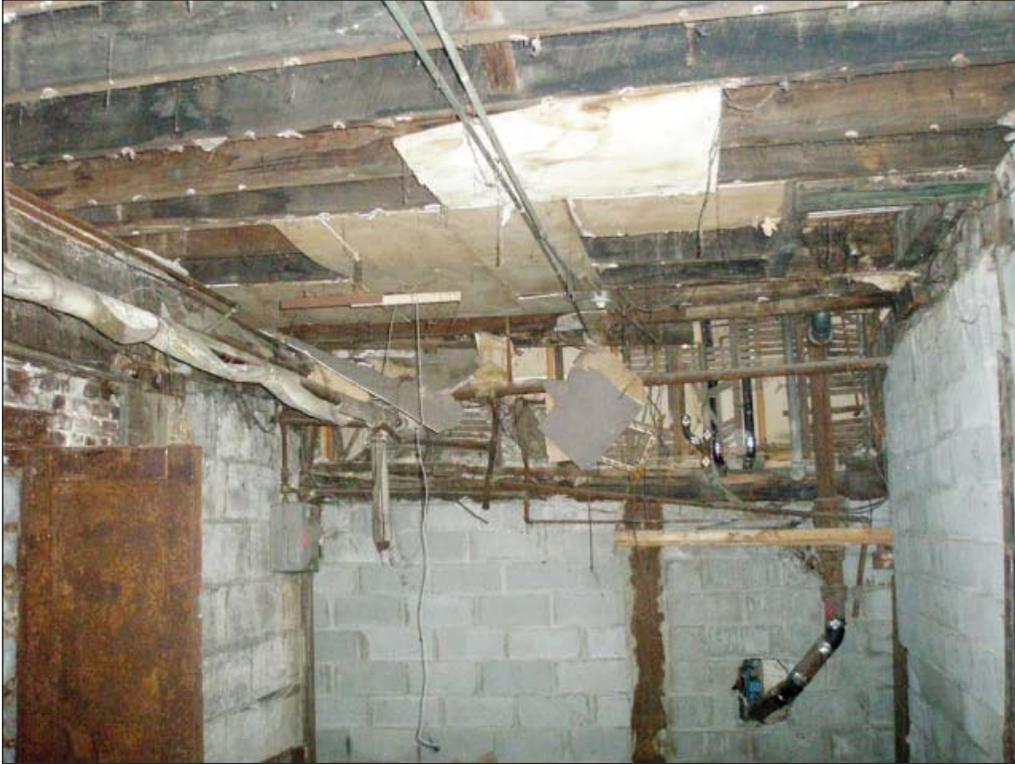
**Photograph 1995-31-E**

A significant amount of distress was observed in the building's basement including: advanced corrosion of a column/steel girder connection (see Photograph C); water intrusion and damage to portions of the stone rubble wall (see Photograph D), including an area close to electrical cabinets; exposed, deteriorated timber joists (see Photograph E); and water-induced ceiling deterioration, indicating that other structural members are experiencing some degree of structural distress in affected areas (see Photograph F). In addition, the slab-on-grade is in poor condition with widespread cracking and spalling, portions of uneven and displaced slab (see Photograph G), and an open trench in the soil below the slab in the western area (see Photograph H). Further, the first-floor framing is in critical condition in the basement under Mi Floridita Restaurant and Bakery. The framing is shored-up haphazardly in many locations, evidently to address sagging floor framing members. Some or all of the shoring beams and columns appear not to have been professionally designed and are the result of many makeshift iterations over time (see Photograph I).

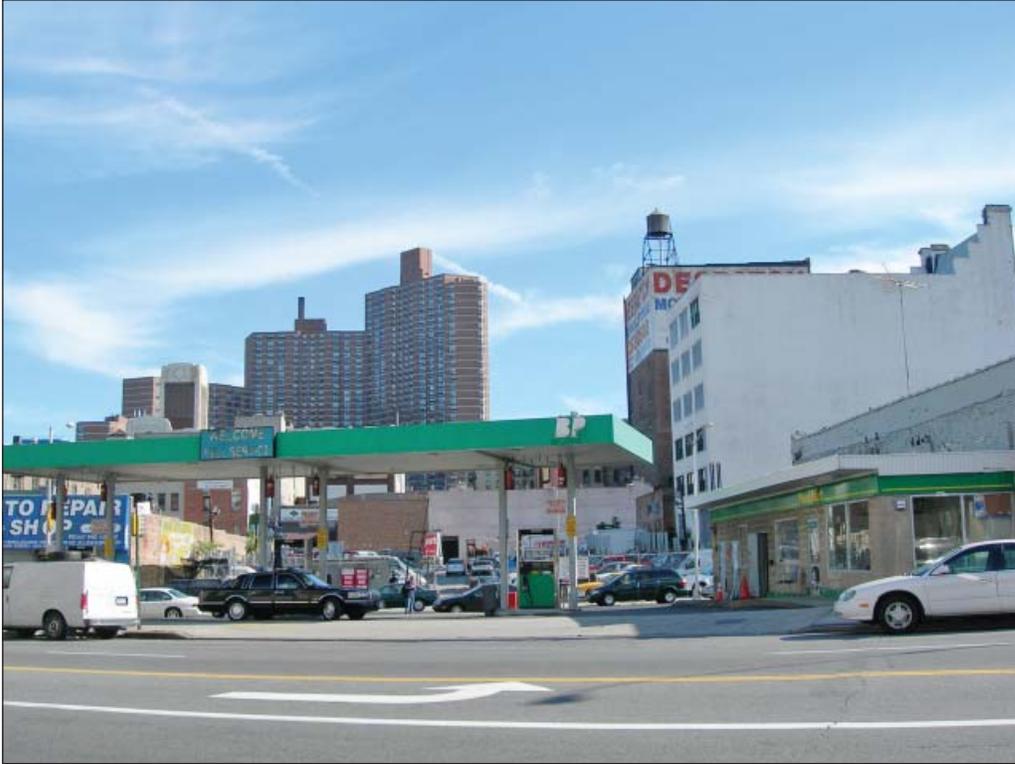
**Photograph 1995-35-A**

This triangular-shaped lot located at 619 West 125th Street, with frontage on both West 129th Street and West 125th Streets, was acquired by Parminder Kaur circa November 2002. Lot 35 is occupied by a one-story 1,320-gsf gas station and is in an M1-2 zoning district (see Photographs A and B). The building was constructed circa 1920 and was renovated in 1992.
