## Block 1996 Lot I

SITE CONDITION: POOR

Manhattanville Neighborhood Conditions Study

## Block 1996 Lot 14

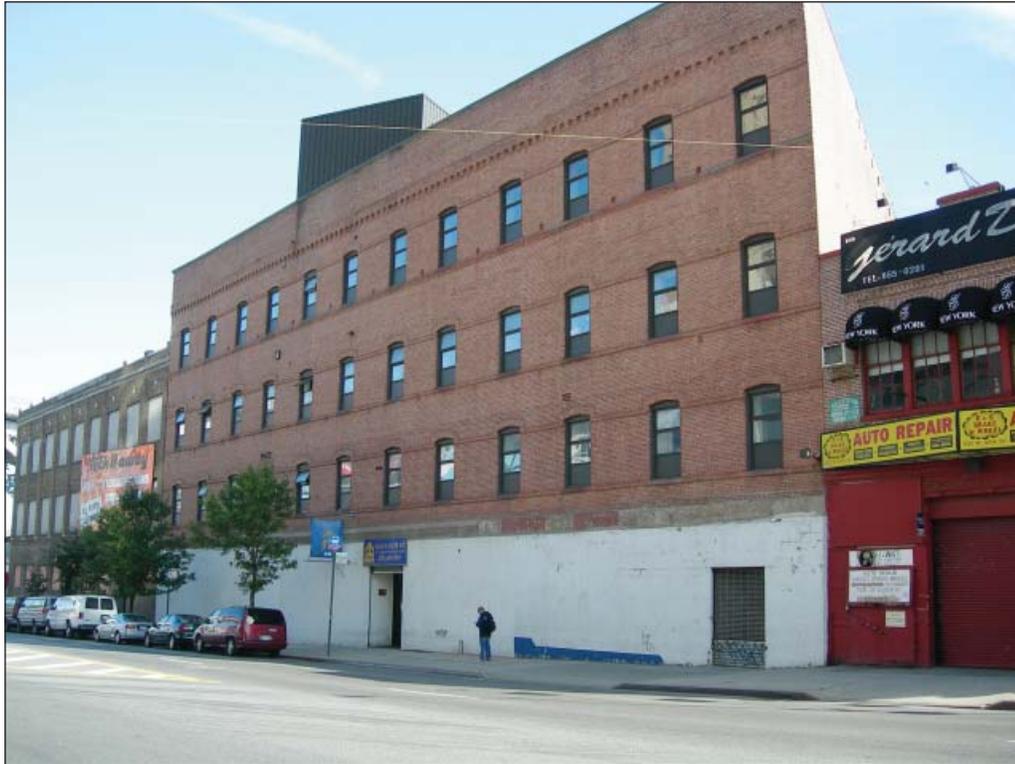
Photograph 1996-14-A

Lot 14 is located in an M1-2 zoning district at 637 West 125th Street, with the lot area fronting West 125th Street and West 130th Street (see Photographs A and B, respectively). The four-story 77,408-gsf brick masonry building was built circa 1908 and renovated in 1992 and 1993. Lot 14 was acquired by the Trustees of Columbia University on October 27, 2006.
