## Block 1996 Lot 20

SITE CONDITION: CRITICAL

Manhattanville Neighborhood Conditions Study

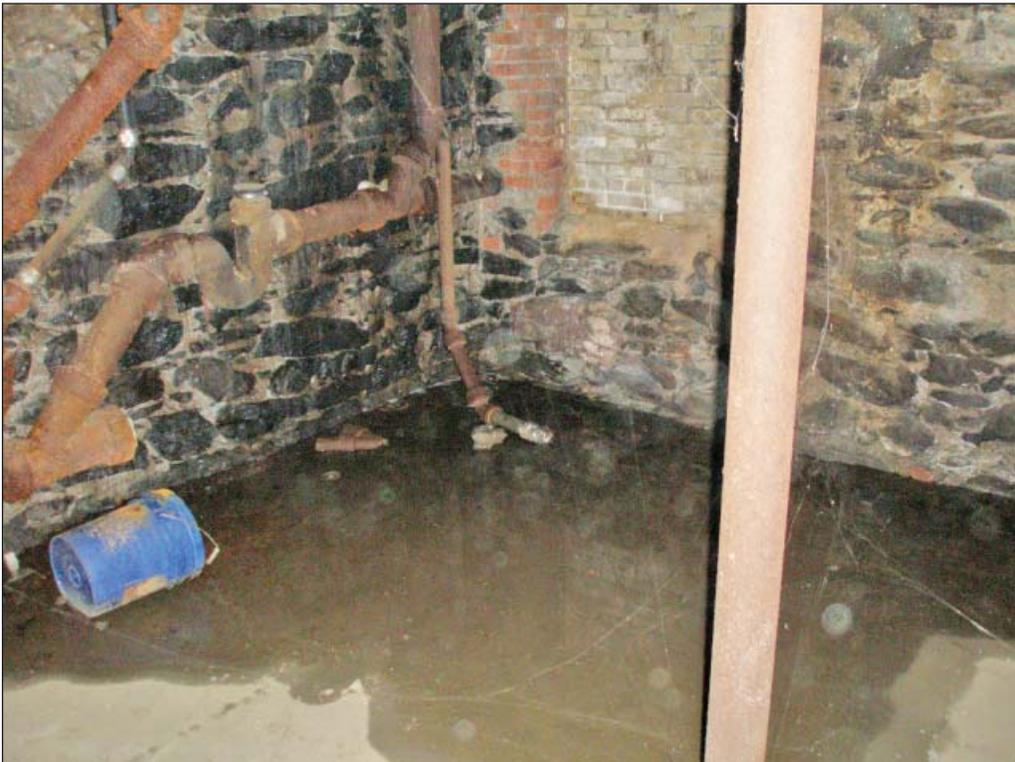
**Photograph 1996-20-P**

Other concerns and signs of poor maintenance in the two story building include: a significant amount of garbage and debris on the first floor and in the basement of the two-story building (see Photographs N and O), and cracks in the two-story building's parapet and coping stones. In the three story building further concerns include: standing water in the basement (see Photograph P), an inoperable elevator, a corroded ladder that leads to the roof (see Photograph Q), damaged coping stones on the lower roof (see Photograph R), and a clogged roof drain, causing ponding on the lower roof (see Photograph S). Although not a structural concern, there are cracks and spalled concrete at several locations on the slab-on-grade in the three-story building and local floor damage in the two-story building (see Photograph T). The sidewalk and curb cuts along West 129th Street are in poor condition, with several wide cracks and spalling concrete (see Photograph U); however the sidewalk along West 130th Street is in fair condition, with a few cracks.
