Block 1996 Lot 29

SITE CONDITION: FAIR

Manhattanville Neighborhood Conditions Study

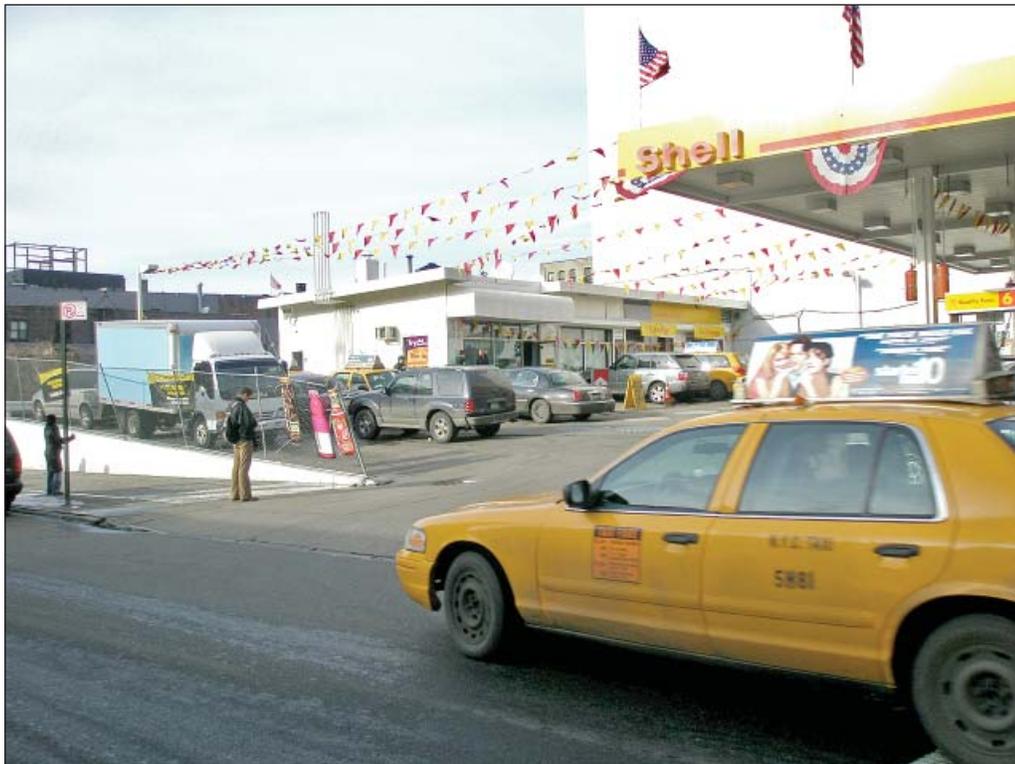
Photograph 1996-29-B

Lot 29 is located at 3221 Broadway (on the northwest corner of Broadway and West 129th Street) in an M1-2 zoning district (see Photographs A and B). Acquired by the Trustees of Columbia University on June 27, 2006, the lot is occupied by a gas station, which includes an auto repair facility and a small convenience store. The 1,845-gsf building was constructed in 1975. No renovations have been recorded.
