## Block 1997 Lot 6

SITE CONDITION: FAIR

Manhattanville Neighborhood Conditions Study

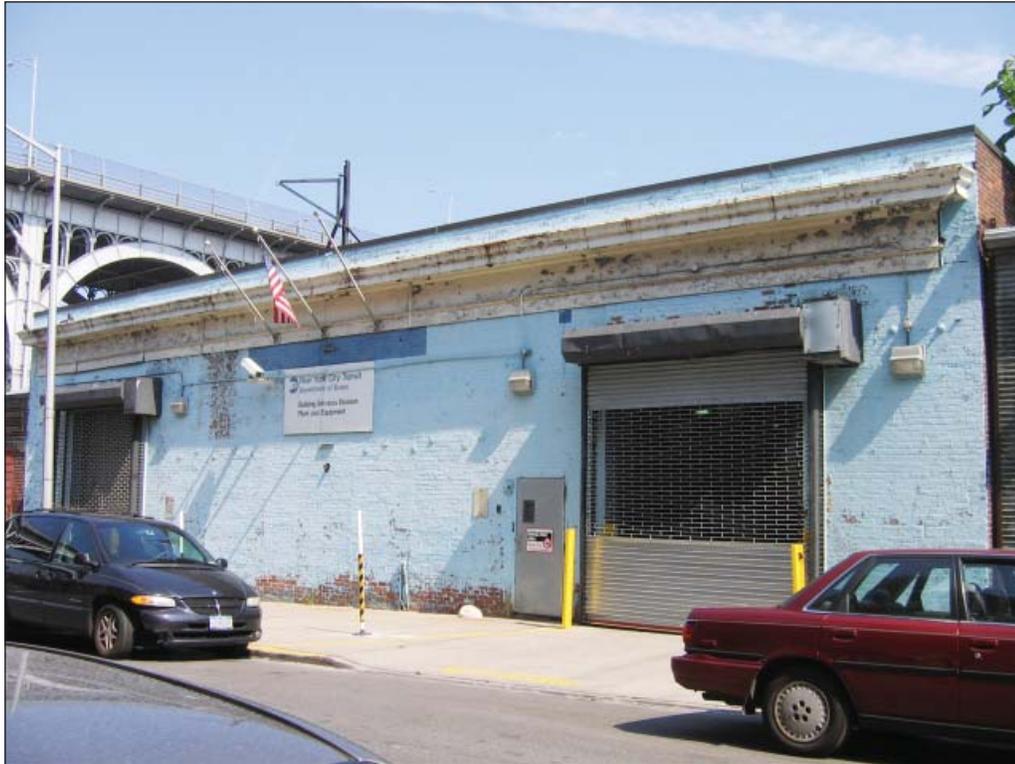
**Photograph 1997-6-A**

Lot 6 is located within an M2-3 zoning district at 641 West 130th Street, with entrances on West 130th and West 131st Streets (see Photographs A and B, respectively). Owned and occupied by MTA/New York City Transit's Department of Buses<sup>1</sup>, the two-story brick building on the lot is 16,187 gsf. The building was constructed circa 1940.
