## Block 1997 Lot 9

SITE CONDITION: POOR

### LOCATION, USE, ZONING, AND OWNERSHIP

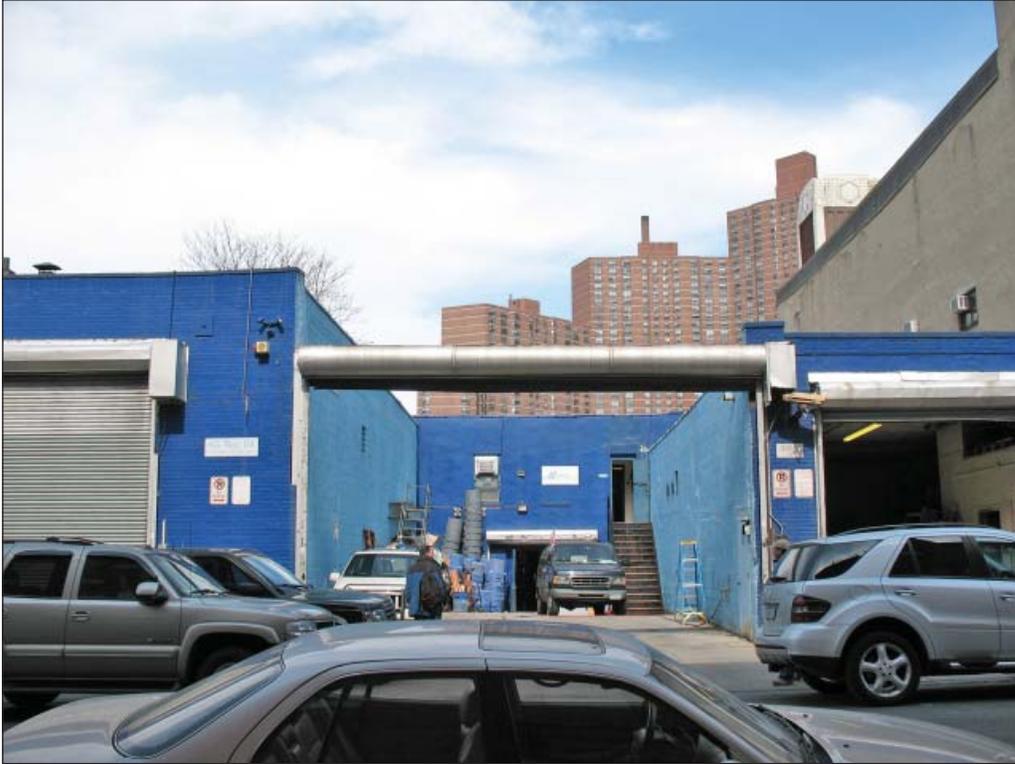
**Photograph 1997-9-A**

Lot 9, acquired by the Trustees of Columbia University on April 11, 2002, is located at 631 West 130th Street between Twelfth Avenue and Broadway in an M1-2 zoning district. As shown in Photograph A, the eastern portion of the lot is occupied by a contracting company in three interconnected buildings (north, east, and west buildings) that have a total building area of 13,956 gsf, and a paved front yard between the three buildings. Another contracting company occupies a parking lot/storage area on the western portion of the lot (see Photograph B). Descriptive information about the north and east building is contained in a historic Sanborn map from 1939, indicating that they were built prior to 1939. Information about the west building is in a historic Sanborn map from 1951, indicating that it was built

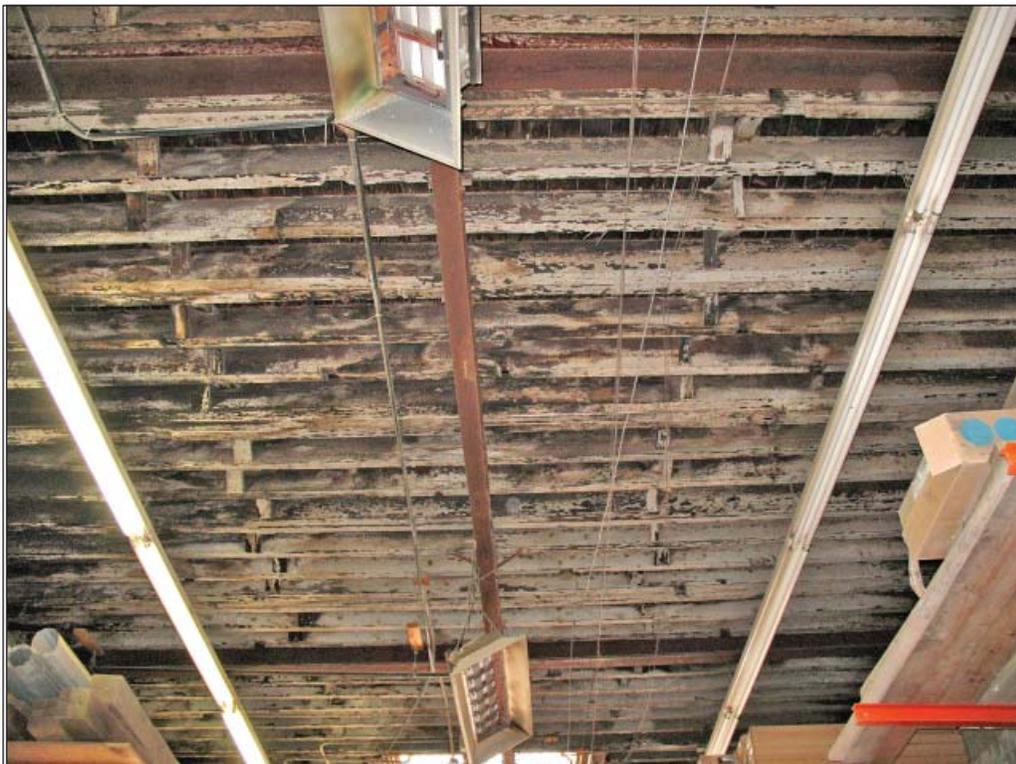
**Photograph 1997-9-D**

Long-term water infiltration has caused the wood and steel framing and masonry walls to deteriorate. There are several signs of corrosion throughout the building, such as a corroded sheet metal ceiling on the first floor of the north building (see Photograph C) and corroded steel beams in the west building (see Photograph D). The north building's timber joists are in poor condition, with widespread signs of termite damage, discoloration, deterioration due to water damage, and some warped and sagging members (see Photograph E). The timber roof joists in the east and west buildings also have signs of water damage (see Photographs D and F). There are signs of efflorescence on the north and south walls of the west building. Also, there are several repair patches on the interior face of the exterior walls of the west building, with cracks visible on some of the repair patches (see Photograph G). Water damage is also evident on the exterior walls, which have wide cracks (see Photographs H and I).

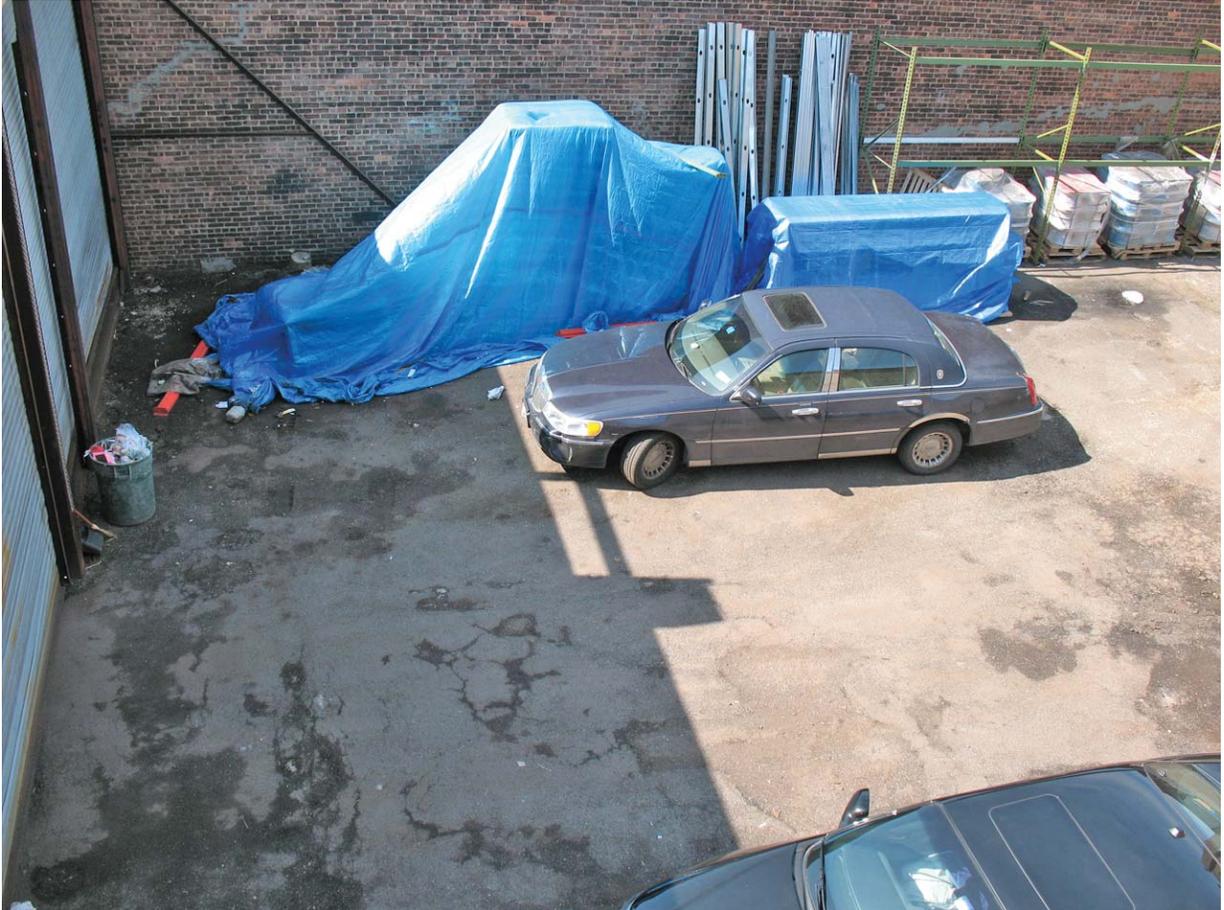
**Photograph 1997-9-Q**

Photograph F) and on a timber column on the second floor of the north building (see Photograph O). The concrete slab-on-grade in the front yard has several large cracks and spalling concrete (see Photograph P). On the western portion of the lot, there are corrosion stains, flaking paint, and spalling on the roll-up doors in front of the parking lot (see Photograph B) and the asphalt surface is badly deteriorated, with spalling and numerous cracks (see Photograph Q). The sidewalks and curb cuts along West 130th Street are in fair condition, with minor cracking and spalling.
