Block 1997 Lot 14

SITE CONDITION: POOR

Manhattanville Neighborhood Conditions Study

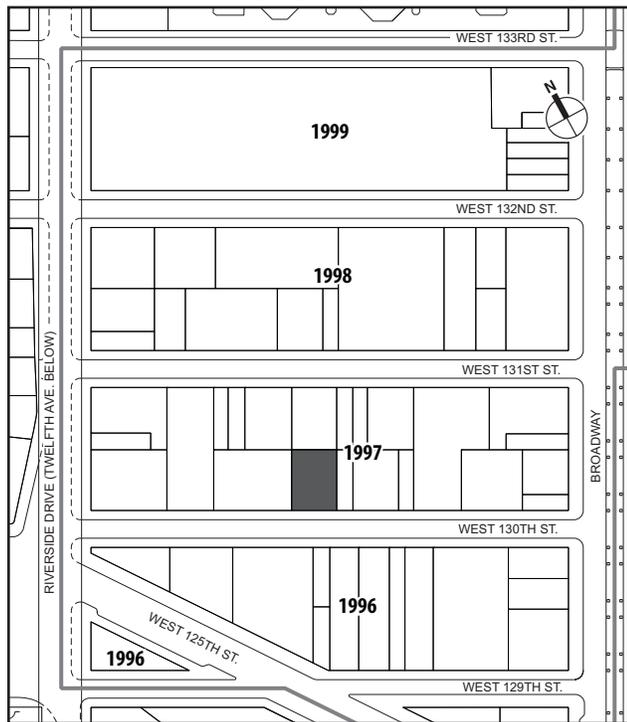
Located in an M1-2 zoning district at 625 West 130th Street between Twelfth Avenue and Broadway, Lot 14 contains a 21,437-gsf three-story brick masonry building that is occupied by a window manufacturer (see Photograph A). There is also a small one-story extension on the building's northeast side. It was acquired by Cigon LLC in January 2004 and is under contract by the Trustees of Columbia University. The structure was constructed in 1920 and was renovated in 1988.
