## Block 1997 Lot 33

SITE CONDITION: POOR

Manhattanville Neighborhood Conditions Study

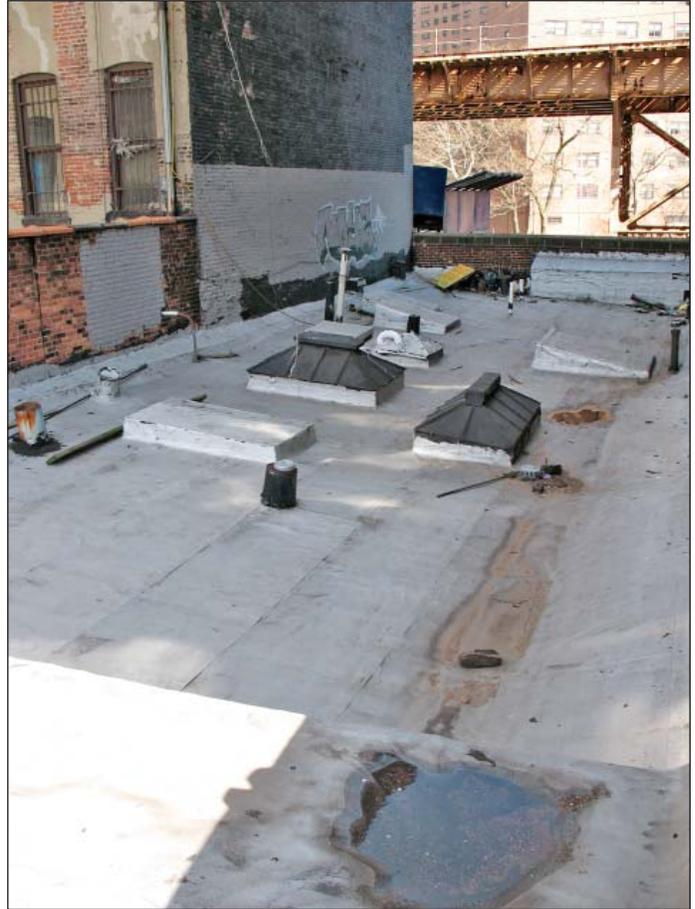
**Photograph 1997-33-K**

The roof shows numerous signs of deterioration, including cracks in the membrane (see Photograph H), delamination at the edges and along the parapet (see Photograph I), cracks around makeshift roof ducts (see Photograph J), and damage to the coping stones. Accumulated debris and water stains near south side of the roof indicate ponding is an issue (see Photograph K), which causes deterioration of the roofing membrane. The brick masonry parapet along Broadway is in poor condition, with a wide crack observed near northeast corner of the building and deteriorated or missing mortar under the coping stone (see Photograph L). A large amount of garbage and debris was also observed in the northeast corner of the roof (see Photograph M). These numerous points of water infiltration in the roof membrane and parapet are likely causing water damage to the roof structure, ceiling and masonry walls below.
