## Block 1997 Lot 34

SITE CONDITION: CRITICAL

Manhattanville Neighborhood Conditions Study

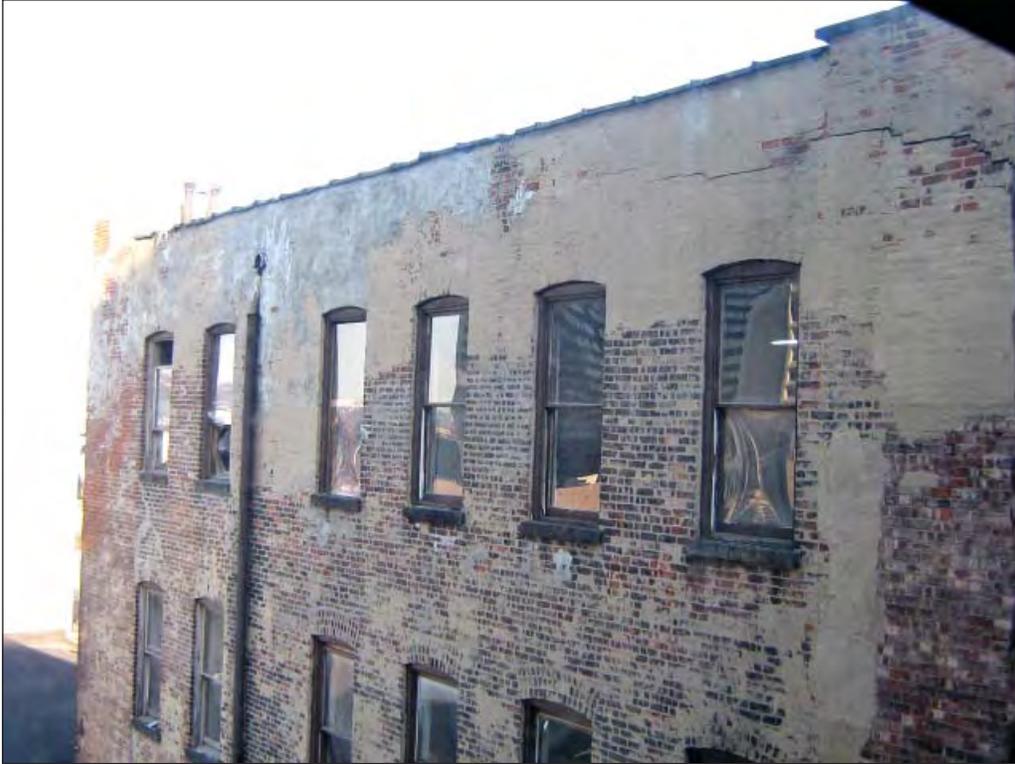
**Photograph 1997-34-E**

Structural distress in the five-story building is significant and widespread. As shown in Photographs C and D, there are several wide cracks and signs of deterioration on the exterior masonry walls. In the south exterior wall, wide cracks are evidence that the structure is deteriorating and that local failure of the masonry bearing wall could occur (see Photograph E). Additional distress in the building includes water damage to the timber joists, masonry walls, and window headers and sills (see Photographs F, G, and H, respectively); a rotting timber column (see Photograph I); corroded steel beams (see Photograph J); and cracked, spalling, and deflecting floor slabs (see Photograph K). Deterioration of the timber joists has already caused local collapses of the floor slab in several locations (see Photograph L). In addition, ceilings throughout the building are corroded and, in some cases, have collapsed (see Photographs M and N). Structural distress is likely worsening due to continued water infiltration through the damaged roof membrane (see Photograph O), cracks in the exterior walls, improperly sealed windows (see Photographs A, B, and P), and a deteriorated door. Also, cars are washed inside the building without an adequate drainage system, which is likely causing water infiltration to the timber joists below and has likely caused or exacerbated the deterioration of the timber joists (see Photographs P and Q). If not addressed, this water infiltration will eventually lead to local collapses of the timber floor and roof joists systems.

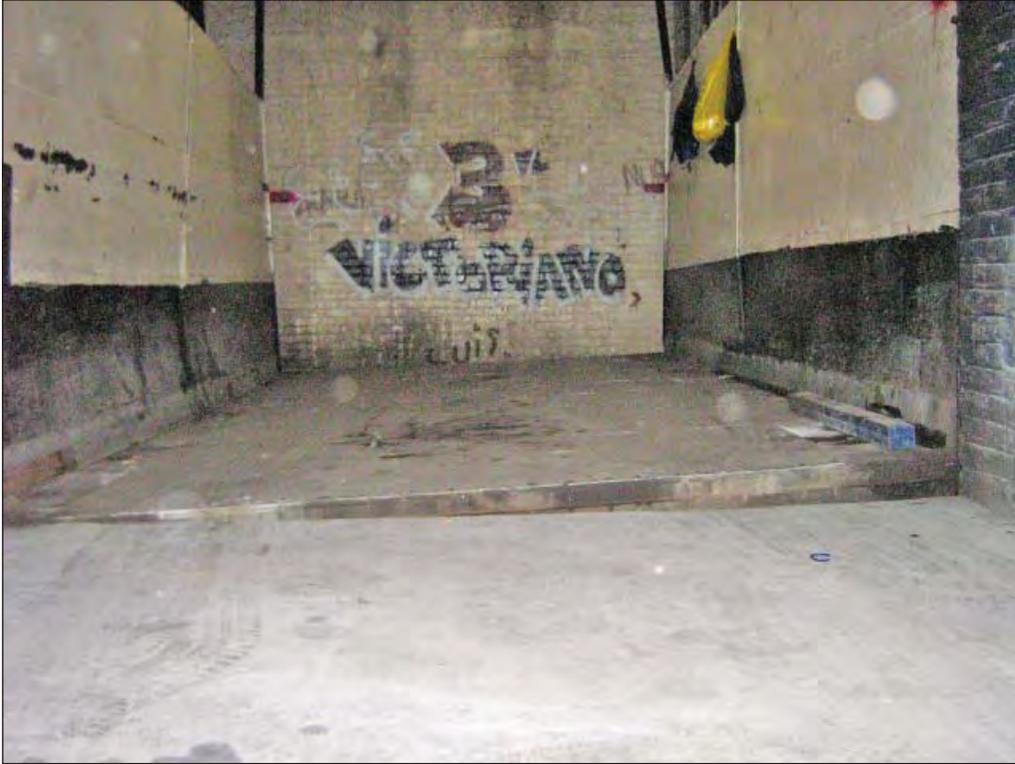
**Photograph 1997-34-U**

There are several health and safety items that create an unsafe environment for tenants and/or customers in the five-story building, most notably the hazardous condition of the freight elevator, which is used to transport cars and people to all five floors and the basement. The elevator is out of alignment with the floor planes, as shown in Photograph U, and the elevator shaft masonry has several cracks (see Photographs V and W). The elevator currently has several open building code violations, as detailed in the next section. Other safety concerns include auto-painting materials that are sprayed in the building without proper ventilation systems and are stored improperly (see Photograph X); haphazardly stored garbage and debris throughout the five-story building, presenting a safety hazard to workers (see Photograph Y); and some evidence of vermin in the stairwell.

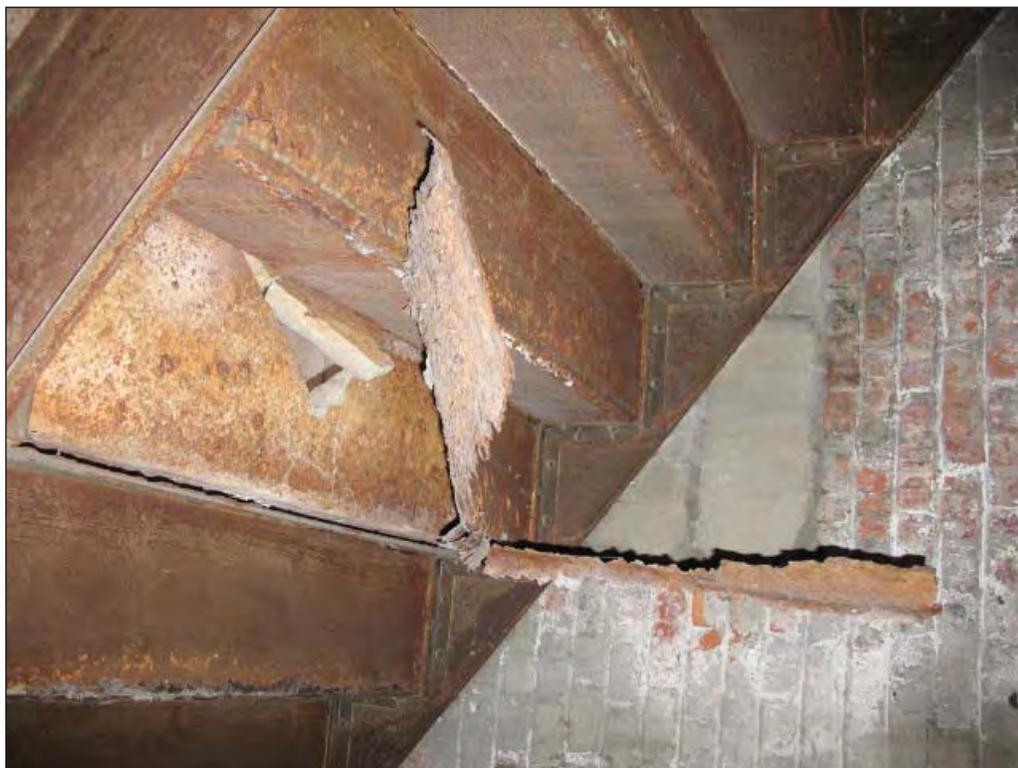
Photograph 1997-34-BB

Fire safety is of particular concern in the five-story building. Concrete encasing, necessary to fireproof the building's structural system, is missing from a portion of three second-floor timber columns and from several steel floor beams on the first level (see Photographs Z and AA). In addition, auto body and auto repair tenants throughout the building use paints and solvents and collect waste oil that could accelerate a potential fire in the building. Further, a portion of the building's southeast emergency stairway is an exposed timber structure without fireproofing, and the timber roof joists and stair risers are deteriorated from water infiltration. A fire stair on the western side of the building has heavily corroded stair treads (see Photograph BB), a severely deteriorated second-floor exit door with the potential for debris to fall from the lintel (see Photograph CC), and a significant amount of dog feces, which, in addition to being an unsanitary condition, presents a slipping hazard (see Photograph DD). The first-floor exit door from this western stairwell was blocked by a piece of wood during the site visit and the gate in a chain-linked fence leading to the street from this egress route was padlocked. In addition, means of egress via the fire escape on the east façade is restricted by the presence of plexiglass and plywood in windows leading to the fire escape, as well as numerous cars parked in close proximity to the exit windows (see Photograph EE).
