**Block 1997 Lot 40**SITE CONDITION: **POOR**

Manhattanville Neighborhood Conditions Study

Block 1997 Lot 40

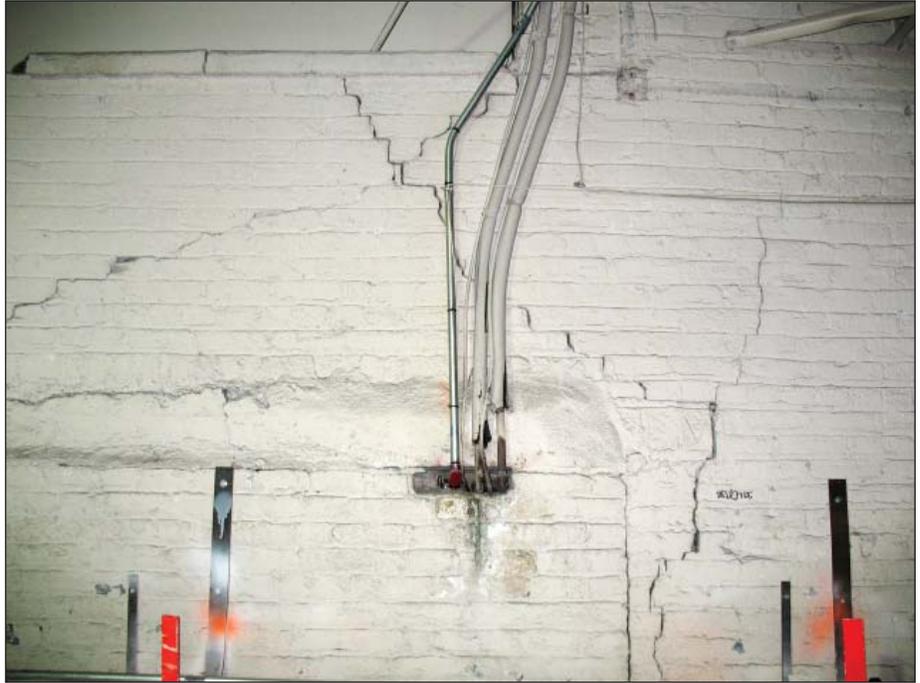
**Photograph 1997-40-E**

Long-term water infiltration has caused deterioration to the main building's concrete and steel framing and masonry walls. There are cracks in several locations, including on the exterior faces of the west and south walls (see Photographs C and D, respectively). Significant cracks were also observed inside the building, including on an interior wall above the ramp in the northeastern portion of the building, above the conveyor belt in the southwestern portion of the building, and on the first floor's western wall (see Photographs E-G, respectively). Water infiltration has also caused peeling paint, mold, and efflorescence on the east brick masonry wall (see Photograph H) and on the stair penthouse ceiling (see Photograph I). Signs of water infiltration and corrosion were observed on the masonry wall (see Photograph J) and on a window header in the northeastern portion of the main building. Steel beams are corroded, causing cracked and spalling concrete encasements (see Photographs K and L). Corrosion stains—likely from the sheet metal ceiling—are on the wall above the conveyor belt (see Photograph F).

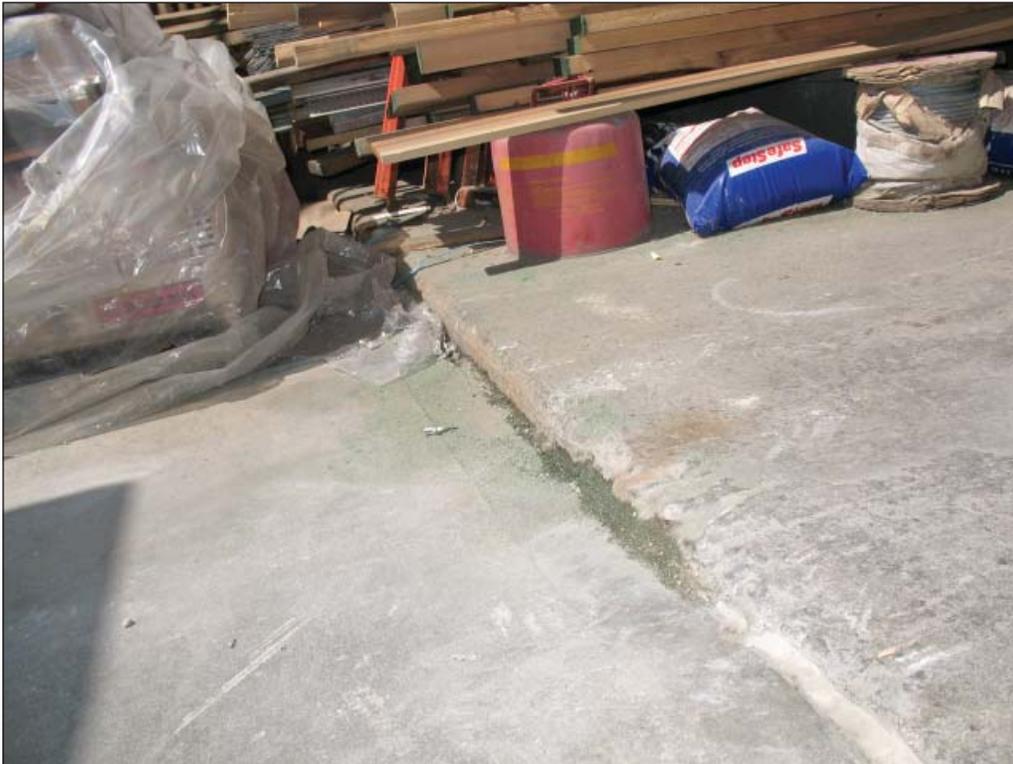
**Photograph 1997-40-S**

The concrete slab-on-grade is cracked in several areas, including the yard and the ramp in the eastern portion of the main building. A few cracks were observed on the slab-on-grade in the east and south buildings. In addition, the concrete slab in the northwest corner of the yard is uneven at a construction joint, indicating differential settlement (see Photograph S). There are also several wide cracks and extensive spalling on the West 130th Street sidewalks and curb cuts, which are in critical condition (see Photograph T), and are likely exacerbated by trucks parking on the sidewalk. The sidewalks and curb cuts along West 131st Street are in fair condition.

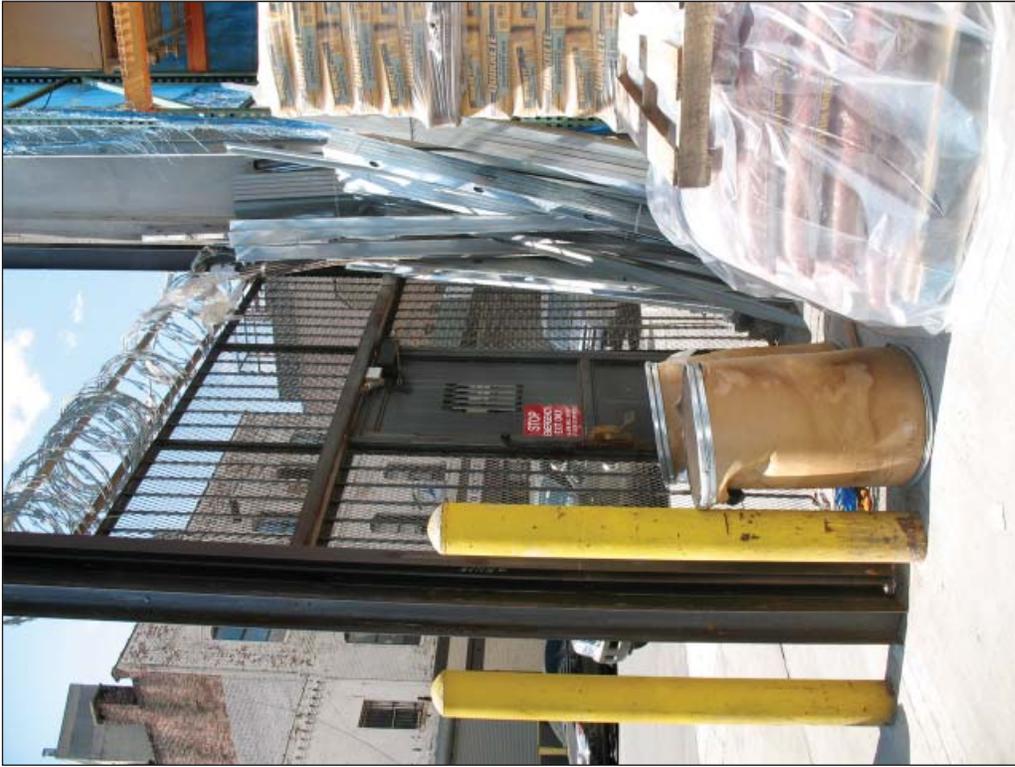
Photograph 1997-40-V

Lot 40 has several unsafe conditions. The floor inside the emergency exit door on the west façade of the south building is higher than the surface of the yard, where the door opens. The lack of warning signs for this height difference is a tripping hazard (see Photograph U). Another safety concern is the storage of materials in front of the door in the southwest corner of the yard on West 130th Street, blocking egress through this emergency exit (see Photograph V). Further, this emergency exit was padlocked from the outside during a site visit. If this lock is not removed when the adjacent roll-down gate is closed (see Photograph A), the means of egress would be obstructed. Also, trucks park on the sidewalk, which is a pedestrian safety issue.
