## Block 1997 Lot 64

SITE CONDITION: CRITICAL

Manhattanville Neighborhood Conditions Study

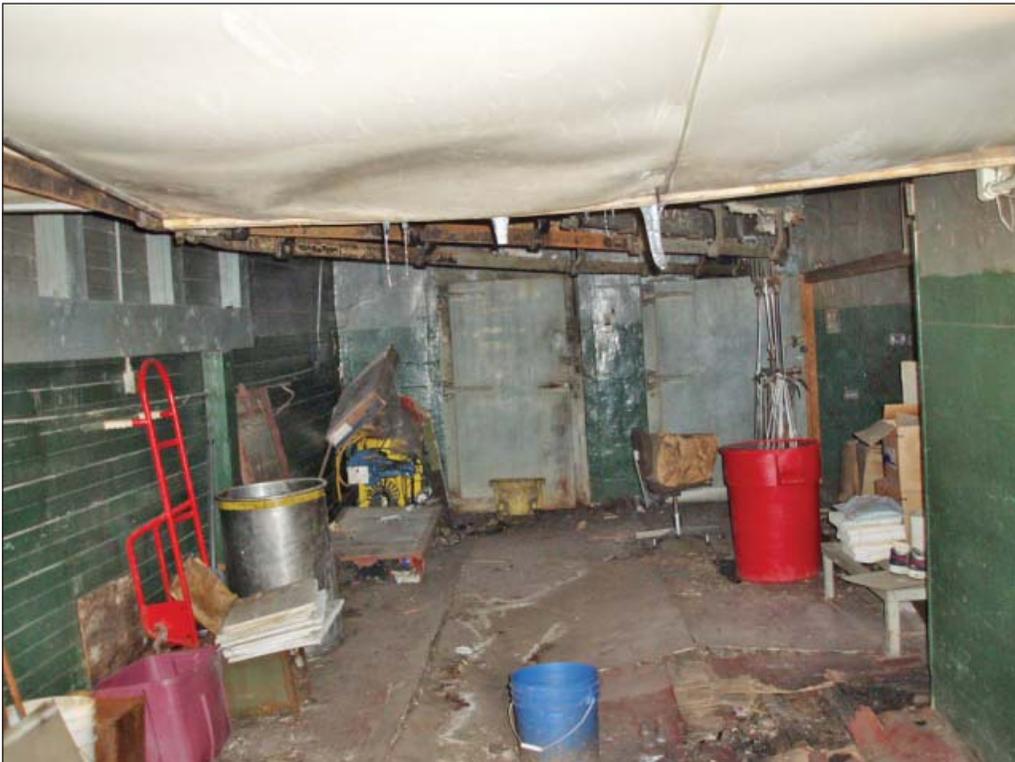
**Photograph 1997-64-D**

Prolonged water infiltration, likely from periodic flooding and substandard building conditions, has caused severe structural distress throughout the building. A fire occurred in August of 2000 that caused substantial damage to the rear roof and exterior wall structures (see Photographs B and C). This damage has not yet been repaired, likely significantly exacerbating the deterioration of the building's structural and non-structural components. The eastern portion of the building, where the fire occurred, was not available for observation on either floor due to safety concerns. In the western portion of the building extensive water infiltration was evident by: the severe sagging of the second floor ceiling (see Photograph D), partial ceiling collapses (see Photographs E and F), shoring of a damaged wood plank deck and tar that has dripped through a gap(s) in the roof components (see Photograph G), corrosion of the meat conveyor belt steel support system (see Photographs H and I), active roof leaks (see Photograph J), and mold infestation in the first floor walk-in refrigerator (see Photograph K). In addition, the second-floor timber structure appears to be unsafe, as evident by the warped and delaminated plywood flooring (see Photograph L). Periodic flooding, reported by business owners and staff at adjacent properties to be a longstanding problem along Twelfth Avenue, is likely a problem in this building as well, as water damage was observed along the lower portion of first-floor walls and doors (see Photographs M and N).
