## Block 1998 Lot 10

SITE CONDITION: POOR

Manhattanville Neighborhood Conditions Study

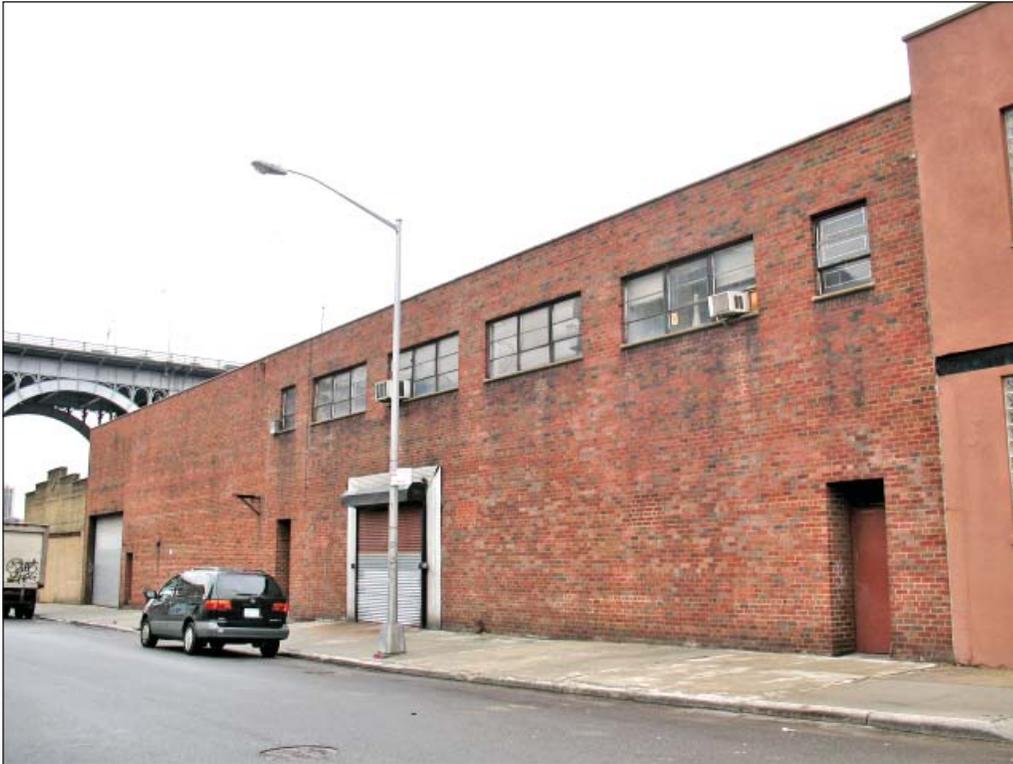
**Photograph 1998-10-A**

Acquired by the Trustees of Columbia University on August 14, 2003, Lot 10 is located at 641 West 131st Street between Twelfth Avenue and Broadway. As shown in Photograph A, the lot hosts a 17,800 gsf brick industrial building; it is internally connected to the building on Lot 6. Most of the building is one-story, with a smaller two-story portion located in the southeastern portion of the lot and a mezzanine level in the western portion of the building. The lot is divided between an M2-3 zoning district on the west, and an M1-2 zoning district on the east. The building was built in 1926; no renovations have been recorded. Although currently vacant, the building is undergoing renovations for the new tenant.

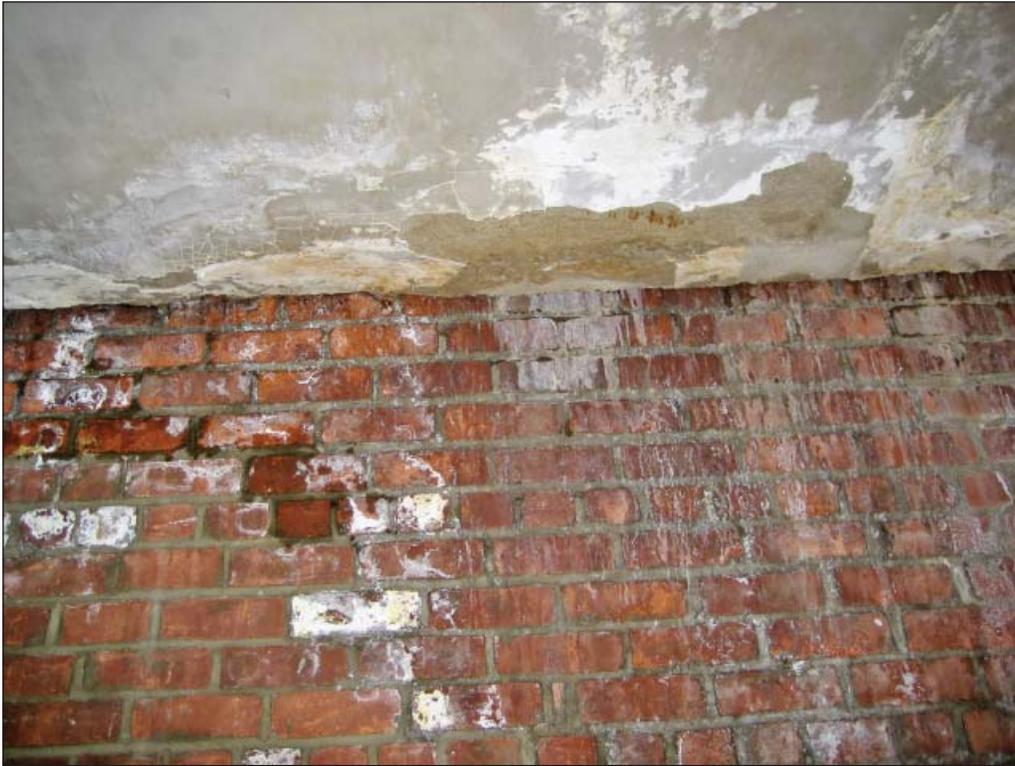
**Photograph 1998-10-E**

Damage caused by long-term water and/or moisture infiltration includes deterioration of the timber joists and roof framing (see Photograph B); and water stains and deteriorated portions of the ceiling (see Photograph C and D). The interior faces of the brick masonry walls have several cracks, and signs of efflorescence and mold (see Photographs C-G). Cracks were also observed on the south façade as shown in Photograph H. Water-related damage to the timber roof framing and brick masonry walls was likely caused by damage on the roof, including signs of deterioration on the roofing membrane (see Photograph I), damaged flashing (see Photograph J), and ponding (see Photograph K). Also, a few coping stones on the southern portion of the building have local damage.

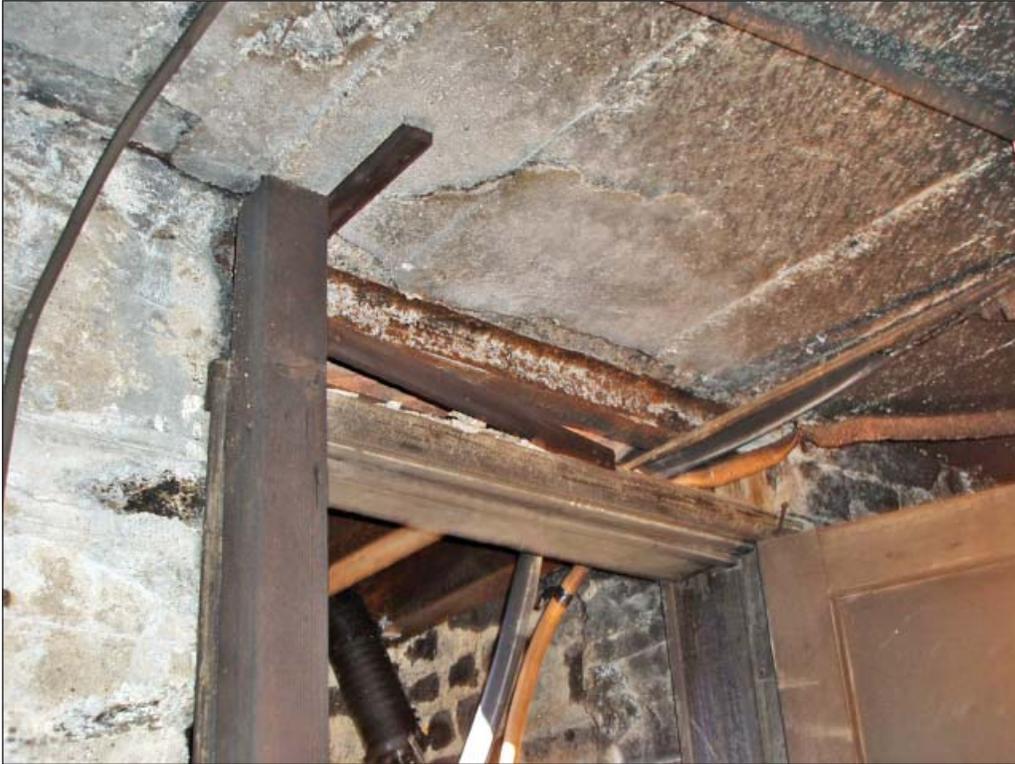
**Photograph 1998-10-O**

Other concerns in the building include: minor corrosion stains on the roll-up door's frame (see Photograph L), uneven metal stair treads to the mezzanine level (see Photograph M), smoke stains throughout the sidewalk vault (see Photograph N), and cracks in the concrete slab and in the rubble foundation wall (see Photograph O). Although the sidewalks and curb cuts are in fair condition, there are cracks and spalling concrete around the sidewalk vault (see Photograph P).
