## Block 1998 Lot 13

SITE CONDITION: FAIR

Manhattanville Neighborhood Conditions Study

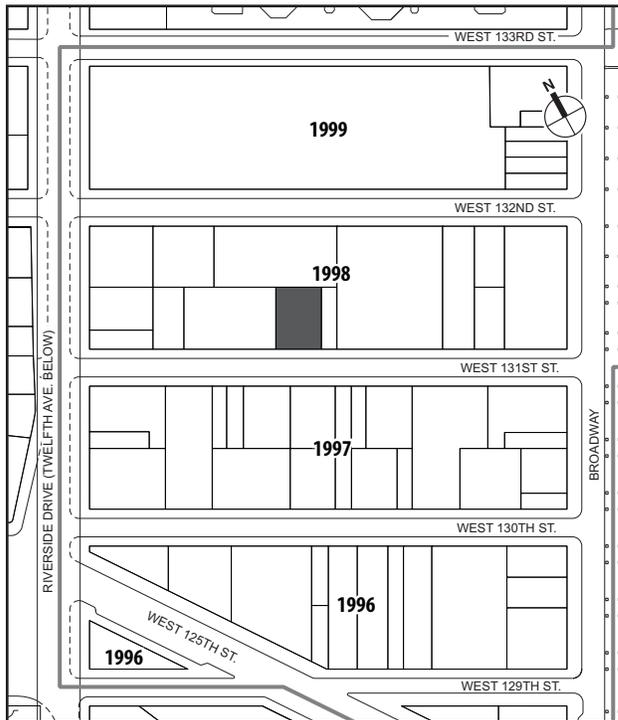
Lot 13 is located at 635 West 131st Street between Twelfth Avenue and Broadway in an M1-2 zoning district. The two-story, 16,000-gsf building is currently being used as a public parking garage (see Photograph A). The structure, which was built circa 1940 and renovated in 2002, was acquired by 635 West 131st Street LLC circa November 1999. Lot 13 is under contract by the Trustees of Columbia University.
