MANHATTANVILLE NEIGHBORHOOD CONDITIONS STUDY

May 2, 2008

Review of Manhattanville Neighborhood Conditions Study

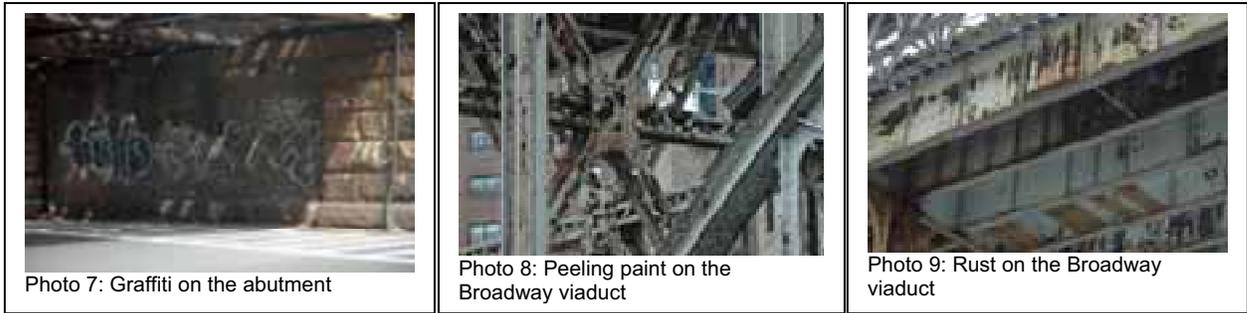
The viaduct and abutment are in poor physical condition, with damaged stone and brick on the abutment and peeling paint and rust on the trussed steel arches, girders and columns, frequently accompanied by a surfeit of graffiti (photos 7-9).

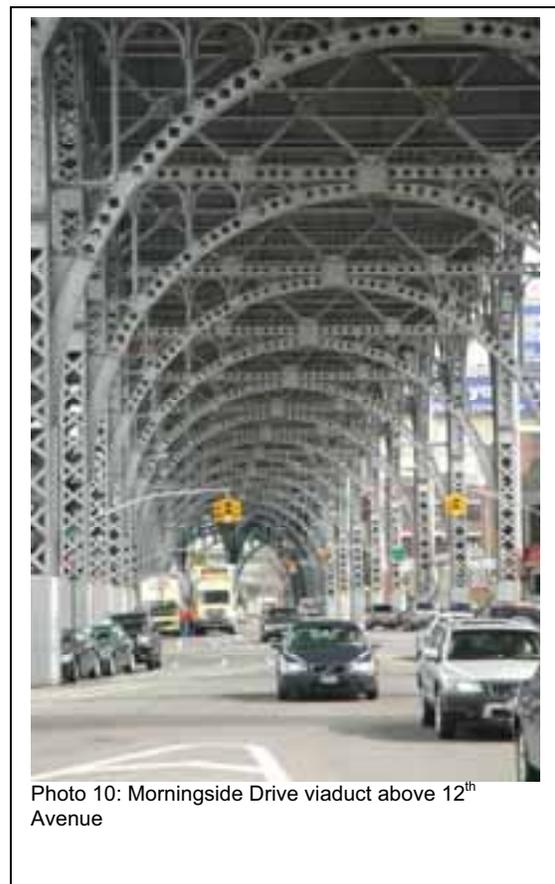
At the western boundary of the study area, three separate viaducts present a formidable visual edge. From the east, Riverside Drive is carried on viaduct above 12th Avenue by massive steel trussed arches approximately 80 ft. tall (Photo 10).

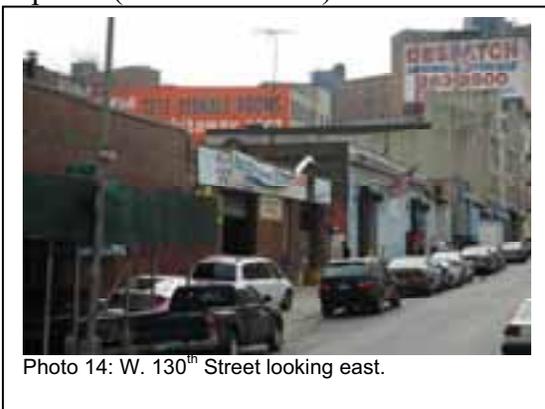
Photo 14: W. 130th Street looking east.

The utilitarian function of most remaining structures has contributed little in the way of quality building design. Typical older industrial structures in the study area reflect decades of neglect and a casual attitude towards appearance as an unnecessary business expense (Photos 14 & 15).

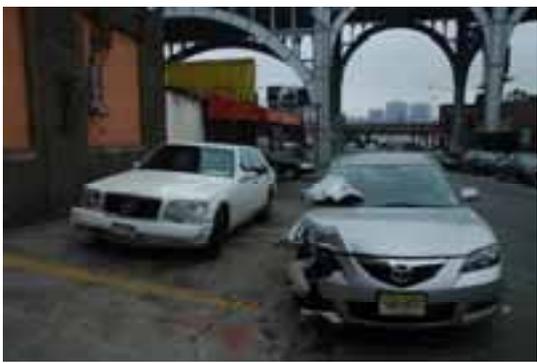
Many businesses appear to be marginal enterprises that place little emphasis on appearance, other than advertising to speeding vehicles. Auto-related businesses especially contribute to streetscape clutter by parking vehicles on sidewalks, double-parking cars, and leaving damaged vehicles around their shops (Photos 16-19).

Photo 17: Sidewalk parking

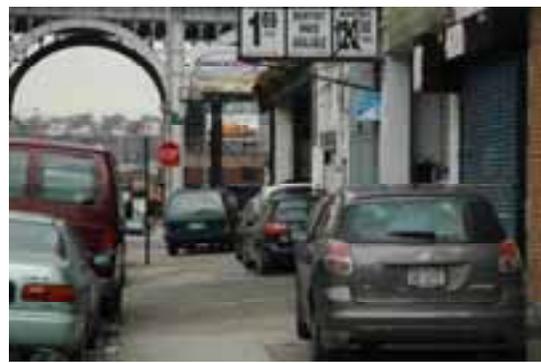
Photo 18: Sidewalk parking

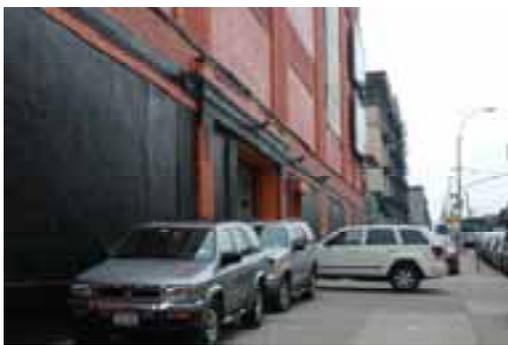
This commonly accepted practice by auto repair shops appears to have had a contagious effect for other businesses, so that trucks are seen unloading from the sidewalk, and customers/owners routinely park cars on the sidewalk at storage warehouses.(Photos 19 & 20)

Photo 19: Sidewalk parking on Broadway

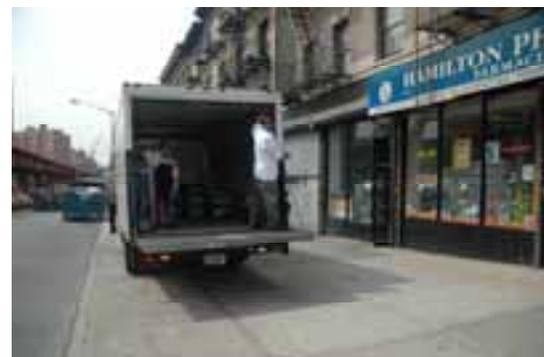
Photo 20: Sidewalk unloading on Broadway

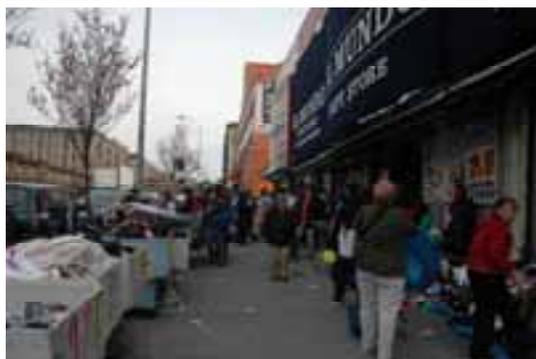
One of the few retailers in the study area (El Mundo on Broadway between W. 133rd Street and W. 134th Street) appears to operate much of its business from the sidewalk in front of its store (including a wooden structures for employees to watch over the stock), with concomitant clutter and obstruction to pedestrian movement on the sidewalk. (Photos 21 & 22)

Photo 21: Sidewalk clutter on Broadway

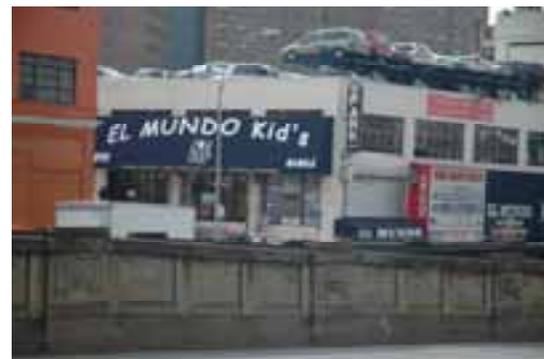
Photo 22: Visual clutter at El Mundo store on Broadway

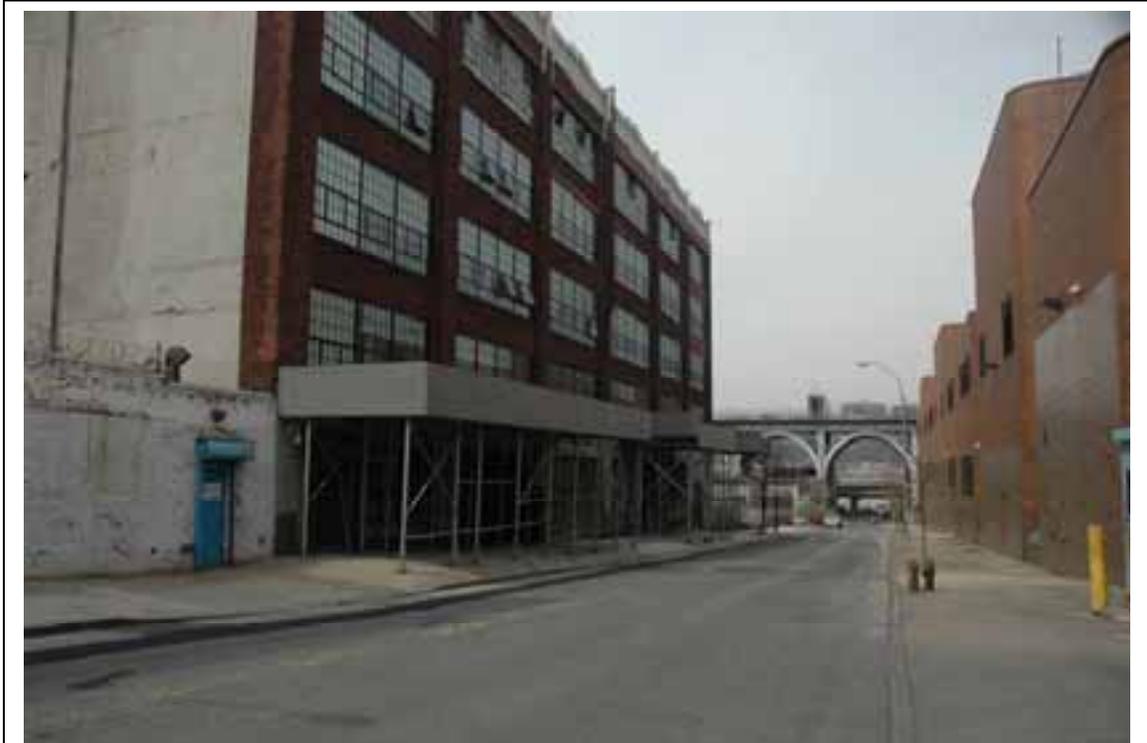
Typically bleak streetscapes further suffer from the almost total absence of any vegetation and street trees (Photo 25). Although the block with the MTA bus depot (W. 132nd Street) has relatively new tree plantings, many of them appear to have already died, limiting the positive effect of this exception.

Photo 25: View west on W. 132nd St, MTA bus depot to right

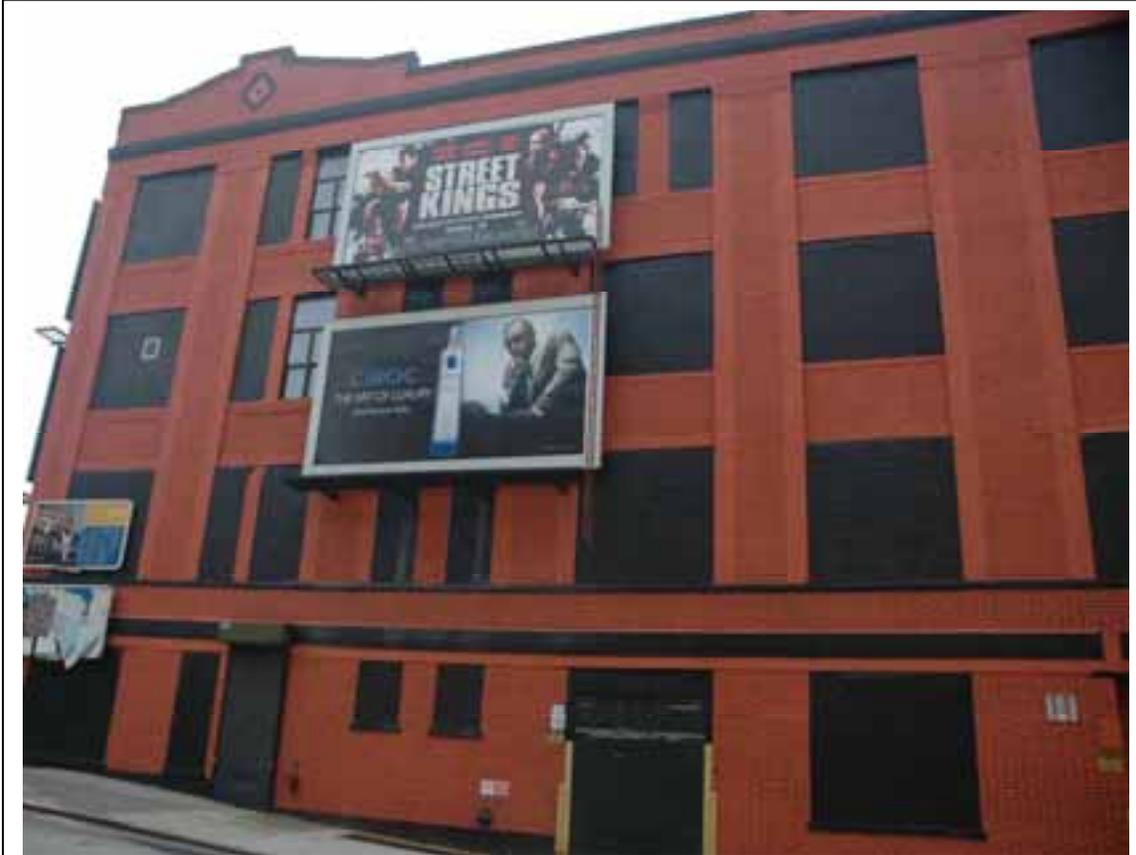
Buildings' street walls contribute negatively to the streetscape's visual quality. Numerous buildings have had former windows blocked off, presenting little transparency, light, or "eyes-on-the-street," offering a grim alternative (Photos 26 & 27).

Photo 26: Note absence of windows and transparency at this self storage warehouse

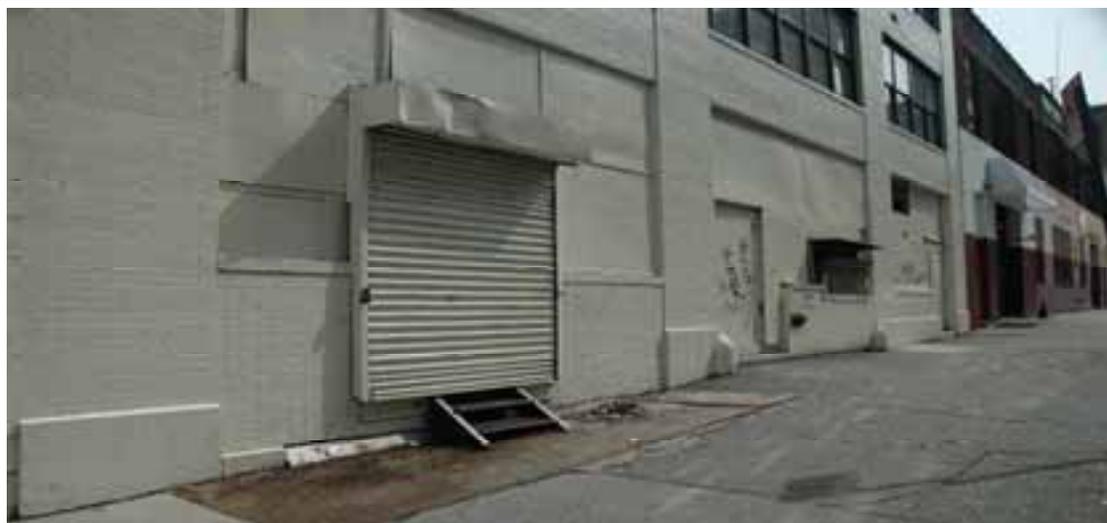
Photo 27: Typical streetwall without windows (W. 133rd Street)

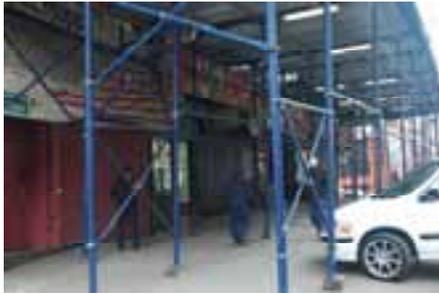
Building walls often display structural deterioration, with cracks in masonry and other deteriorated features, reflecting years of neglect. Several buildings have been “sealed” by the Fire Department because of their unsafe condition and numerous properties now have sidewalk sheds to protect pedestrians from falling masonry (Photos 28-37). These sheds inevitably add to the gloom and clutter along several streets.

Photo 28: Sidewalk shed on Broadway

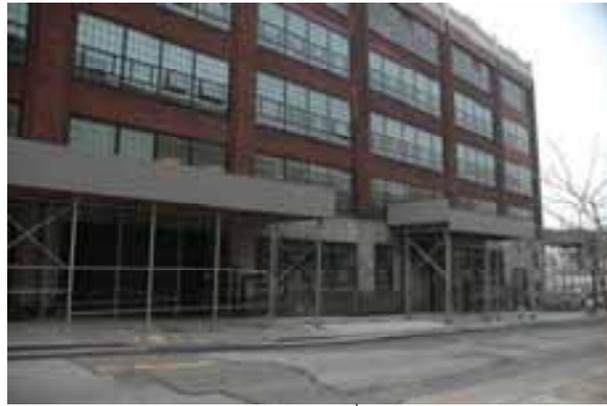
Photo 29: Sidewalk shed on W. 132nd Street

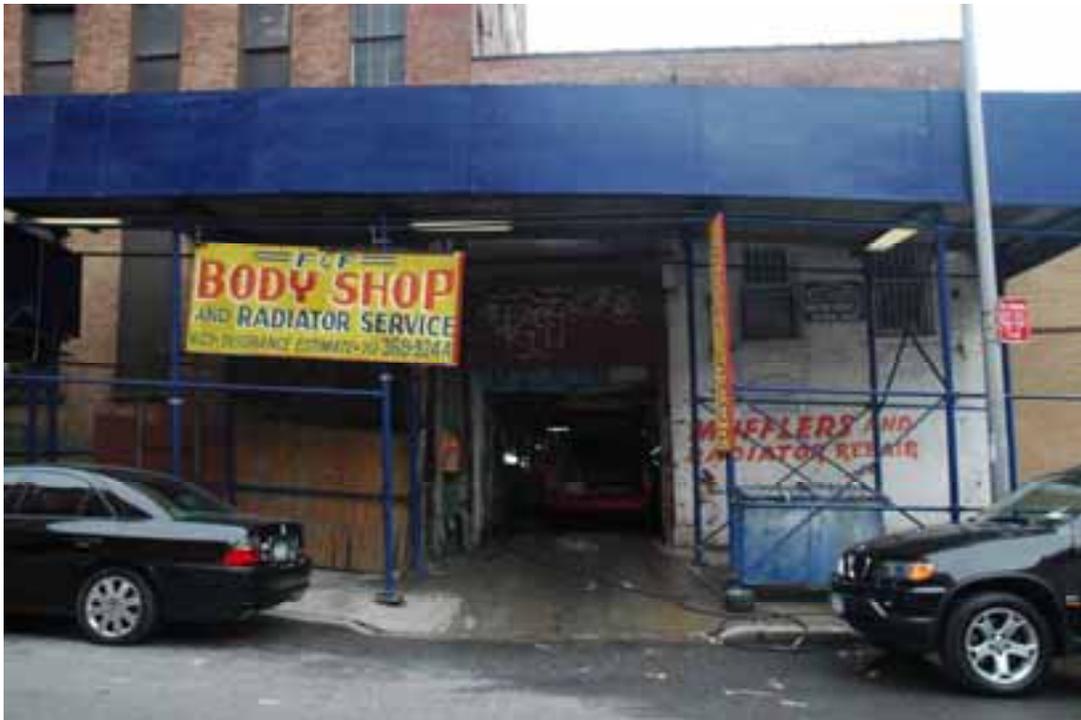
Photo 30: Sidewalk shed on W. 131st Street

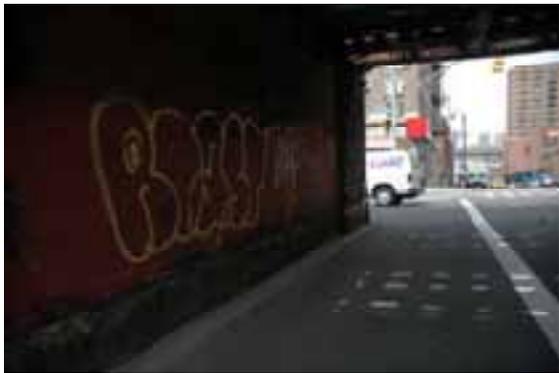
Photo 43: beneath the IRT viaduct

Walls and other visible surfaces are common targets of graffiti, which unless quickly removed tends to accumulate rapidly, substantially contributing to visual blight (Photos 43-45). The AKRF report noted from interviews with Police Department officials that graffiti is one of the more prevalent crimes in the study area.

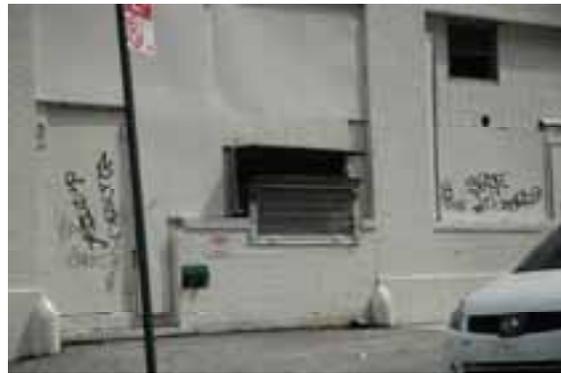
Photo 44: Walls as frequent graffiti targets

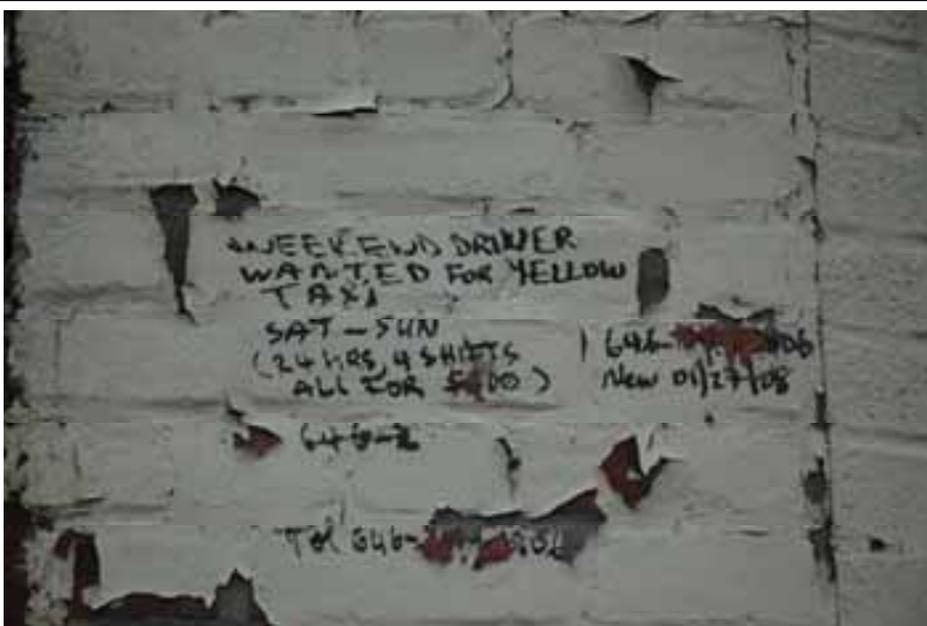
Photo 45: Graffiti "advertising"

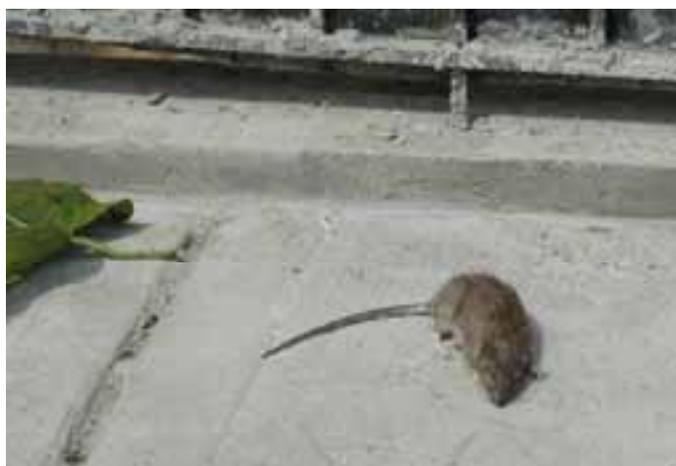
Another eyesore to note is the frequent evidence of vermin, including rats (Photo 46).

Photo 46: Dead rat on sidewalk of Broadway

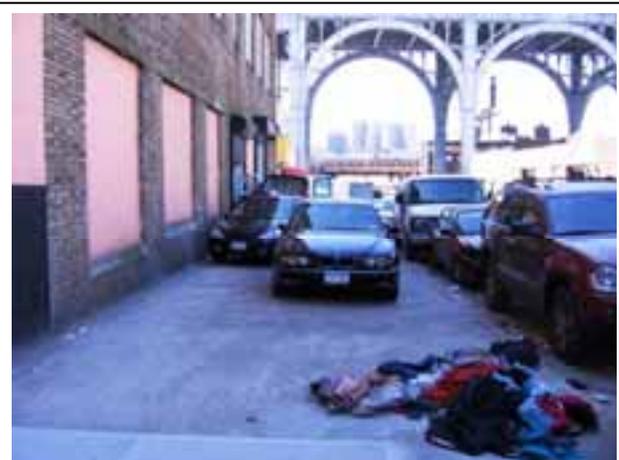
Photo 89: Block 1996 Lot 56

Other poor exterior conditions – Many buildings suffer from deficient finishes, peeling paint, rusted fences, gates and equipment. Graffiti and litter is also a common eyesore in the study area (see photos 88 and 89).

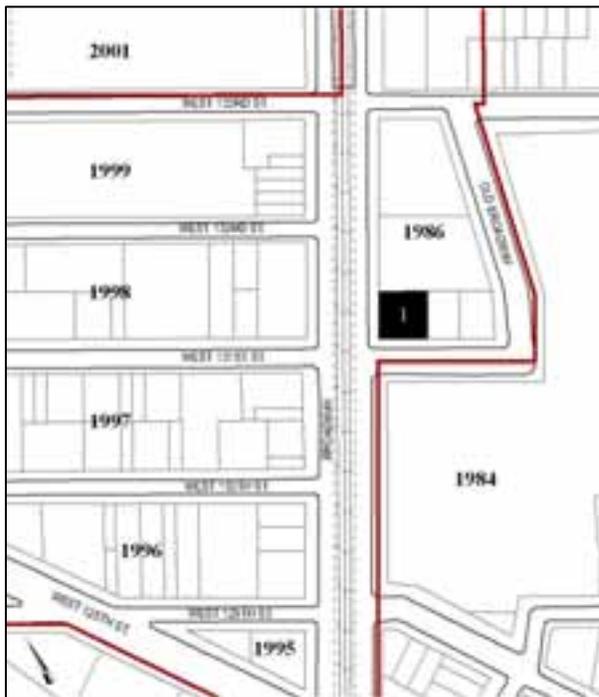
Block 1986 Lot 1

SITE CONDITION: POOR
