SITE CONDITION: POOR

Block 1987 Lot 1

LOCATION, USE, ZONING, AND OWNERSHIP

PHYSICAL AND STRUCTURAL CONCERNS

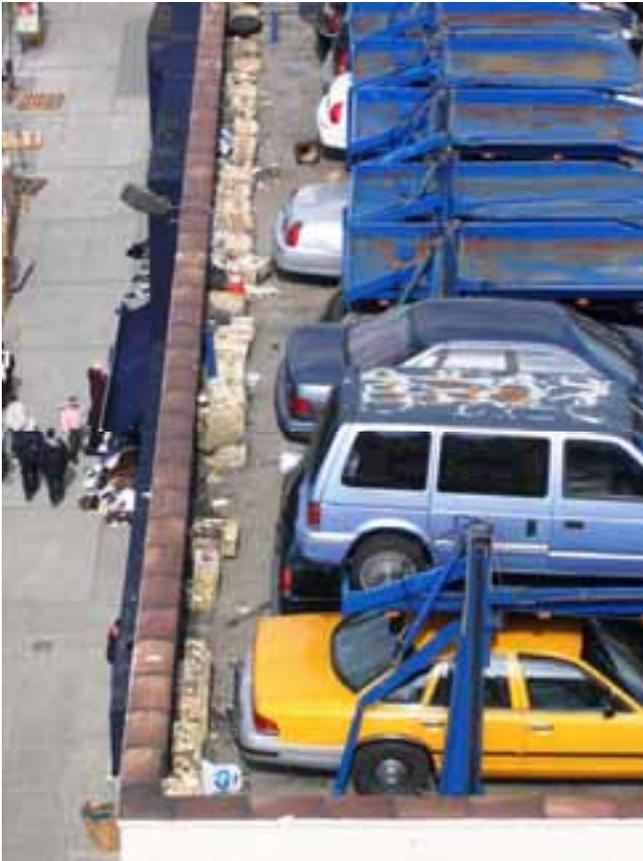
Photograph 1987-1-S

An additional concern Earth Tech noted from its visual survey of the roof of the building from a higher roof across West 133rd Street. The roof is currently used for parking vehicles. Earth Tech observed a multitude of what appeared to be terra cotta blocks lying along the parapets, probably the remains of the former cornice. Given that the roof is actively used and accessible, this debris is a potential safety hazard for pedestrians below (see photos S and T).

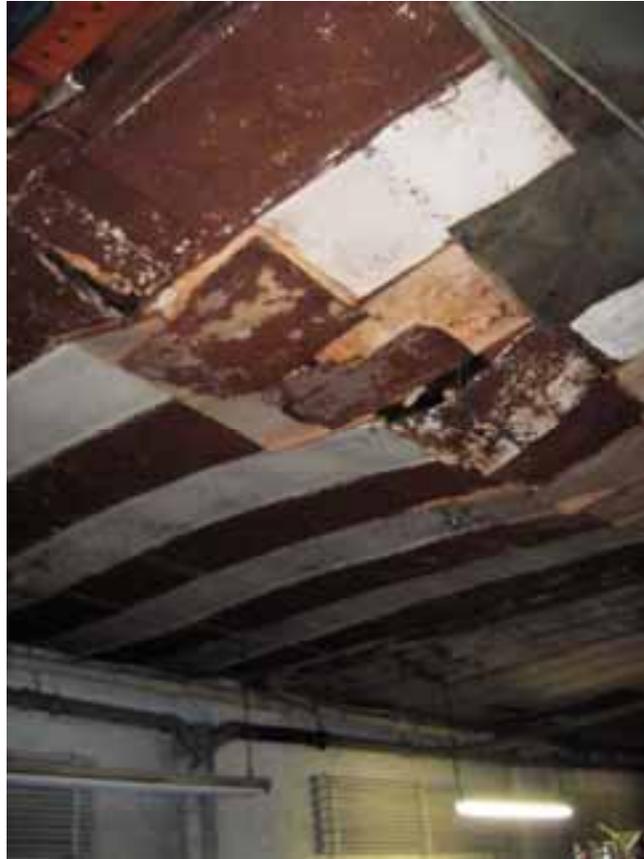
Photograph 1987-7-I

- There are areas of local ceiling collapse on the second floor with broken/missing sections of tin panels; evidence of severe water damage throughout (see photos I and Y).

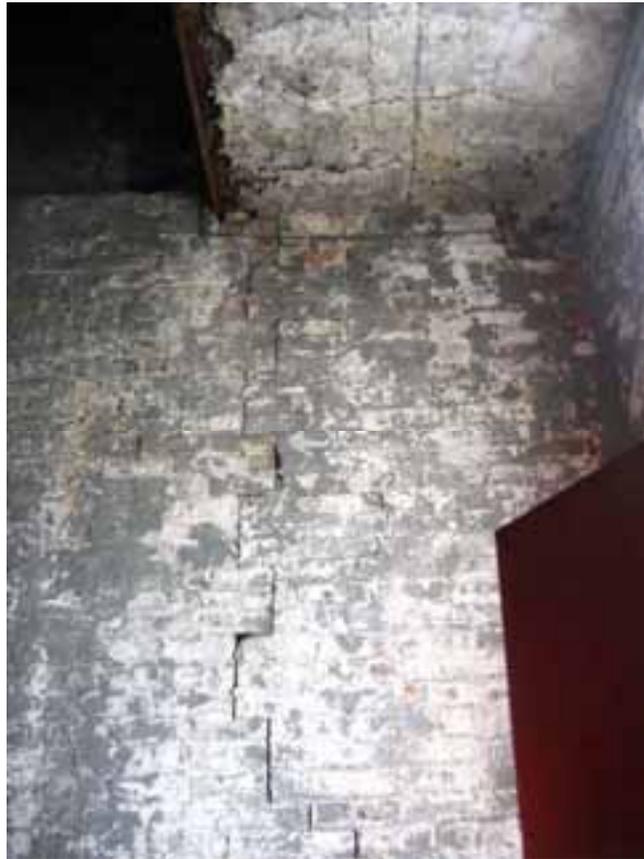
Photograph 1987-7-L

The building was inspected by Earth Tech on February 27, 2008 and no interim or permanent repairs to correct or to mitigate the previously reported instances of structural damage, distress or instability were found where inspection was possible. The deficiencies remaining evident included: cracked and settled floor slab of the parking garage along 134th Street (see photos C and D); heavy damage to timber joists due to water infiltration (see photos E and F); water damage with mold and efflorescence; stepped cracks in the interior east wall at the 2nd floor (see photos G and H); dripping water from roof; sagging and deteriorated steel panel ceiling (see photos I and J); wide stepped cracks in stair walls, with concrete steps showing cracked and crumbled concrete

(see photos K and L); large pool of water in roof bays with broken, buckled or missing cross bracings (see photos M, N and O).

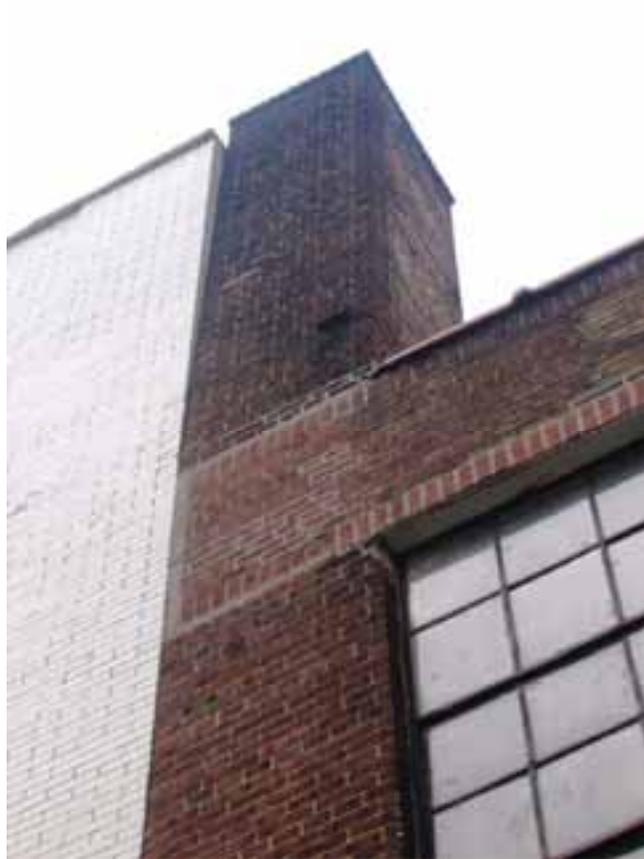
Photograph 1987-7-P

A brick masonry chimney on the roof along 133rd Street exhibits 1 to 1 ½ inches of outward tilting (see photo P). This deficiency was not reported in the previous report.

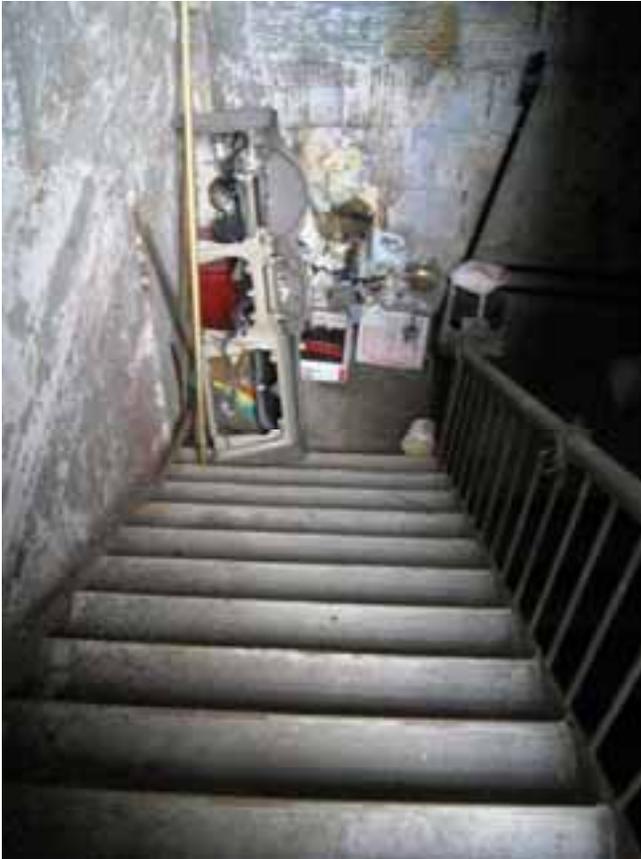
Photograph 1987-7-Q

- Both fire exits from second floor leading to West 133rd Street are not usable. The stairwell to the southwest is used as storage (see photo Q); its exit door does not have an exit sign, the required hardware, and was locked at the day of survey (see photo R). The stairwell at the southeast corner was blocked by parked cars and inaccessible; at street level, the threshold step at exit door is damaged and does not meet code (see photo S).

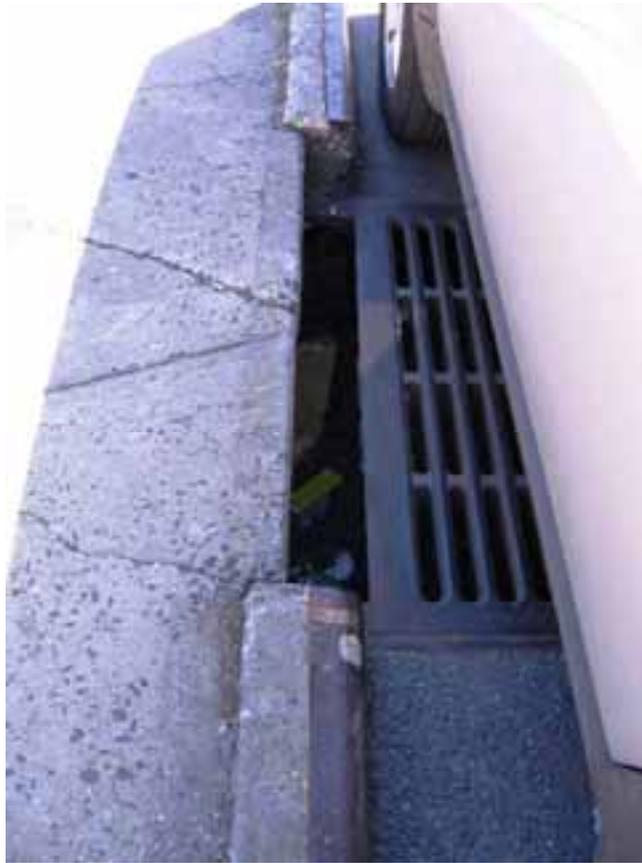
Photograph 1995-35-I

- Earth Tech concurs with the AKRF/Thornton Tomasetti's evaluation of the sidewalks which were listed as *"in fair condition, with local spalling and cracks. The asphalt paving is also in fair condition, with typical degradation and staining associated with gas station operations"* (see photos D, E, G and H).
- At the West 125th Street sidewalk, a piece of steel curb at the street storm drain is completely missing – this is a safety hazard for pedestrians (see photo I).

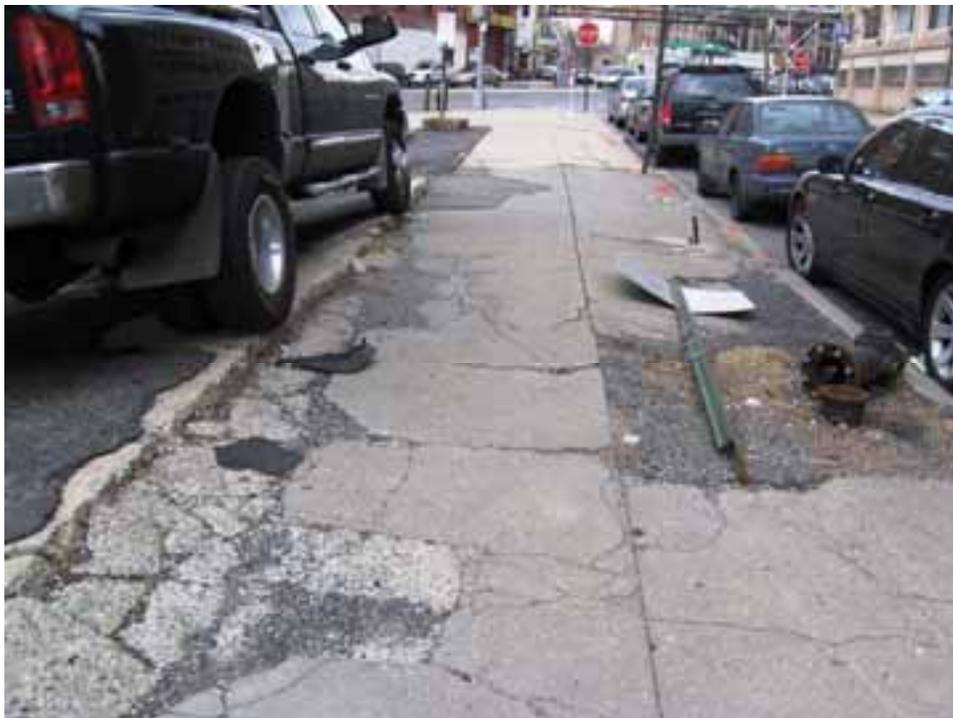
Photograph 1996-1-F

Based upon their visual, exterior inspection in 2006 and 2007, Thornton Tomasetti reported sidewalks in fair to poor condition (cracks and spalls, see photo F), poor paved parking area (cracks and spalls, see photo G), and fair window frames and doors; also noting a corroded doorway header, corroded exterior stairways (see photo H), and cracked stucco (see photo I). When inspected on March 12, 2008, Earth Tech's observations were generally consistent with the conditions reported by Thornton Tomasetti. There was no evidence of significant renovation subsequent to the 2006/2007 inspections.

- The sidewalk at Twelfth Avenue and St.Clair Place is in poor condition with cracked, damaged, spalling, uneven concrete slabs and asphalt patches (see photos J, K, L and M), which is a safety hazard to pedestrians.
- On the day of the survey, Earth Tech noticed a damaged and inoperable traffic sign and a fire hydrant on the St.Clair Place sidewalk (see photos F and N).
