SITE CONDITION: POOR

Block 1996 Lot 14

PHYSICAL AND STRUCTURAL CONCERNS

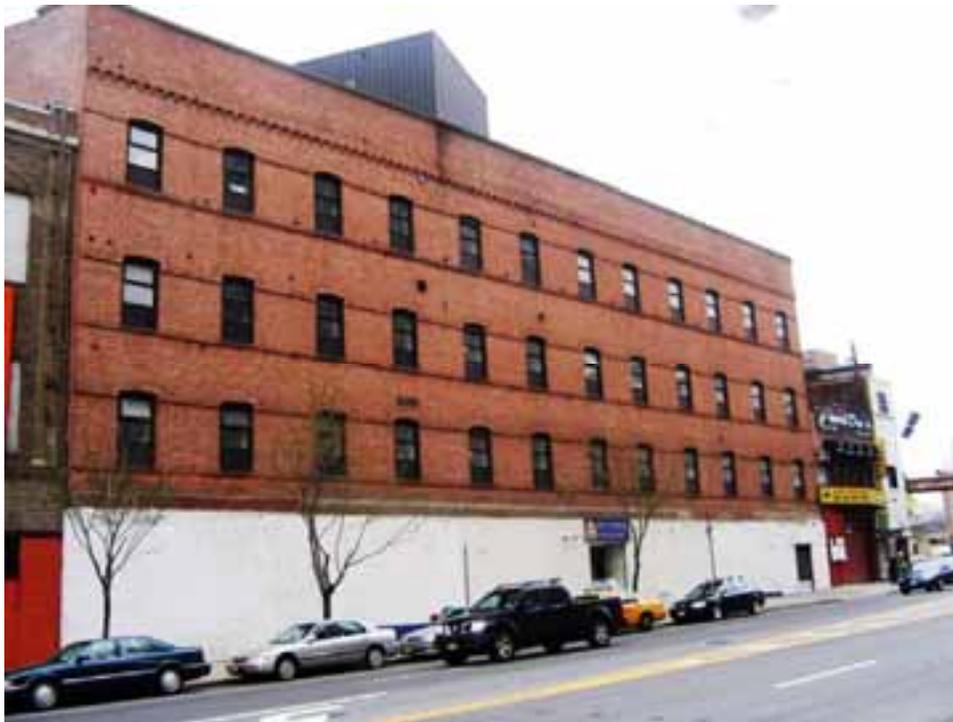
Photograph 1996-14-A

Lot 14 is located at 637 West 125th Street between Broadway and Twelfth Avenue with frontage on both West 125th (see photo A) and West 130th Streets (see photo B). The 18,850-sf lot contains a four-story 77,408-gsf brick masonry building. The first and second floors are used as offices by Columbia University, and the third and fourth floors are unoccupied. According to the Department of Finance RPAD Master File, the building was constructed in 1908 with alterations subsequently recorded in 1992 and 1993. Earth Tech reviewed the NYC Department of Finance Automated City Register Information System (ACRIS) and found

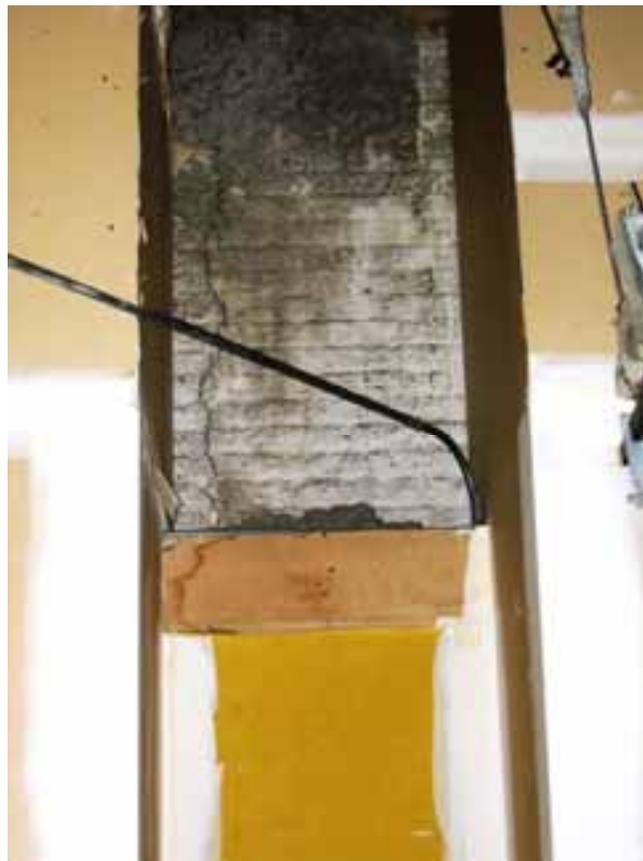
Photograph 1996-14-D

1. Cracks in the masonry walls along the interior and water infiltration on various floors (see photos C, D, E and F).
2. Cracks in the masonry walls along the exterior of the building (see photos G, H and I).

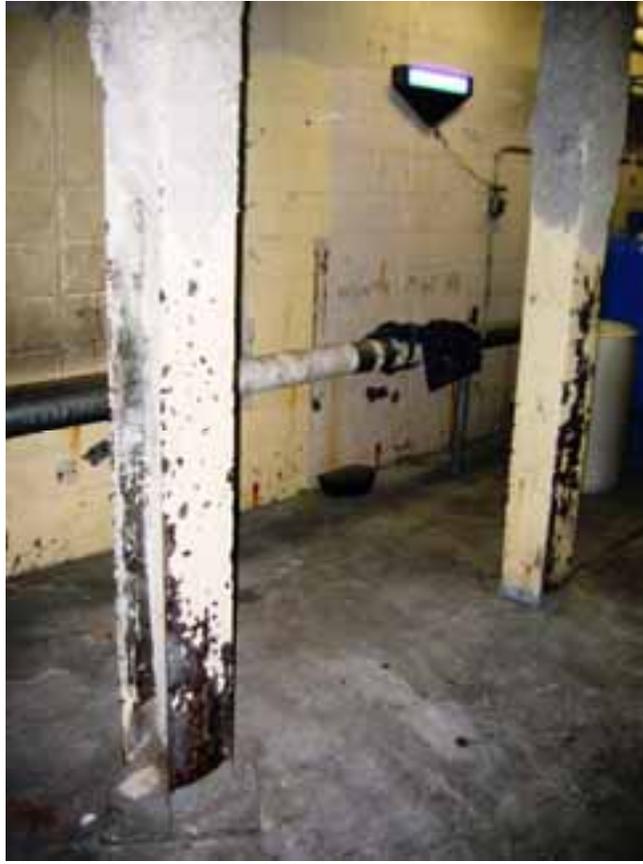
Photograph 1996-14-W

3. Deteriorated window header and sills (see photos J, K and L).
4. Corroded roof slab reinforcement (see photos M and N).
5. Spalled concrete and corrosion stains on concrete encased steel beams (see photos O and P).
6. Localized water filtration continues to occur through the north exterior wall on the first floor. The wall is partially missing and is filled in with clothing and pillows (see photos Q and S).
7. The side walks and curb along the north sidewalk have been repaired and are now in good condition (see photo T).
8. Unfinished metal deck floor on second floor (see photos U and V).
9. Spray-on fireproofing is only applied to partial height of several columns (see photos W and X).

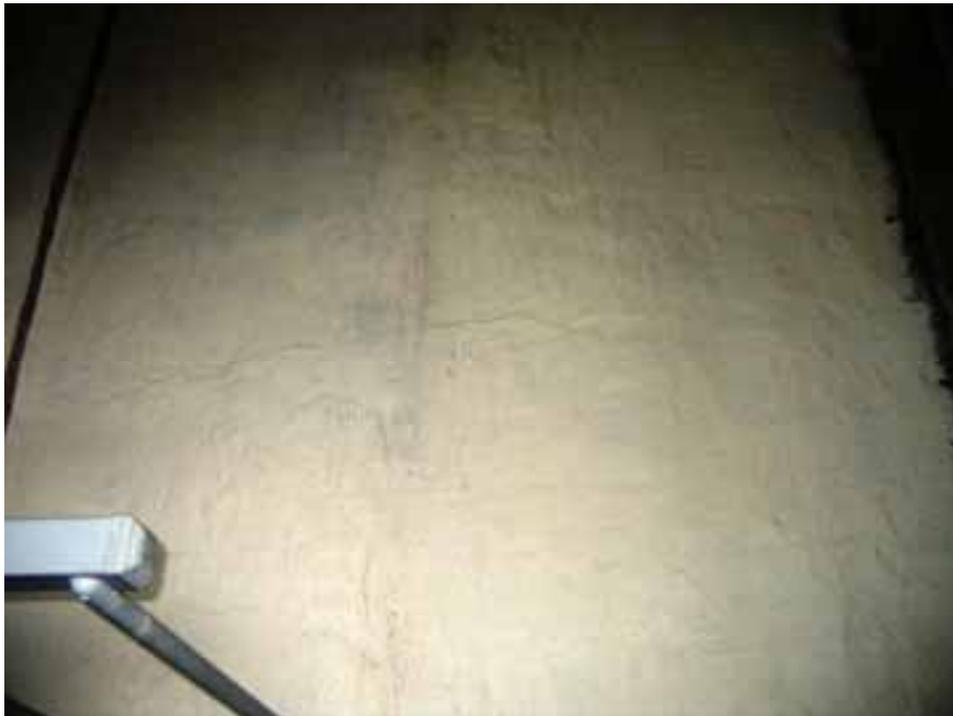
Photograph 1996-14-AB

1. The top of door frame is filled in with broken-up masonry outside of the electrical room on the first floor (see photo Y).
2. Cracks in stairwell walls (see photos Z, AA and AB).
3. Missing fireproofing on beams in first floor room (see photos AC and AD).
4. Temporary repairs to ceiling slab (see photos AE and AF).
5. On the 4th floor, an opening has been cut out in the masonry wall without providing a lintel or other means of masonry support above opening (see photo AG).
6. Exterior anchors to brick facade are no longer bearing against exterior wall (see photos AH, AI and AJ).
7. Chimney requires repointing (see photo AK).
8. North east parapet needs repointing (see photo AL).

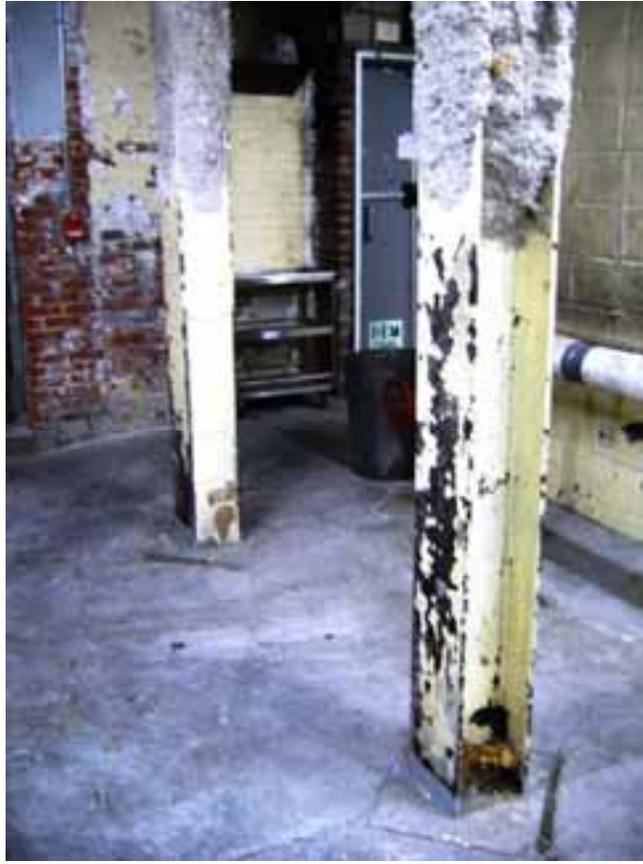
Photograph 1996-14-AM

- Spray-on fireproofing was only applied to partial height of several columns (see photo AM).
- Steel columns and beams in the electrical room are not fireproofed (see photo AN).
- A drain pipe outlet located above the electrical switch board is a safety hazard (see photo AO).
- Mold on the ceiling and masonry walls, peeling paint, cracks at various locations on the walls, signs of vermin, and excessive debris throughout the unoccupied space (see photos AP, AQ, AR AS, AT, AU AV and AW) - these are all confirmed safety concerns.

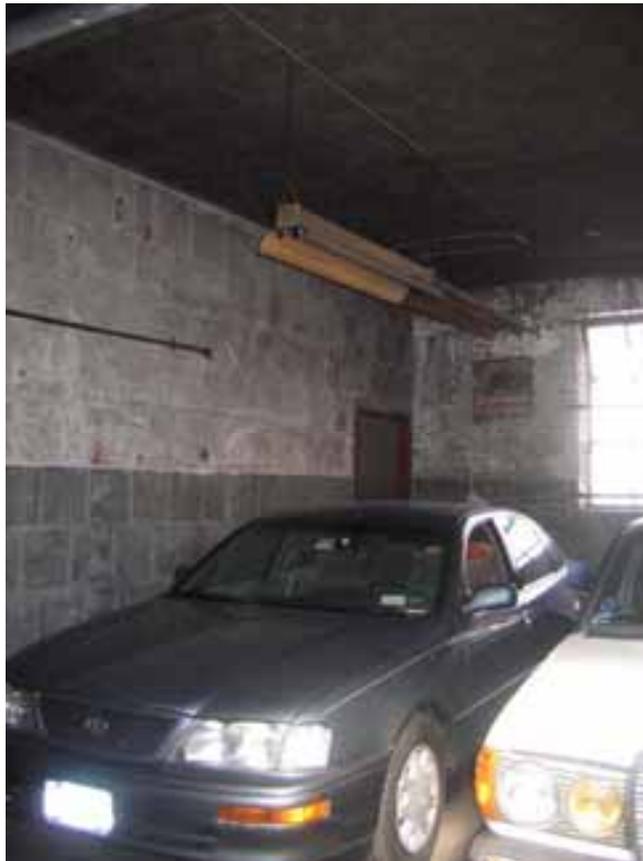
Photograph 1996-16-F

The building was evaluated by Thornton Tomasetti, and was later reported by AKRF, as being in poor condition owing to a combination of localized structural distress (especially the exterior concrete masonry units (CMU) bearing walls, see photos A, C), other deficient interior (see photo D,E) and exterior (see photo F,G) building conditions, and hazardous site conditions.

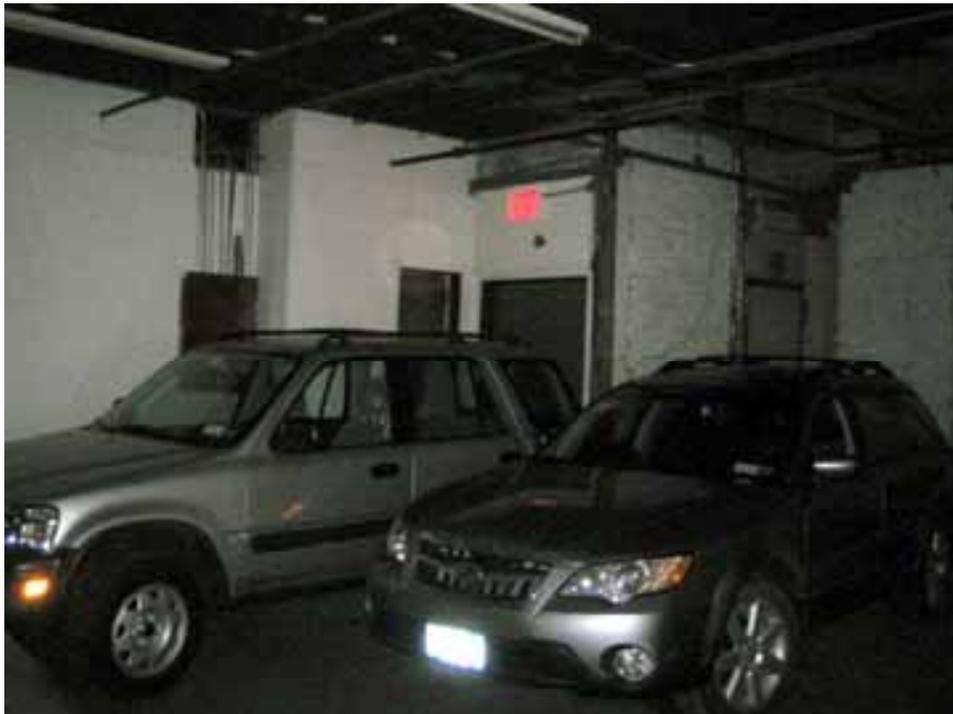
Photograph 1996-16-L

On the day of Earth Tech's survey, both fire exits from the second floor were blocked by the tightly parked vehicles (see photos L and M). The exit stairwell on the north side was totally inaccessible from the second floor, while at the same time blocked with carts/debris on the first floor; the electrical exit sign above the door appeared disconnected (see photo N). The stairwell on the south side (discharging to West 129th Street) shows considerable corrosion of steel stair structure (see photo O); however, the

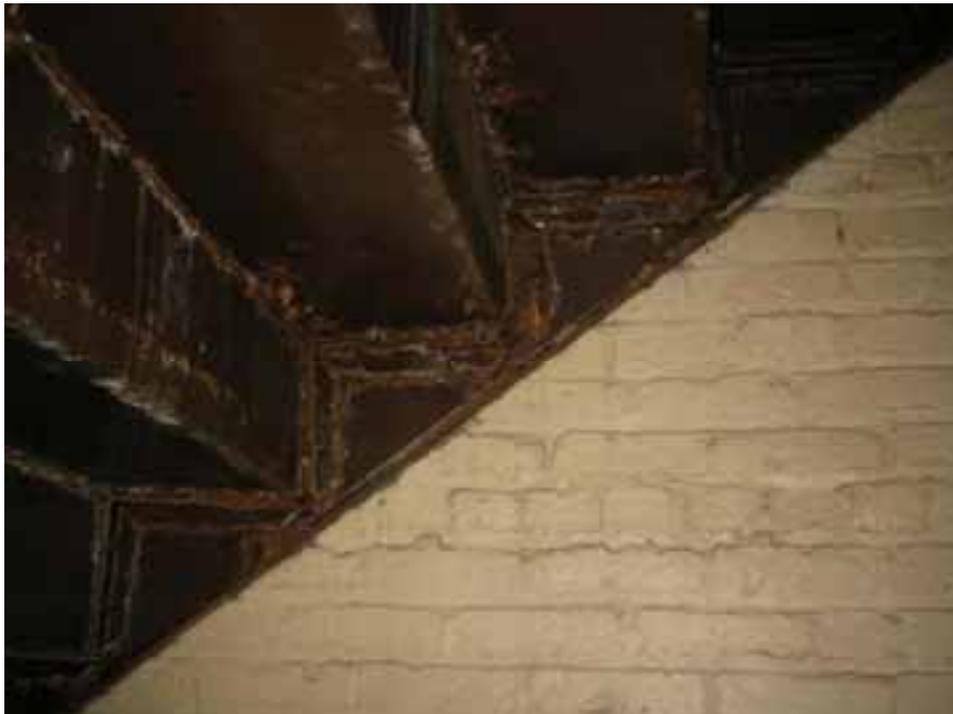
Photograph 1996-16-P

most deteriorated portion of the stair (leading from second floor up to intermediate landing) has been replaced by Columbia University recently with a new flight of steel stairs (see photo P).

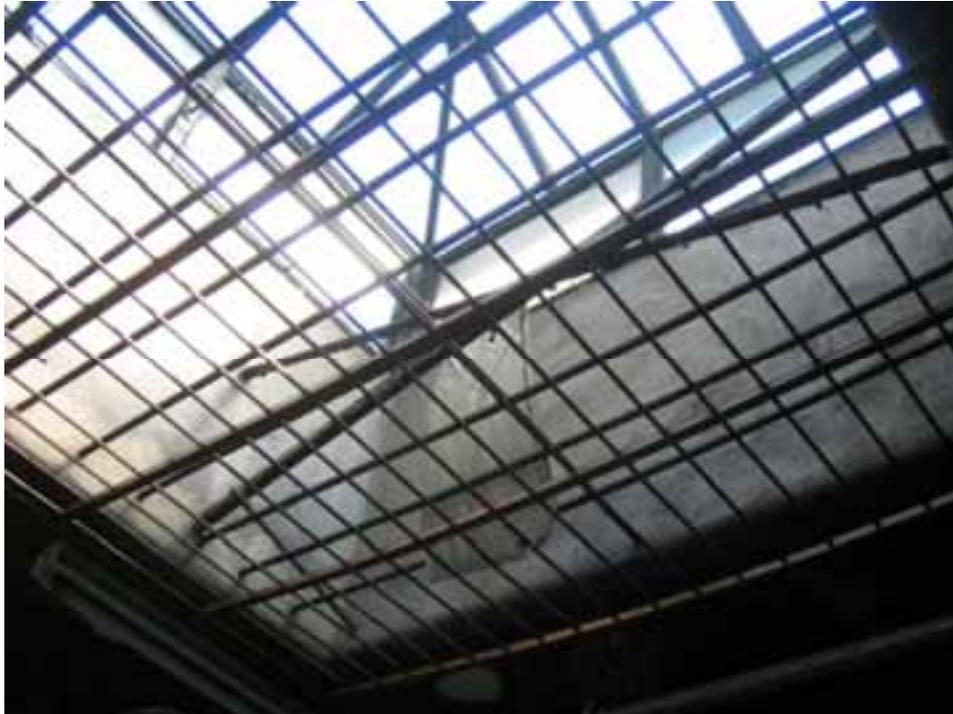
Photograph 1996-16-Q

- One of the skylights has a piece of broken glass suspended haphazardly in the air by just a steel rod (see photo Q)
- Poor lighting on the second floor due to broken or missing lighting fixtures (see photo R)
- Sidewalk at West 130th Street is in poor condition, which is a safety concern for pedestrians (see photo S)
- Loading dock at 129th Street was filled with newspaper/cardboard debris on the day of the survey (see photo T).
