SITE CONDITION: CRITICAL

Block 1996 Lot 20

SITE CONDITION: POOR

Block 1996 Lot 21

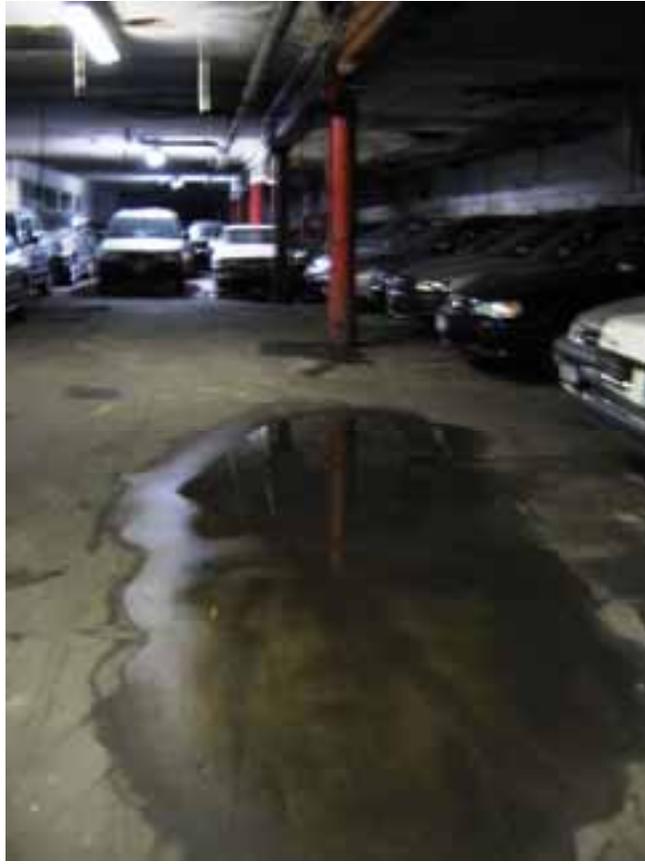
Photograph 1996-18-M

In the three-story building at the south of the lot, several inclined columns have been built in the basement probably to support the heavy dry cleaning equipment of a previous occupant (see photo H). Extensive water infiltration was evident, with heavy efflorescences, mold, wet patches, and water stains visible on the basement walls (see photos I and J). Water is leaking profusely into the basement near the north wall and an approximately 3 inches of standing water was present during Earth Tech's inspection (see photos K and L). The brick columns in the basement exhibit significant buckling/bowing. The concrete slab in the basement shows large spalls and medium random cracking (see photo J). Access to the artist-occupied second and third floors was not available to Earth Tech, however, observation of the roof was available from an adjacent roof and damaged and missing coping stones are visible on the roof parapet (see photo M).

Earth Tech confirms the findings of Thornton Tomasetti's inspection of this site, noting that no interim or permanent repairs to correct the reported deficiencies have occurred since their inspection. In the two-story building to the north, evidence of water infiltration damage is extensive in the basement, with cracks in the stone walls, severely deteriorated timber columns, beams and rotated timber floor joists, deteriorated and collapsed steel ceiling, and a corroded steel ceiling is also present on the second floor, with pooling water on the roof. The north exterior wall exhibits wide stepped cracks and displaced bricks. The three-story building to the south also exhibits extensive water infiltration, with heavy efflorescences and mold on the basement walls, and leaking and standing water. The brick columns in the basement exhibit significant buckling/bowing, and its concrete slab shows large spalls and medium cracking. Damaged and missing coping stones are visible on the roof parapet.

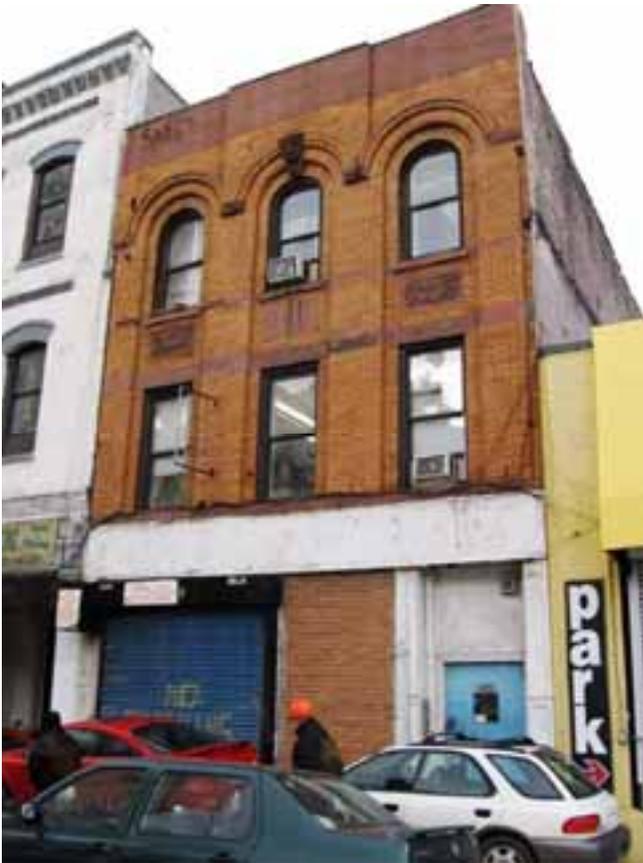
Photograph 1996-20-A

This building was evaluated by Thornton Tomasetti, and was later reported by AKRF, as being in poor condition due to a combination of localized structural distress and other deficient interior, exterior, and site conditions (see photos A, B).

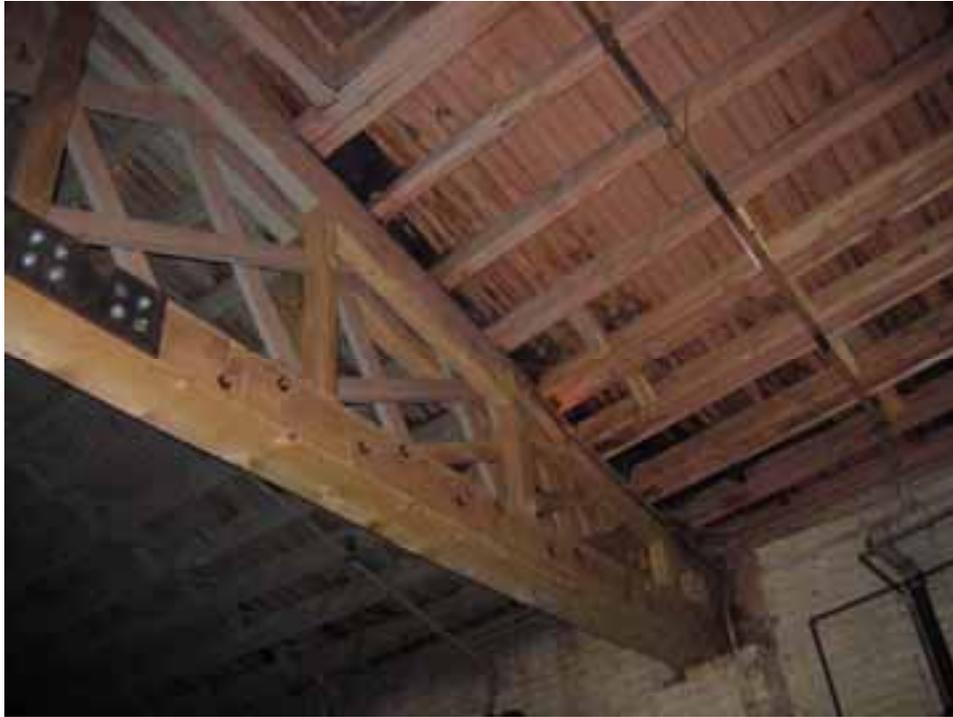
Photograph 1996-21-I

reportedly because of rotting beams; signs of water damage remain evident on the original timber members (see photos I, J).

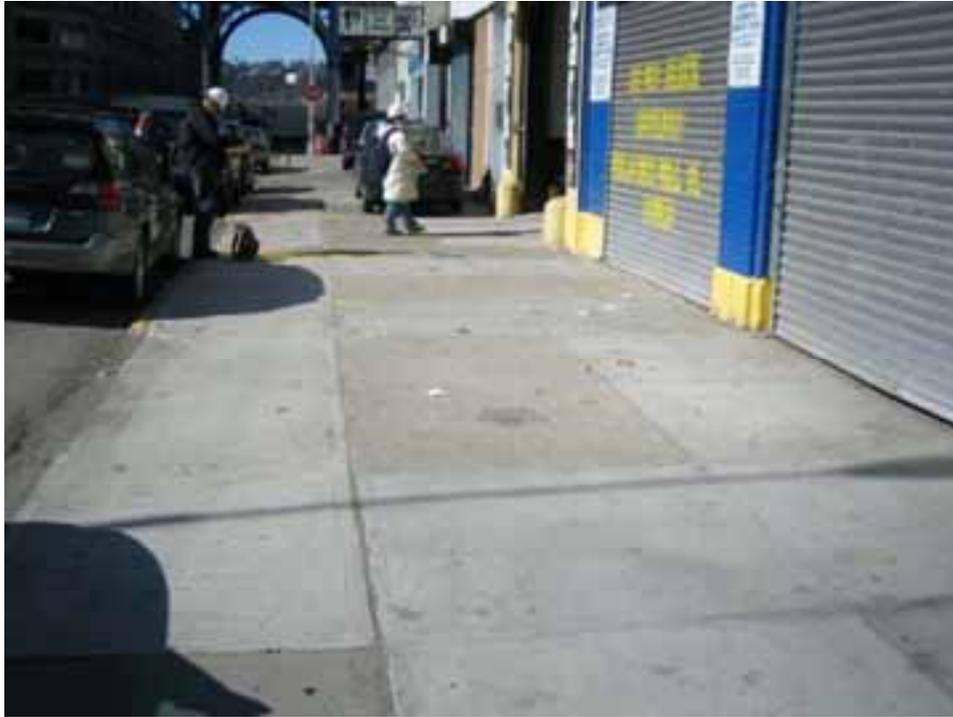
Photograph 1996-21-K

Subsequent to the inspections by Thornton Tomasetti, sections of the sidewalk along (see photo K) on W. 129th Street were replaced and the sidewalks there are now in satisfactory condition. However, the condition of the sidewalk on W. 130th Street has since deteriorated with spalled concrete. In addition the membrane roofing has significantly worsened since Thornton Tomasetti's inspections, and several areas of membrane have completely delaminated along the inside of the east parapet (see photo L).

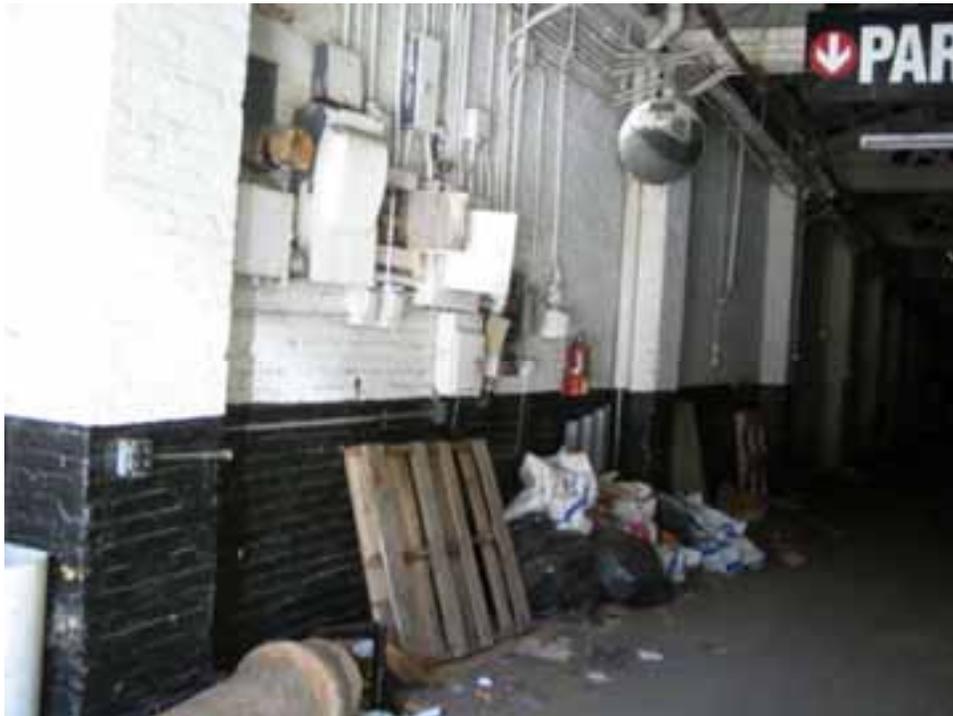
Photograph 1996-21-P

- Water infiltration directly above electrical panel is a safety hazard (see photo N)
- Mold on masonry walls (see photo O)
- Litter and debris with evidence of vermin infestation (see photo P).

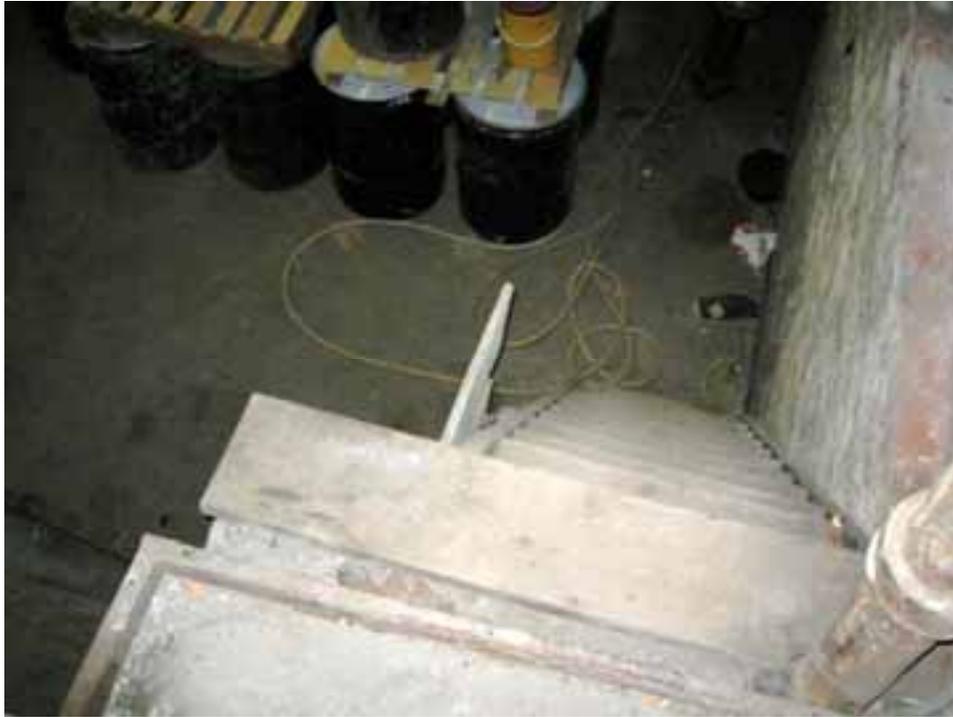
Photograph 1996-21-Q

- The existing stair at the northern wall, leading to West 130th Street, is not code-compliant, with combustible wooden structure, non-compliant treads with open risers, and absent handrail/guardrail both at stair and landing (see photo Q). The traces of another stair at eastern wall suggest that the original stair was replaced

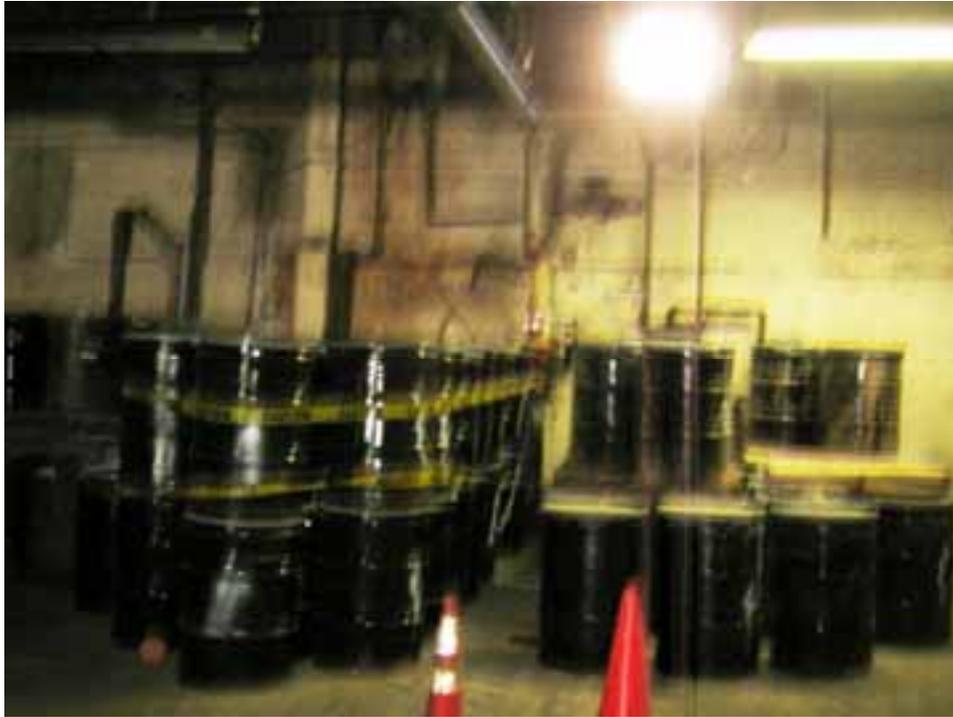
Photograph 1996-21-S

- Metal drums with unidentified content were stored at the northern part of the building, possibly presenting a safety/ health hazard (see photo S).
- Although portions of sidewalk at 129th Street appear to have been repaired and are in fair condition now, the 130th Street sidewalk now has two areas of poor spalled concrete that present a hazard to pedestrians (see photo T).

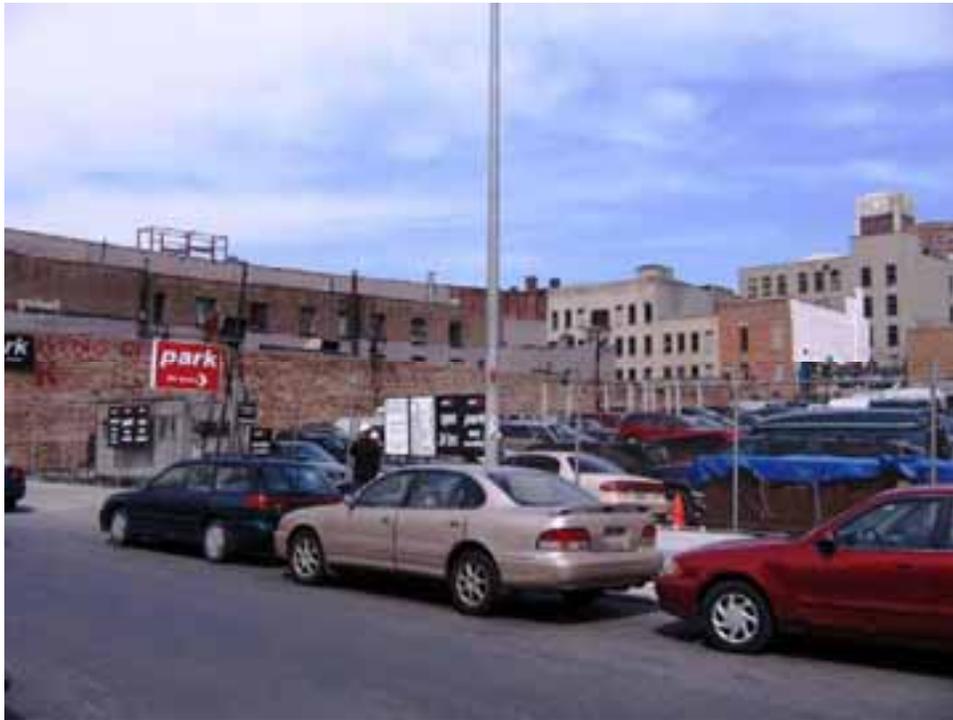
Photograph 1996-23-A

Lot 23 is located at 603 West 129th Street between Broadway and Twelfth Avenue with frontage on both West 129th (see photo A) and 130th Streets (see Photo B). The 24,979-sf lot is occupied by a commercial 24-hour surface parking lot. A temporary structure used as office space for parking attendants is located on the southern portion of the lot. Earth Tech reviewed the NYC Department of Finance Automated City Register Information System (ACRIS) and found that Lot 23 was acquired by The Trustees of Columbia University on November 16, 1967 (date of deed transfer). At the time of the AKRF

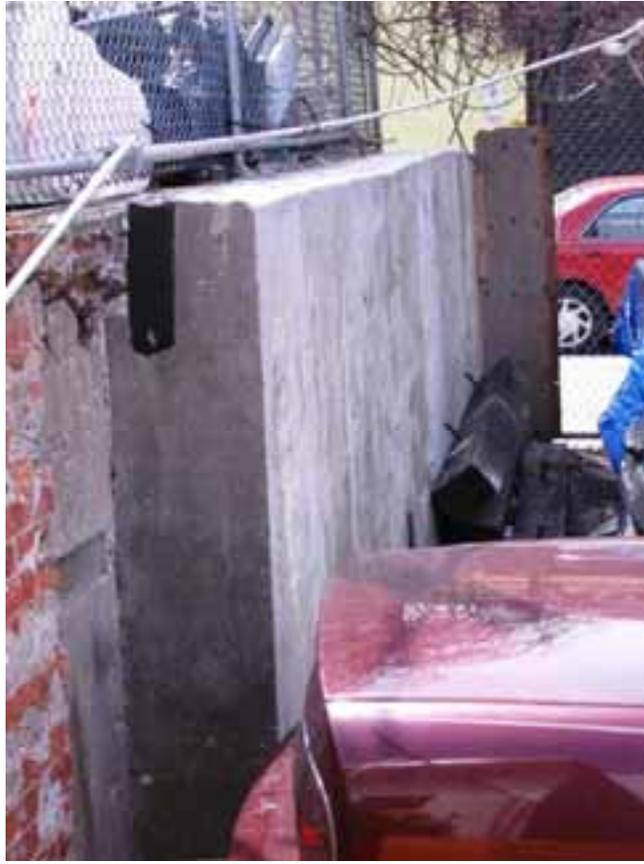
Photograph 1996-23-C

At the time this site was inspected by Earth Tech on April 3, 2008, repairs to correct a bulging-out brick retaining wall at the north east corner reported by Thornton Tomasetti have been made, replacing it with a new concrete wall (see photo C). The wall is supporting the parking area of the adjacent Block 1996, lot 29.

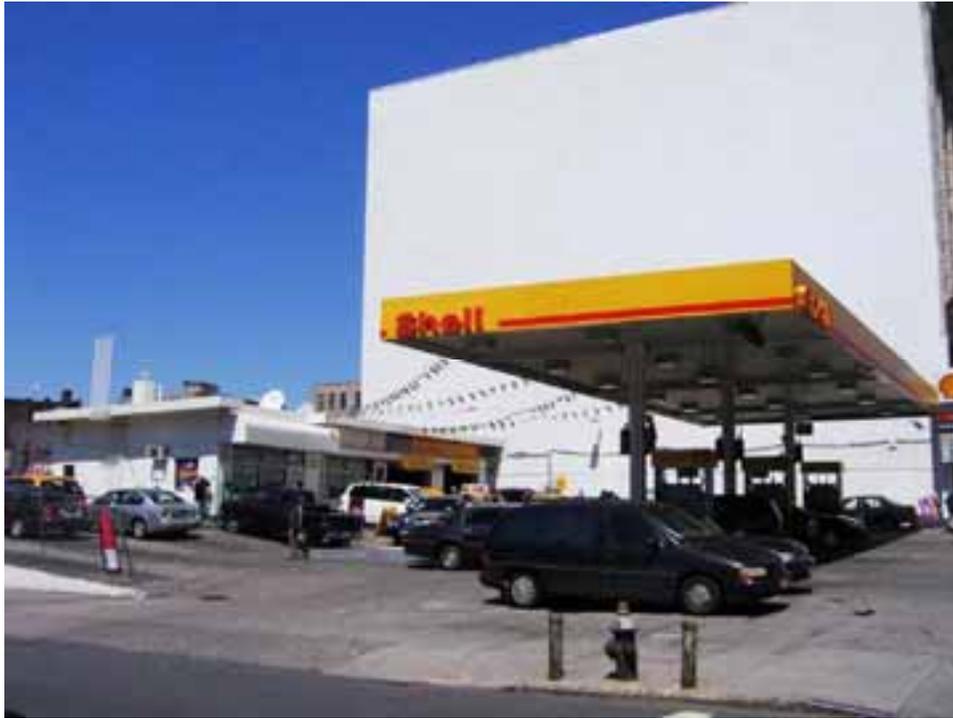
Photograph 1996-29-A

Lot 29 is located at 3221 Broadway on the corner of Broadway and West 129th Street. The 9,992-sf lot contains a gas station and a 1,185-gsf auto repair shop and a small convenience store (see photo A). According to the Department of Finance RPAD Master File, the building was constructed in 1975 with no subsequent recorded alterations. Earth Tech reviewed the NYC Department of Finance Automated City Register Information System (ACRIS) and found that Lot 29 was acquired by The Trustees of Columbia University from Broadway-129 St. Gasoline Corp. on July 10, 2006 (date of deed transfer).

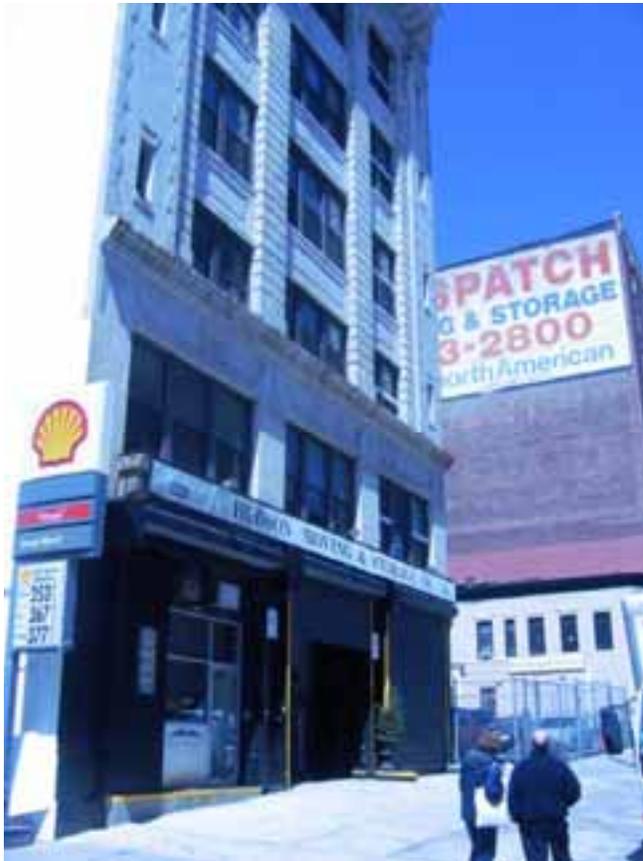
Photograph 1996-34-A

Lot 34 is located at 3229 Broadway between West 129th and West 130th Streets. The 4,983-sf lot contains a six-story 30,000-gsf building occupied by a moving and storage company (see photo A). According to the Department of Finance RPAD Master File, the building was constructed in 1943 with no subsequent recorded alterations. Earth Tech reviewed the NYC Department of Finance Automated City Register Information System (ACRIS) and found that Lot 34 was acquired by Mid-Atlantic Moving Storage from E. Smolka Sons Corp. on September 8, 1972 (date of deed transfer). At the time of the AKRF report, Lot 34 was zoned
