SITE CONDITION: POOR

Block 1996 Lot 50

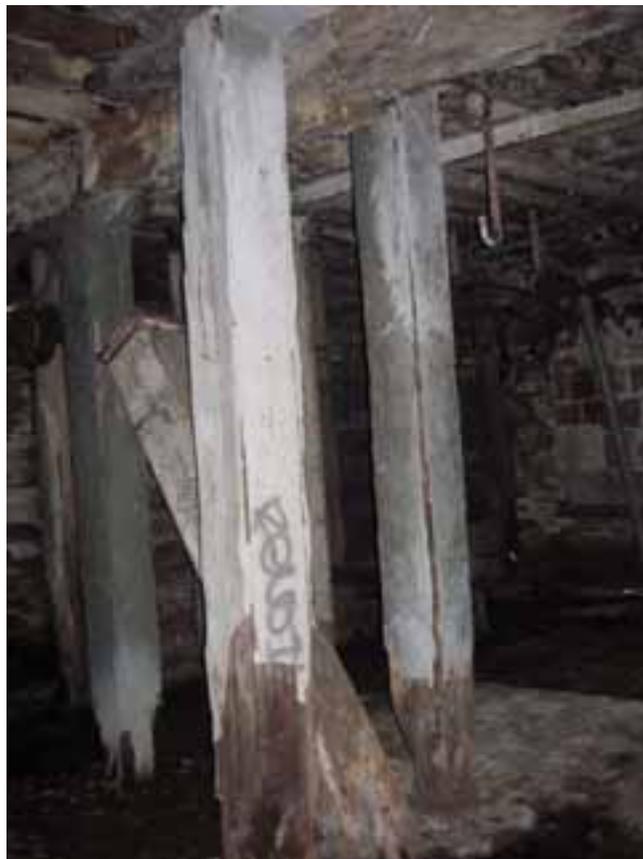
Photograph 1996-36-B

Earth Tech concurs with all the health and safety concerns listed in the AKRF report (see photos R, F, B, S and T), including:

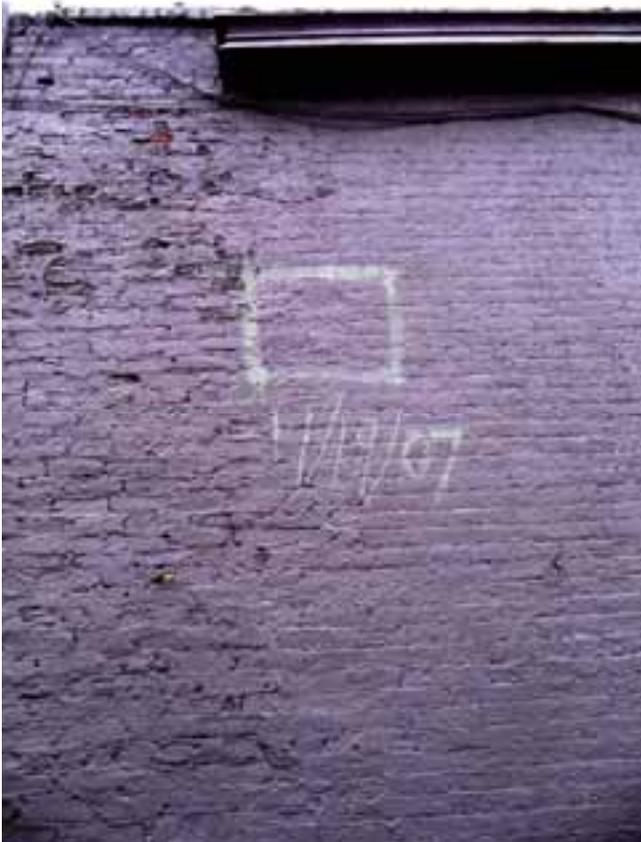
Photograph 1996-36-O

The AKRF report stated that *“overall health and safety concerns associated with this property make it essentially unusable in its current conditions”*. The building is currently vacant; but the parking lot is used by a local automotive repair shop (see photo M). The building was marked in November of 2007, on its West 130th Street façade, by the Fire Department of the City of New York as “shut down” (see photos N and O).

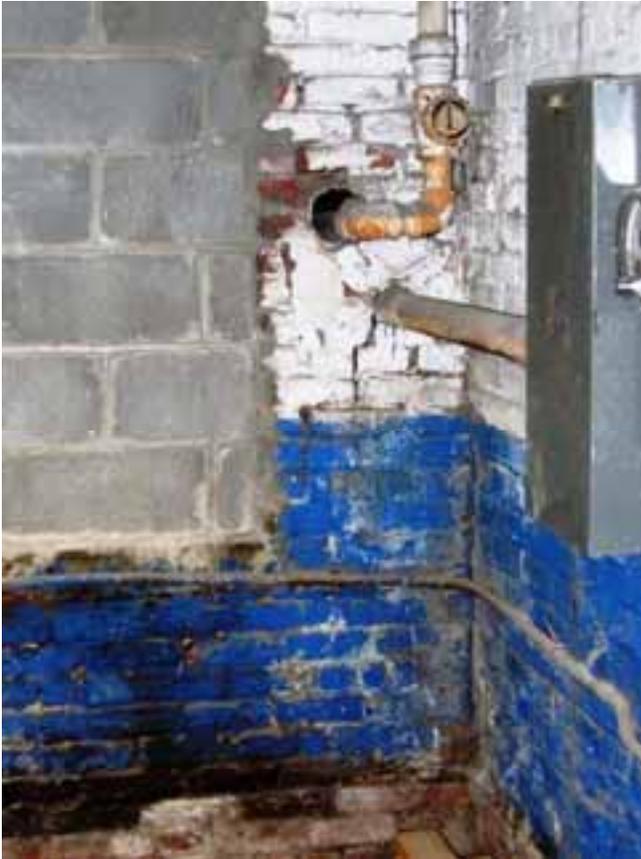
Photograph 1996-50-G

2. The water damage is evident by heavily corroded steel beams on the south side of the building (see photos E and F), cracks in the exterior and interior walls with mold, wet patches (see photos G, H and I), mold and wet patches on the roof timber beams with deflection (see photos J and K).

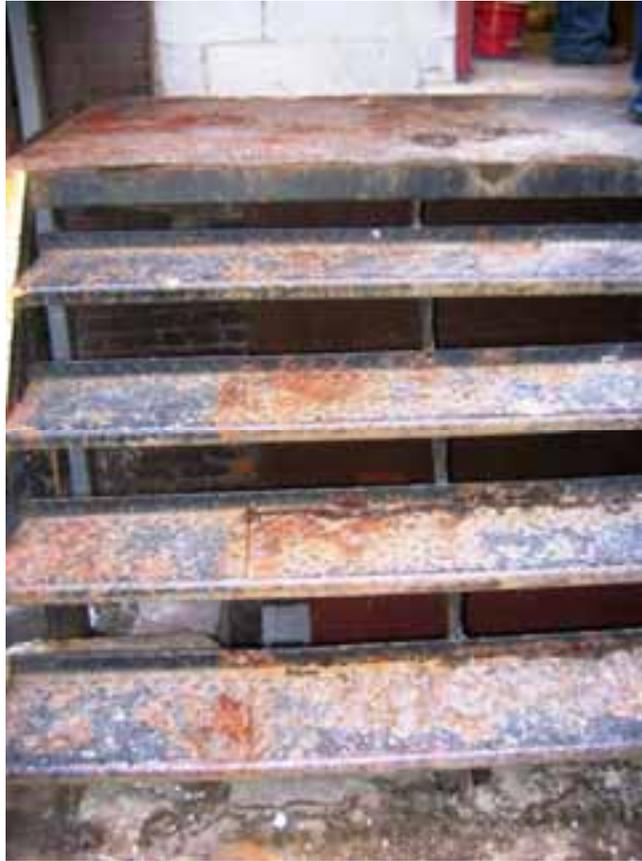
Photograph 1996-50-O

5. The exterior steel stair is in poor condition with heavy corrosion on all members, a hole in the pipe column due to severe deterioration (See photos N, O and P), bent and buckled steel angle column in the entrance area, probably due to collision damage (see photo Q).

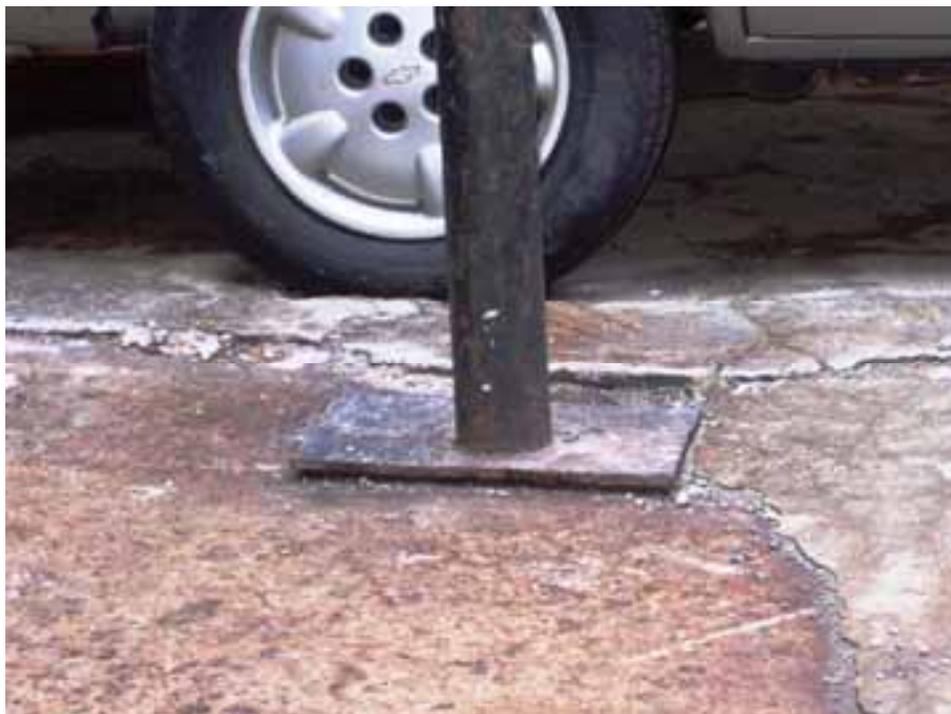
Photograph 1996-50-R

6. One steel column supporting the stair has no anchor bolts (See photo R) and, at the first landing, the steel plate is lifted up and detached from its support due to severe deterioration (see photo S).

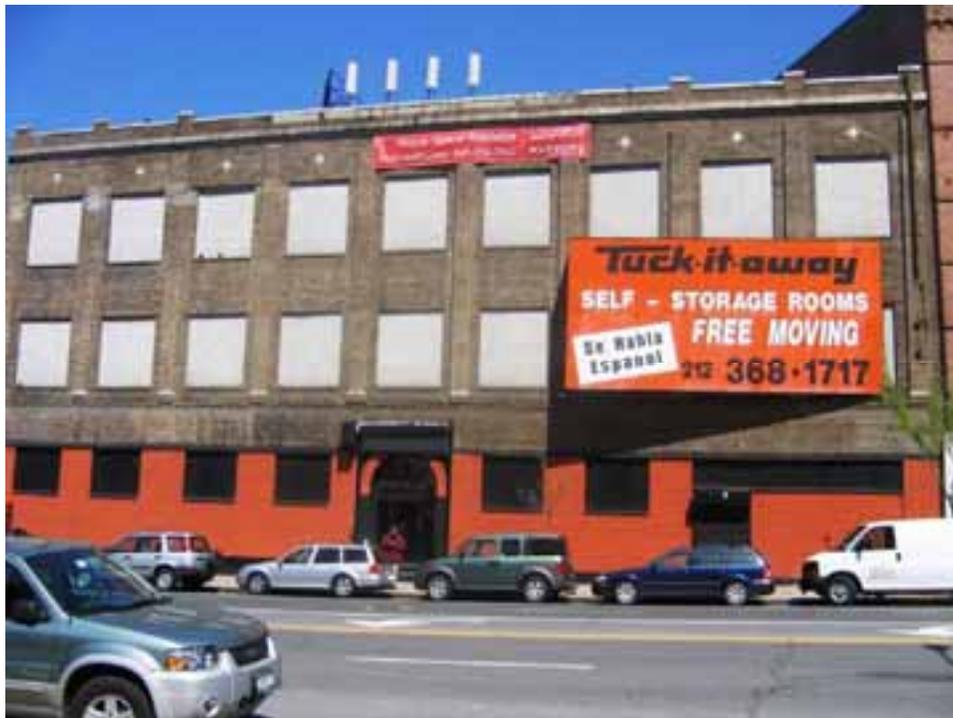
Photograph 1996-56-A

Lot 56 is located at 651 West 125th Street between Twelfth Avenue and Broadway and fronts both West 125th (see photo A) and 130th Streets (see photo B). The 13,492-sf lot contains a three-story 28,000-gsf building that, according to the Department of Finance RPAD Master File, was constructed in 1923 with subsequent alterations recorded in 1993. The building covers the entire site and is occupied by a Tuck-It-Away self-storage facility. Earth Tech reviewed the NYC Department of Finance Automated City Register Information System (ACRIS) and found that Tuck-It-Away acquired the property from Riverside Place

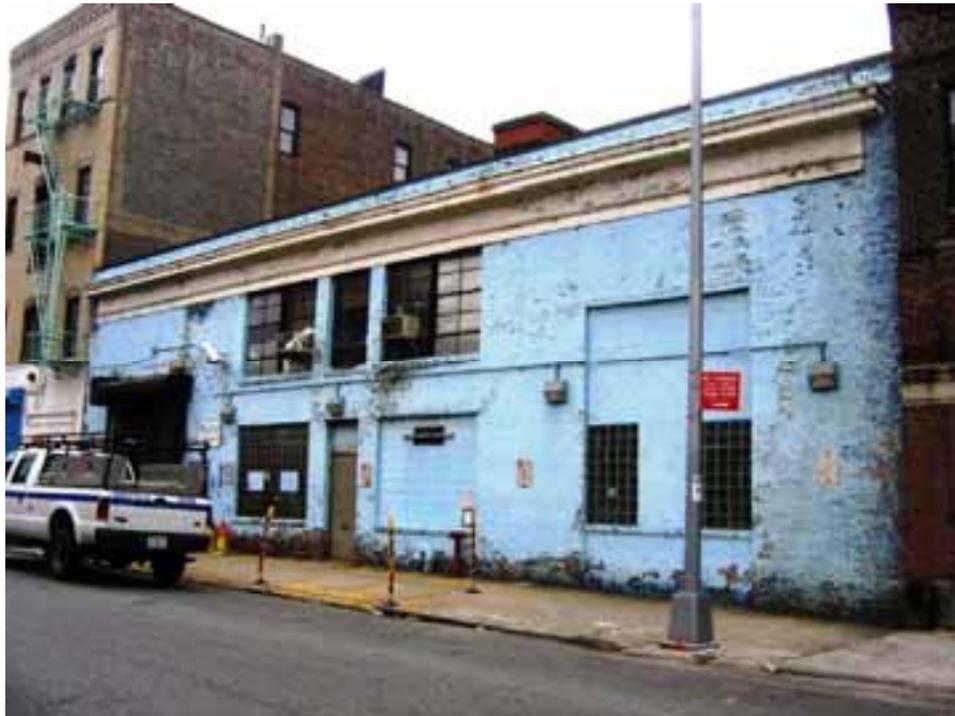
Photograph 1997-6-B

- Both the south (on West 130th Street) and north (on West 131st Street) facades of the building have paint peeling off the walls, which is a health concern (see photos B, C, P, Q and R).
- At the West 130th Street façade, a formed metal cornice has shifted from its original location and is visibly separated from the wall; it presents a potential safety concern for pedestrians (see photos A and S).
- At West 131st Street sidewalk, several flexible post guards have been installed to prevent parking on the sidewalk. The sidewalk is in poor condition, with cracking and spalling throughout (see photos H and T), which is a safety concern for pedestrians. However, the sidewalk at West 130th Street is in fair condition.

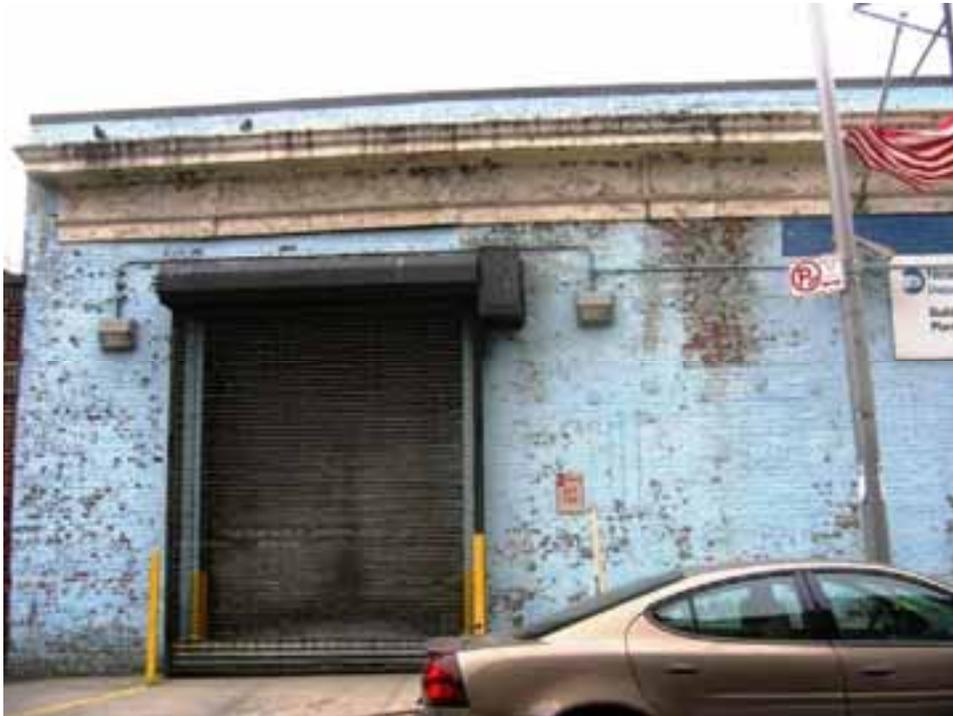
Photograph 1997-6-C

1. The north and south facades exhibit water infiltration and moisture causing the paint to deteriorate (see photos C and D), the header beam above the former window is corroded (see photo E).
2. The roof membrane is in fair condition, it has a few air pockets and debris accumulated on the south west corner (see photos F and G).
3. The side walks and curb cuts are in fair condition (see photos H and I)

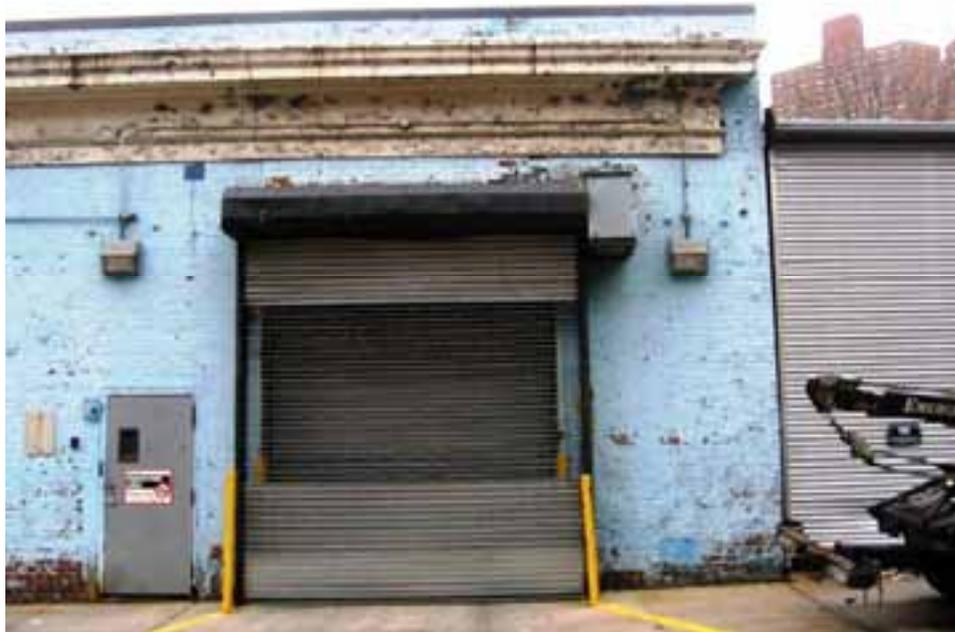
Photograph 1997-6-J

1. The north and south facades have random step cracking (see photos J, K, L and M)
2. Rust at various locations (see photos N and O).
