SITE CONDITION: POOR

Block 1997 Lot 14

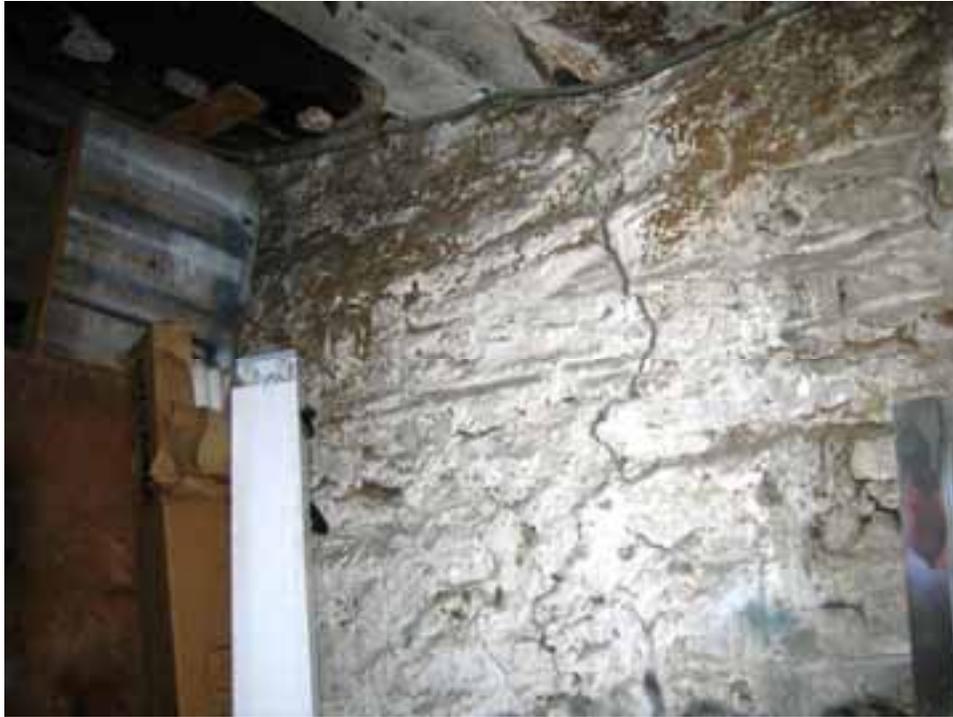
Photograph 1997-14-C

1. Signs of efflorescence and wide crack on masonry walls (see photos B, C, D, E, F, G and H).
2. Cracks and spalling on the underside of the concrete slab. (see photos I and J)
3. Corroding exposed reinforcement bars (see photos K and L).
4. Corroding sheet metal ceiling (see photo M).

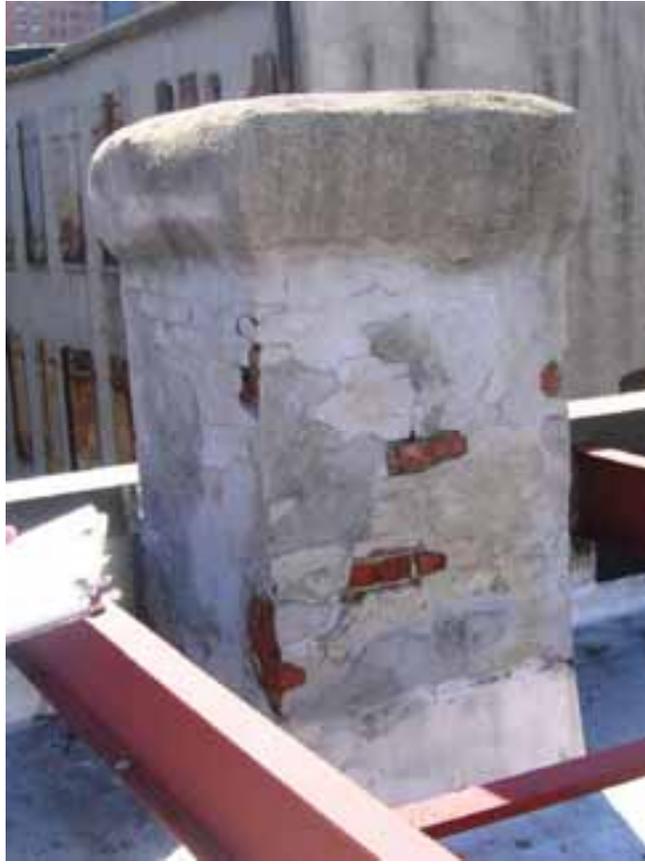
Photograph 1997-14-O

5. Water stains on ceiling (see photo N)
6. Spalling and cracking of west stair's concrete treads (see photo R)
7. Cracked and spalled stucco on chimney (see photo O)
8. Basement floor has numerous cracks. (see photos P and Q)
9. Ponding continues to occur on roof. (see photo S and T)
10. Lower roof is completely covered with moss (see photo U)
11. Sidewalks along West 130th street are in fair condition. Trucks continue to use the sidewalk as a parking area. (see photo V)
12. Staining on first floor ceiling by garage entrance. Possibly from fire damage. (see photo W)

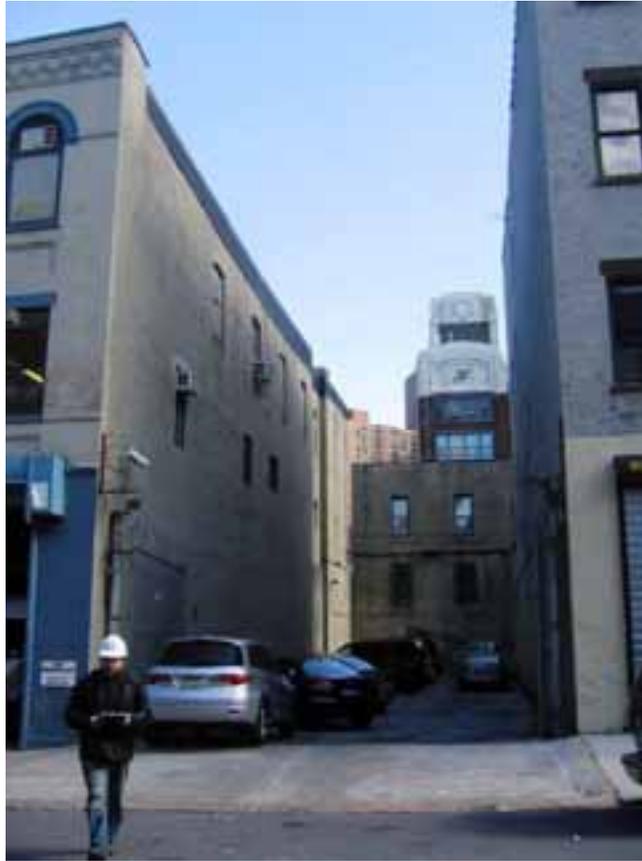
Photograph 1997-17-A

Lot 17 is located at 623 West 130th Street between Twelfth Avenue and Broadway. The 2,498-sf lot is used as an accessory parking lot (see photo A). Earth Tech reviewed the NYC Department of Finance Automated City Register Information System (ACRIS) and found that Cignon LLC acquired the property in 2007. It is under contract by The Trustees of Columbia University. At the time of the AKRF report, Lot 17 was zoned M1-2; however it has since been designated C6-1 as part of the Special Manhattanville Mixed Use District (MMU) rezoning (effective December 19, 2007).

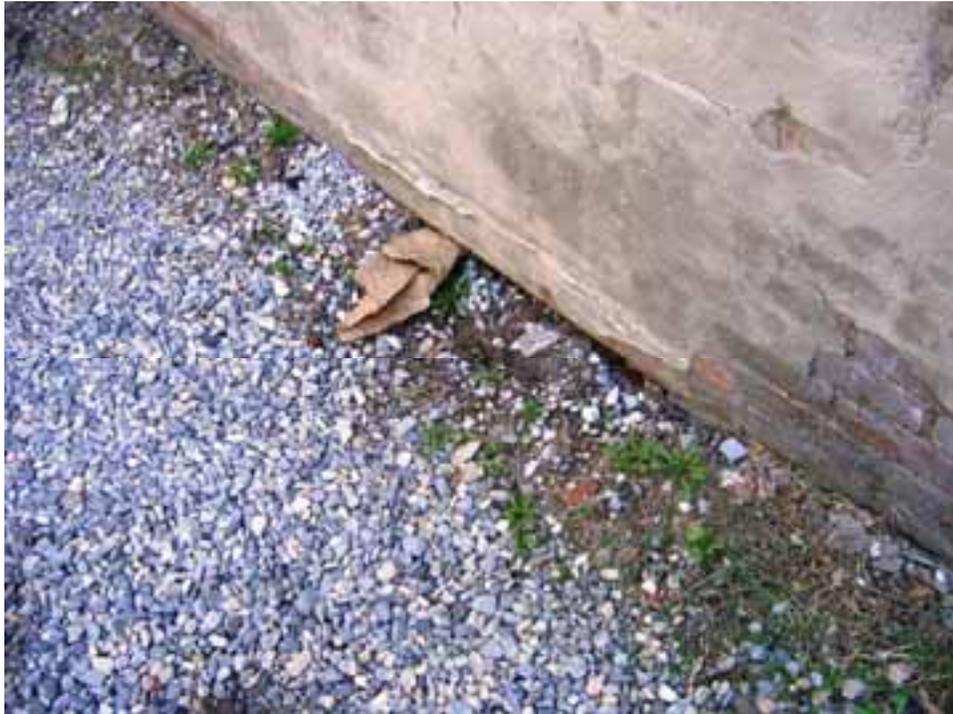
Photograph 1997-17-B

1. The site consists of a gravel surface parking lot, with some weeds growing the east and west sides (see photo B).
2. The security fence topped with barbed wire at the entry way appears to be in good condition, although minor corrosion has begun on the barbed wire fence (see photo C).
3. The sidewalk and curb cut on West 130th Street are in fair condition, although there still remains some wide cracks (see photos D and E)
