SITE CONDITION: CRITICAL

Block 1997 Lot 21

LOCATION, USE, ZONING, AND OWNERSHIP

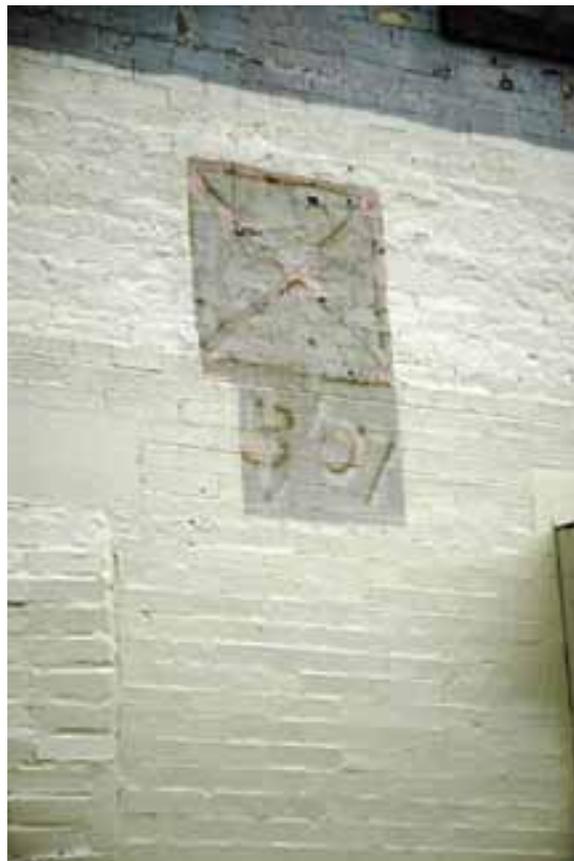
Photograph 1997-18-R

A sign on the West 130th Street façade, indicates that the building was declared unsafe by the Fire Department of the City of New York in March of 2007 and locked (see photo R). Columbia University has performed some minor upgrades to the West 130th Street building façade, including: blocking with CMU several openings on the first floor; boarded missing windows with PCB plastic sheets; and painted the first floor of the façade (see photo S). Also, emergency repairs were conducted at the sidewalk vault on the southwest corner; a new sidewalk slab (concrete slab on corrugated metal deck) was installed by Columbia University (see photo T).

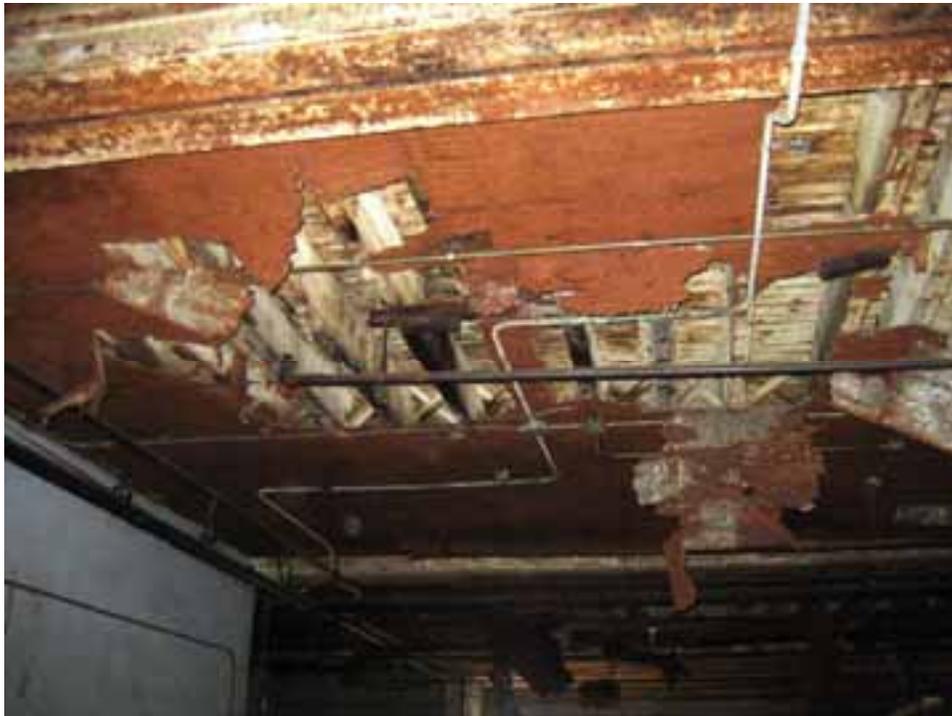
Photograph 1997-18-W

Earth Tech concurs with all the health and safety concerns listed in the AKRF report (see photos U, V, W, X, Y, Z, AA, AB and AC). The building is unsafe and essentially unusable in its current condition.

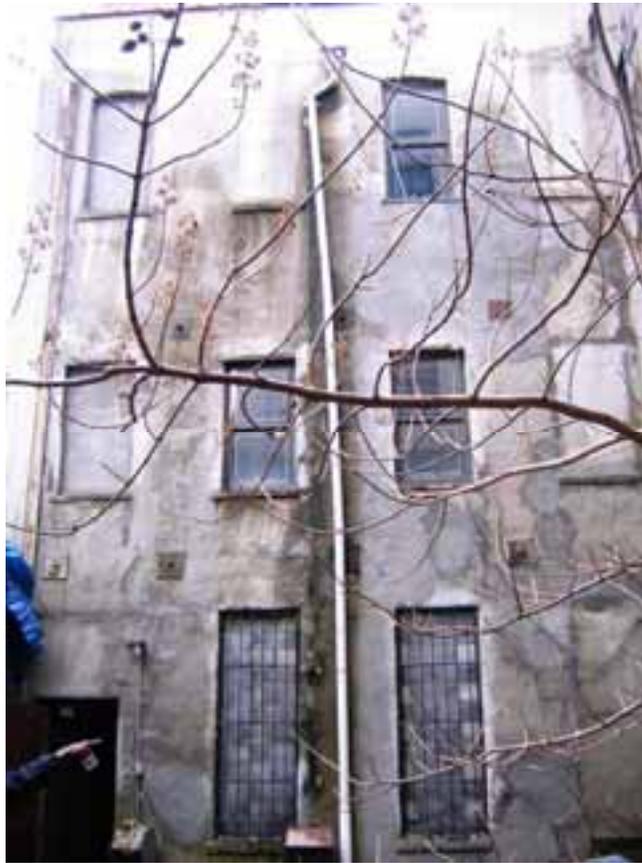
Photograph 1997-21-C

including: efflorescences, mold, and water stains; and collapsed ceilings at all floors (see photos F, G, H and I). The steel lintels in the north wall are severely deteriorated, and extensive mold and efflorescences are present around windows, all due to water infiltration (see photo J). The south roof parapet shows a wide stepped crack, and plaster is hollow with random cracking (see photos K and L). A medium crack in the north wall above the first floor is visible, permitting leaks into the building. The crack and damaged stucco is patched but water continues to infiltrate the building, causing extensive water damage (see photos C and D).

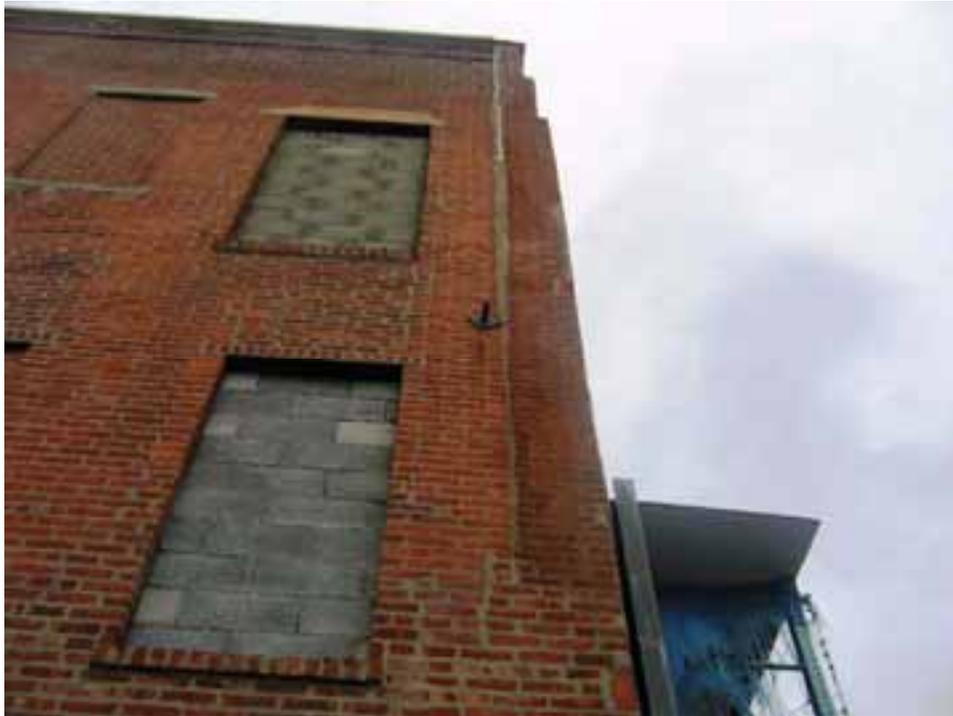
Photograph 1997-21-E

An approximately 30 foot long medium sealed vertical crack is present on the south elevation end of the building (see photo E). The first floor exhibits warped and ripped floor tile, a pool of water, and uneven floors due to extensive water infiltration. The widespread water damage is evident in the north wall and stair walls from inside,

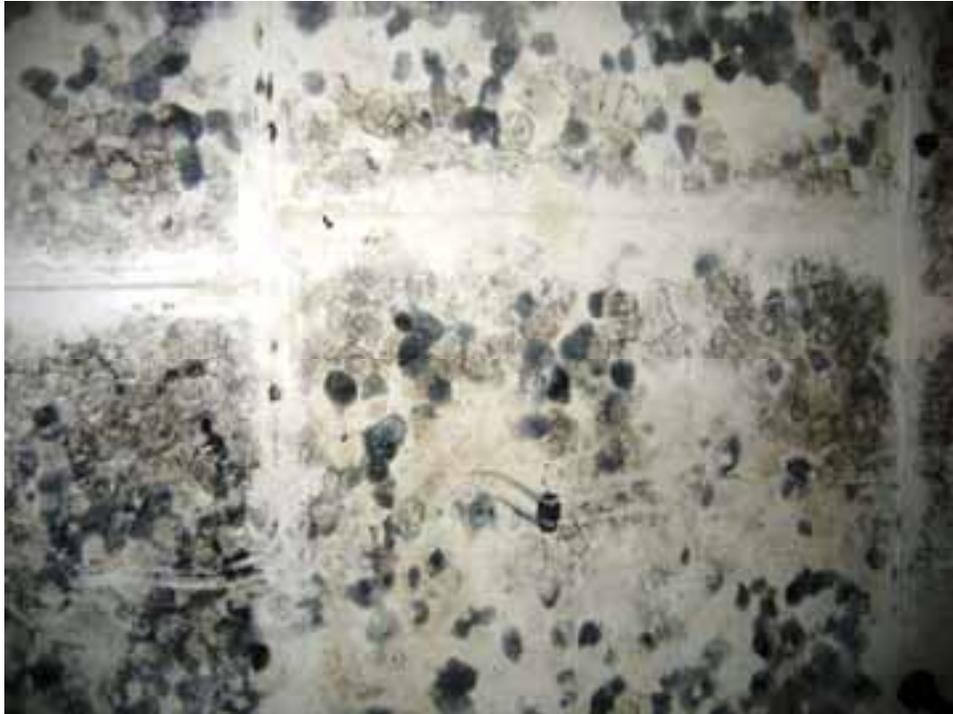
Photograph 1997-21-O

- *“A significant amount of mold was observed throughout the building... which is a health concern“.* The extensive mold was observed throughout the building's north side and along the stair walls (see photos M, N, O and P).
- A 4' wide gap between the north edge of the yard and a building wall on Lot 44 *“presents an unsafe condition for those in the yard as there is no barrier between the yard and the gap”* (see photos Q and R).

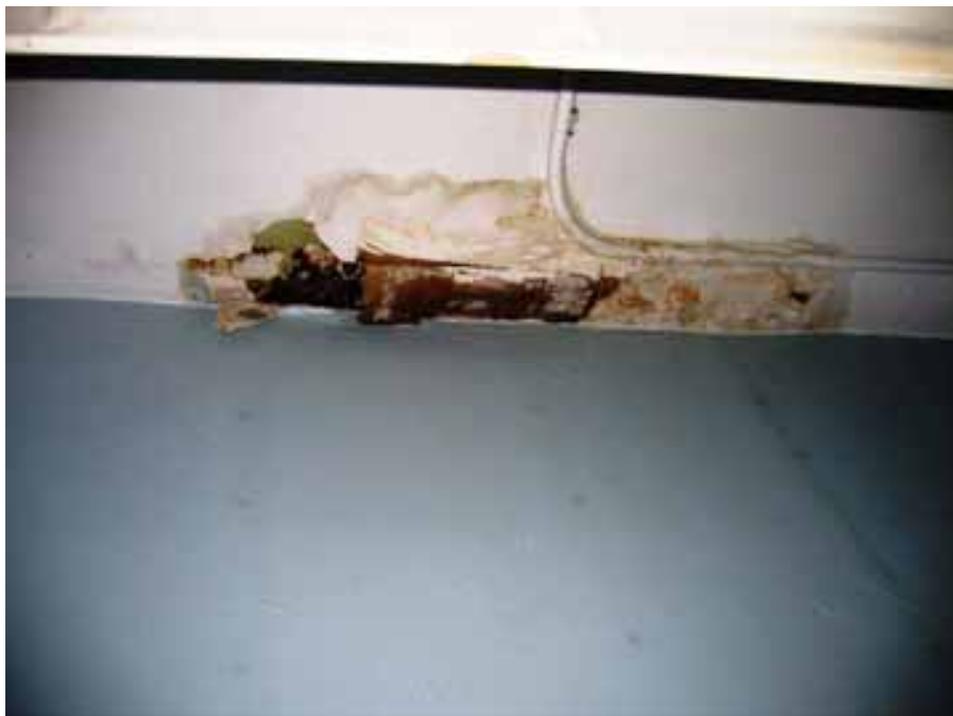
Photograph 1997-27-H

The east exterior wall has a wide step crack with the bricks in need of repointing (see photo B), and the rollup door has step cracks on both sides of its lintel (see photo C). The south east corner of the building has vertical and horizontal cracks, and signs of paint deterioration (see photos A, D and E). The south exterior wall is in need of brick repointing (see photo F). The west exterior wall has wide random cracking typically around the windows (see photo G). The cornice at the south west corner appears to be

damaged (see photos H and I). The sidewalks are in fair to poor condition as a result of random cracks and a severe spall at one location (see photos J and K).

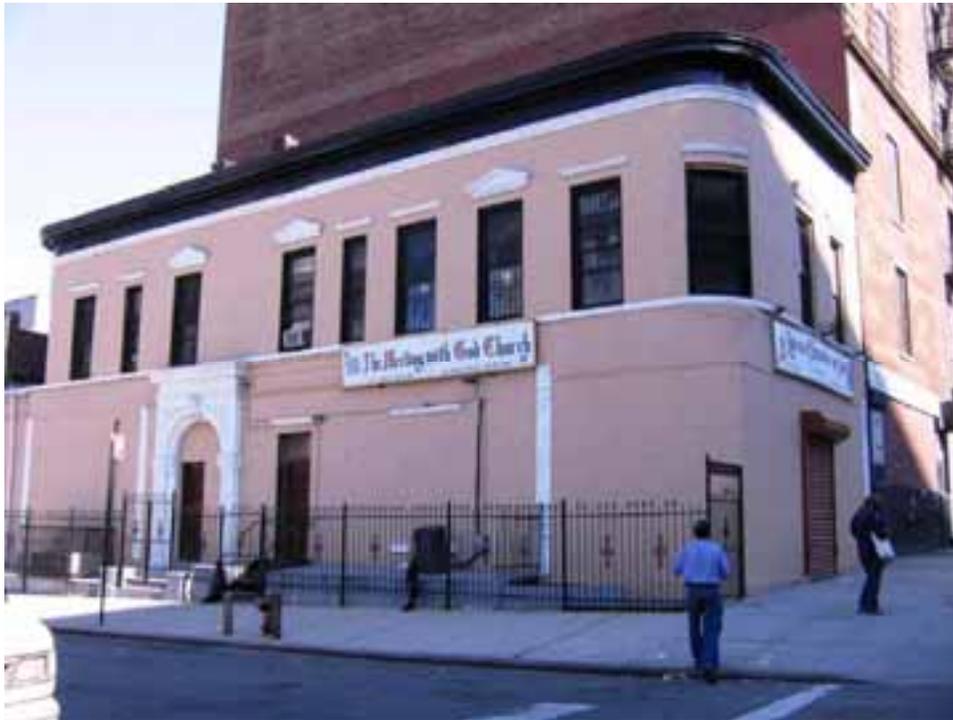
Photograph 1997-29-A

The AKRF report did not list any health and safety concerns for this building, except for the poor condition of the sidewalk on Broadway. Earth Tech's observations confirmed the condition of the sidewalks and curbs (see photos A, L and M). However, Earth Tech notes that, at one location on Broadway, the sidewalk is in critical condition with excessive spalling concrete, which is a safety concern for pedestrians (see photos N and J).

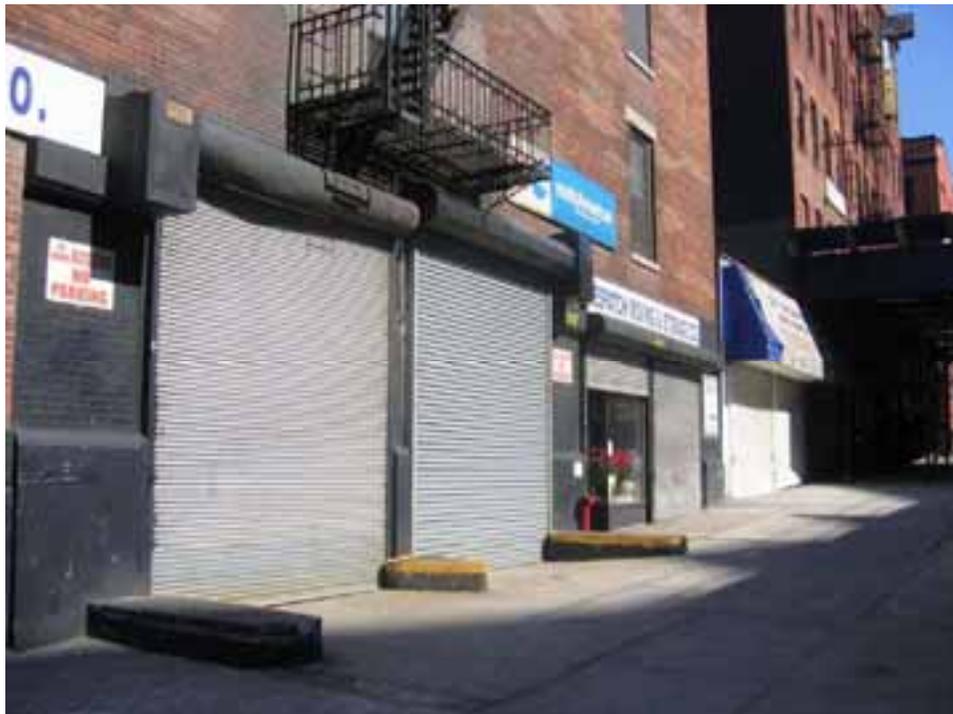
Photograph 1997-30-B

The rollup doors, windows and the wall at the east exterior appear to be in good condition (see photos B and C). The west exterior wall is generally weathered (see photo D), and has a wide vertical crack at the south corner (see Photo E). The fire escape on the building's east façade is in fair condition with minor rusting (see photo F). The sidewalk is in poor condition (see photos F and G).
