<b>SITE CONDITION: POOR</b>
-----------------------------

## Block 1997 Lot 33

### LOCATION, USE, ZONING, AND OWNERSHIP

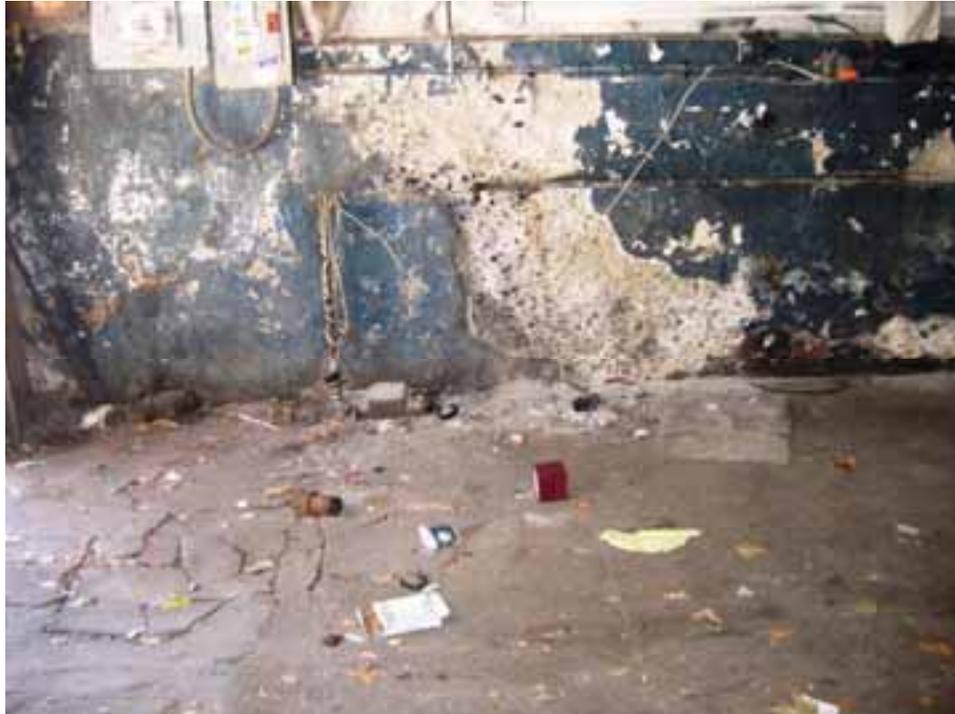
**Photograph 1997-33-G**

Most surfaces of the interior structural elements and finishes are deteriorated, soiled and in a poor state of repair (see photos E and F). The slab-on-grade exhibits surface deterioration, e.g., cracks, spalls and non-level areas, and the brick and concrete bearing walls also have cracks and a few spalls (see photos G, H, I and J). The sidewalks along Broadway appear to be relatively new (see photo K).

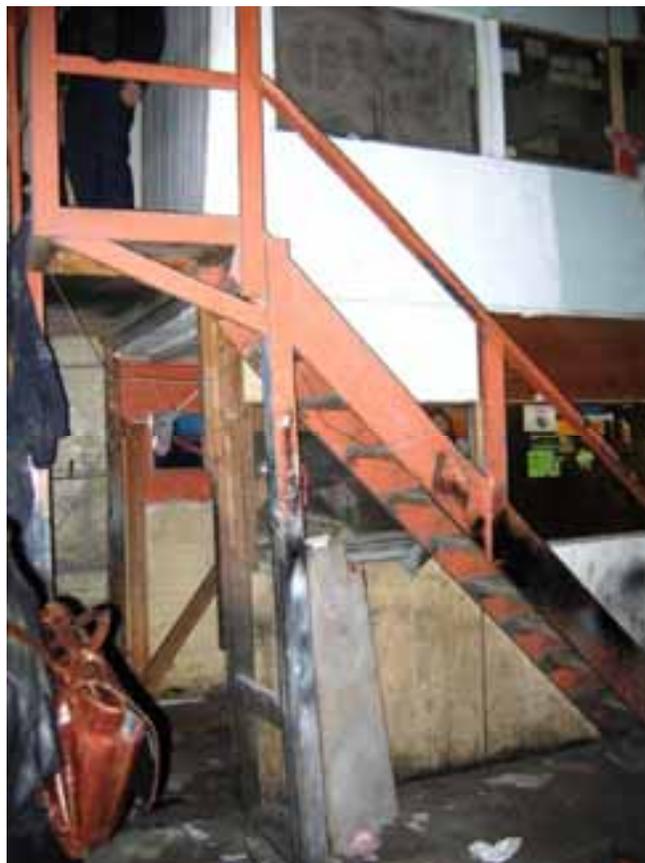
Photograph 1997-33-N

- The building has two overhead roll-up doors on the Broadway façade and no man door/ fire exits whatsoever (see photo A).
- The timber stair from mezzanine is not code compliant with a handrail on one side and a splice at a stringer that is potentially unsafe (see photos N and O).

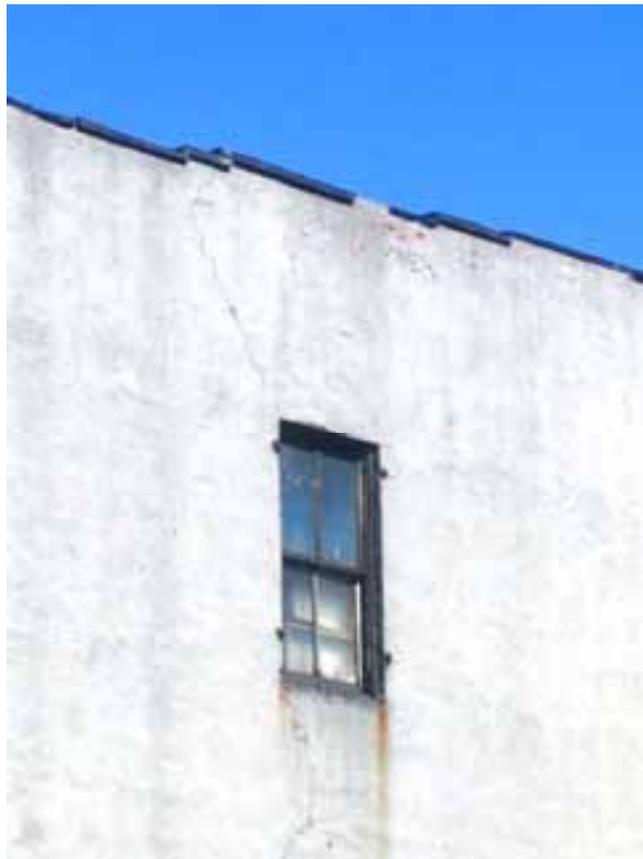
**Photograph 1997-44-B**

The east exterior wall has a wide vertical crack that extends from the roof to the second floor and rust marks between windows at all floors (see photos B and C). The south exterior wall shows signs of rust and spalling towards the top of the wall (see photos D and C). The west exterior wall has minor paint deterioration towards the roof area. The north exterior wall has severe paint deterioration typically around the windows, and possible water damage at those locations (see photos E and F). It also has stepped cracks (see photos F and G), a vertical crack at the rollup personnel door (see photo H), displaced bricks (see photo I), and a damaged possible parapet coping (see photo J). The

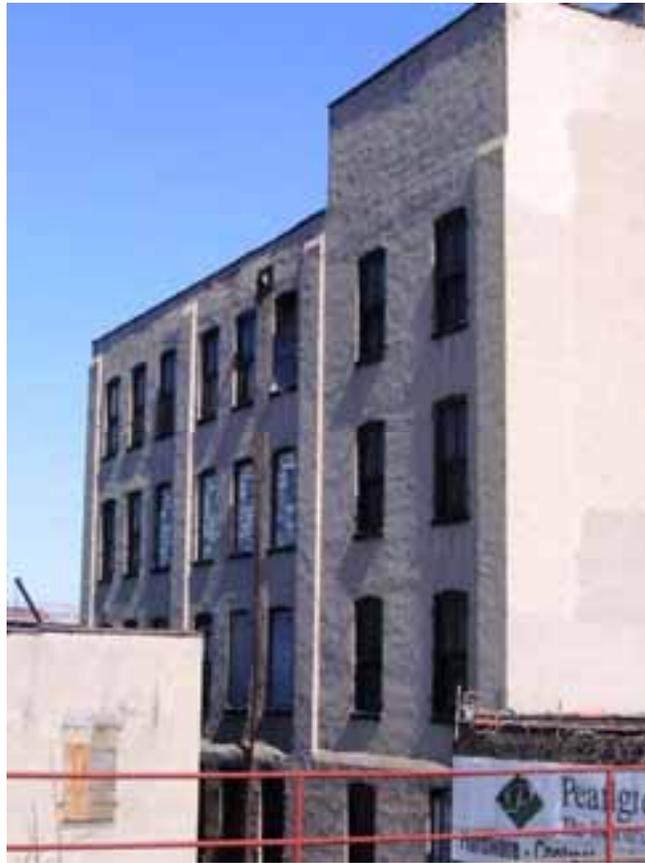
**Photograph 1997-44-M**

- Earth Tech concurs with the AKRF evaluation of sidewalks and curbs as fair and good, respectively (see photos K and L).
- Earth Tech did not observe hazardous *“spalling stucco on the south exterior wall”* as reported by AKRF (see photos M and N).
