<b>SITE CONDITION: CRITICAL</b>
---------------------------------

## Block 1997 Lot 48

As evaluated by Thornton Tomasetti, and later reported by AKRF, the building is in critical condition due to a combination of structural damage, deficient interior and exterior building conditions, other health and safety concerns and hazardous site conditions.

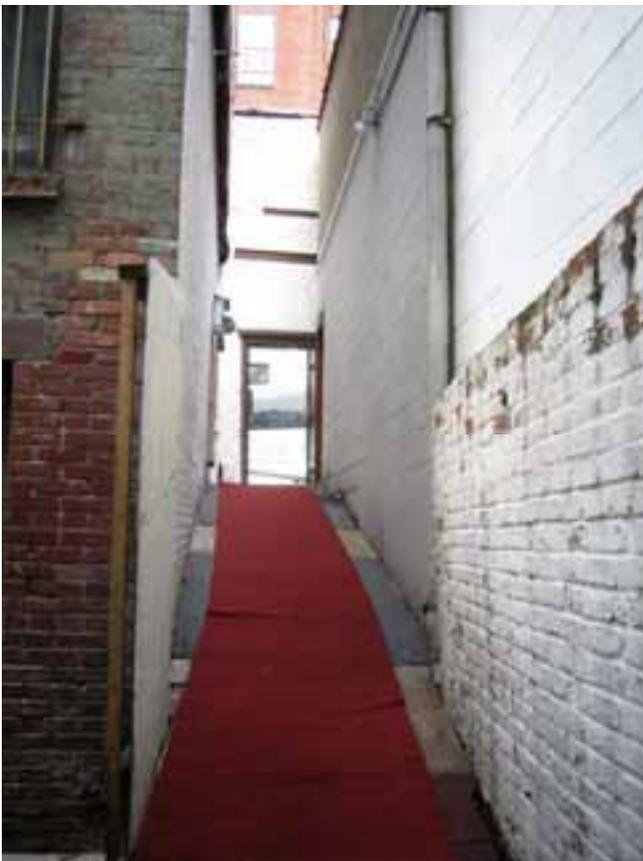
Photograph 1997-48-N

- The exit passageway from the South building leading to West 131<sup>st</sup> Street has a gate, blocked with a keyed deadbolt lock; no panic exit hardware is provided. This passageway also serves as a fire exit from adjacent building on Lot 47. This is an obstructed exit passageway violation and a safety hazard (photos N and O).

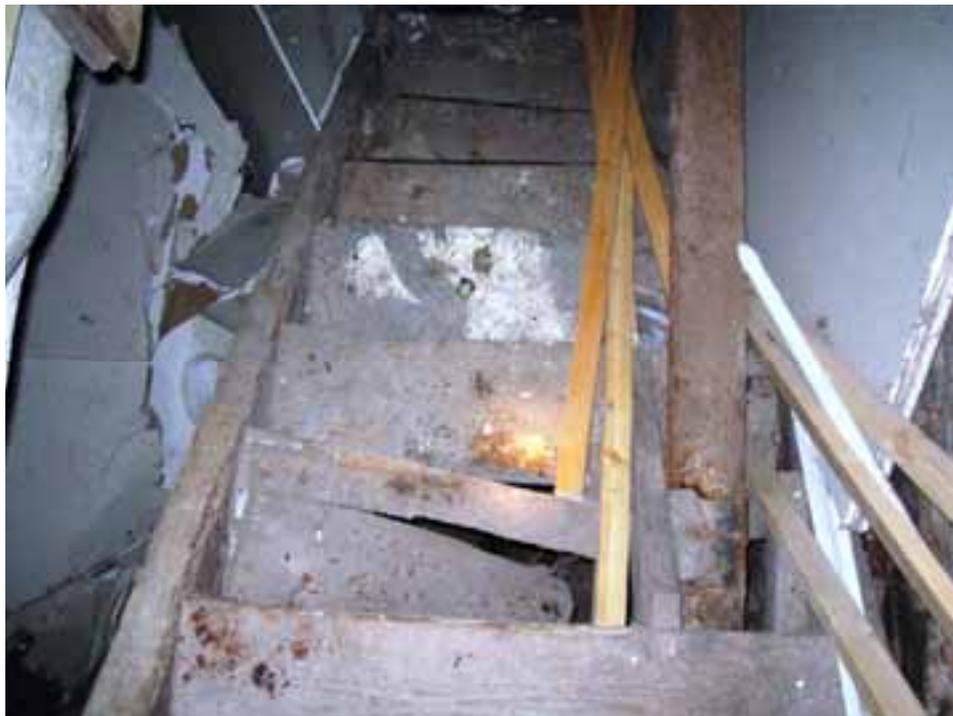
**Photograph 1997-48-R**

- Stairs going to basements in both buildings do not meet code and are both damaged, a safety hazard (see photo R).
- The basement in the North building (boiler room) was flooded with what appeared to be sewer waste coming up from the floor drain; an active health hazard that needs to be corrected (see photos S and D).

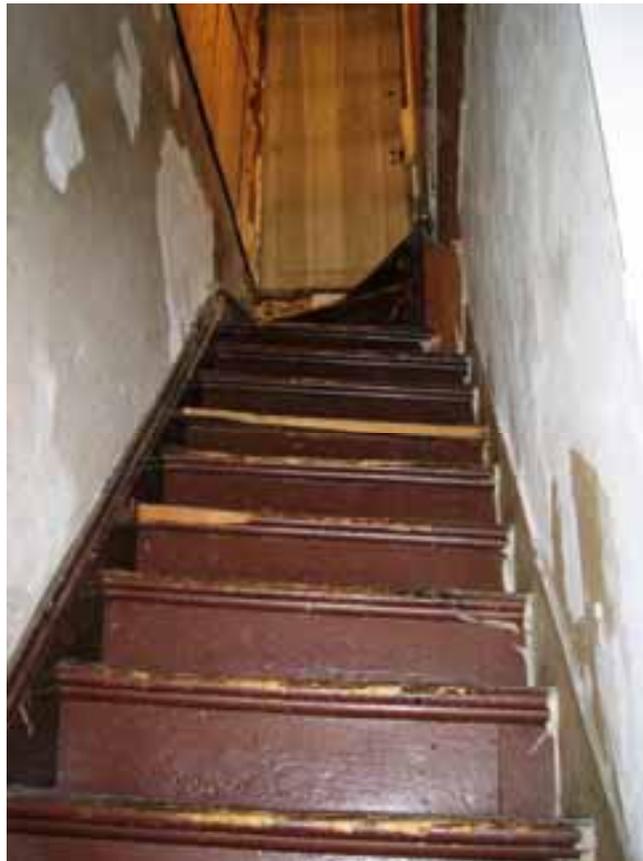
Photograph 1997-48-T

- Stairs to upper floors in both North and South buildings do not meet code requirements, with miscellaneous violations (see photos T, U, V, and W).
- Second exit door from the main prayer hall is obstructed with band equipment and flower arrangement; no panic exit hardware is provided; - a safety hazard (see photo X).

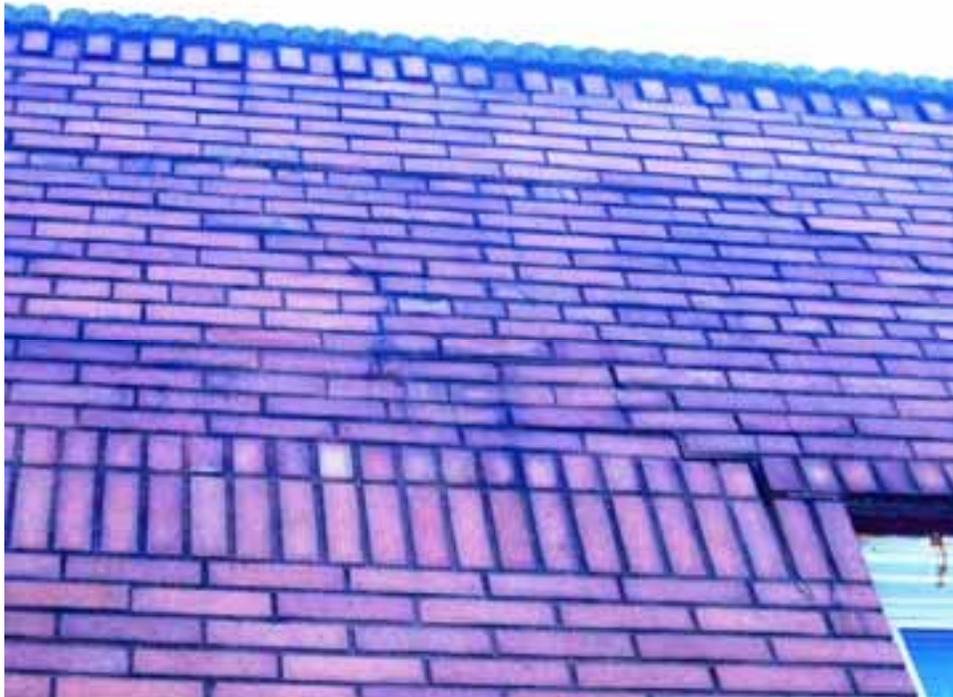
**Photograph 1997-49-C**

The exterior brick wall on the north side shows a wide stepped crack at both ends (see photos A and B). The stepped crack at the west end above the window extends to the top of the parapet and bricks are significantly displaced along the crack (see photo C). The concrete floor shows wide random cracks and several small spalls (see photo D). There is water infiltration and damage with paint peel off and water stains on the interior of the north wall (See photo E). The water appears to be infiltrating through the stepped crack at the east end (See photo F). The concrete roof planks and steel beams are in good condition but appear to be carrying excessive load (see photos G and H).

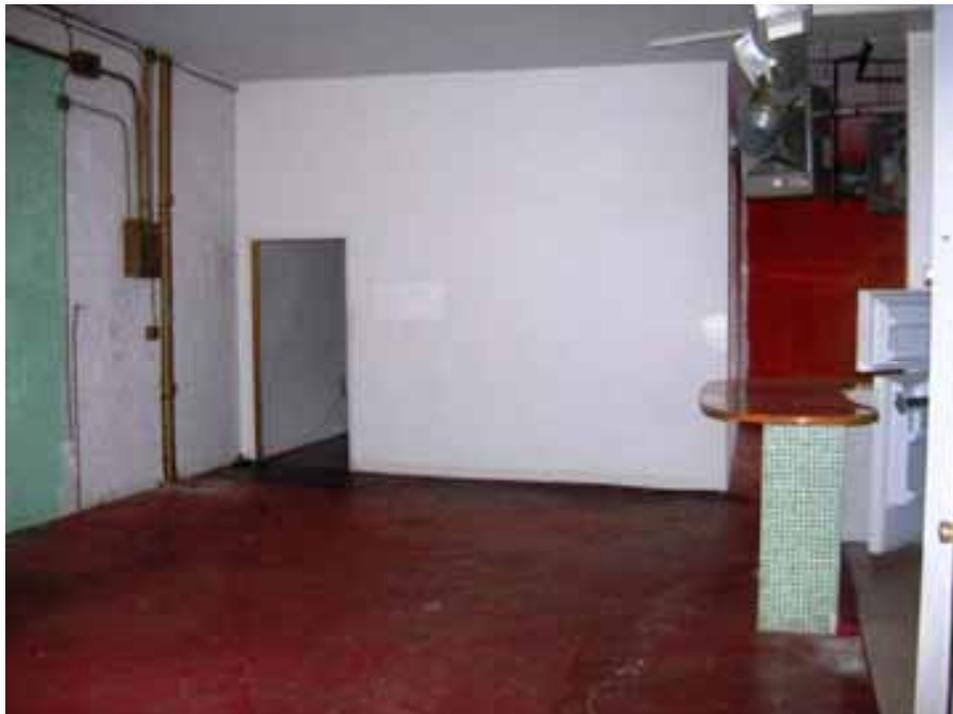
Photograph 1997-56-B

1. Sidewalk repairs were done along the north sidewalk and the previously poor condition rating is upgraded to good (see photo L).
2. The condition of the floor slab on the third floor was in fair condition. The concrete slab had a concrete leveling layer placed then painted (see photos B and C).
3. Lintel above doorway to roof has been repaired (see photo H).

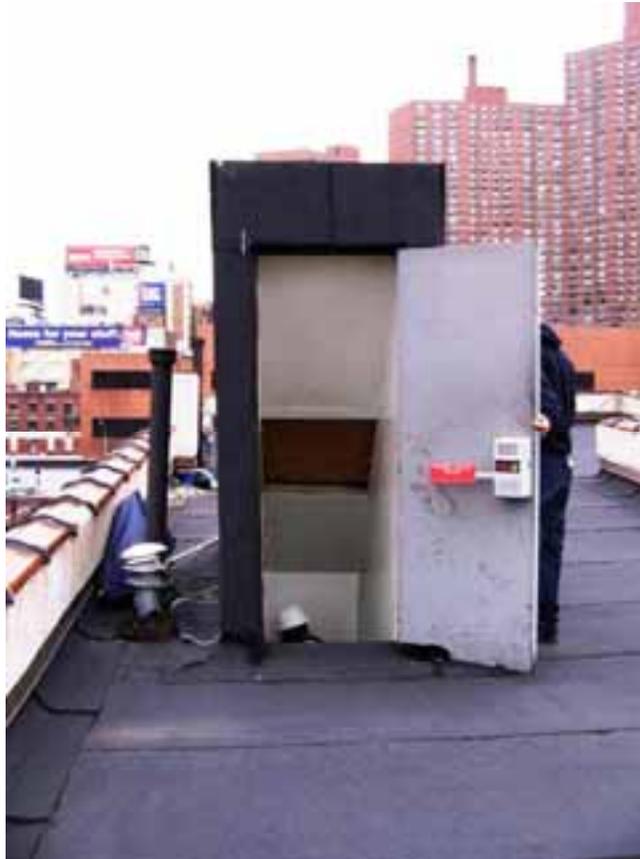
**Photograph 1997-56-H**

- The stair flight from 4<sup>th</sup> floor to the roof has non-uniform steps and the railing abruptly ends half-way through the length of the flight; this is a code violation and a safety concern (see photos I and V).
- 3<sup>rd</sup> floor level is approximately 5 inches higher than the stair landing; this is a tripping hazard (see photo W).
- On the day of Earth Tech’s survey, a bicycle was stored on the stair landing on the 3<sup>rd</sup> floor, reducing the minimal clearance and obstructing the egress; this is a code violation and a safety concern (see photo X).
- The roof is used by tenants for recreational purposes. However, the parapets are much lower than 42” of height required by code; this is a code violation and a safety concern (see photos H and Y).

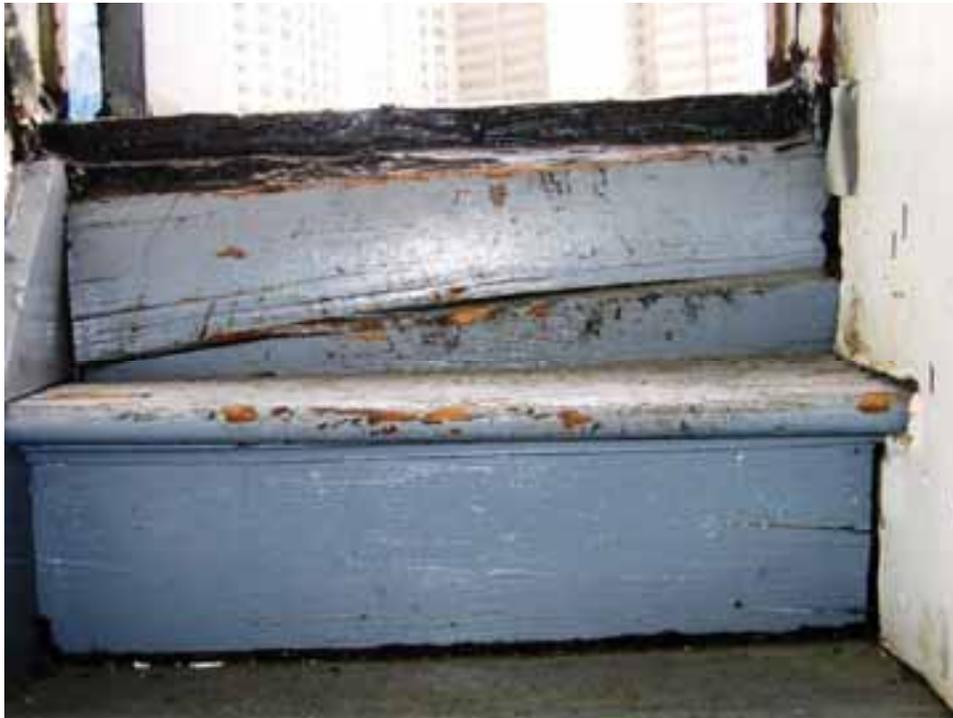
Photograph 1997-56-I

1. Some timber treads in the stairwell are slightly sloped, and the timber railings and wood floored landings show signs of long-term degradation from old age (see photo I).
2. The interior faces of the brick masonry walls have minor water stains (see photos F and G).
3. Minor cracking and flaking paint on the north facade (see photo K).
4. The third floor ceiling has some locations with water damage (see photos M and N).
5. Cracks in masonry exterior wall above third floor windows (see photos O and P).
6. Crack in interior third floor wall (see photo Q).

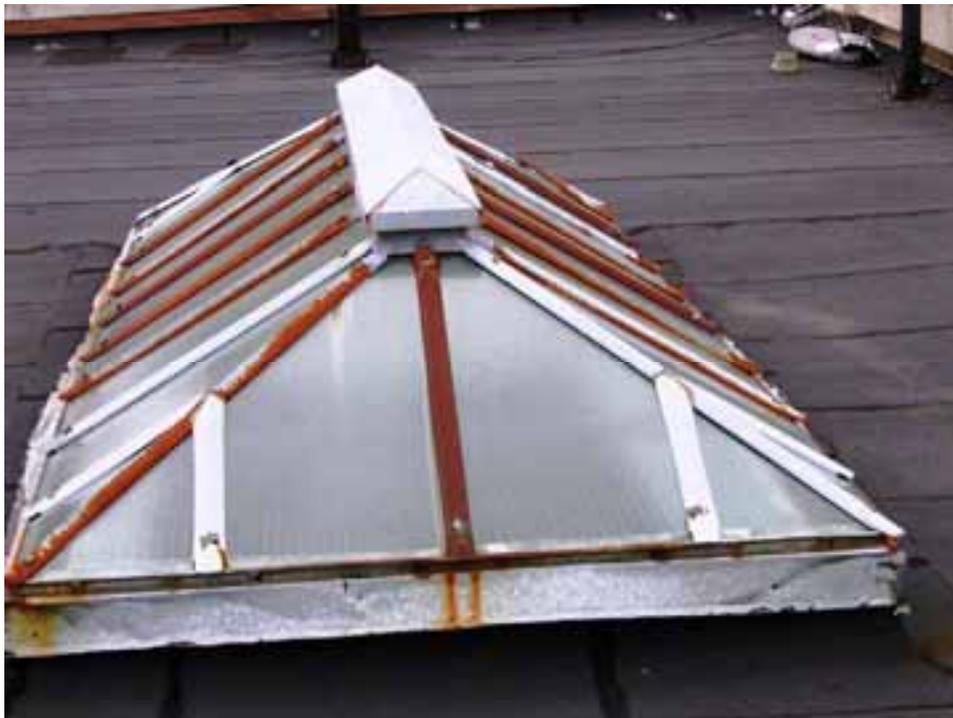
Photograph 1997-56-J

4. Cracked glass pane has been replaced on the roof skylight but elements continue to be corroded (see photo J).
