Block 1997 Lot 61

SITE CONDITION: FAIR

PHYSICAL AND STRUCTURAL CONCERNS

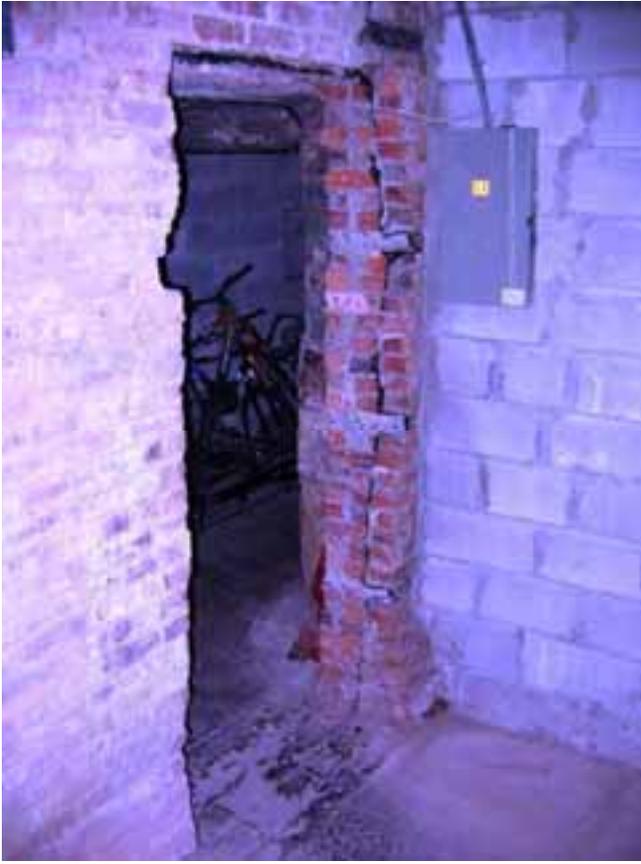
Photograph 1997-61-O

mold, efflorescences, and wet stains (see photo I). A large spall 4 ft by 1 ft is present in the second floor soffit in the entrance area (see photo J). The basement area of the restaurant area on west side also shows signs of water intrusion as evident by the presence of mold, water stains and a few wet patches (see photos K and L). The floor shows wide extensive cracking over large areas (see photos M and N). An opening in a brick wall; is provided without a door frame or lintel (see photo O).

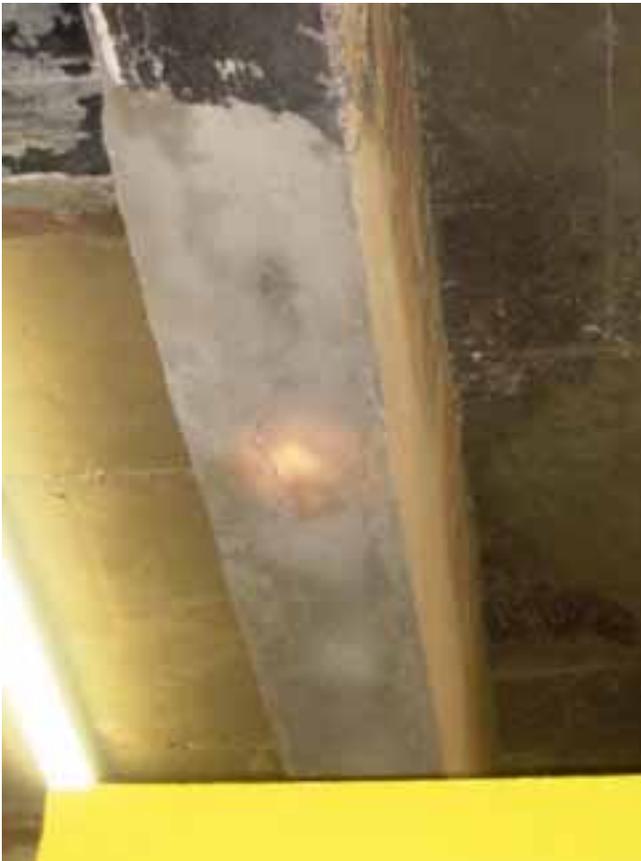
Photograph 1997-61-P

In addition, there are several medium to wide cracks in the concrete beams on the first and second floor beams in the north entrance area and elevator lobby area (see photo P). The west exterior wall exhibits a wide horizontal crack at the second floor sill level (see photo Q). The approximately 6 ft high brick parapet on the roof shows a wide horizontal crack in brick piers at the locations of the bracings (see photos R and S). The bracings may have been provided to prevent the inward leaning of the parapet. The south parapet on west building also shows some inward leaning but bracings are not installed.

- At the West 131st Street lobby, an ADA access ramp was obstructed with stored furniture, rendering it unusable for handicapped access to the building (see photo X).
- Water stained ceiling panels in the men's room (2nd floor) indicate water damage and a potential health hazard to employees (see photo P).

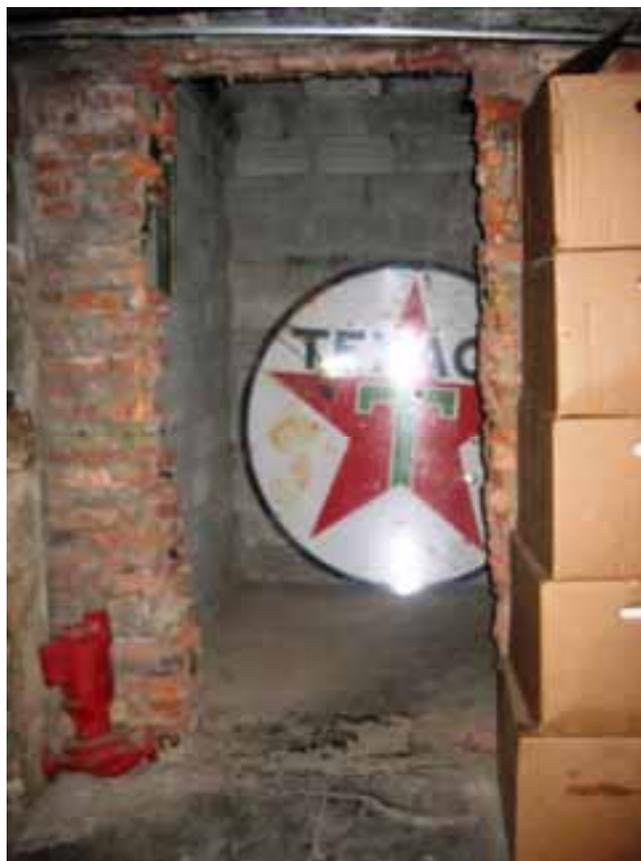
Photograph 1997-61-V

- *“The absence of a lintel above the opening in the demising wall... is a safety concern”* – Earth Tech concurs with this statement (see photos U and V).
- *“water accumulation on the floor of the basement... create an unsanitary condition”* – Earth Tech did not observe water accumulation in the basement on the day of survey, however, a small active water leak was noticed in the area below the restaurant kitchen area (see photo W).
- *“problems with vermin in the building are likely as several rat traps were noted”*- on the day of Earth Tech's survey, no rat traps were visible.

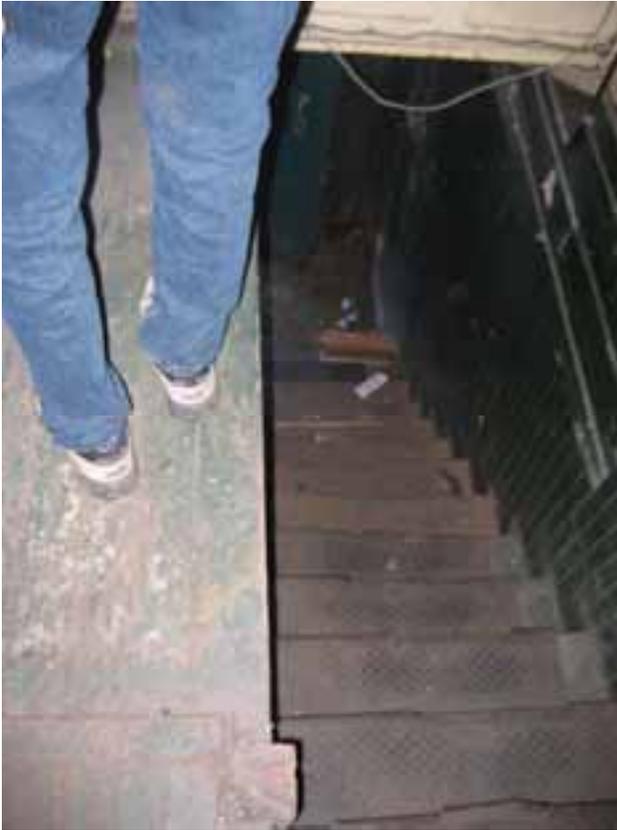
Photograph 1997-64-K

Despite these stabilization efforts, the continuous water infiltration through the collapsed portion of the roof contributes to further deterioration of the building structure and may lead to subsequent additional collapses (see photo J). The exit stair from the second floor is not enclosed, does not have guardrails/handrails, and has severely deteriorated and loose treads (see photo K).

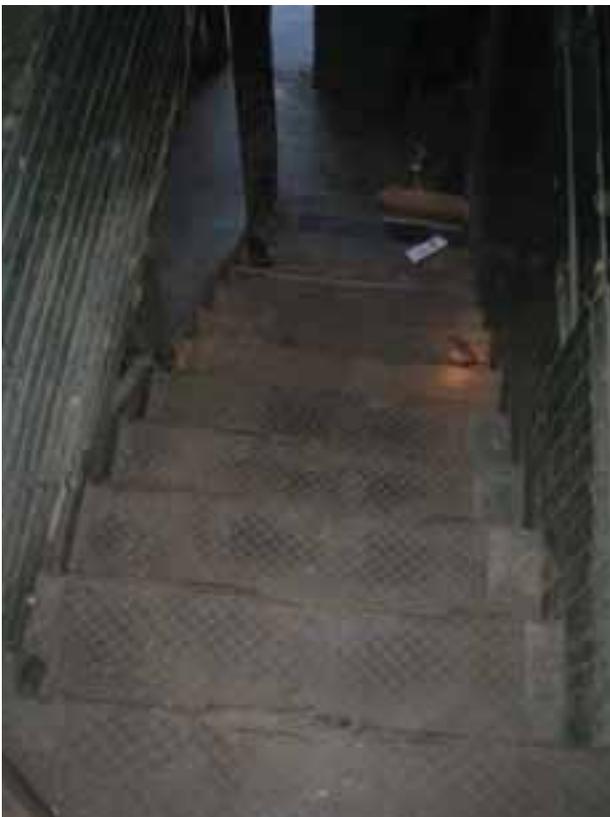
Photograph 1997-64-L

Earth Tech concurs with numerous findings of unhealthy and unsanitary conditions reported by AKRF. The continuous vermin infestation was presented by the dead rat on the stairs, observed at the time of the survey (see photo L).

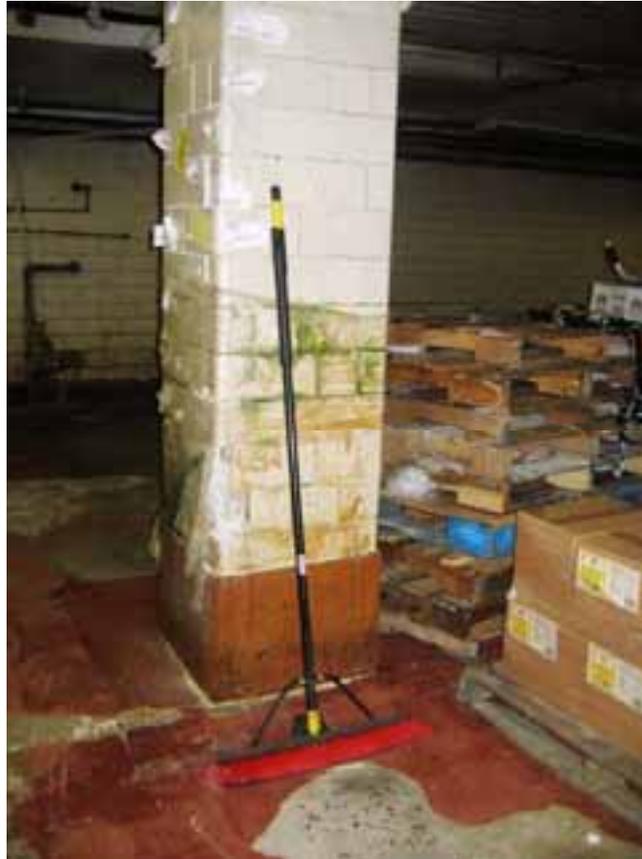
Photograph 1998-3-C

- Mold growth was observed in several locations (see photo C).
- A strong foul smelling odor (resembling decaying organic waste) was present in the refrigeration rooms.

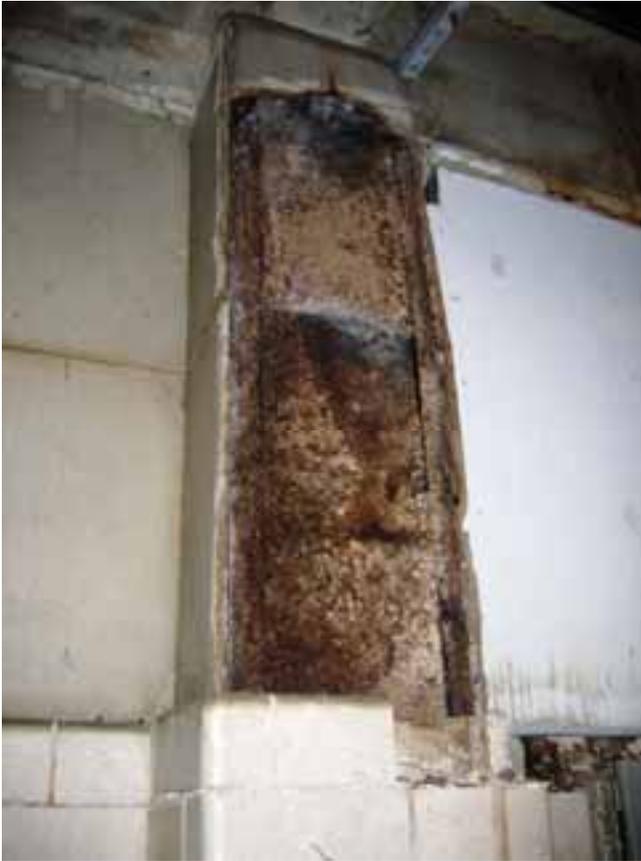
Photograph 1998-3-G

- Earth Tech observed ceramic tiles, plaster and what appeared to be cork insulation panels that are falling off the walls and ceiling in numerous locations throughout the building (east wall in northern refrigerator room; column pilasters and ceiling in southern refrigerator room) (see photo K); (see photo R); (see photo S), (see photo G), which presents a falling debris hazard.

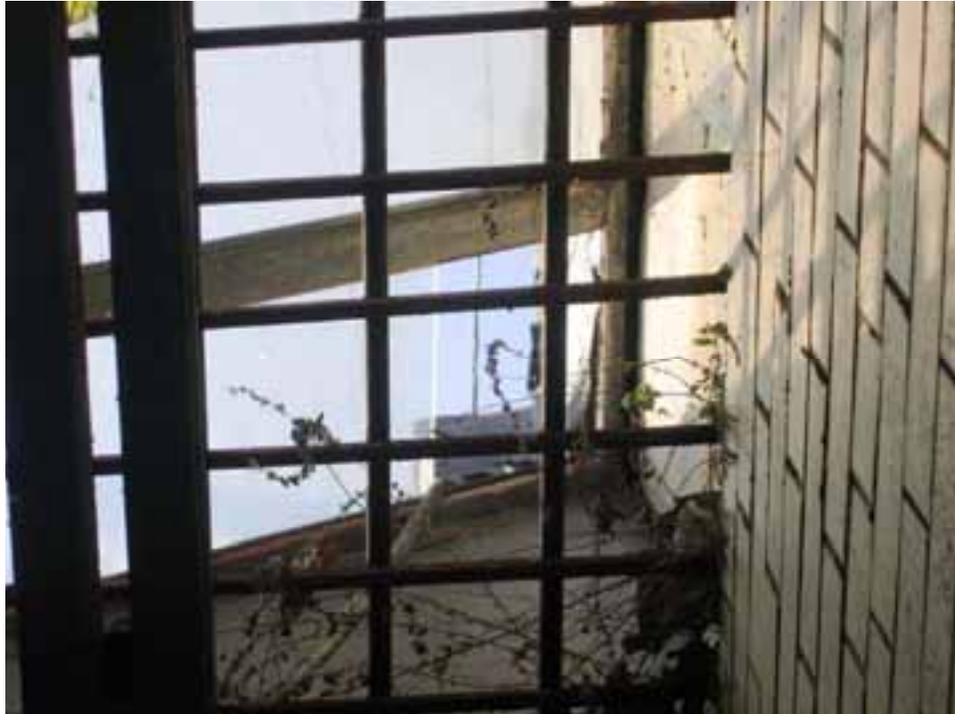
Photograph 1998-3-U

- Automotive-type batteries were haphazardly stored next to the utility/electrical room, leaking battery fluid onto the floor (see photo T). The skylight above this room had an opening (one of the glass panels slid back) allowing the elements into the building (see photo U); (see photo V).

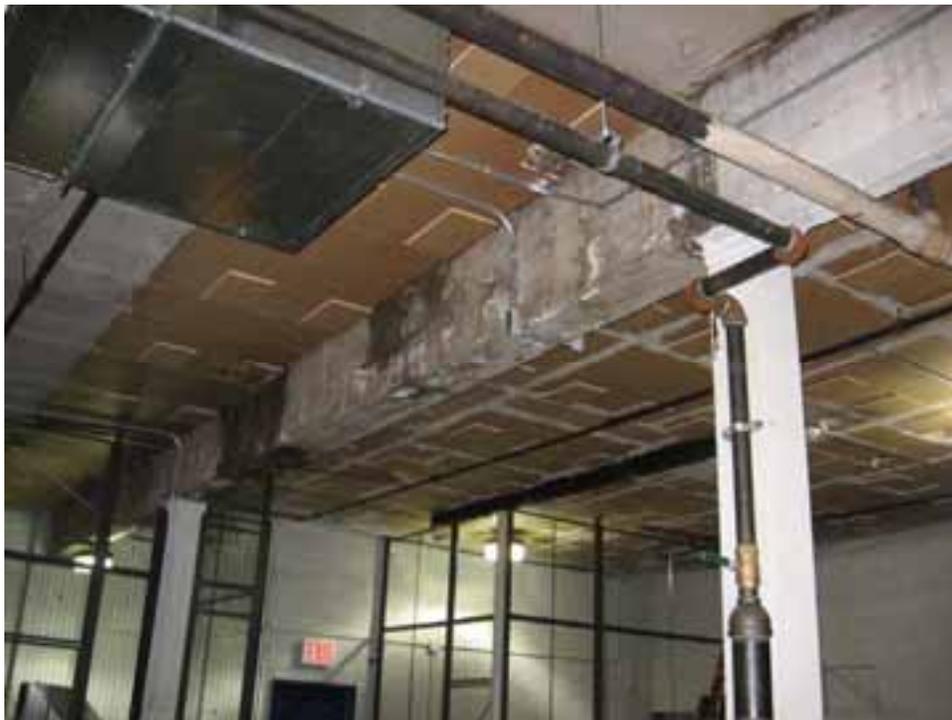
Photograph 1998-10-G

The concrete encased beam near the SE corner has a cracked encasement and water continues to leak from the roof at this location (see photos G and photo H). These deficiencies were not noted and reported in the previous report.
