Block 1986 Lot 6

Block 1986 Lot 10

Block 1986 Lot 30

Block 1986 Lot 65

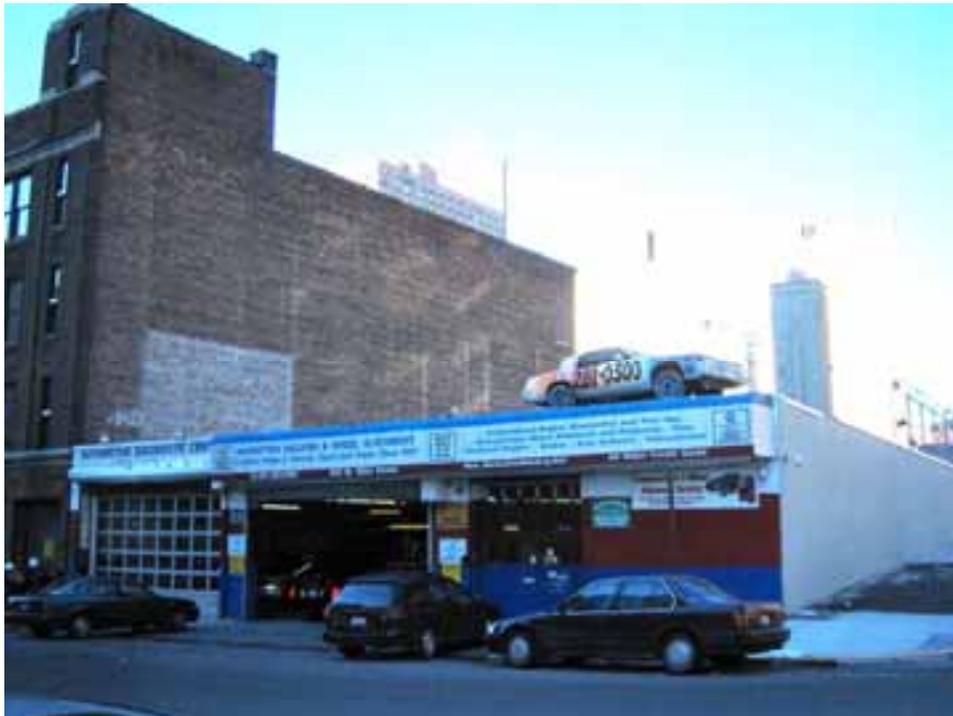
Photograph 1986-10-B

The building was evaluated by Thornton Tomasetti, and was later reported by AKRF, as being in poor condition due to a combination of localized structural distress and other deficient interior, exterior, and site conditions (see photo B).

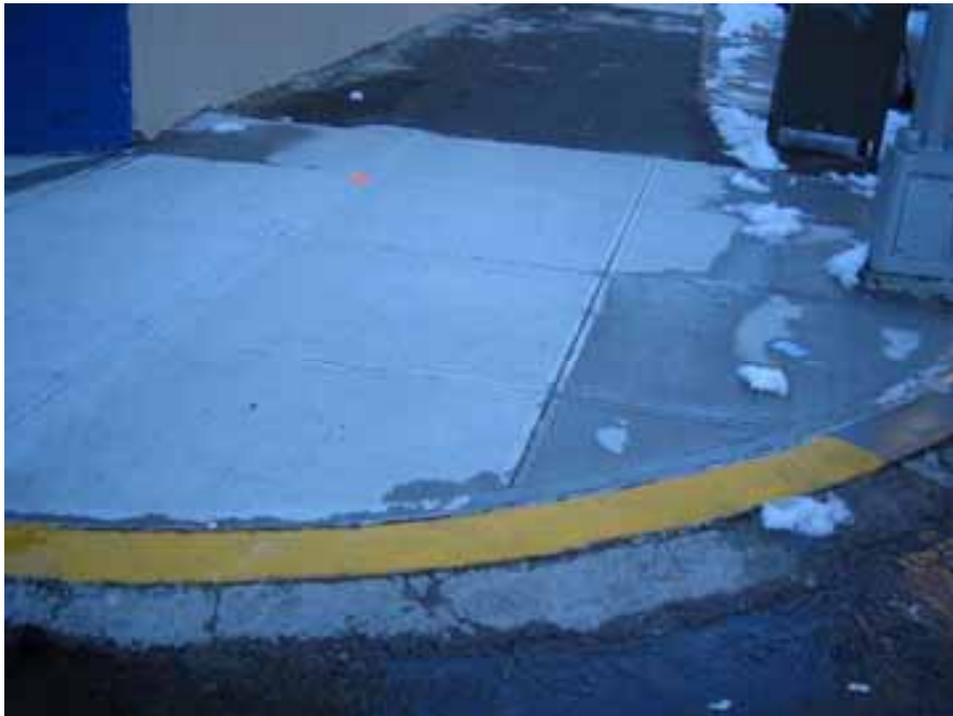
Photograph 1986-10-D

Subsequent to the inspections by Thornton Tomasetti, sections of the sidewalk (see photo D) were replaced. As to the “distressed” doorway lintel in the south exterior wall, Earth Tech could not determine by visual inspection alone whether it is the structural element (the lintel beam) itself or merely the finish materials (wooden soffit) covering the lintel that are sagging. In either case, the lintel clearly carries little more than the brick wall masonry directly above, and does not carry the roof deck or roof beams (the timber roof rafters run parallel to the south exterior wall). The cracked brick masonry should, however, be removed as soon as possible, along with finish materials so that the condition of the lintel beam can be confirmed.

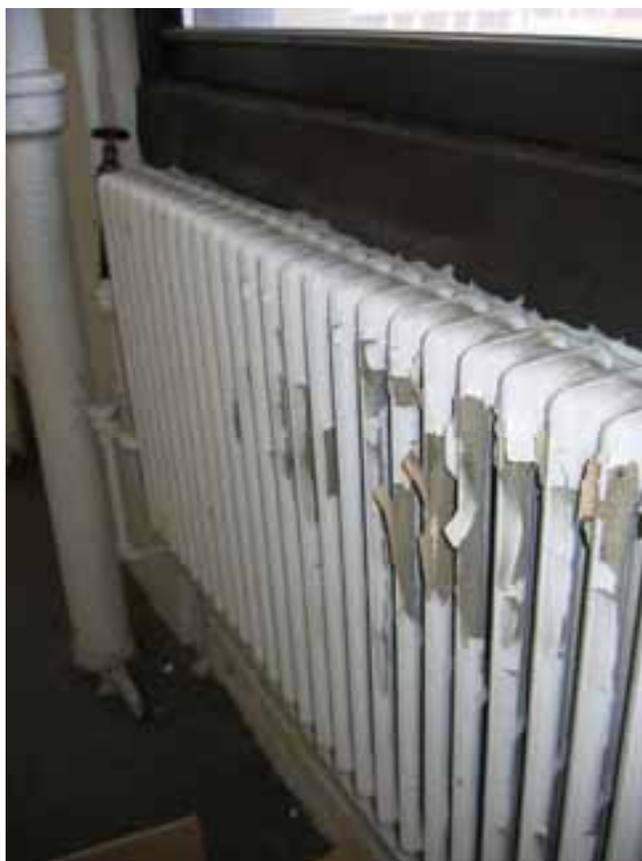
Photograph 1986-65-AH

- On the roof of this 7 to 8-story building, portions of the parapet are completely absent at several locations; this is a code violation and a safety hazard (see photos X and Y).
- The flagpole on the roof near the west parapet has lost one out of three structural bracings; this creates an unsafe condition because of the instability and possible collapse of the flagpole (see photo Z).
- Earth Tech observed haphazardly installed electrical wiring at several locations throughout the building (see photos AA and AB).
- The ceiling paint in the parking garage (ground level) is peeling off throughout the level (see photo AC, AD, AE and N); this is a possible health concern for employees.
- The paint is peeling off in several other locations throughout the building (see photos AF, AG and AH).
