SITE CONDITION: FAIR

Block 1998 Lot 13

LOCATION, USE, ZONING, AND OWNERSHIP

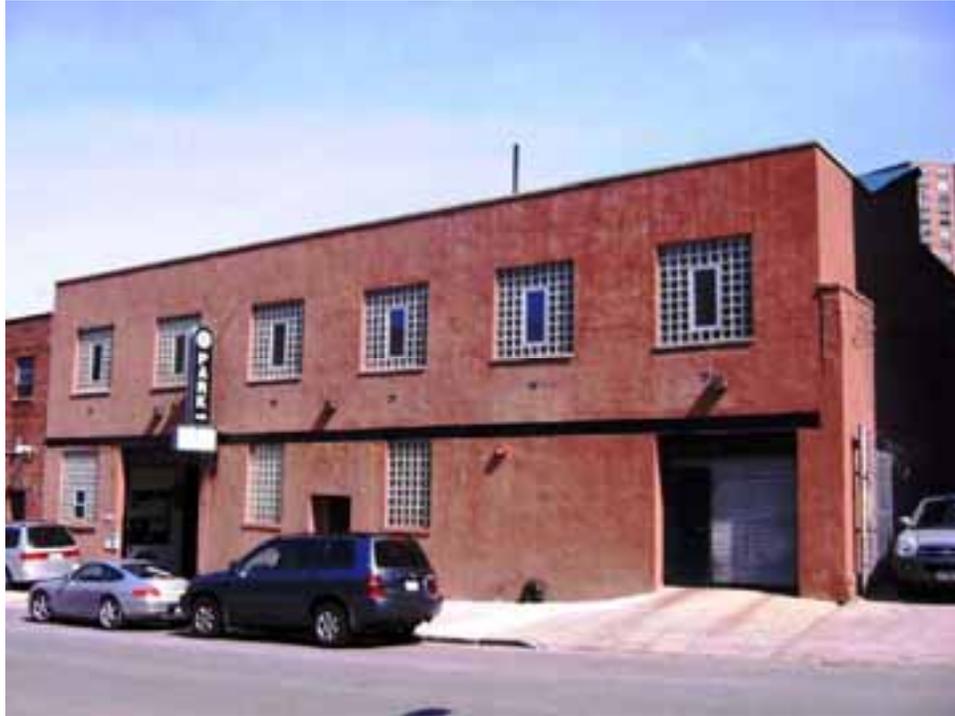
Photograph 1998-13-A

Lot 13 is located at 635 West 131st Street between Twelfth Avenue and Broadway. The 7,494-sf lot contains a two-story 16,000-gsf building used as a public parking garage (see photo A). According to the Department of Finance RPAD Master File, the building was constructed in 1940 and altered in 2002. Earth Tech reviewed the NYC Department of Finance Automated City Register Information System (ACRIS) and found that The Trustees of Columbia University acquired the property from 635 West 131st Street LLC on July 10, 2007. At the time of the AKRF report, Lot 13 was zoned M1-2; however it has since been designated

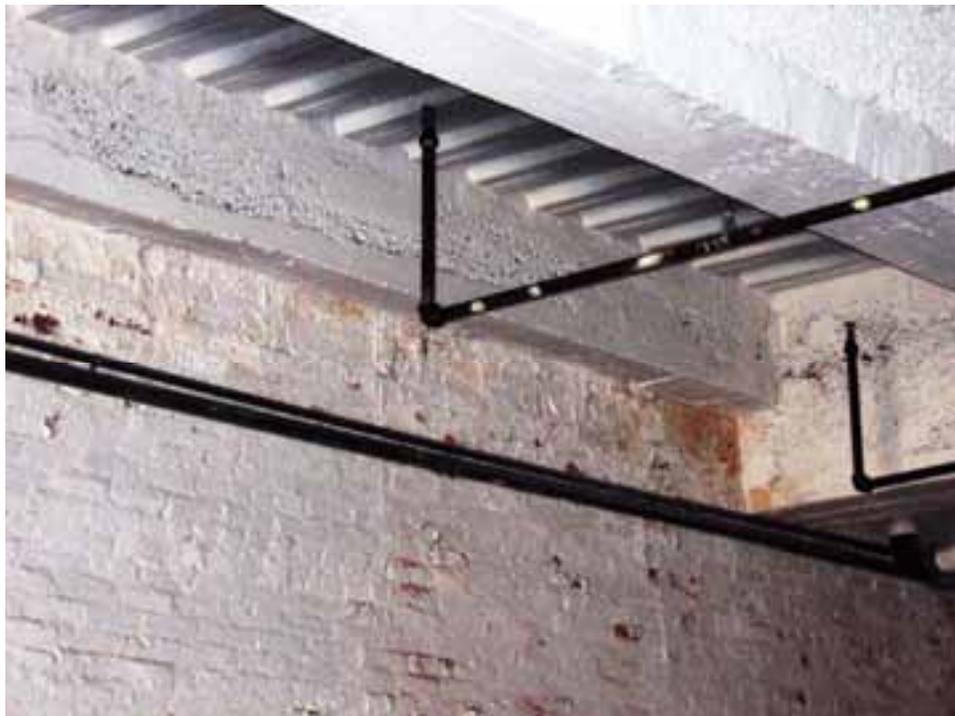
Photograph 1998-13-D

The entrance area in the parking area on first floor shows wide random cracking with settlement (see photos B and C). The metal deck and concrete encased beams are in fair condition with moderate amount of honeycombing (see photos D and E). The east wall has stepped cracks and a large spall at the bottom (see photos F and G). The underside of the ramp shows extensive paint peel off and several beams at the south end show heavy efflorescences and a wide crack at the bottom (see photos H, I and J). The second floor west wall shows water infiltration all along in the top area (see photos K, L and M). The aluminum channel framing for support of the roof shows significant rotation of a few channels and several cross bracing bars have bent (see photos N and O). The roof

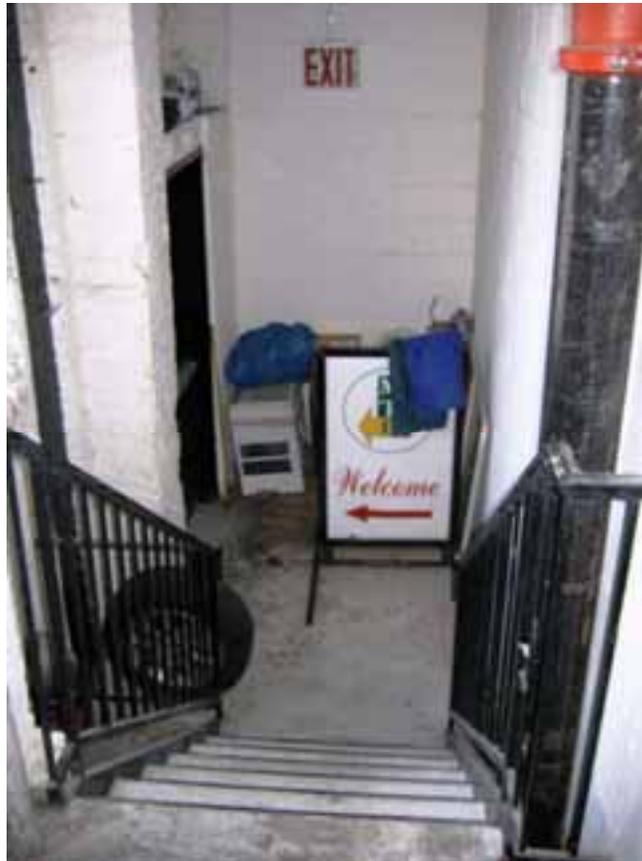
Photograph 1998-13-R

- *“Items stored between a flight of stairs and the door to West 131st Street, are obstructing a means of egress, and pose a tripping hazard”*. Earth Tech concurs with this statement (see photo R).
- *“On the second floor, tightly parked vehicles directly adjacent to the fire exit door would interfere with proper egress from the building”*. Earth Tech concurs with this statement (see photos S and T)

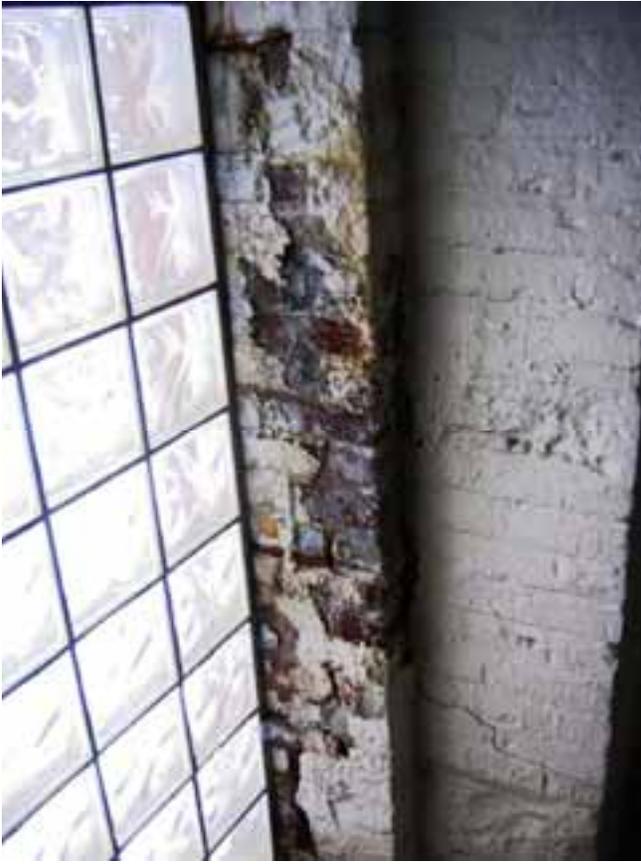
Photograph 1998-13-AA

- On the day of the survey, direct access to exit door on the 1st floor was obstructed by stored equipment parts (see photo U). Also, some parts were protruding into the passageway at the height below the clearance required to safely pass under; this is a safety hazard (see photo V).
- The surface of the intermediate landing in the stairwell is not uniform; the elevations of concrete slabs differ by 1.5 in to 3 in; this is a tripping hazard (see photo W). Also, in the flight of the same stair leading to the roof, the last riser is at least 2 in higher than the rest of steps; this is another tripping hazard (see photo X).
- There are signs of water intrusion and efflorescence along the south and east interior masonry walls, as well as peeling paint - a potential health hazard (see photos Y, K, Z and AA).
- There are signs of local vermin infestation (see photos AB and AC).

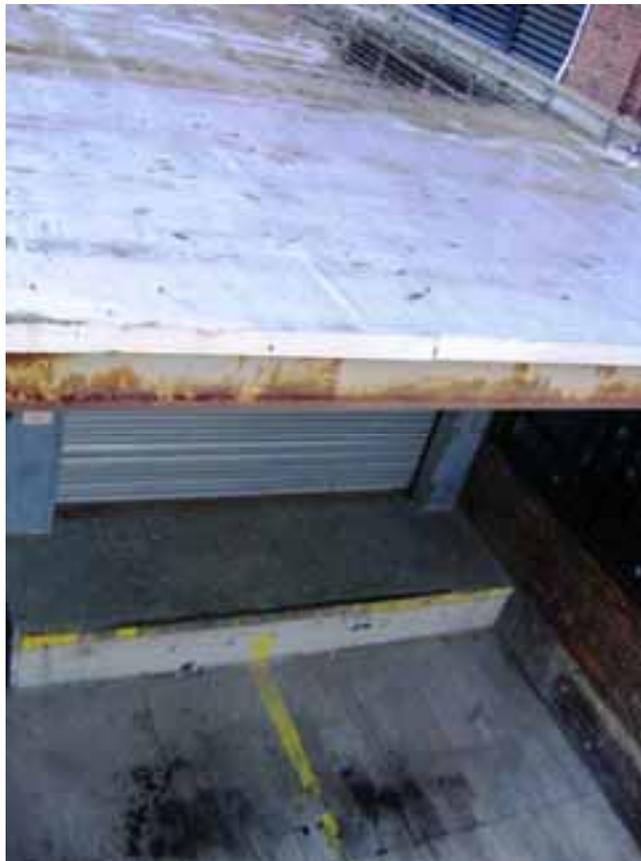
Photograph 1998-16-B

There are minor signs of light rust on the roof beams in the entrance area (see photo B). The slab on grade in the open entrance area shows wide cracks and minor settlement (See photo A and C). The CMU wall with a rolling door and the main door exhibits medium to wide cracks and stepped cracks (see photo D and E). Day light is visible through cracks in the wall above the lintel over the entrance door (see photo F). A brick column in the west wall has collision damage with loose bricks at the bottom area (see photo G). The spray-on fireproofing is missing on the roof beams at a few locations (see photo H).

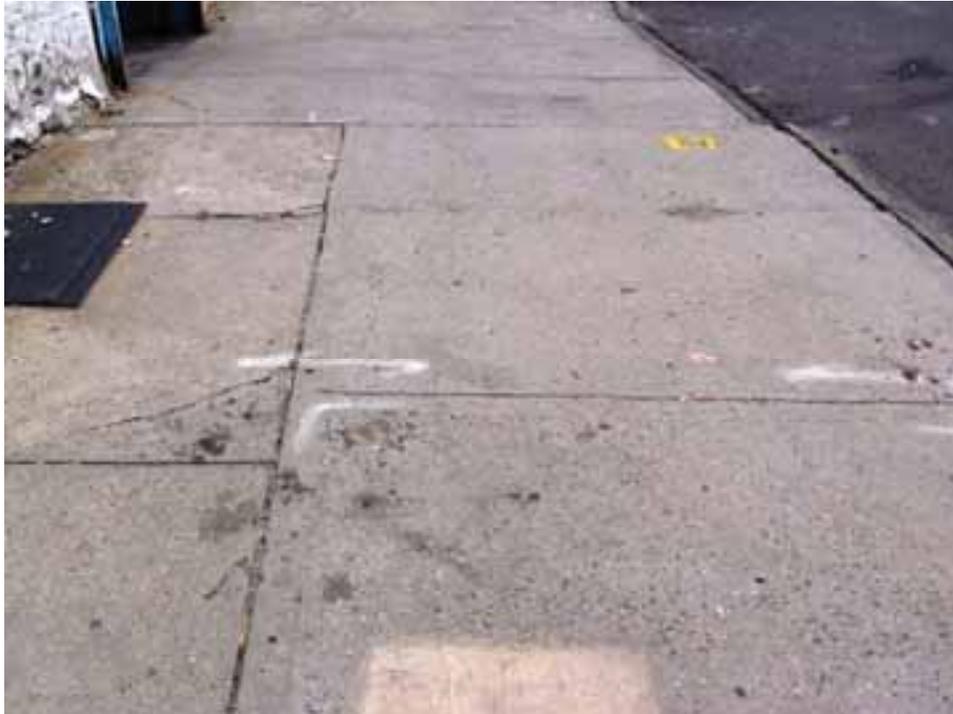
Photograph 1998-24-C

Based upon their visual, exterior inspection in 2006 and 2007, Thornton Tomasetti reported the poor conditions of sidewalks (cracks and spalls, see photo C), exterior wall (cracks and settlement, see photo D), windows (corrosion, see photo E), and roof (ponding stains and debris, see photo F). When inspected on March 12, 2008, Earth Tech's observations were generally consistent with the conditions reported by Thornton Tomasetti, or have possibly worsened. New or previously unreported deficiencies observed by Earth Tech include: decayed, disintegrating wooden window headers at the south face; and several local areas of bulging brickwork at the north face (see photos B and G). Except for 11 replaced sidewalk panels along West 132nd Street, there was no evidence of any repairs or renovation following the 2006/2007 inspections. Insulation boards and timber planks covering the west side of the roof remain in place (see photo F). (Thornton Tomasetti's speculation was that these were protection from façade renovation construction on the adjacent building).

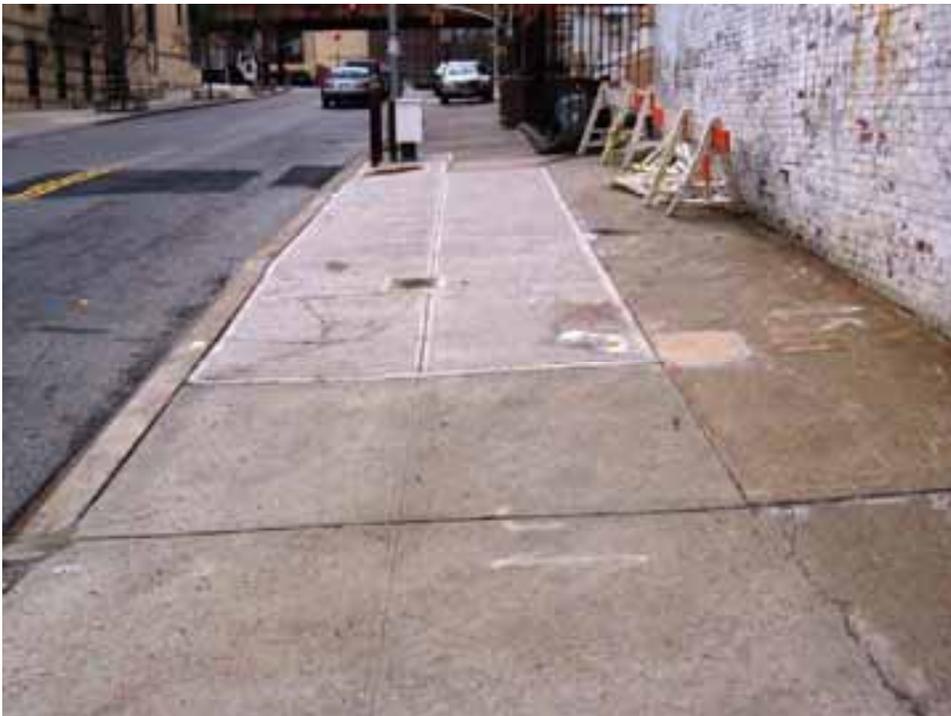
Photograph 1998-24-J

- The sidewalk at West 131st Street is in fair to poor condition with several cracks; the worst condition is at the western side close to the building, where, due to differential settlement, the concrete sidewalk slabs create a tripping hazard for pedestrians (see photos A, H and I).
- The sidewalk at West 132nd Street is in fair to poor condition with an area of cracked and spalling concrete slab (see photos J and K).

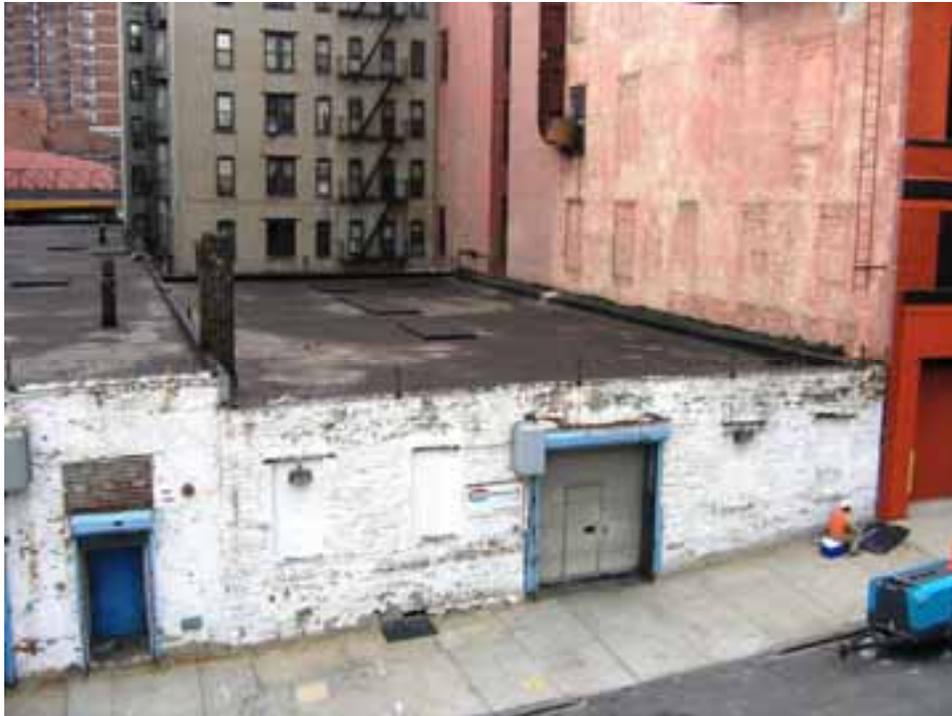
Photograph 1998-26-B

This property was available for exterior survey only. AKRF report did not list any health and safety concerns for this building other than *"the sidewalk along West 131st Street is in poor condition with some wide cracks and vegetation observed, while curb cuts appear to be in fair condition"*. Earth Tech concurs with this finding. At the time of the survey, Earth Tech observed: the sidewalk at West 131st Street as in fair to poor condition with several wide cracks and chunks of brick and concrete spalling off the building wall in one location (see photos B and E).

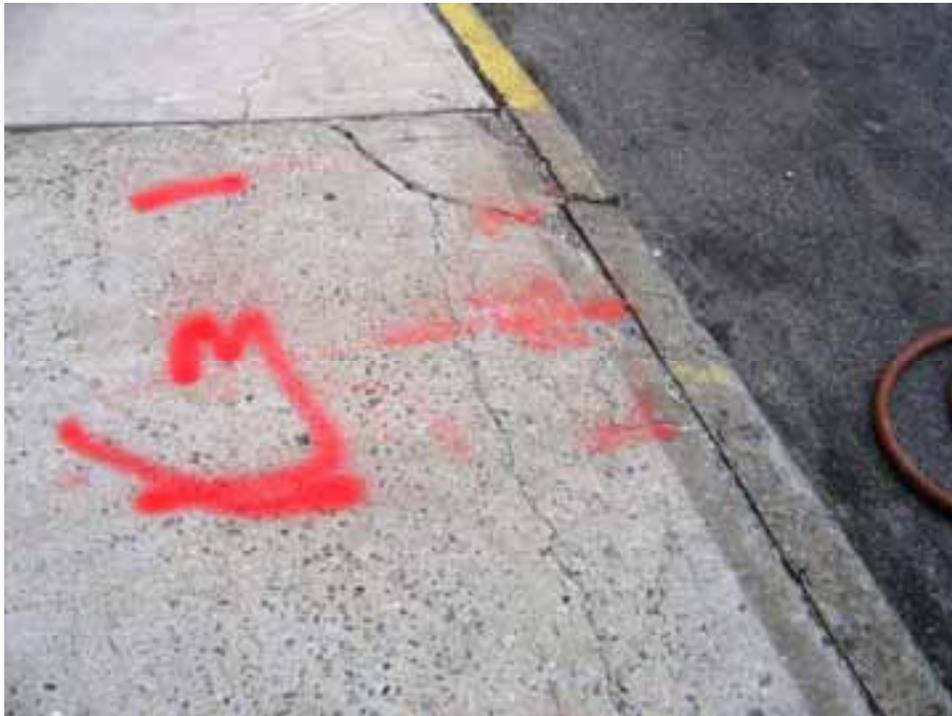
Photograph 1998-26-C

Based upon their visual, exterior inspection in 2006 and 2007, Thornton Tomasetti reported the poor conditions of sidewalks (cracks, see photo C), exterior wall (cracks, hole, and deteriorated lintels, see photos D, E, F and G); and the fair conditions of the roll-up door (minor damage, see photo H), and roofing (ponding stains, see photo I). When inspected on March 12, 2008, Earth Tech's observations were generally consistent with the conditions reported by Thornton Tomasetti.
