<b>SITE CONDITION: FAIR</b>
-----------------------------

## Block 1998 Lot 38

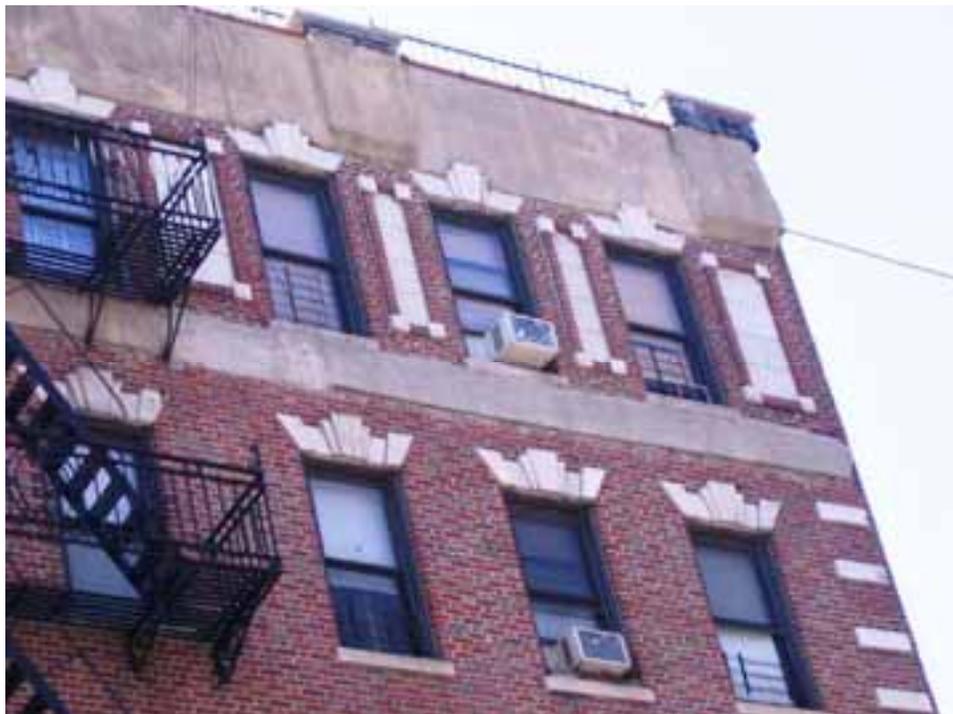
**Photograph 1998-38-B**

There are medium sized cracks and minor spalls in the repair work on the north exterior wall (see photos B, C and D), it also has water stains, typically at the window sill, and at other random locations. The west exterior wall has minor fine-line cracks (see photo E). The roof membrane was not accessible.

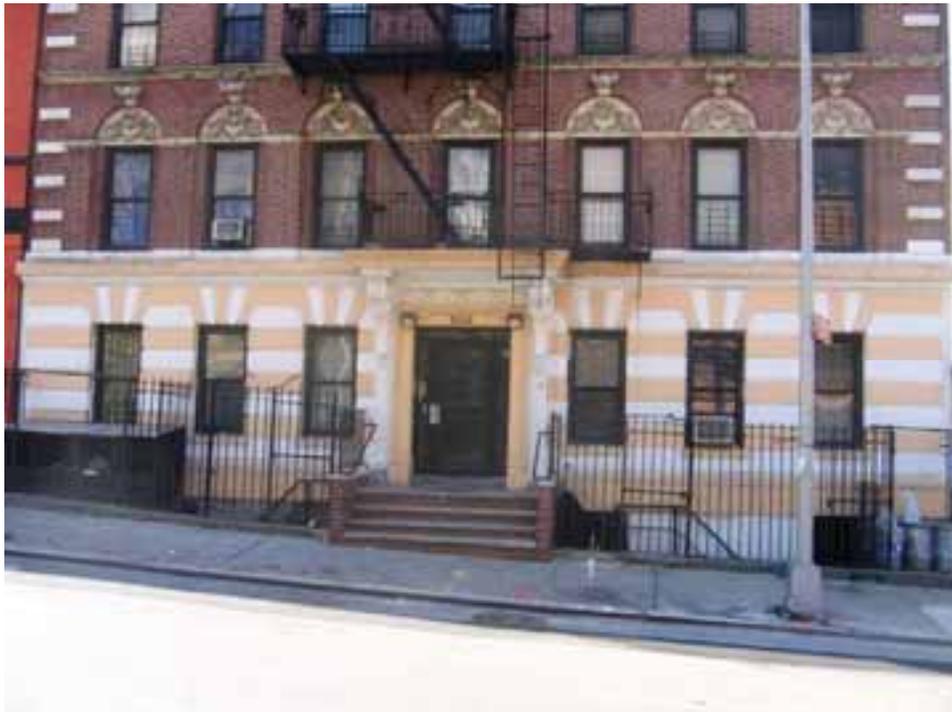
**Photograph 1998-38-F**

AKRF reported no health and safety concerns for this building, except for the poor condition of the sidewalk. Earth Tech did not observe any vegetation on the sidewalk on West 132<sup>nd</sup> Street, but concurs with the evaluation of the sidewalk as being in poor condition (see photos F and G).

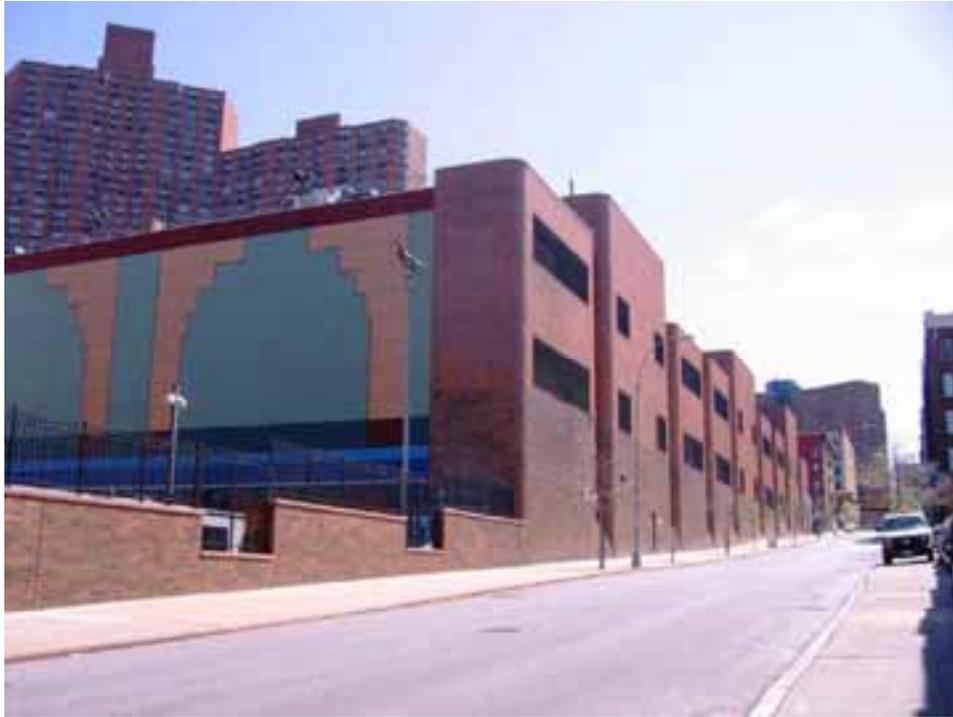
**Photograph 1999-1-B**

1. The exterior wall exhibits step, vertical and horizontal cracking typically along the portions of the wall that are on a horizontal curve (see photos B, C and D).
2. The exterior walls have spalls at various locations (See photos D, E and F), and the bricks should be repointed at various locations (see photo G).

- It appears that inadequately provided control joints in masonry wall are the reason why the signature rounded corners, especially on the south façade, consistently exhibit the signs of face brick cracking (see photos C, D and V). In several locations, the face brick has been chipping off (see photo W), presenting a safety concern for pedestrians.

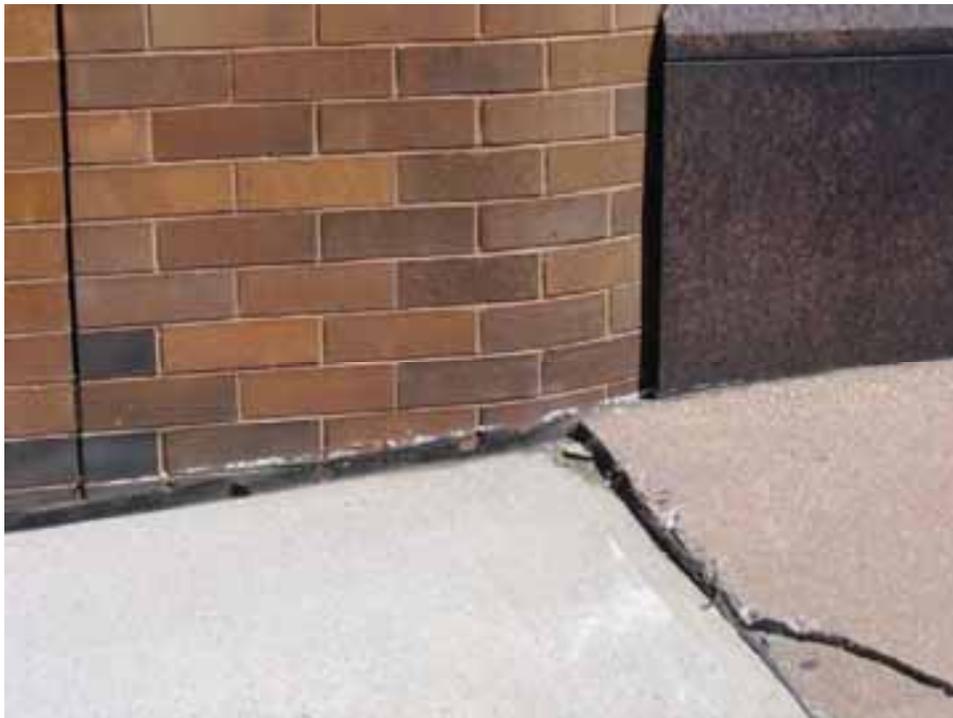
**Photograph 1999-1-H**

3. Settlement of the sidewalk typically at the base of the exterior walls (See photos H, I and J), and random cracking in the sidewalk (see photos K and L).
4. Recent partial sidewalk repair (see photo M).
5. The pavement at the south entrance area is spalled (see photo N).
6. Minor corrosion at the west picket fence and its railing (see photo O) .

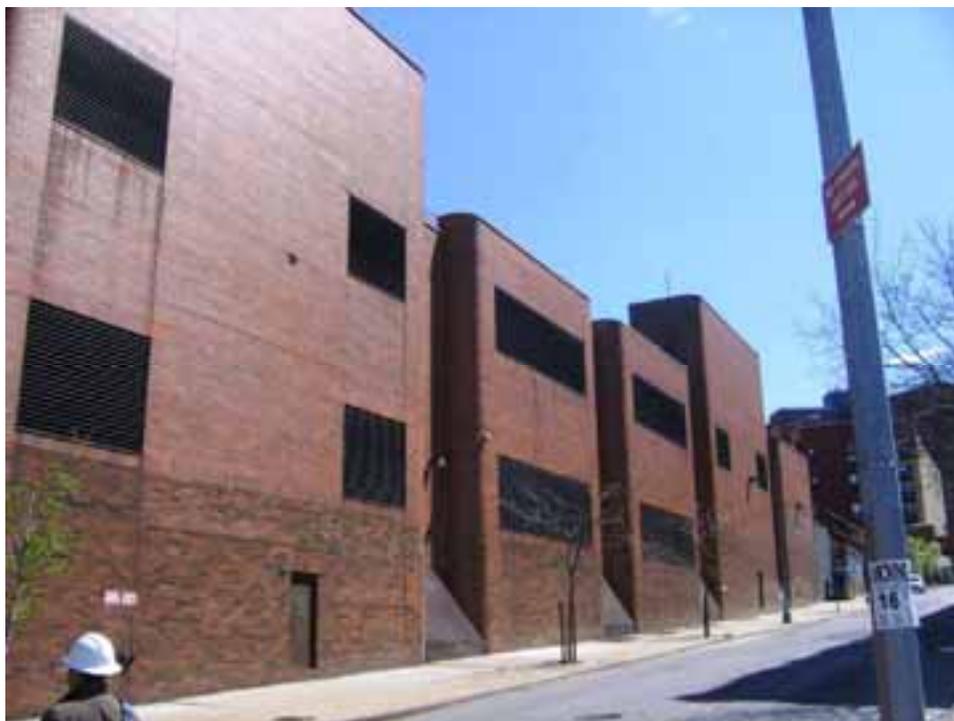
Photograph 1999-1-P

- Several man-doors on the south façade (facing West 132<sup>nd</sup> Street), which appear to be fire exit doors, do not have any landings, while the difference between the floor level inside and a sloped sidewalk outside varies from 9 in to 12 in (see photos P and Q). This is a potential tripping hazard and is a safety concern for employees.

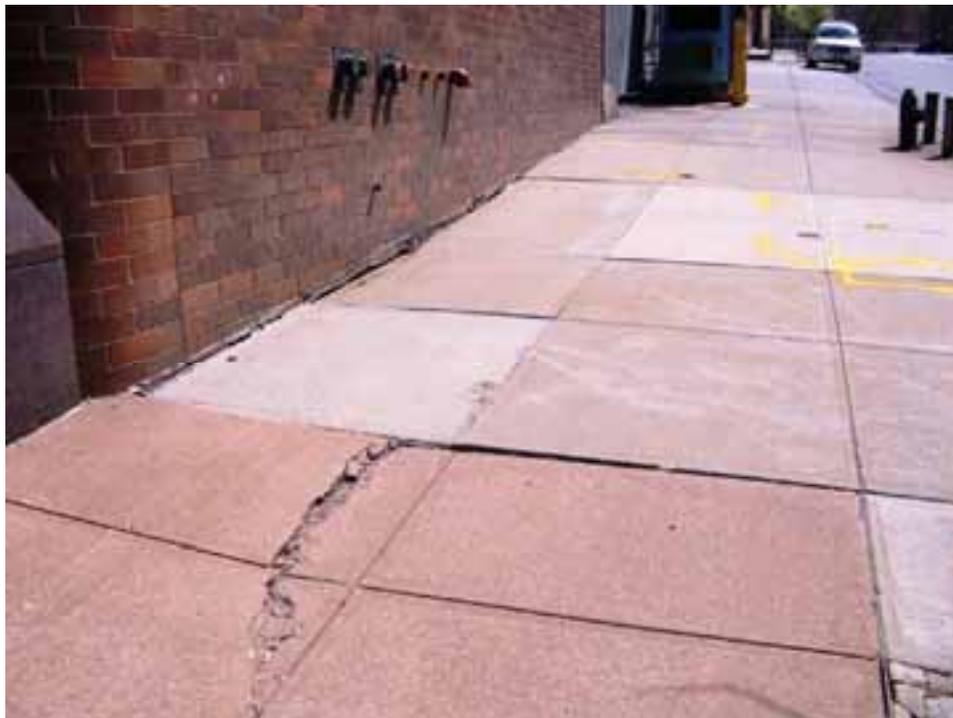
Photograph 1999-1-S

- While the sidewalk around the building is in good condition generally, there are several locations where the concrete slabs have cracked, spalled, or moved (see photos R, S, F and T). In one location on West 132<sup>nd</sup> Street, the steel curb next to the street storm drain has shifted from its place, exposing a wide gap (See photo U). These present tripping/safety hazards for pedestrians.
