ALTERNATIVES ANALYSIS WITH BCA CONDITIONS ASSESSMENT UPDATE

**VICTORIA THEATER
235-237 WEST 125TH STREET
NEW YORK, NY
ALTERNATIVES ANALYSIS**

Conditions Assessment Update

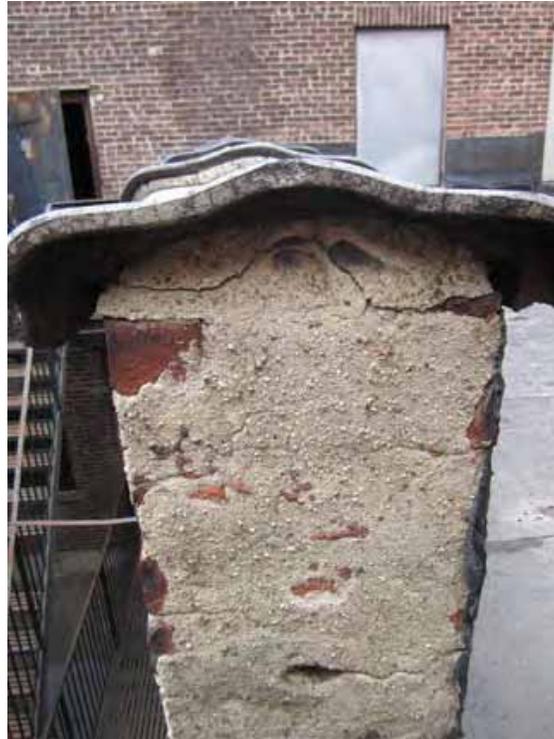
Figure: 6 Location: Foyer Roof

Deteriorated parging at parapet. This condition was not noted in the PACA report, as the roof was inaccessible during their survey.

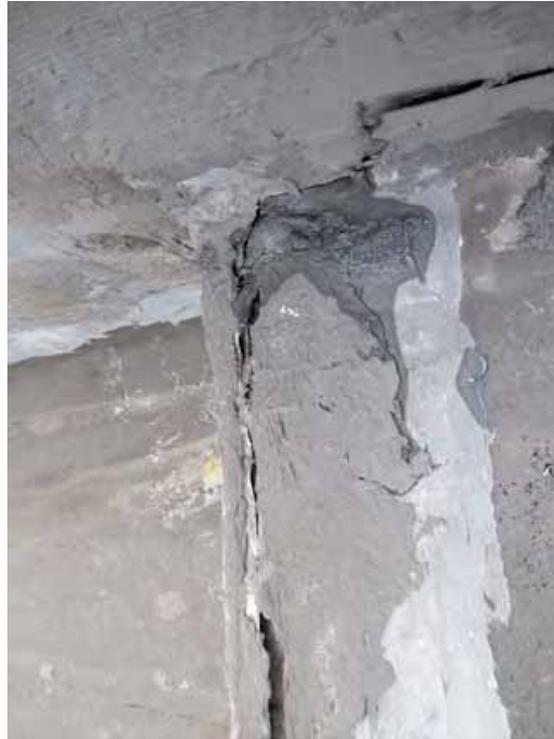
Figure: 11 **Location:** North Roof

Deteriorated bitumen coating with open joints at the roof edge. The PACA report did not identify this condition, as the north roof was inaccessible during their survey.

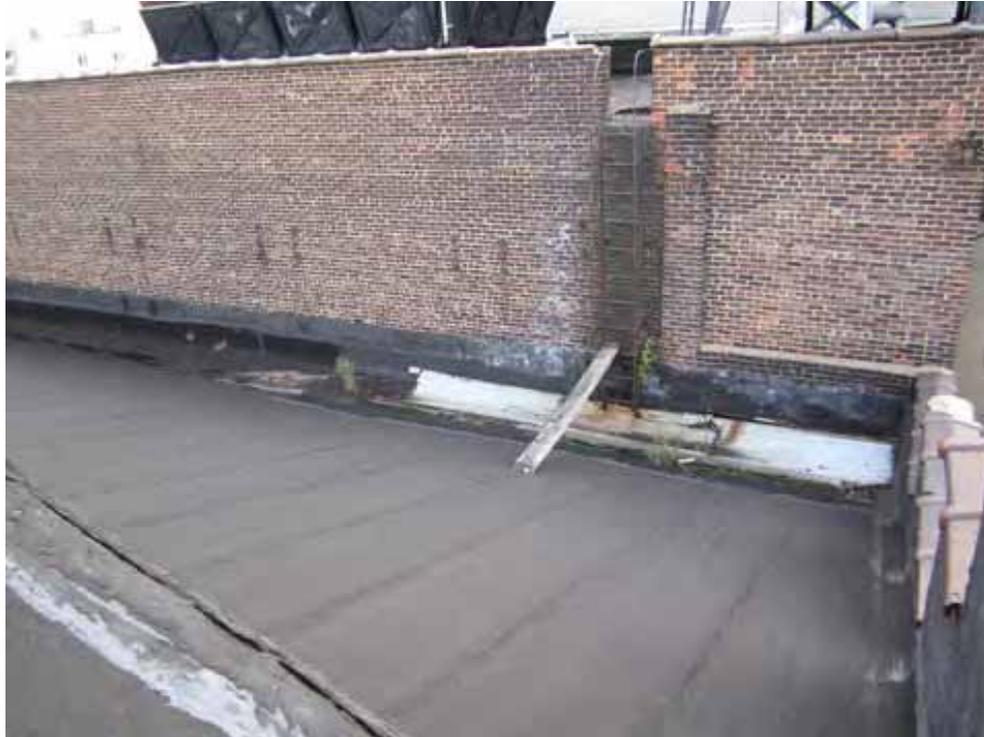
Figure: 12 **Location:** North Roof

Deteriorated roofing materials in foreground. Standing water and inappropriate repair materials at base of pitched roof, along brick wall that delineates the backstage area of the auditorium. The PACA report identified the north roof as inaccessible.

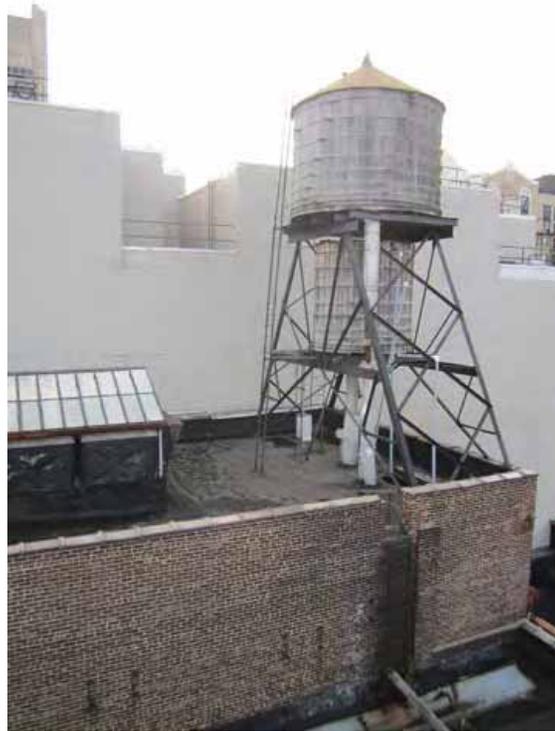
Figure: 13 Location: North Roof

The PACA report identified the water tower at southeast corner of roof as a source of water infiltration into Theater 5. The exterior brick below the tower exhibits efflorescence. Pooling water is visible on flat roof.

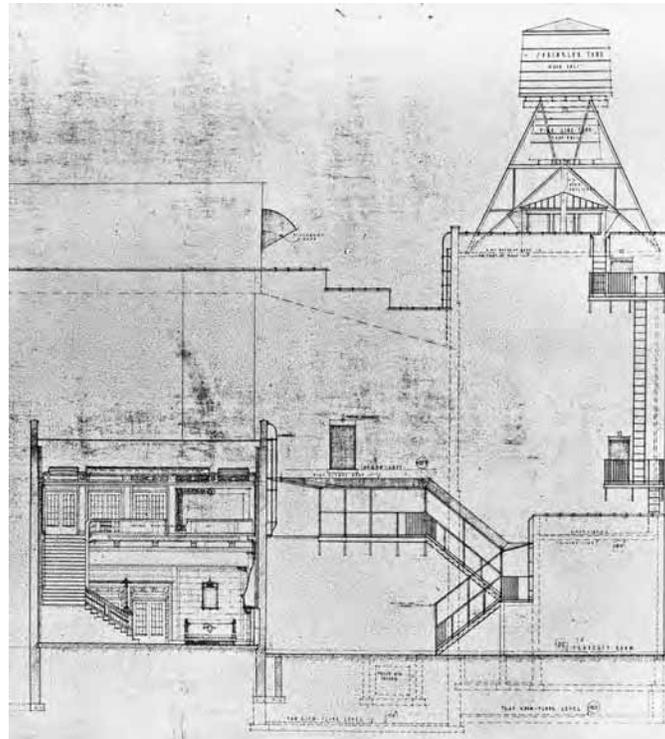
Figure: 15 Location: North Roof

Archival drawings show the bulkhead and water tower over the stage (Theater 5). These elements are corroding (See Figures 13 and 14). The PACA report did not identify this deterioration, as the north roof was inaccessible during their survey.

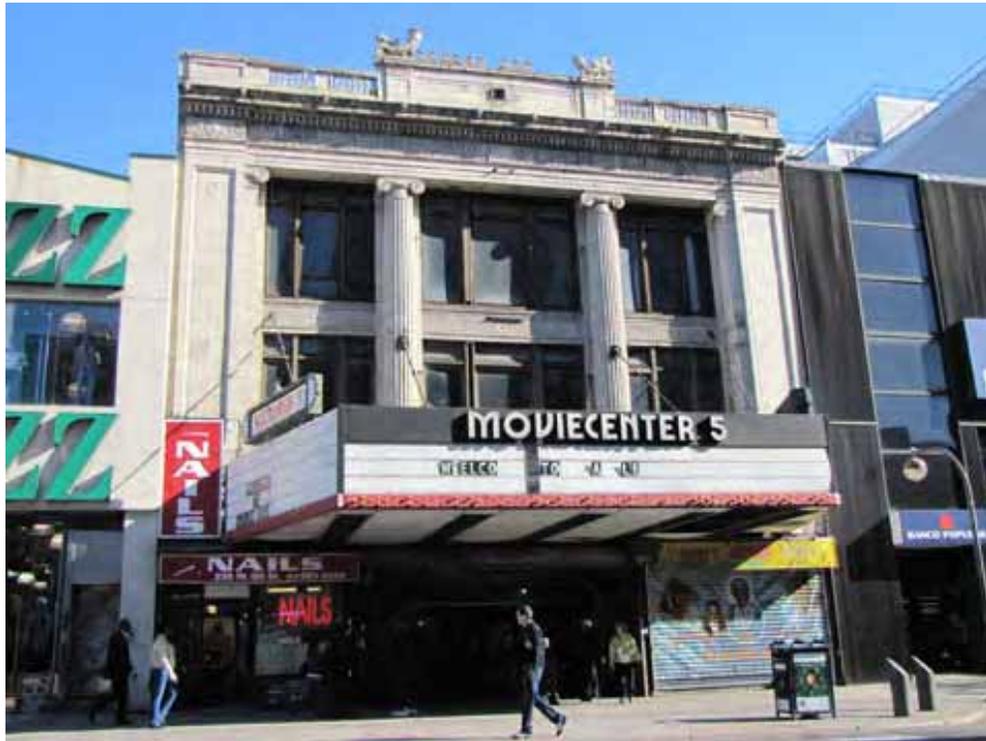
Figure: 16 Location: South Façade

Current photograph of the south façade. Store fronts are located at the east and west corners and the marquee has undergone several alterations. The vertical marquee sign was previously removed.

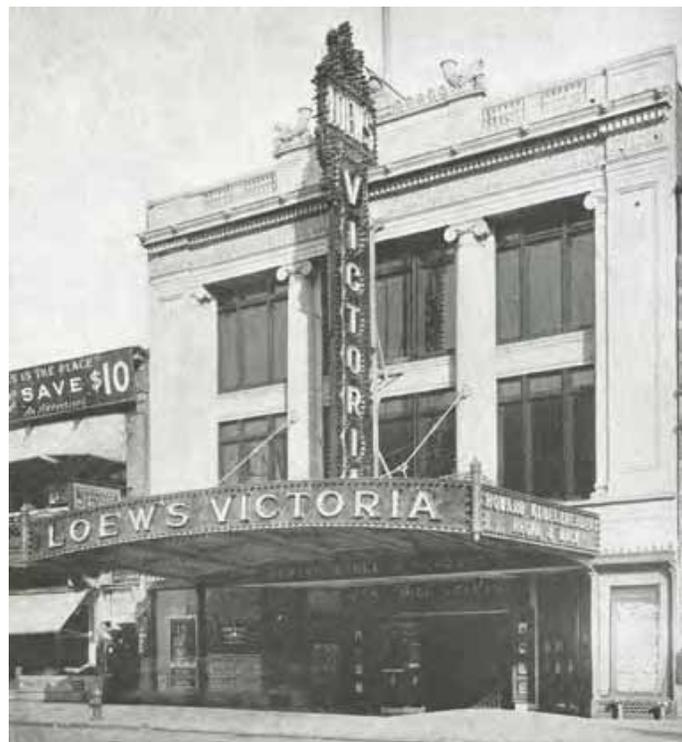
Figure: 17 Location: South Façade

Archival image, c. 1918. The original marquee included horizontal and vertical components. Abandoned anchors for the vertical sign remain visible on the façade and roof.

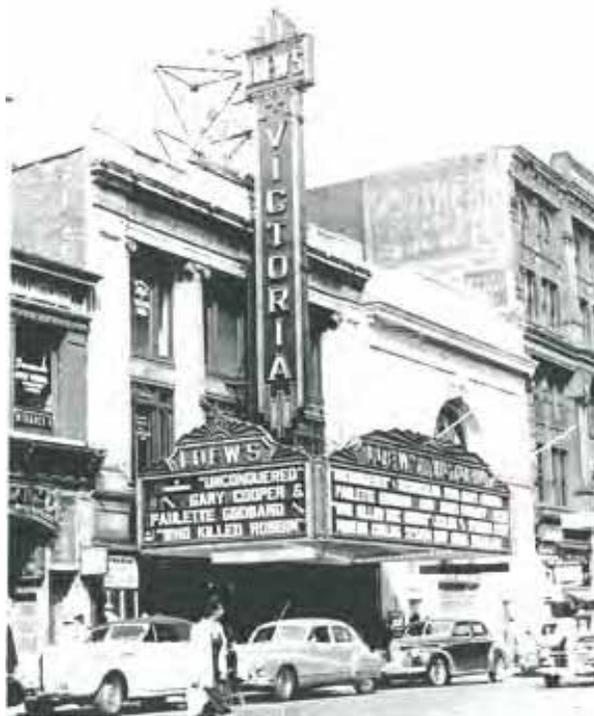
Figure: 18 Location: South Façade

Archival image, c. 1948 shows a new vertical and horizontal marquee. The acroteria along the top of the center parapet were altered to their current configuration (See Figure 20).

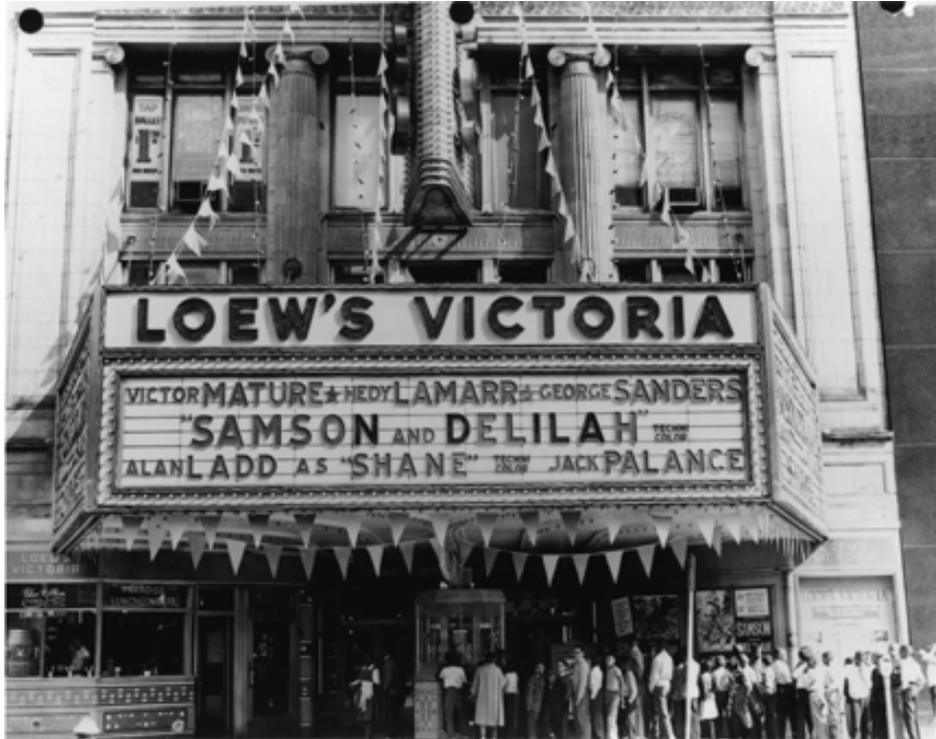
Figure: 19 Location: South Façade

Archival image, c. 1949 shows a new vertical and horizontal marquee as well as tile finishes at the entrance, which remain in part today.

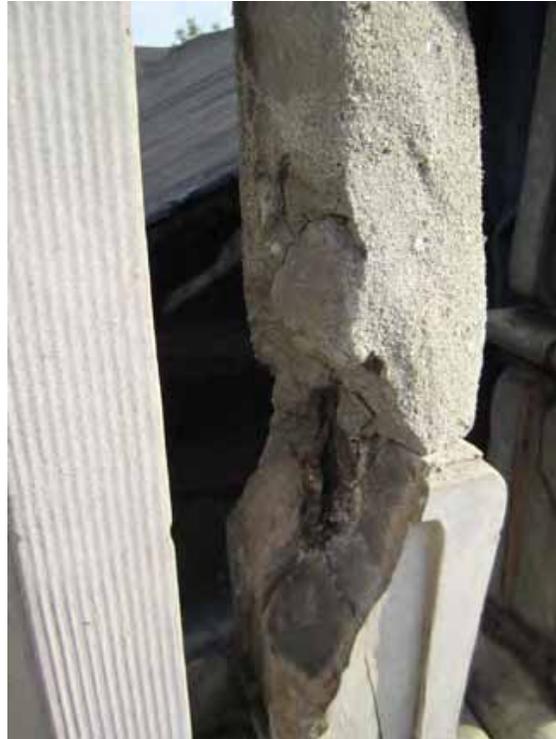
Figure: 23 **Location:** South Façade
Deterioration of terra cotta and previous patching material at balustrade caused by corrosion of embedded steel support. The PACA report did not identify these conditions.

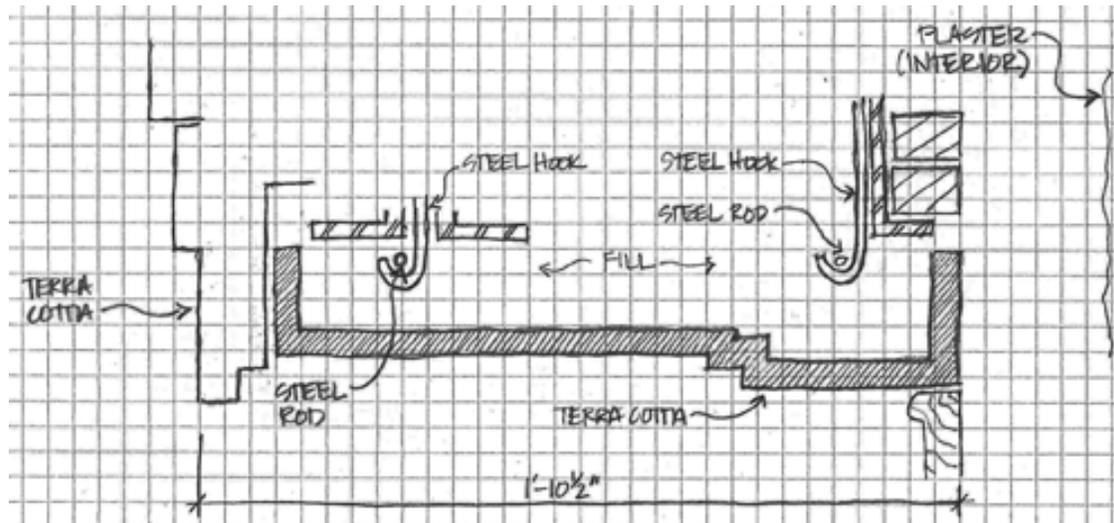
Figure: 34 Location: South Façade

BCA Probe X3, located at the cracked soffit above the third floor, east window (Figure 33), revealed the construction of the hanging terra cotta units. The steel rods, anchors and structure exhibit corrosion.

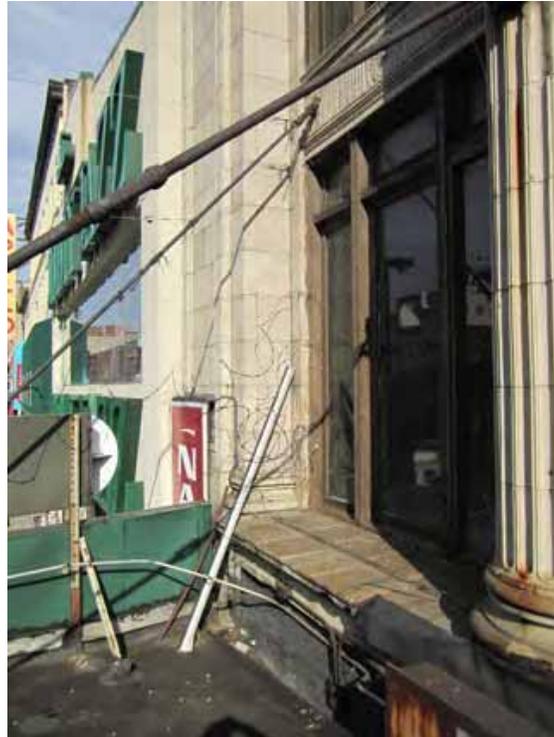
Figure: 35 Location: South Façade

Abandoned anchors and conduits are typical on the façade. Barbed wire is installed at the perimeter of the marquee. The PACA report did not identify these conditions.

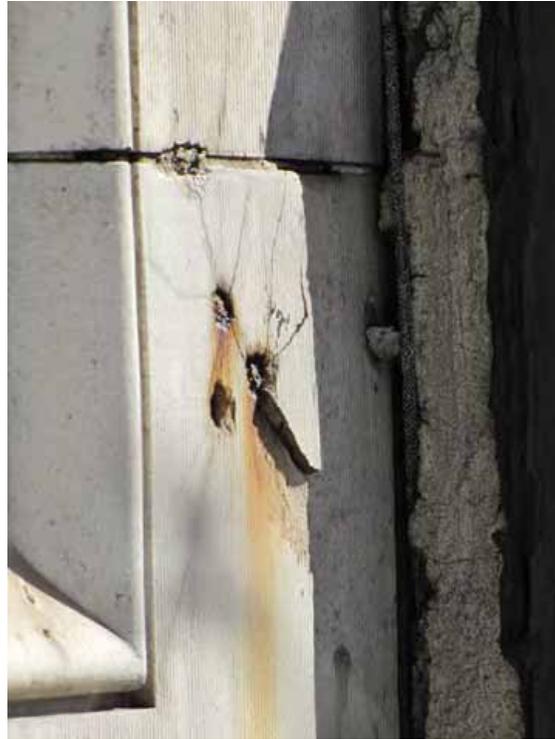
Figure: 36 Location: South Façade
Corroding abandoned anchors are causing cracks and spalls in terra cotta. The PACA report did not identify this condition.

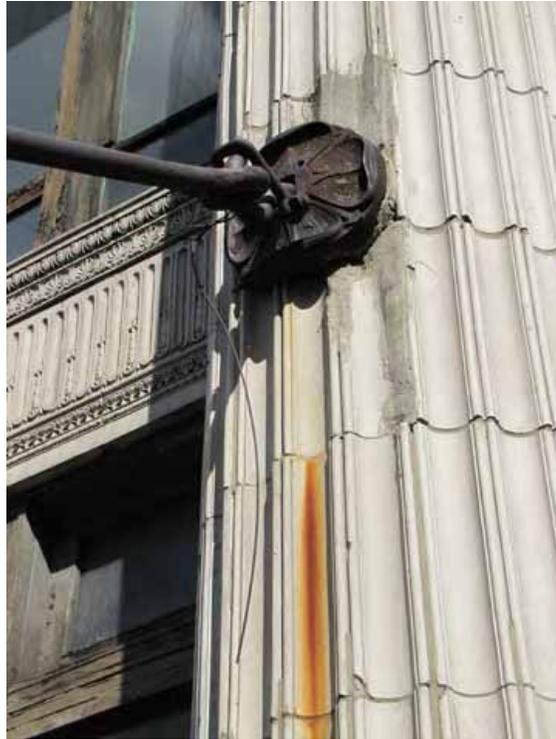
Figure: 38 Location: South Façade

Cracks and previous patching material at what appears to be the original decorative marquee anchor. The PACA report noted that cracking was typical at marquee anchors. Corrosion of the anchor has resulted in ferrous stains on column below.

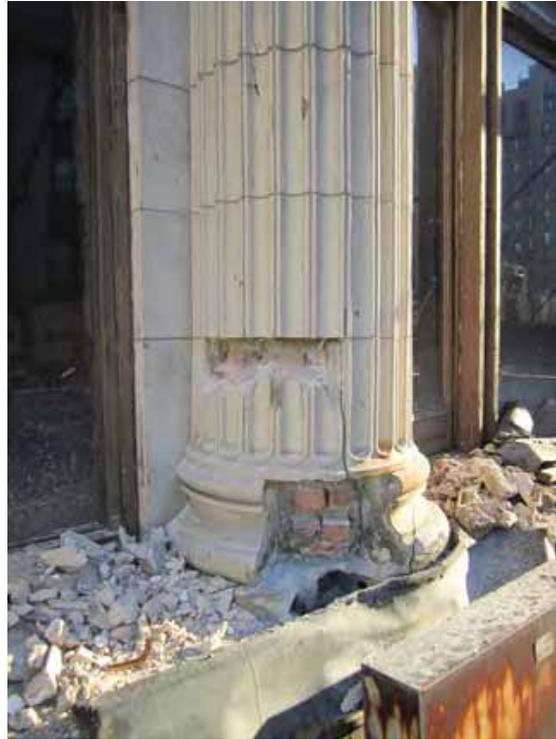
Figure: 40 **Location:** South Façade
BCA Probe X4, located at the cracked based of the column between the west and center bays, revealed brick backup construction with corroded steel straps anchors.

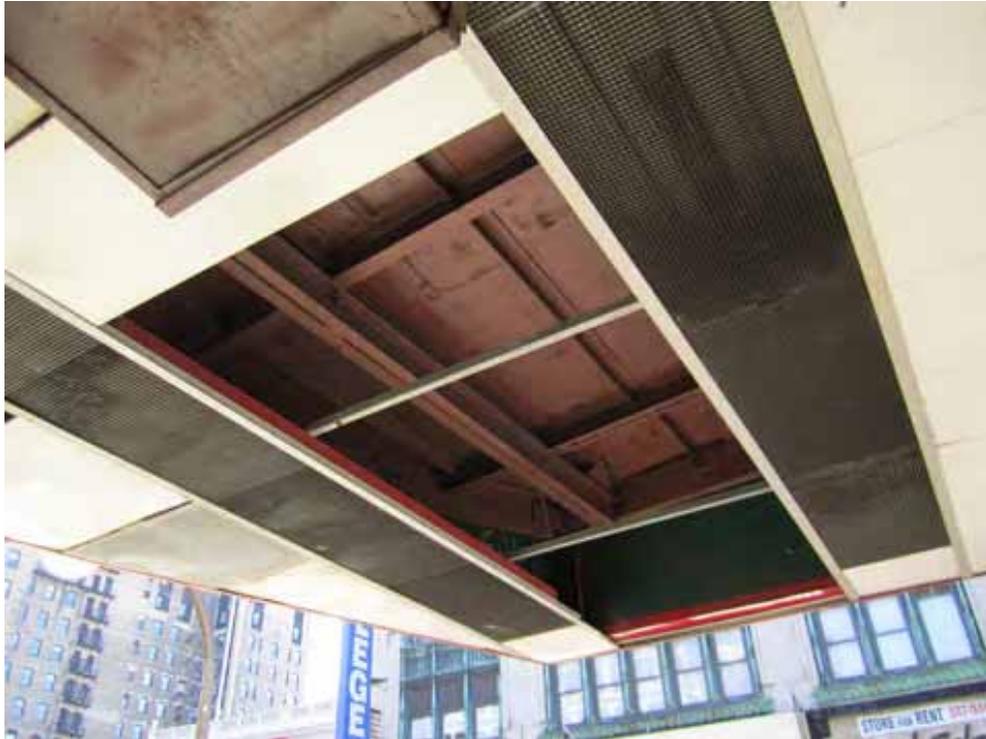
Figure: 47 **Location:** Marquee
As noted in the PACA report, portions of the steel frame to the original marquee are concealed within the modern marquee.

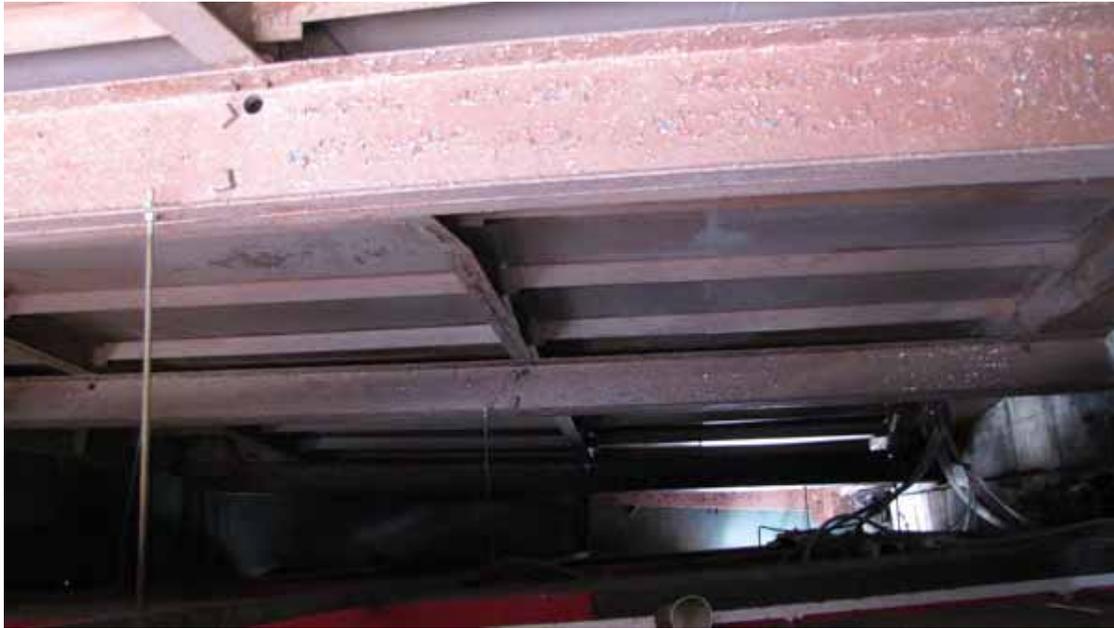
Figure: 48 Location: Marquee

As noted in the PACA report, the existing marquee is hung from the frame of original marquee.

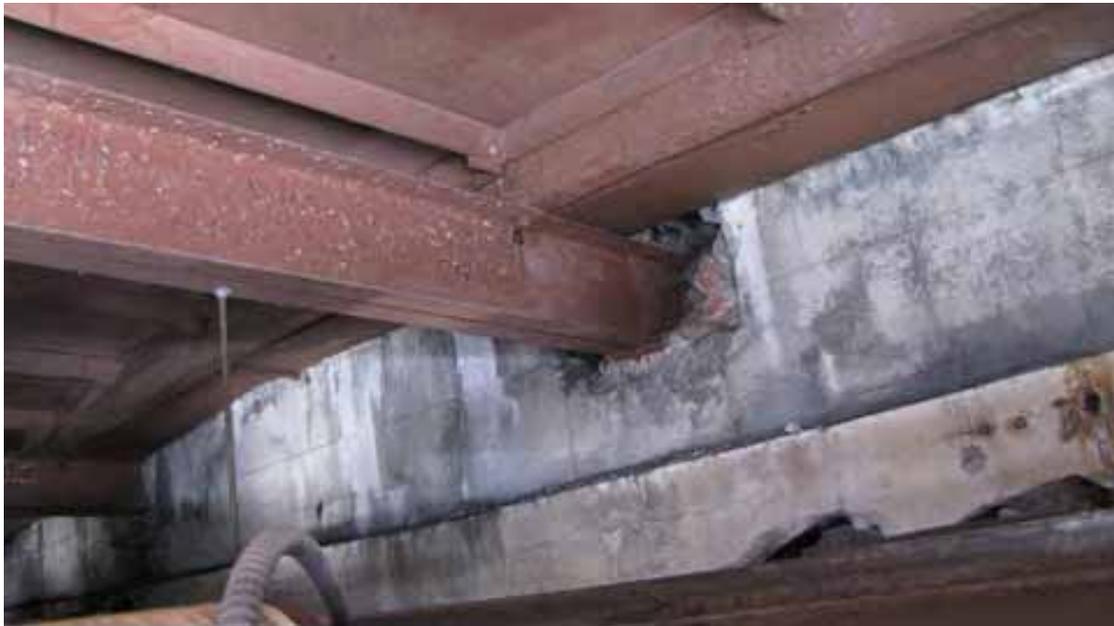
Figure: 49 Location: Marquee

Intersection of the steel structure of the marquee and the south façade.

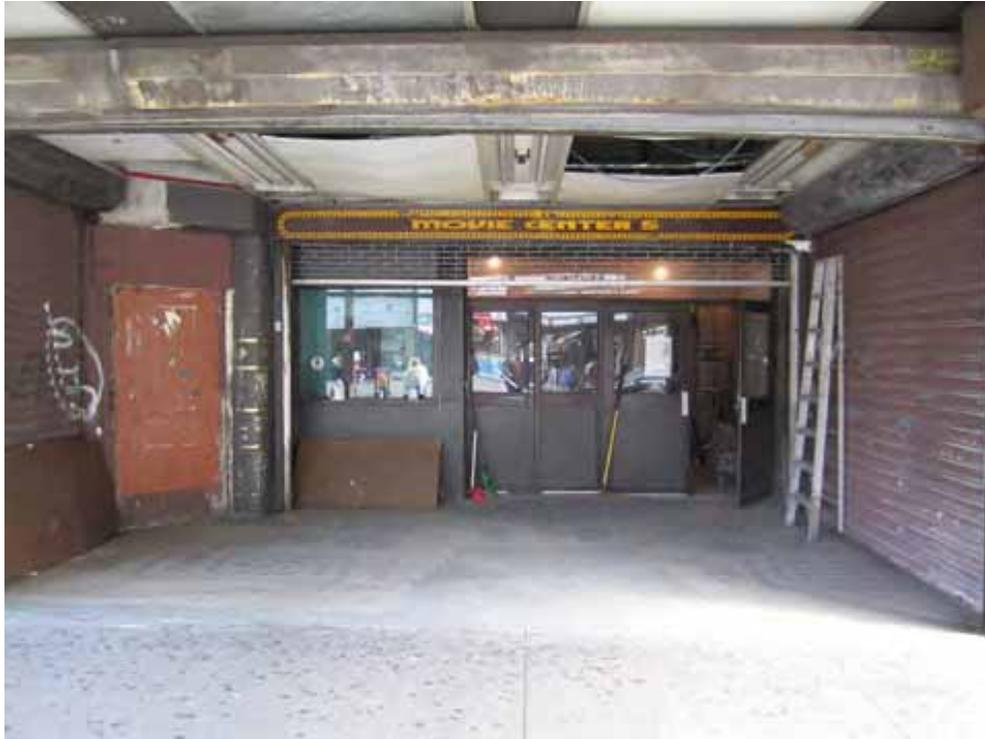
Figure: 54 Location: Entrance

As noted in the PACA report, the chamfered walls of the original entrance have been reconfigured, and the rolling gates, ticket booth, entrance doors, tiled walls, and tile floor were installed during building alterations. The wall tiles are painted.

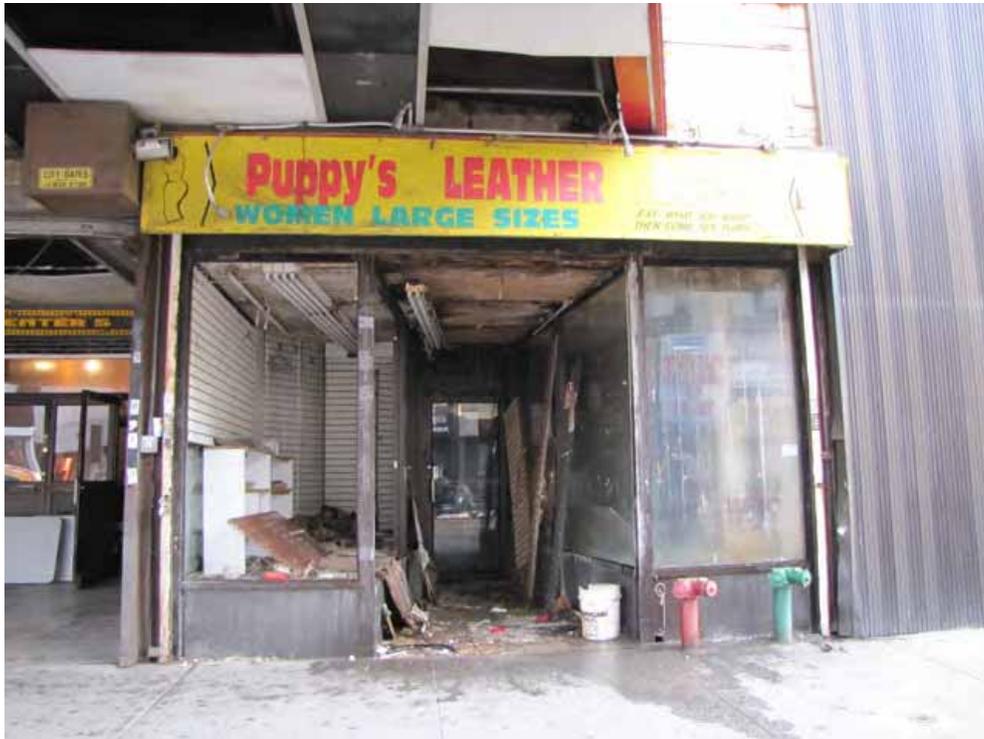
Figure: 56 Location: Entrance

An abandoned storefront now occupies the east corner. Archival images show a vitrine with an ornamental frame at this location (See Figure 17).

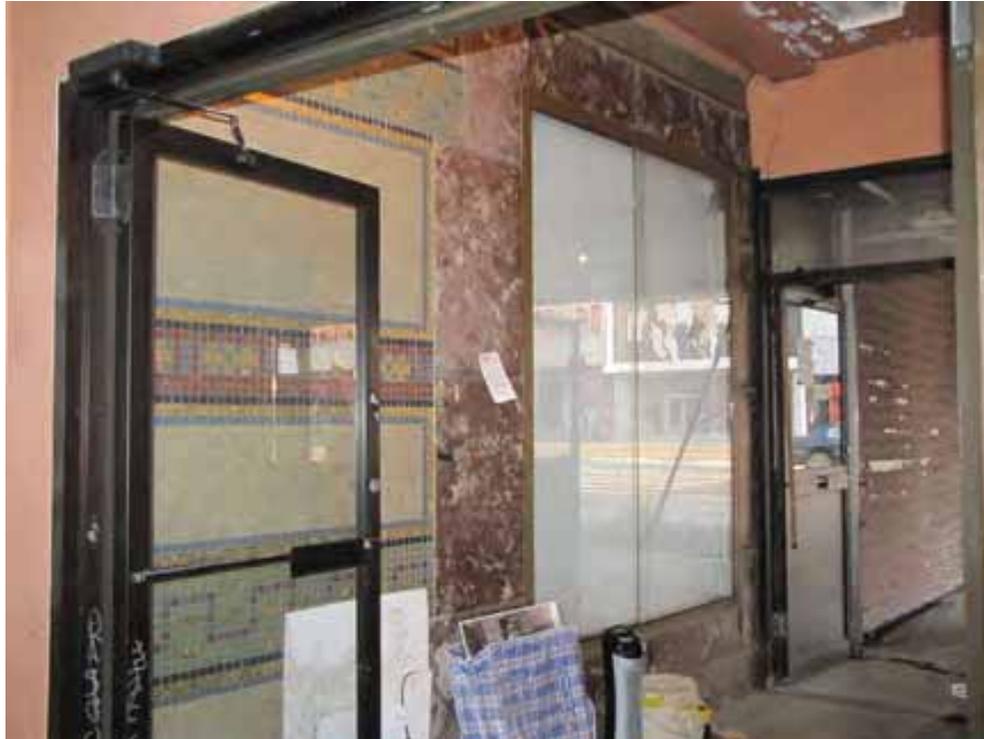
Figure: 59 Location: Vestibule

The vestibule walls are decorated with tiles and marble installed during previous alterations. The PACA report did not discuss finishes or conditions in this area.

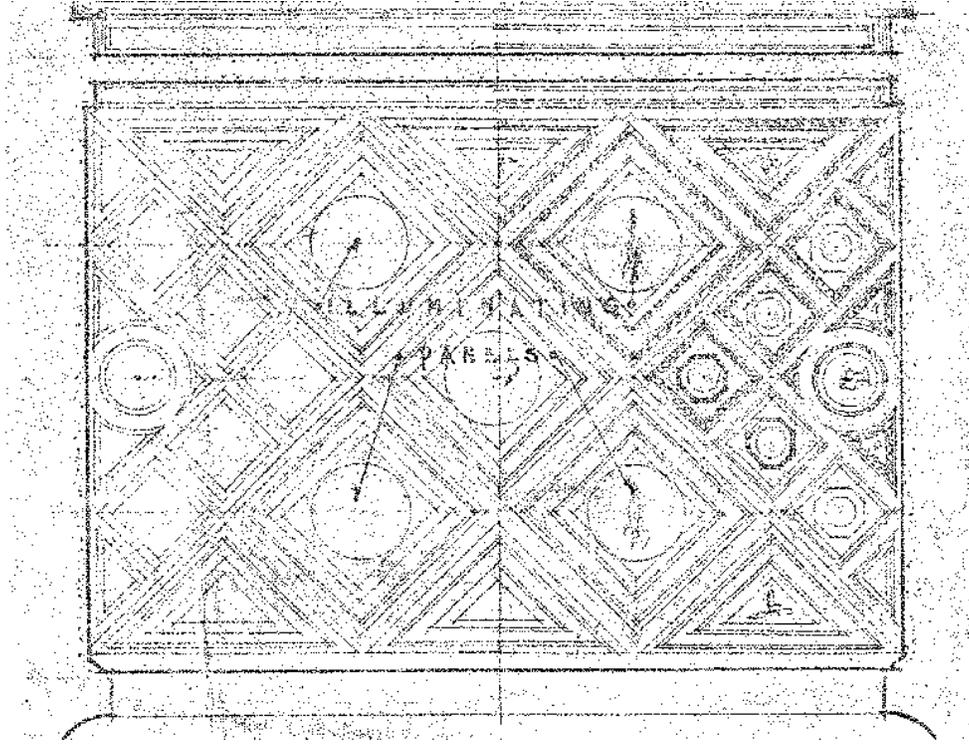
Figure: 60 Location: Vestibule

Archival drawings indicate the original vestibule ceiling was highly decorative, with five illuminating panels in the center of the room. The ceiling and panels are no longer extant.

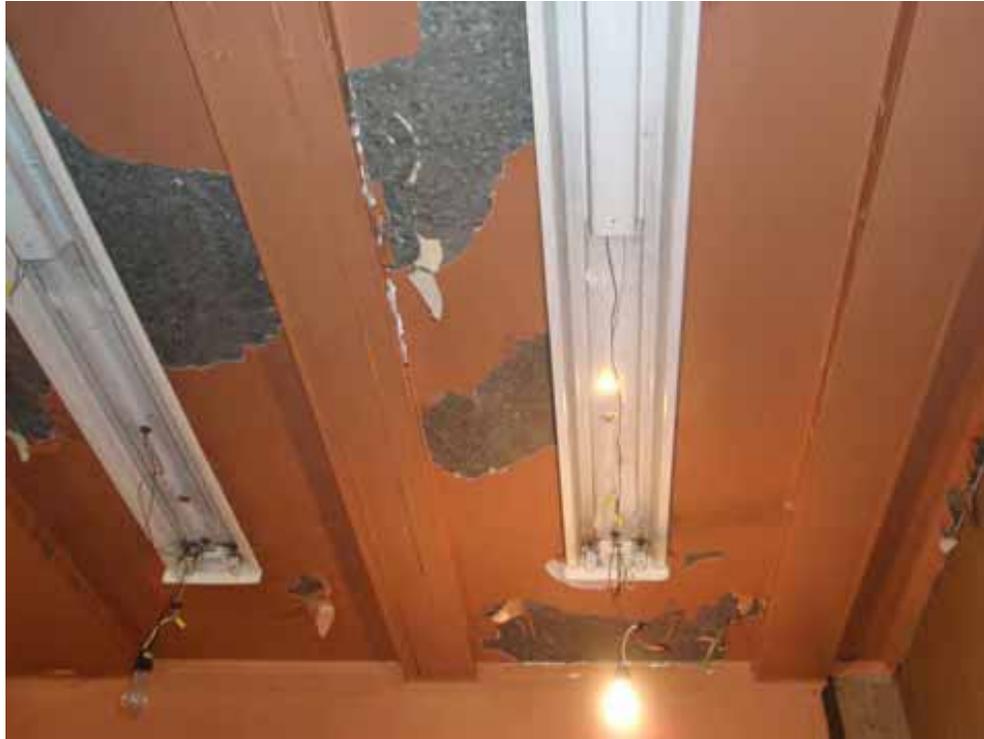
Figure: 61 Location: Vestibule

The vestibule ceiling is covered with galvanized sheet metal and fluorescent lighting, installed during previous alterations. The PACA report did not discuss finishes or conditions in this area.

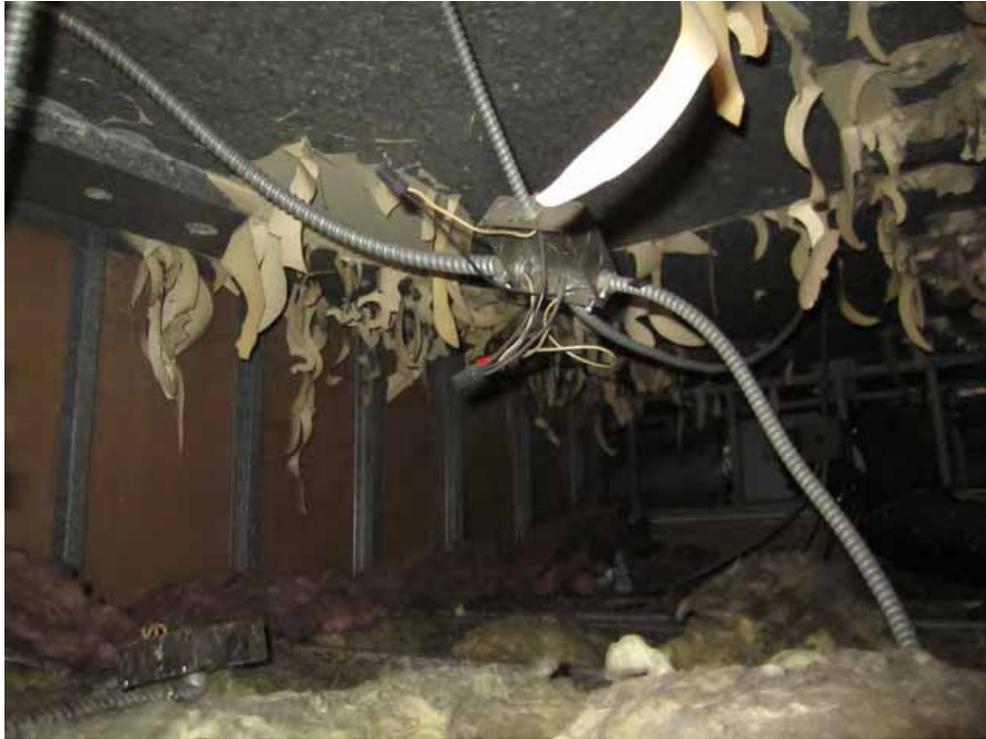
Figure: 62 Location: Existing Ticket Booth

BCA Probe 8 above the ticket booth ceiling determined that the vaulted ceiling over the vestibule, shown in Figure 60, was removed during previous alterations.

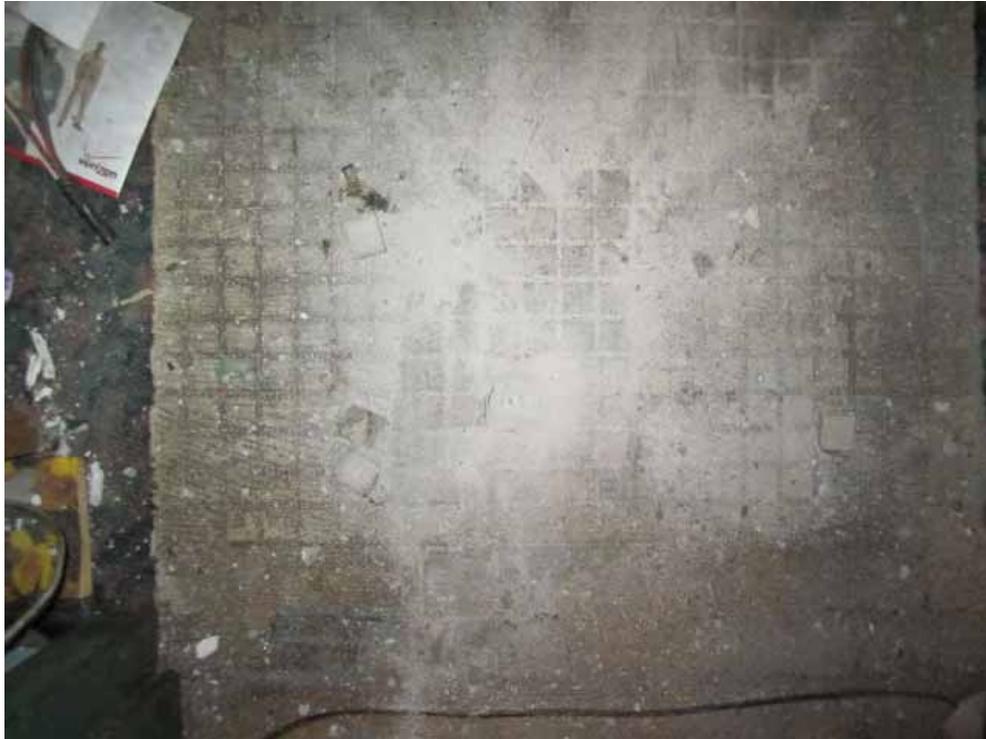
Figure: 63 Location: Existing Ticket Booth

BCA Probe 5 revealed floor tiles under the carpet in the existing ticket booth. The tiles appear to be part of the building alterations; the original floor is no longer extant. Their installation date is undetermined.

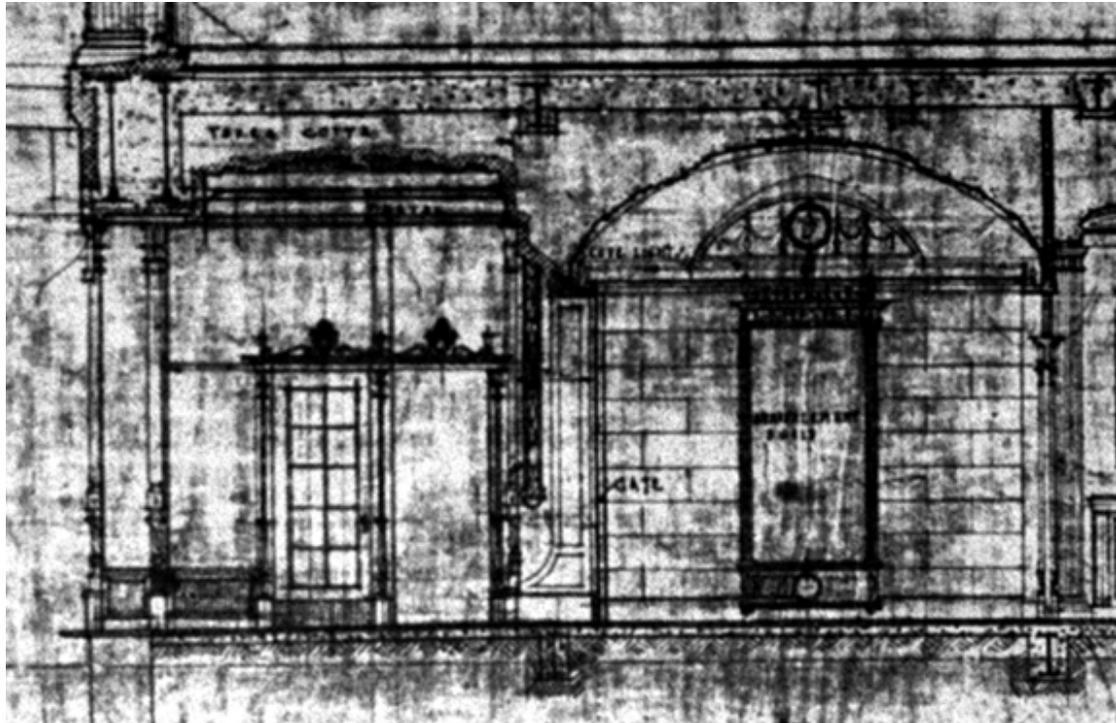
Figure: 64 Location: Existing Ticket Booth

An archival drawing shows what appears to be a mirror with a decorative frame at the original west wall of the vestibule. However, an archival floor plan shows a door at this location that opened to a stairway leading to the second floor.

BCA Probe 6. An archival drawing shows masonry joints on the west wall (Figure 64); it remains undetermined if the vestibule walls were initially finished with a stone veneer or a faux stone finish. The original finishes were removed from this location.

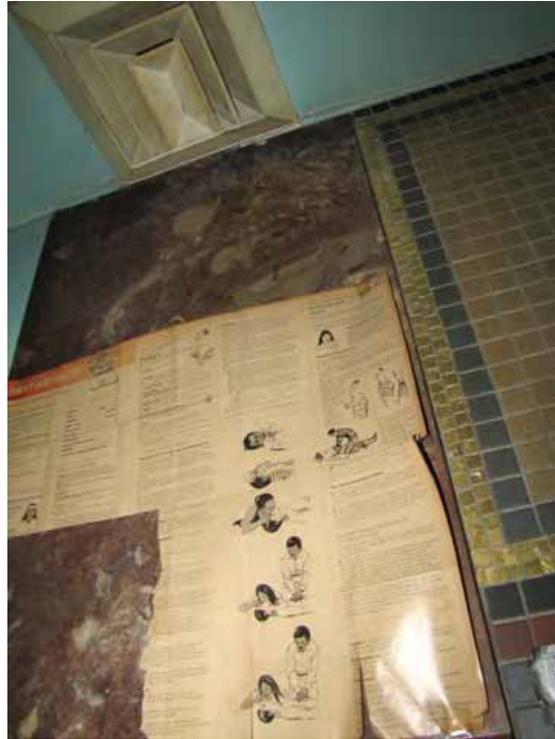
Figure: 66 Location: Existing Ticket Booth

Marble and tile at west wall were installed during previous building alterations, as was done in the entrance vestibule.

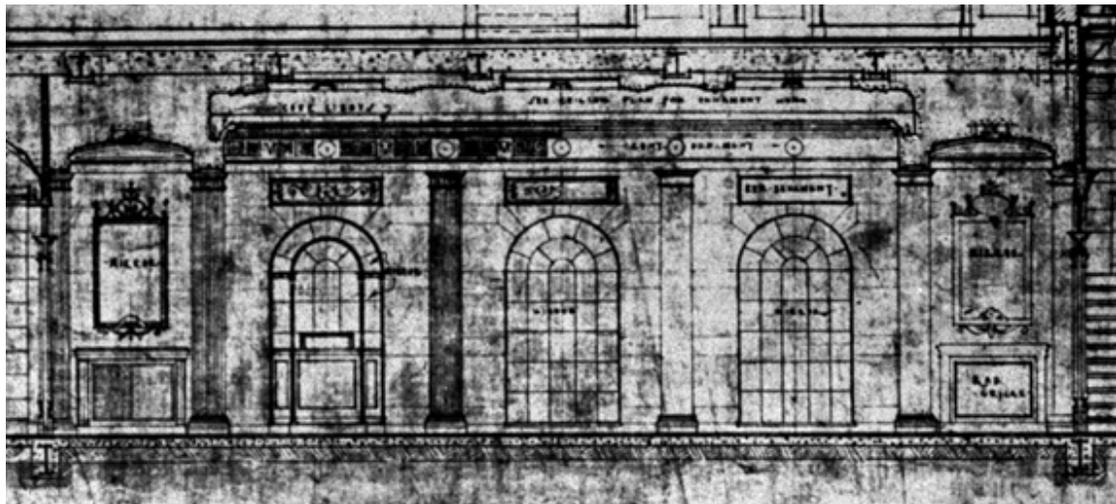
Figure: 67 Location: Lobby

Archival elevation of west wall of lobby, showing three arched mirrors and radiators at the north and south ends of the room.

PACA probe 4 revealed all historic finishes at the west wall were removed during previous alterations.

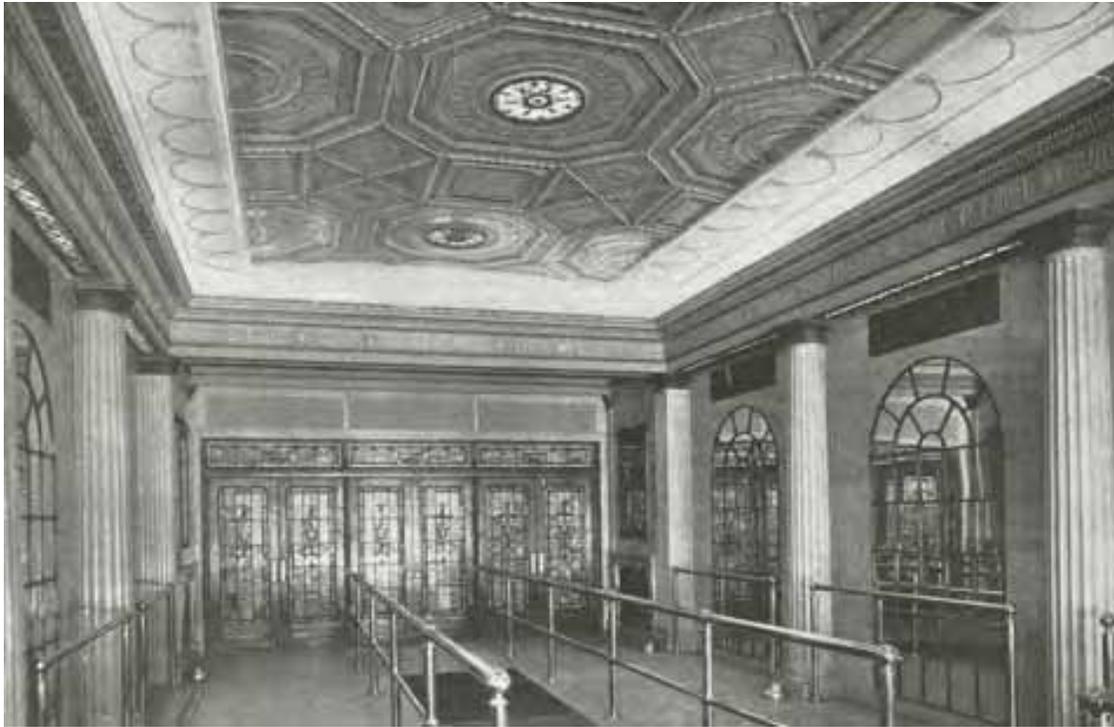
Figure: 68 Location: Lobby

Archival photo c. 1918. Alterations removed the arched mirrors, pilasters, columns, cove lighting, illuminating panels at the perimeter soffit and ceiling (except center panel), railings, flooring and stained glass doors separating the lobby and foyer.

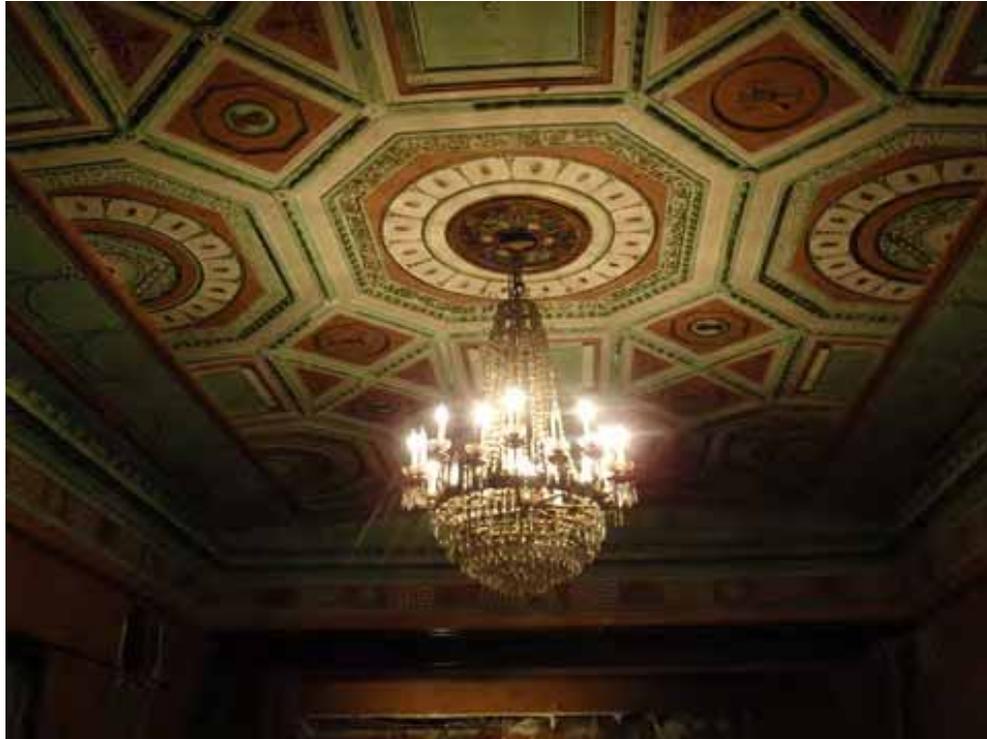
Figure: 69 Location: Lobby

The PACA report noted the presence of the candelabrum but could not determine if it was original or a replica. Figure 68 indicates that a chandelier was not originally installed at this location.

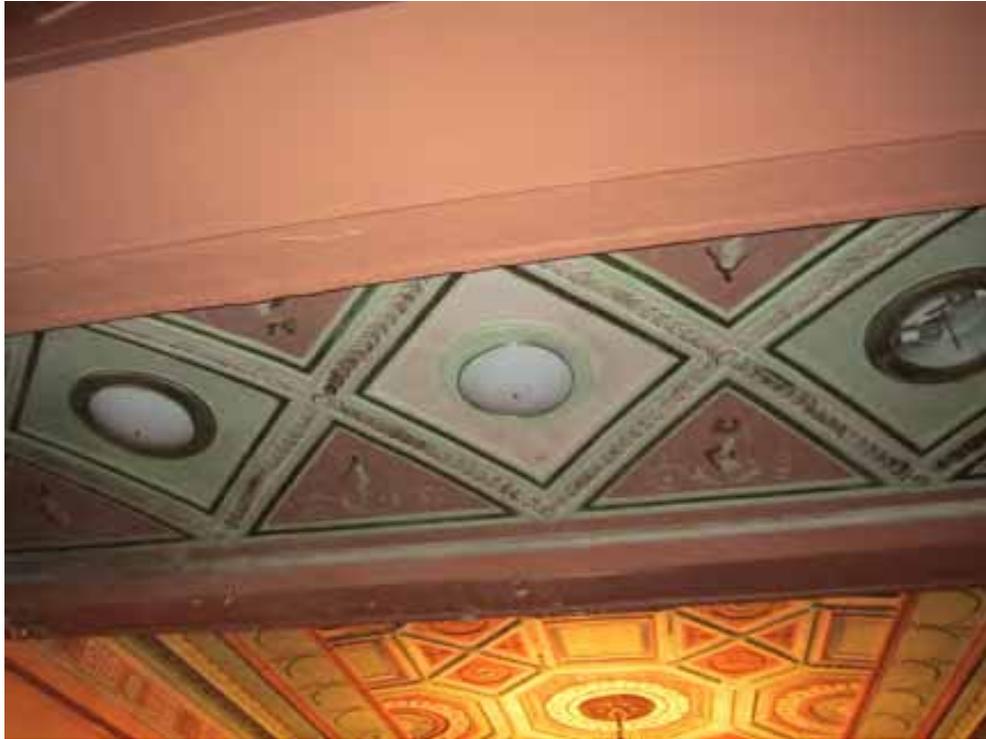
Figure: 74 Location: Lobby

Recessed ceiling light fixtures typical at both ends of lobby. The PACA report did not identify this lighting. Archival drawings suggests that the fixtures would have originally been illuminating panels.

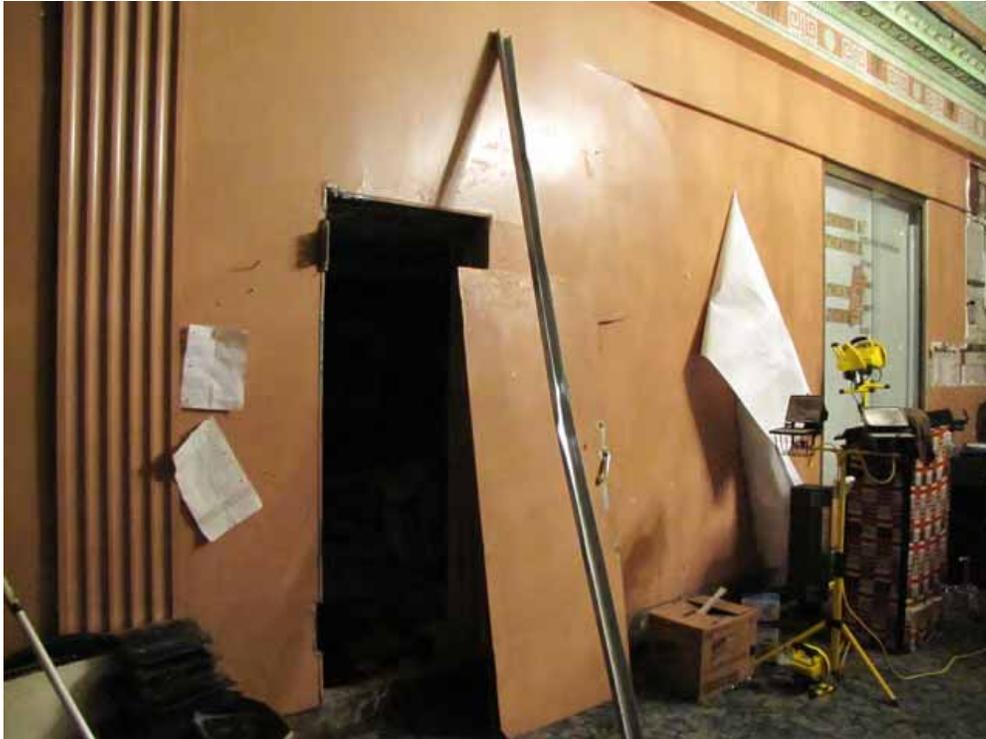
Figure: 75 Location: Lobby

Existing door opening marks original location of ticket office in archival drawings. The door frame and adjacent finishes are modern. Figure 67 shows the door behind the ticket booth at this location to be an arched mirror.

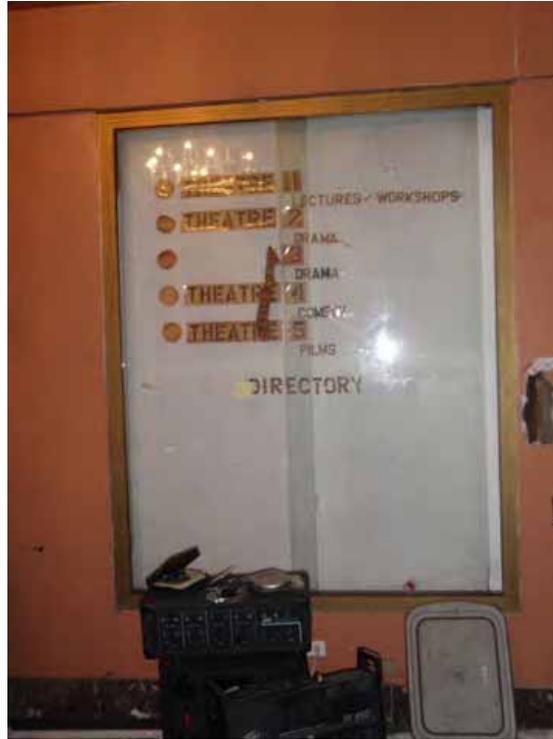
Figure: 76 Location: Lobby

The PACA report noted that the vitrine frames were an earlier finish and were painted gold. These vitrines are not shown in archival drawings and were likely installed during building alterations. See Figure 67.

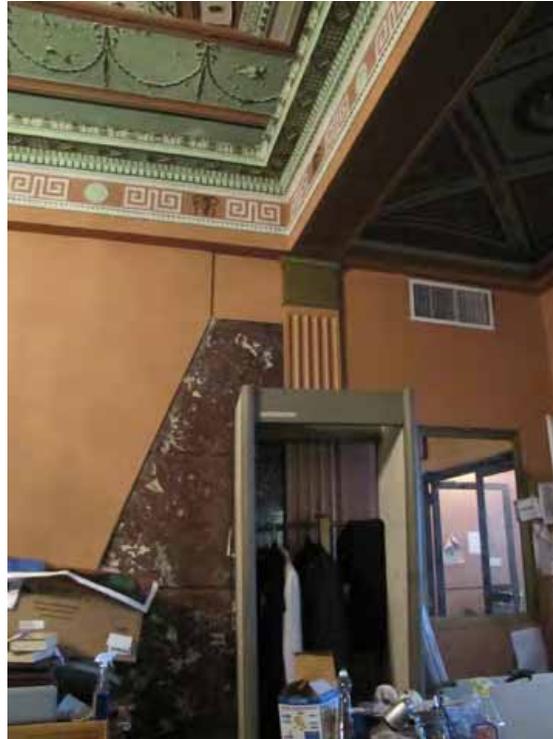
Figure: 77 Location: Lobby

The engaged pilasters visible in the lobby are composed of wood and were installed during previous building alterations. As noted in the PACA report, the flat wall surfaces were built up with fire blocks and gypsum wallboard during previous alterations.

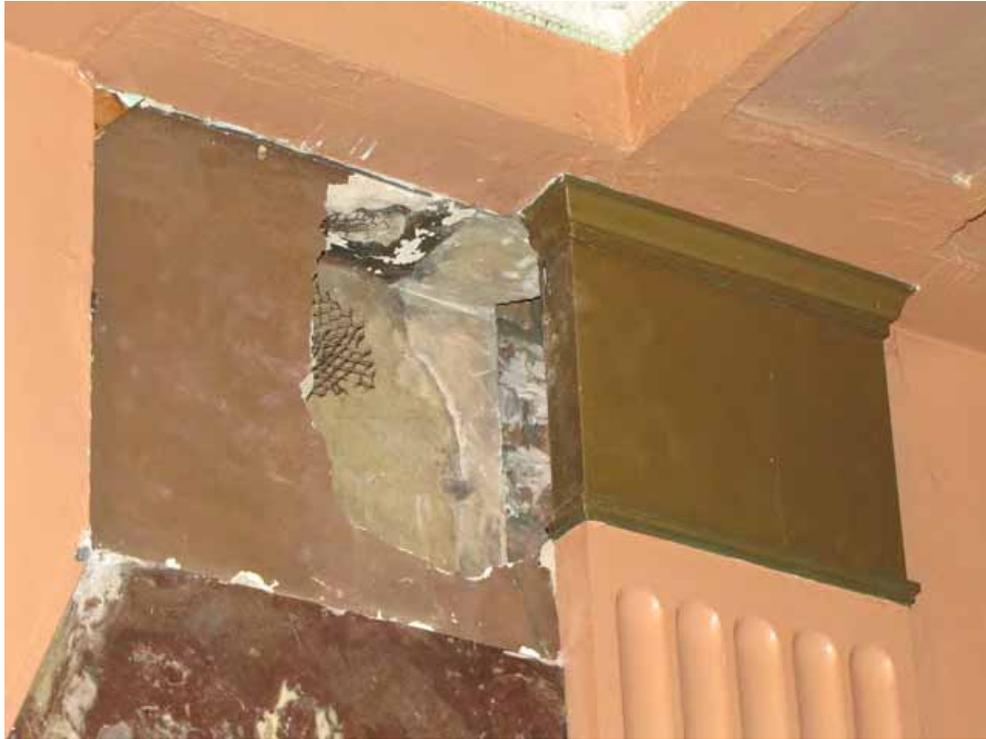
Figure: 78 Location: Lobby

BCA Probe 10A revealed the profile of the original capital of the south pilaster left by soiling on the historic east wall. The original pilaster was installed at approximately the same location but was much deeper.
