ALTERNATIVES ANALYSIS WITH BCA CONDITIONS ASSESSMENT UPDATE

**VICTORIA THEATER
235-237 WEST 125TH STREET
NEW YORK, NY
ALTERNATIVES ANALYSIS**

Conditions Assessment Update

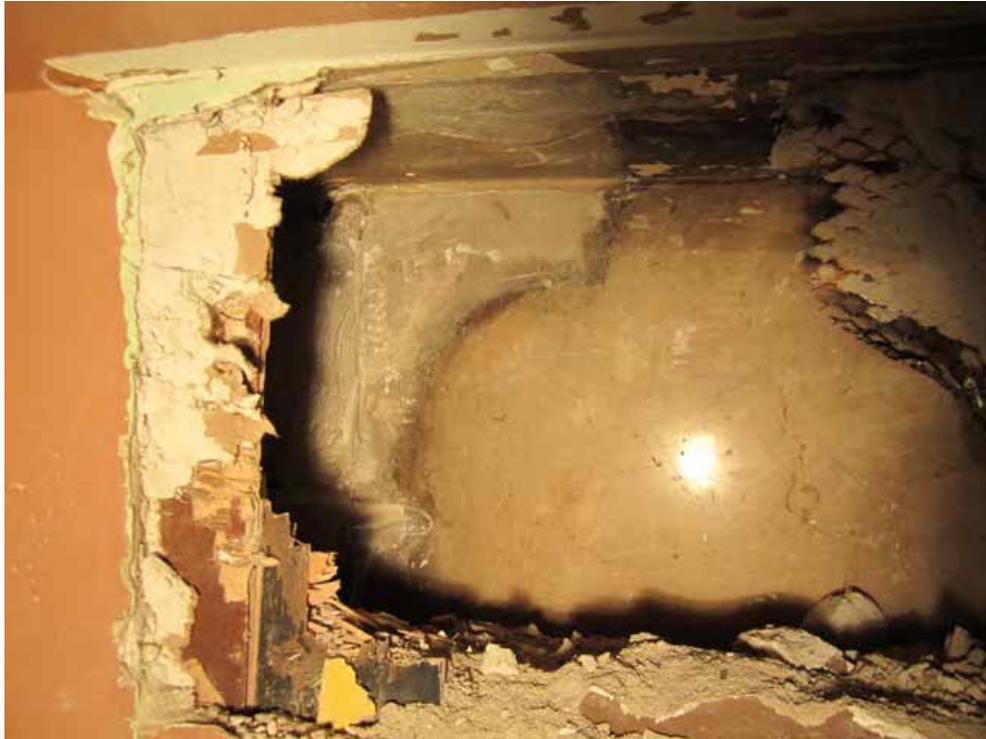
Figure: 79 Location: Lobby

BCA Probe 10B. Archival drawings indicate a total of four engaged columns were originally installed on both the east and west walls of the lobby. This probe revealed the profile of a column capital left by soiling on the historic east wall.

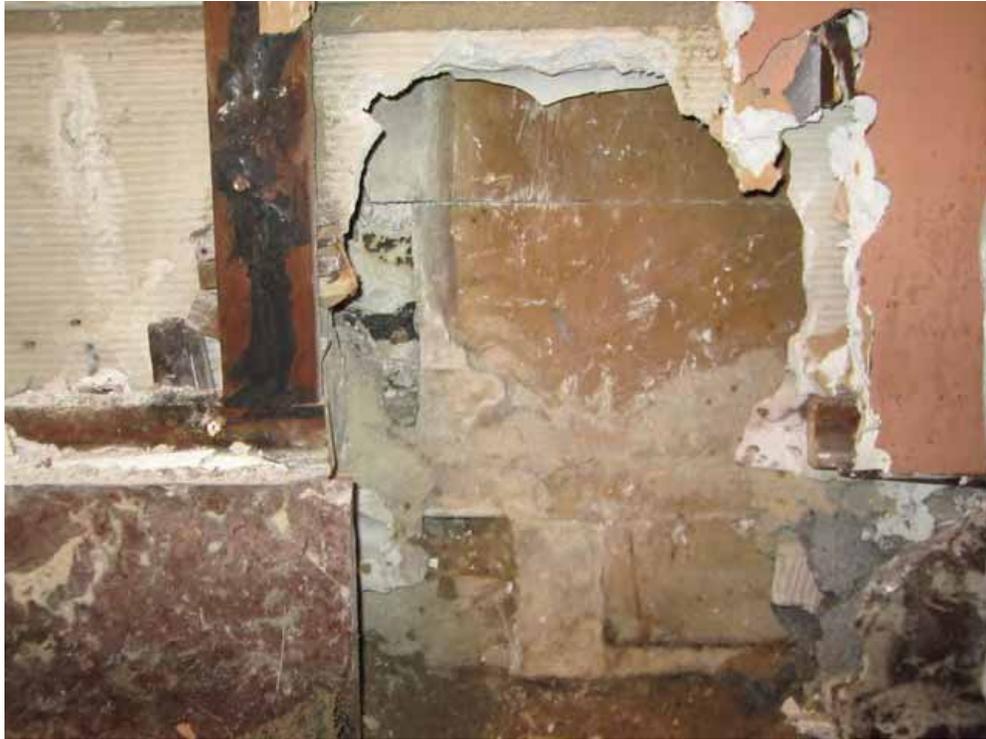
Figure: 80 Location: Lobby

BCA Probe 10C. Archival drawings indicate a total of four engaged columns were originally installed on both the east and west walls of the lobby. This probe revealed the profile of a column base left by soiling on the historic east wall.

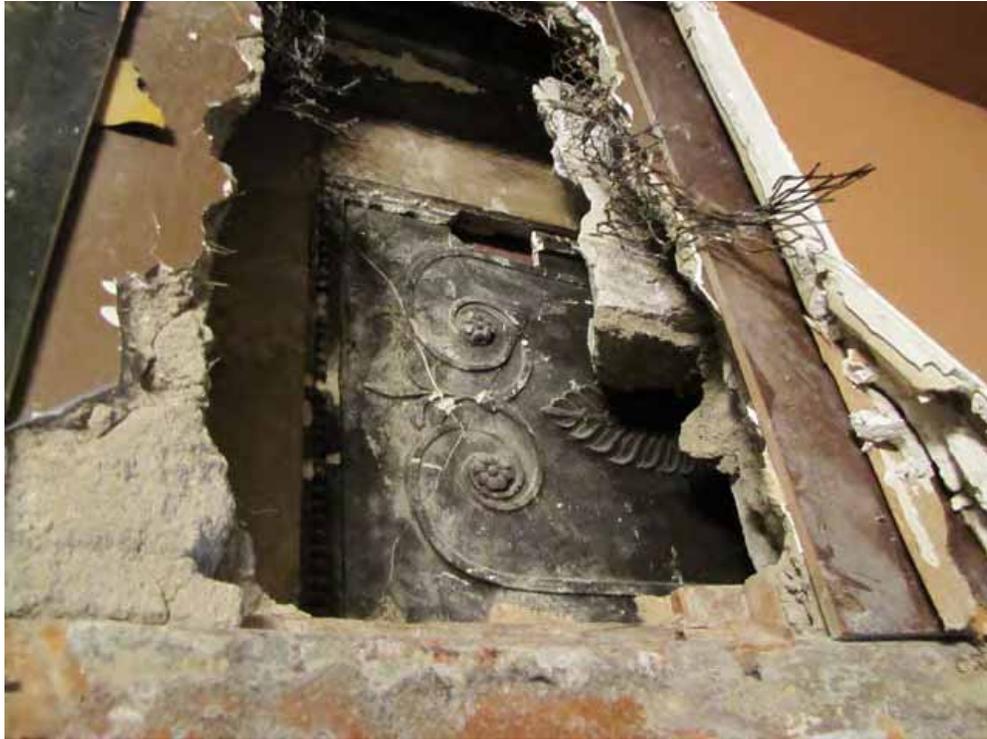
Figure: 82 Location: Lobby

BCA Probe 10D revealed the location of one of the decorative panels originally installed above the arched mirror. See Figure 67 for the configuration of these panels.

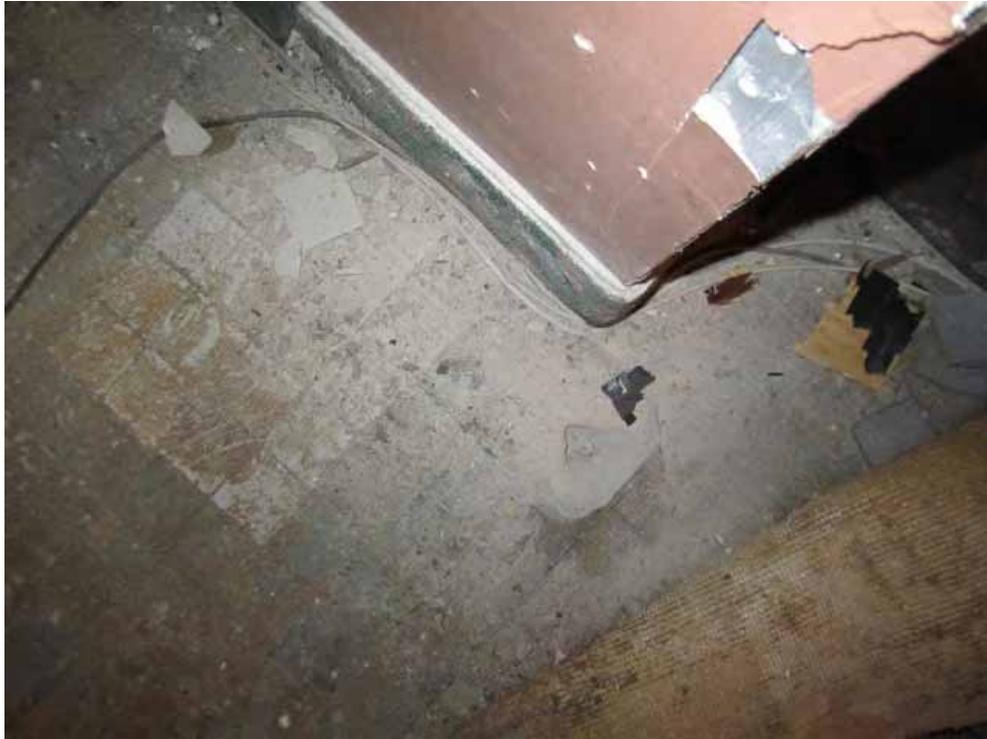
Figure: 83 Location: Lobby

BCA Probe 9 removed a section of the carpet at the southwest corner of the lobby. The probe revealed tiles, which were installed as part of the building alterations. The original flooring is no longer extant.

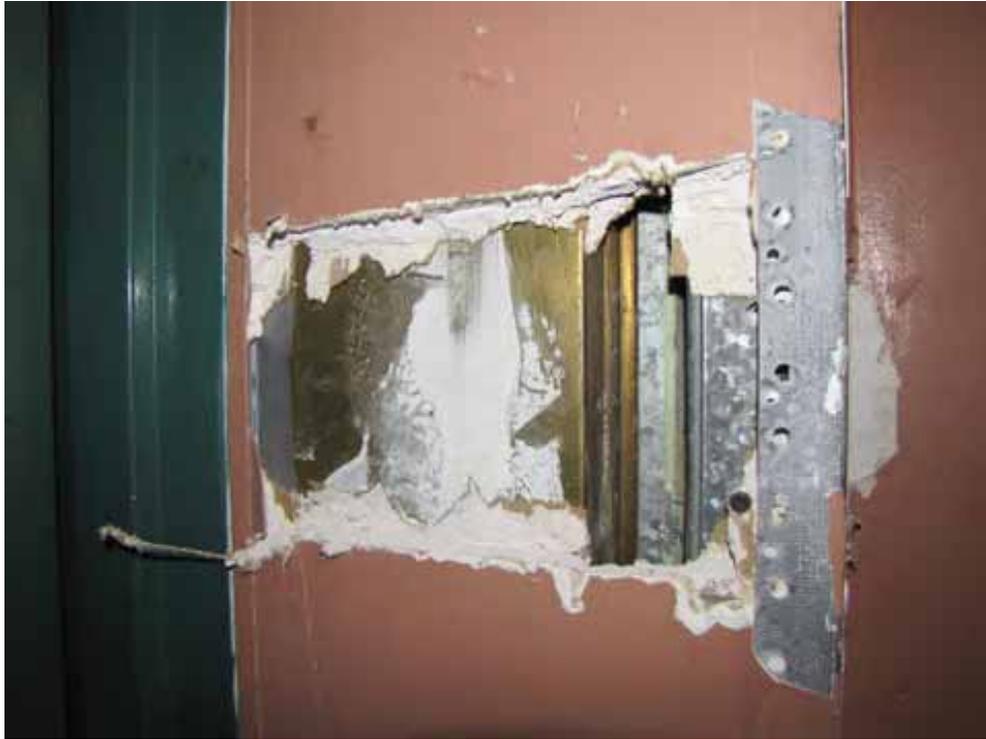
Figure: 84 Location: Lobby

BCA Probe 7A revealed a copper alloy frame at the entrance doors between the lobby and existing ticket booth, abutting the west wall. Construction at this wall indicates that this frame was not original.

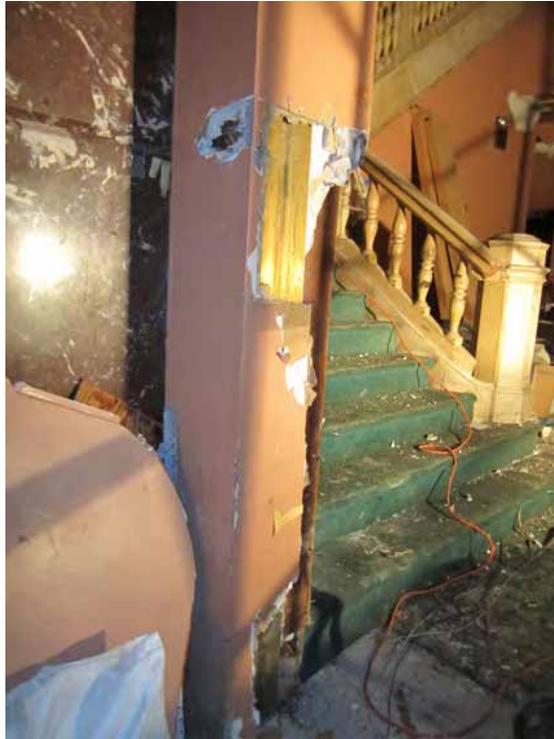
Figure: 85 Location: Lobby

BCA Probe 11A revealed a copper alloy frame at the doors that were once located between the lobby and foyer. Construction at this wall indicates that this frame was not original. Figure 68 shows copper and leaded glass doors originally in this location.

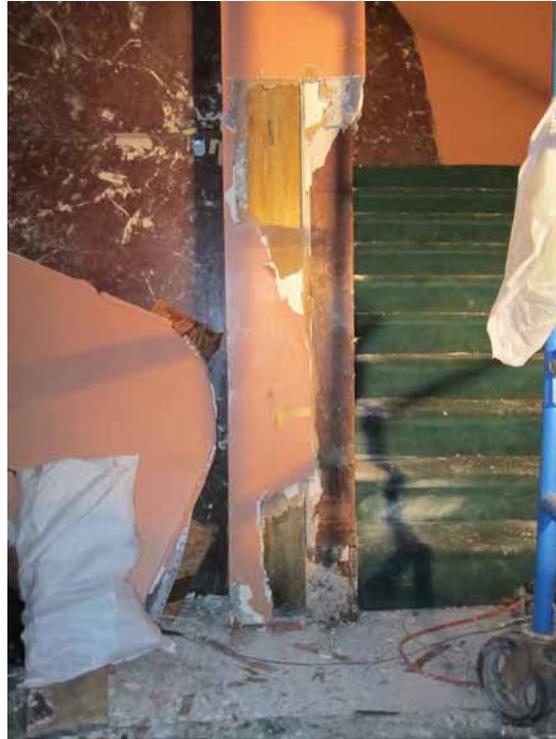
Figure: 86 Location: Lobby

BCA Probe IIA shows the west end of the non-original copper alloy door frame between the lobby and foyer. The finishes visible to the right of the frame were built-up during previous alterations.

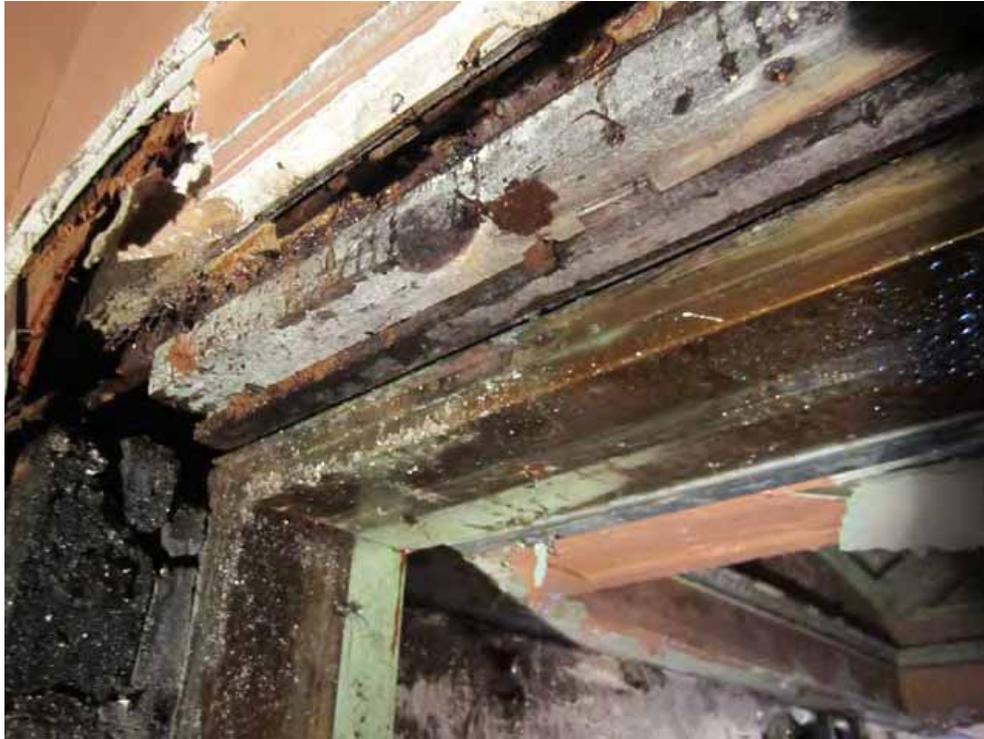
Figure: 87 Location: Lobby

BCA Probe IIA revealing the east end of the non-original copper alloy door frame between the lobby and foyer. Water infiltration is ongoing at this location. The PACA report did not identify water damage in this area.

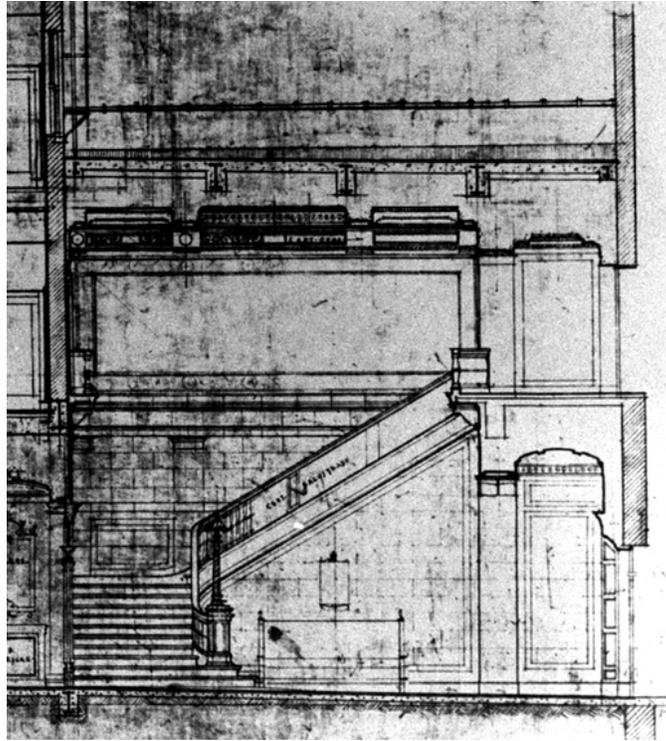
Figure: 88 Location: Foyer

Archival drawings of the foyer looking east show imitation Caen stone joints on the lower foyer walls. The upper portions of the walls are currently covered with mirrors.

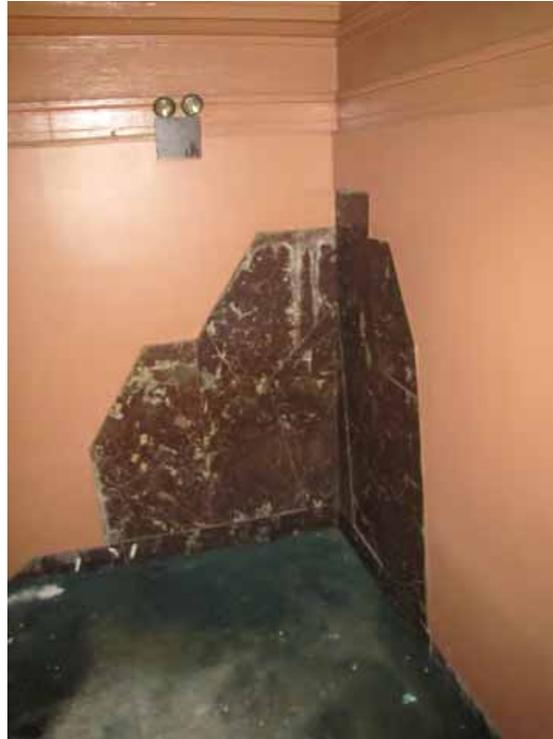
Figure: 89 Location: Foyer

Marble inset at southwest corner. The marble is typical of that found in the vestibule, ticket booth, and lobby. The PACA report noted this was an earlier finish.

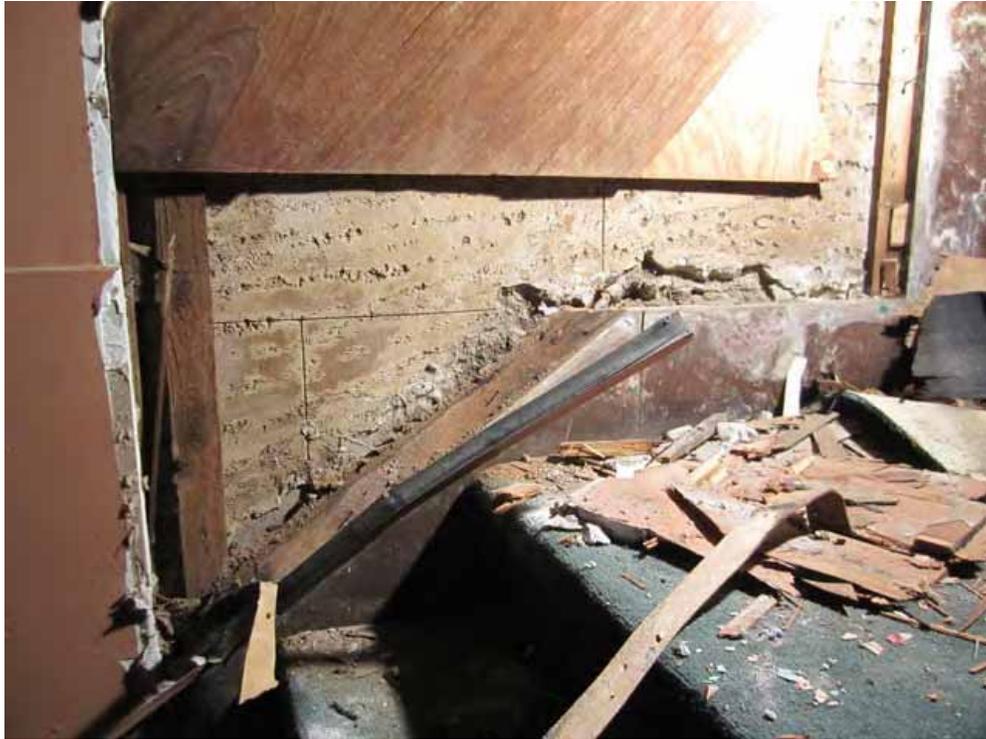
Figure: 90 Location: Foyer

BCA Probe 12 revealed wood boards directly behind the gypsum wallboard; these were installed during earlier alterations. Removal of the wood boards revealed the original imitation Caen stone walls (faux stone walls produced with plaster).

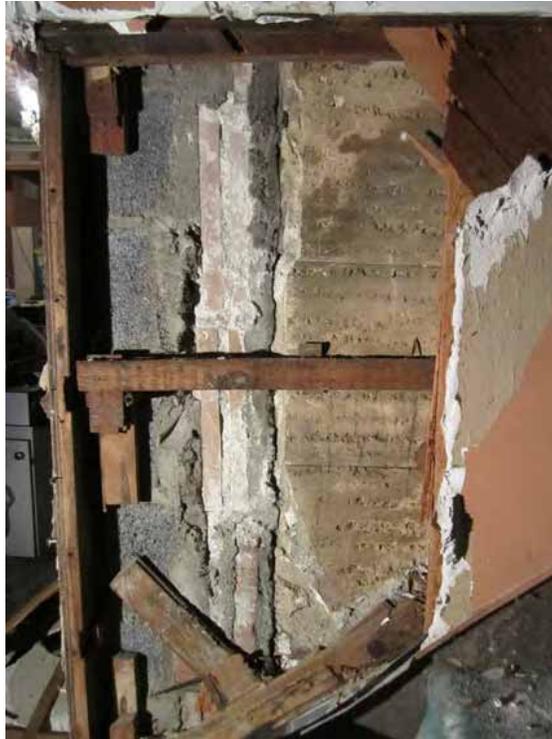
Figure: 91 Location: Foyer

BCA Probe 11B revealed the original imitation Caen stone on the south wall of the foyer. Note the layers of built-up finishes over the Caen stone at the wall return (left side of the image).

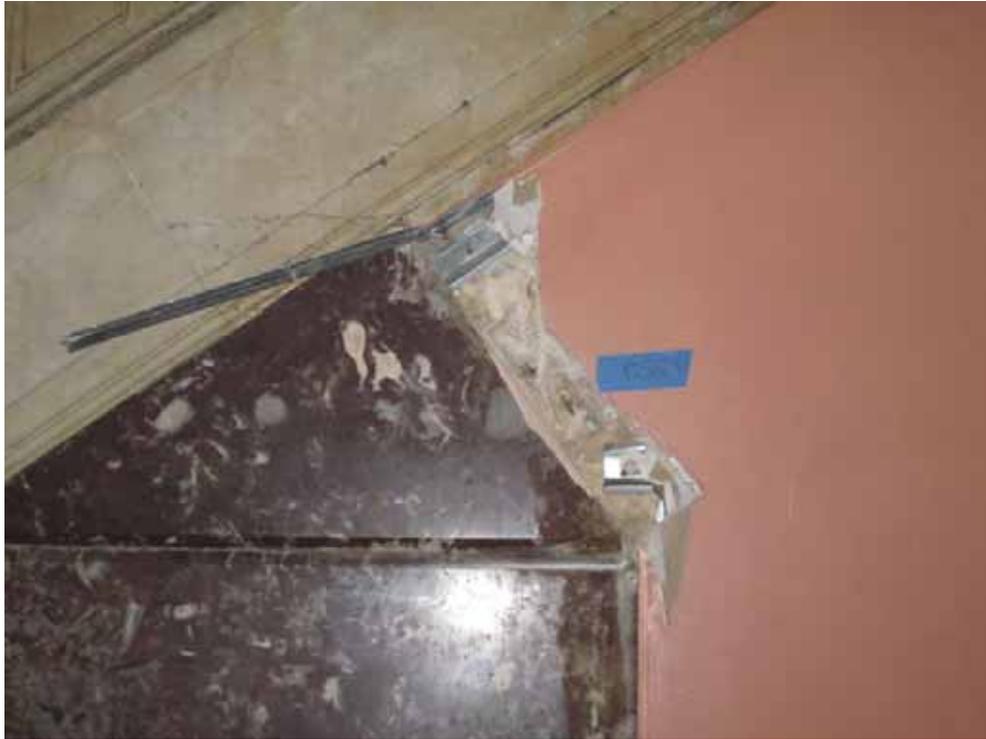
Figure: 92 Location: Foyer
BCA Probe 13A revealed the original imitation Caen stone wall under modern finishes below the stair face stringer.

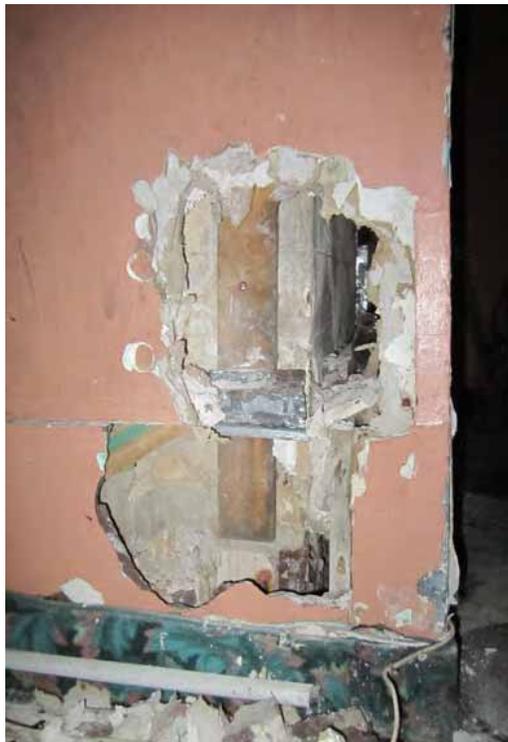
Figure: 93 Location: Foyer
BCA Probe 13B revealed the original imitation Caen stone wall below the stairs. Note the layers of built-up finishes over the imitation Caen stone at the wall return (right side of the image).

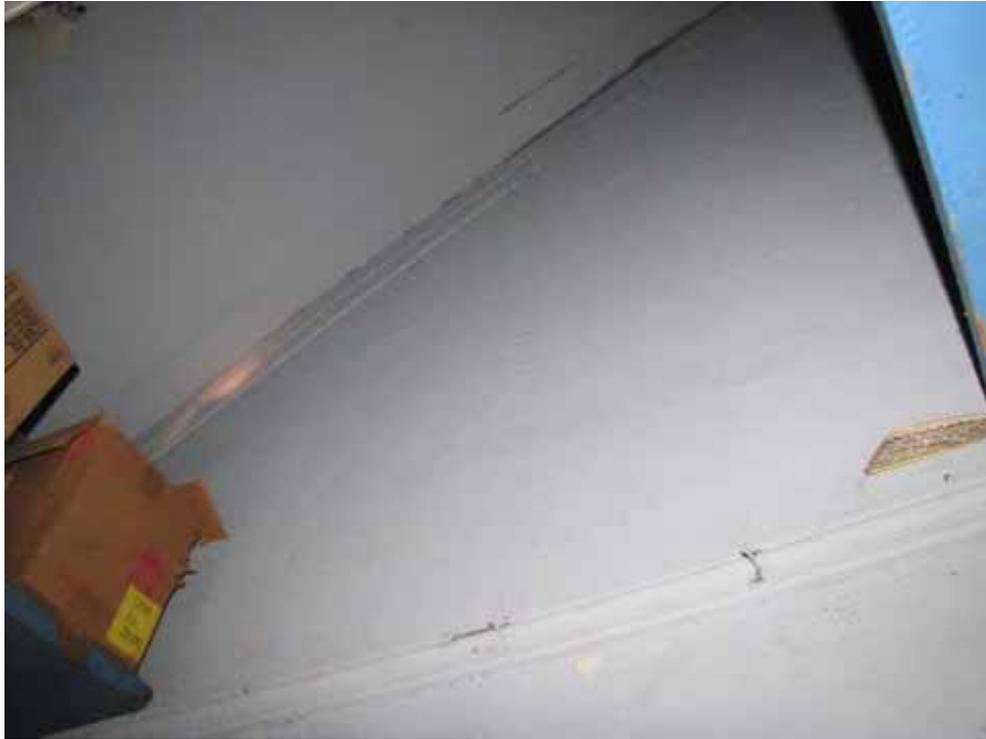
Figure: 94 Location: Foyer
The faux joints of original imitation Caen stone are visible through the paint on the west wall of the closet under the stairs.

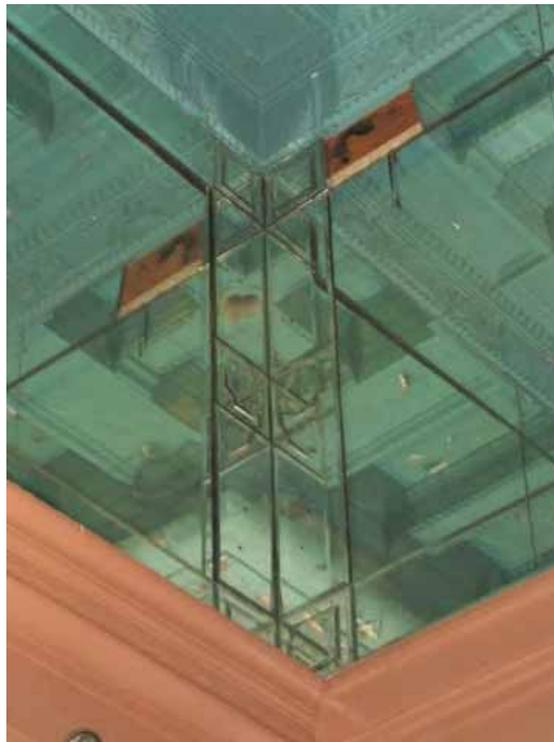
Figure: 95 Location: Foyer
As noted in the PACA report, mirrors are applied to the upper west half of the foyer walls. These mirrors include raised decorative sections. Some mirror panels are visibly detached and missing; the PACA report did not note this condition.

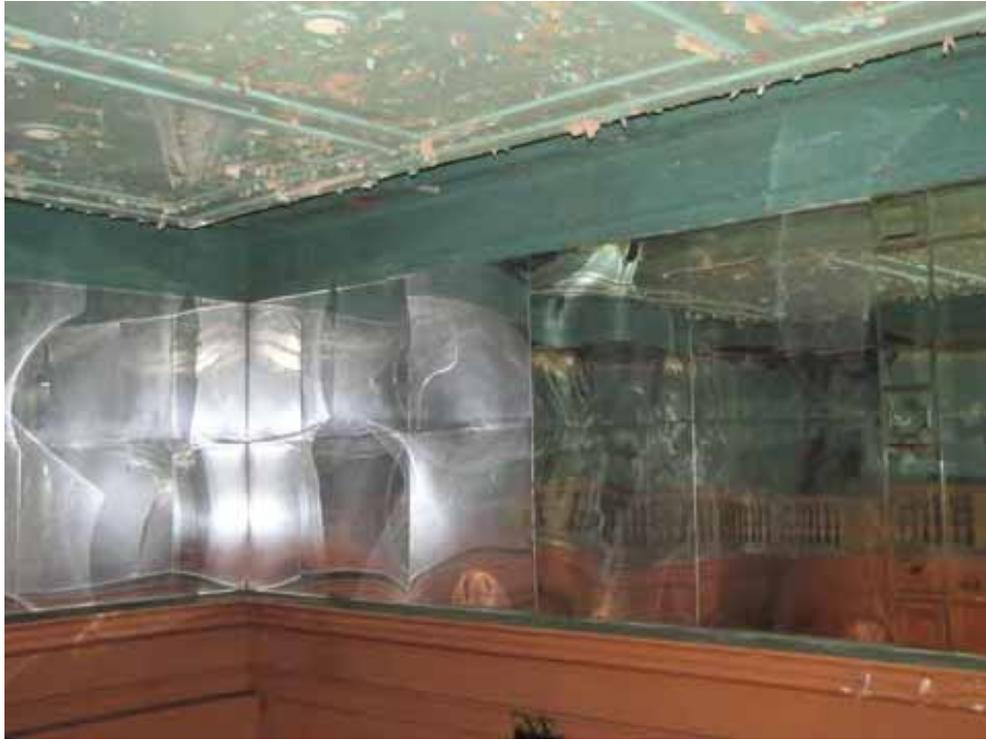
Figure: 96 Location: Foyer

Unlike the west half of the foyer, mirrors applied to the upper east half are flat panels, without decorative elements.

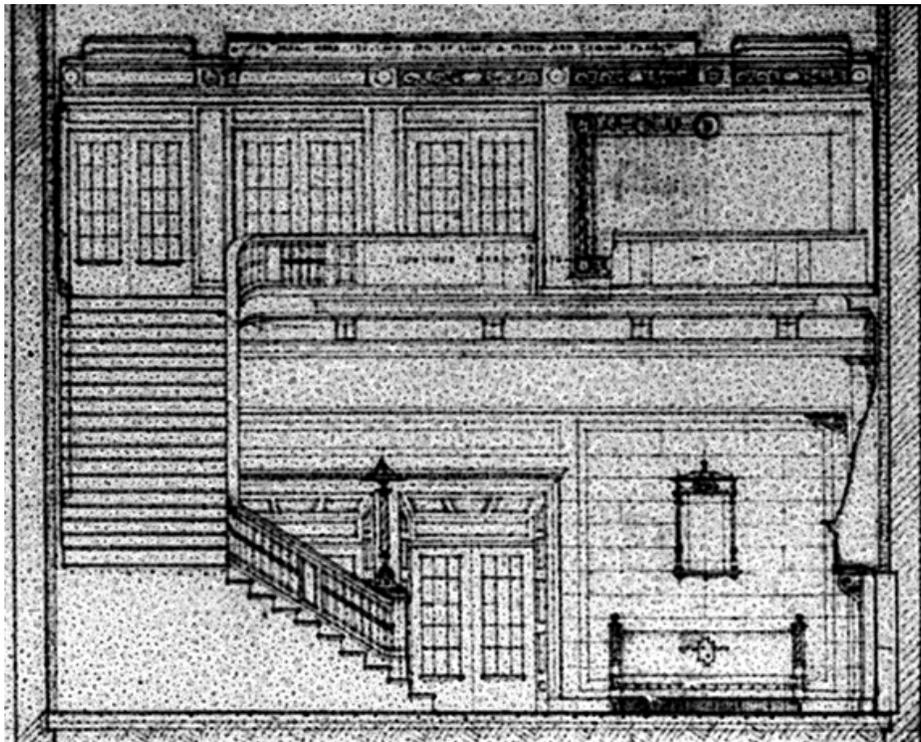
Figure: 97 Location: Foyer

Archival drawings of the north wall of the lobby show a decorative light fixture mounted on the top of the newel post at the bottom of the stairs. See Figure 98 for the current configuration of the newel post.

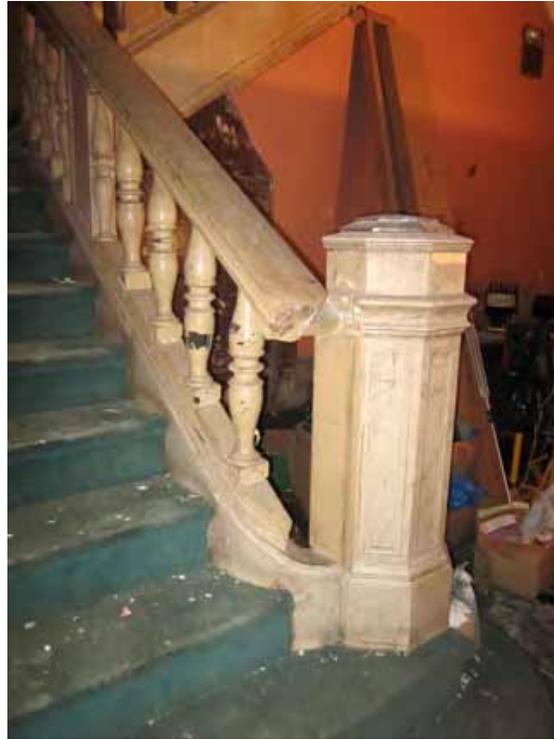
Figure: 98 Location: Foyer

The PACA report noted the grand staircase to be very steep. In actuality, the stair treads measure between 10-3/4" to 10-7/8" and risers measure between 7-1/8" to 7-1/4".

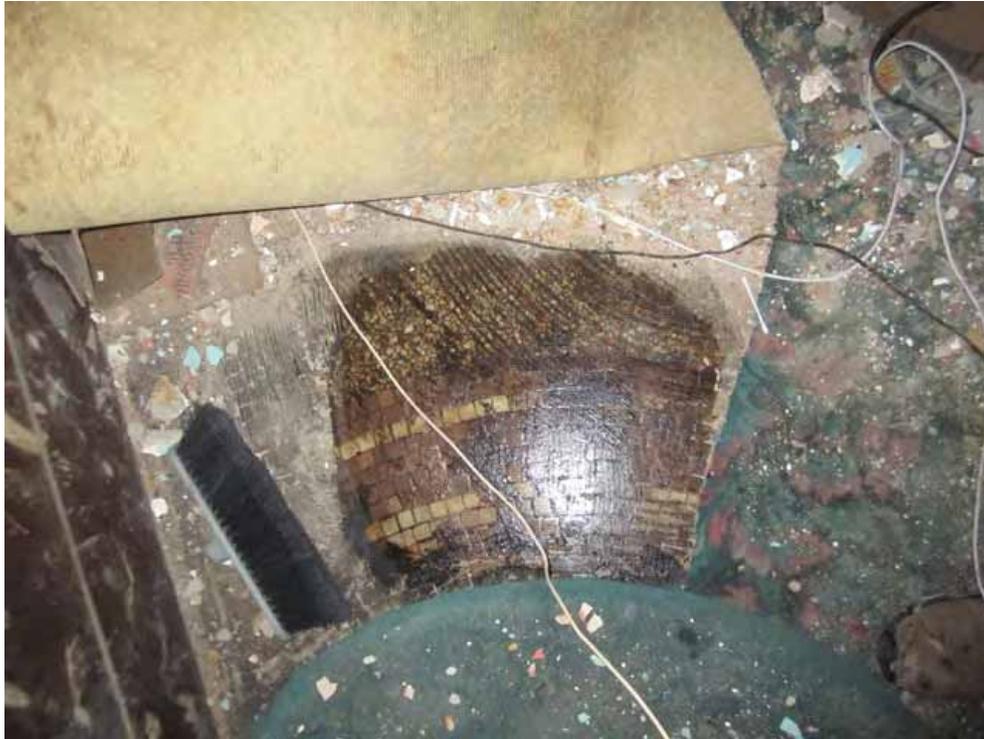
Figure: 99 Location: Foyer

BCA Probe 14 removed carpet near the stair. As noted in the PACA report, the original terrazzo and tile flooring exists under the carpet. BCA stripped a small section of mastic from the floor finishes. The condition of the entire floor is undetermined.

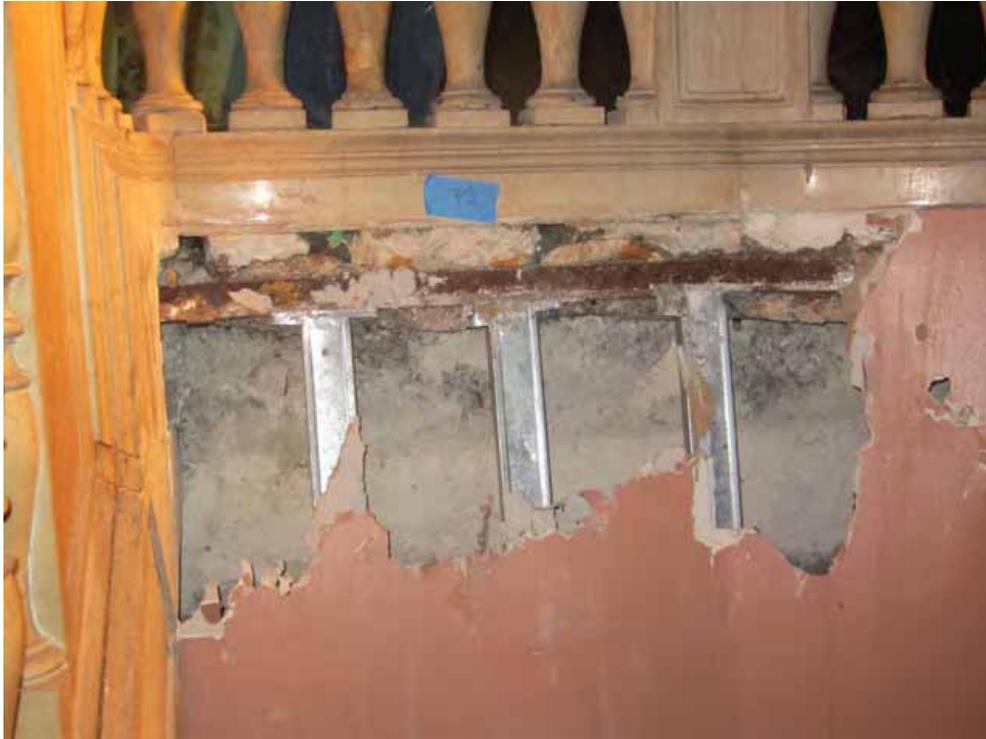
Figure: 101 Location: Foyer

BCA Probe 1, located at the west side of the balcony, reveals the decorative bracket below the balustrade was removed in an earlier alteration, however the profile is still visible from soiling on the marble stair stringer. See Figure 104.

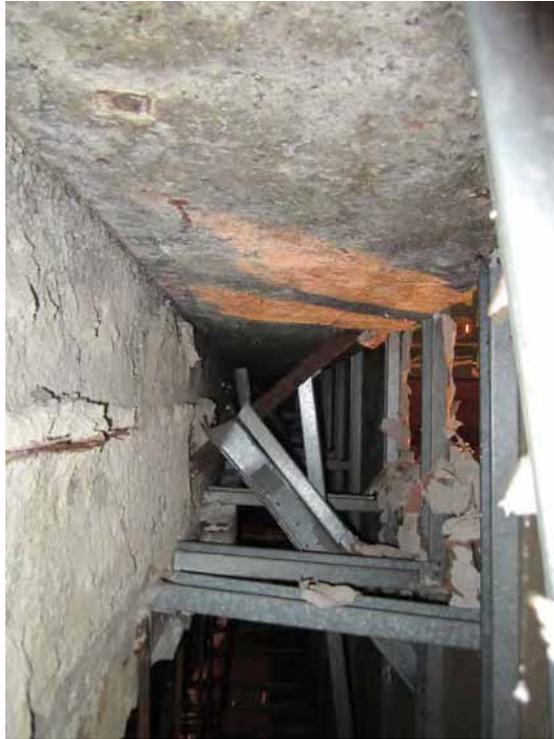
Figure: 102 Location: Foyer

BCA Probe 1, view looking east under the projecting balcony. This probe revealed that no historic finishes remain under the balustrade above.

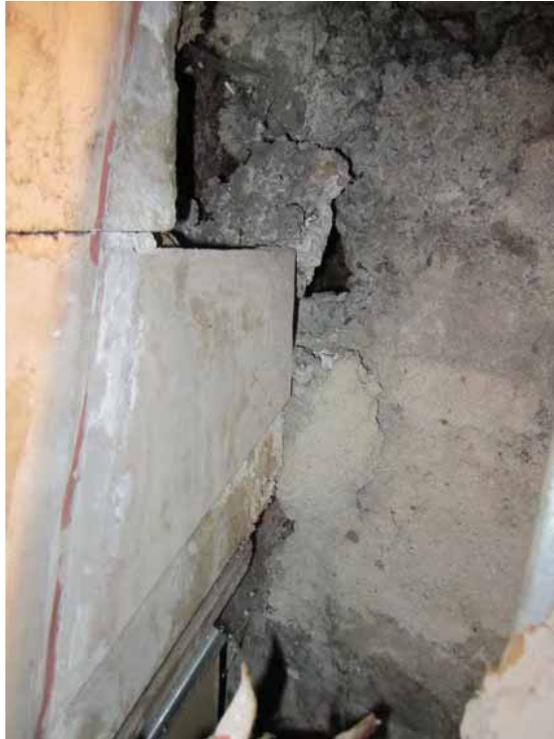
Figure: 103 Location: Foyer

BCA Probe 1 revealed the intersection of the marble finish wall below the stairs and the concrete beneath the balcony.

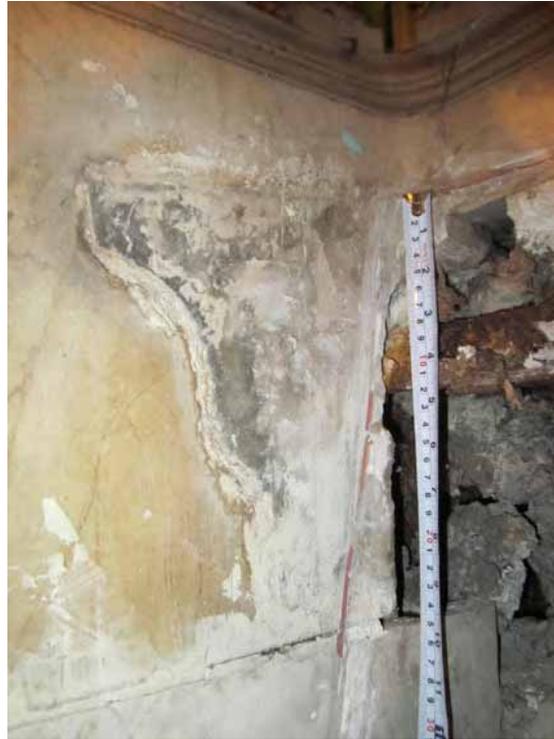
Figure: 104 Location: Foyer

BCA Probe 1 revealed the profile of a removed decorative bracket located under the balcony, abutting the stairs. Corroded steel is visible at the base of the balcony, on the right side of the image.

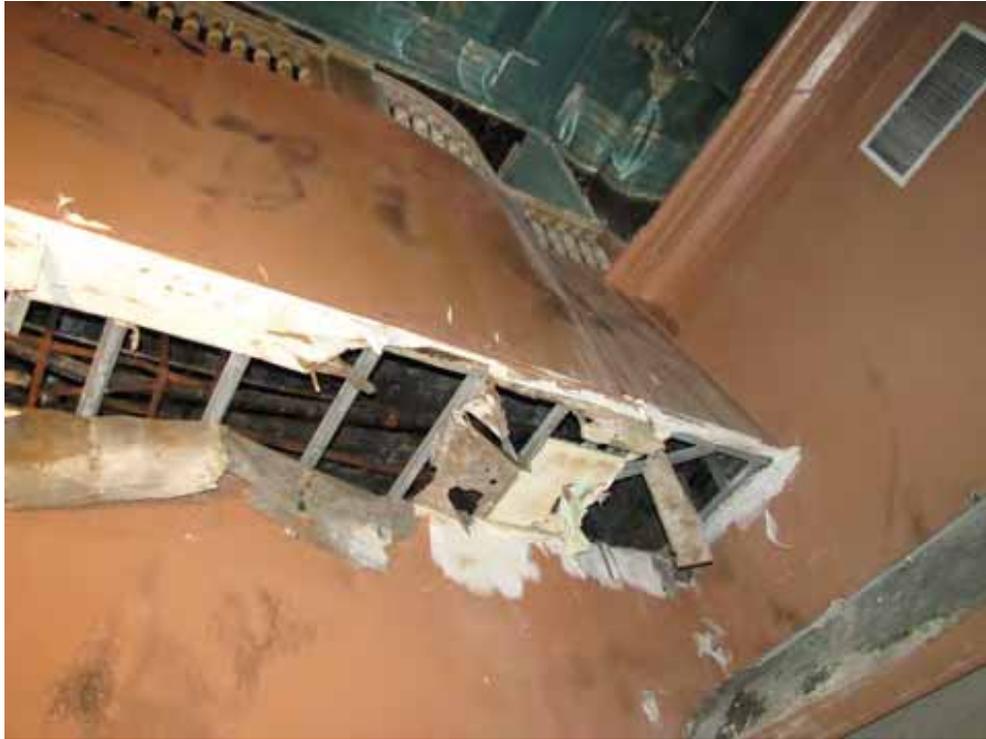
Figure: 108 Location: Foyer

Damage from water infiltration at the underside of the balcony, where modern finishes at the ceiling have fallen. Mold is visible on the walls. The PACA report did not identify damage in this area.

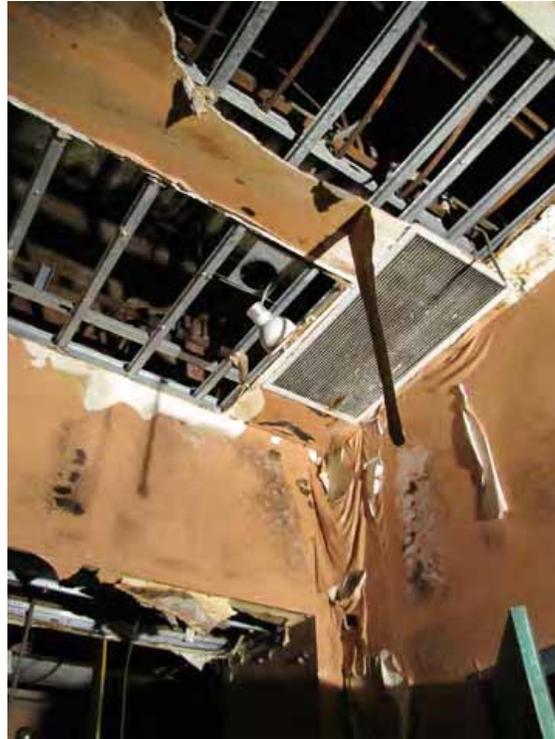
Figure: 109 Location: Foyer

Ongoing water infiltration below the balcony, at the entrance to the north building. Ceiling finishes have fallen and the ferrous armature above is corroded. Mold is visible on the walls. The PACA report did not identify damage in this area.

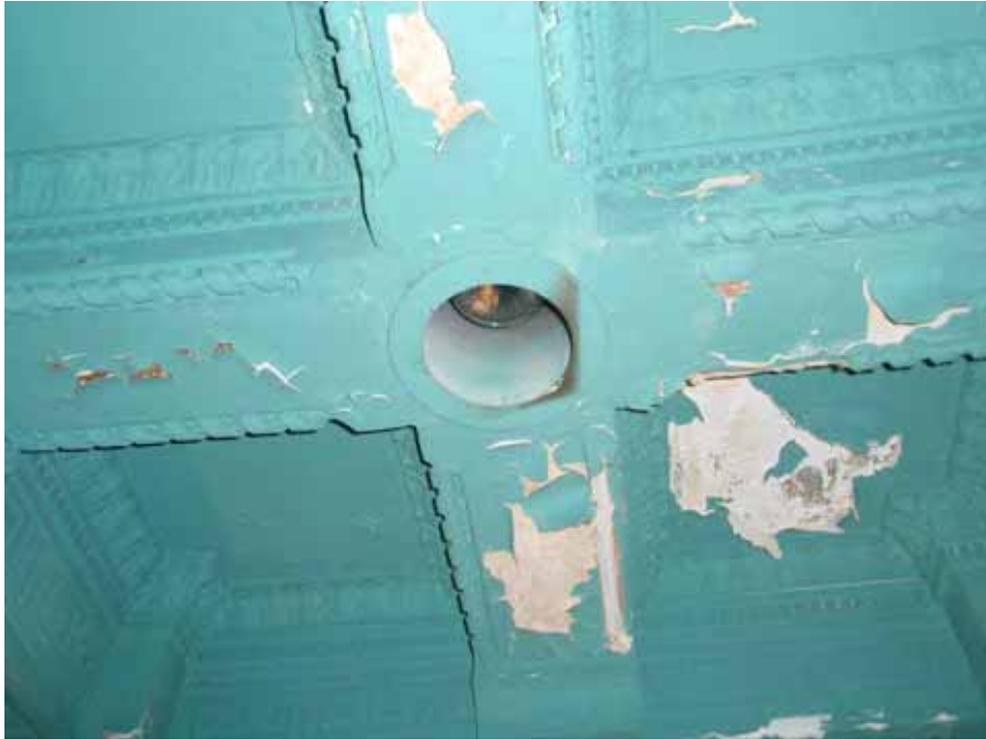
Figure: 110 Location: Foyer

The PACA report noted there are no light fixtures in the Foyer, however recessed fixtures are located in the center suspended ceiling panel as well as in ceiling coffers. Archival drawings suggest these lights were added during building alterations.

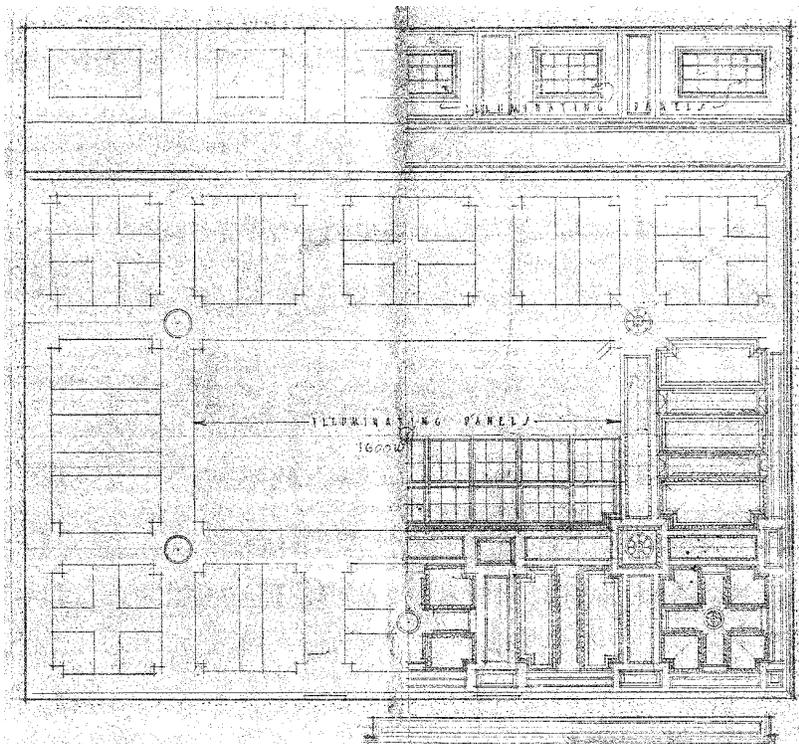
Figure: 111 Location: Foyer

Archival drawings indicate a large illuminating panel was initially installed at the center of the ceiling. Similarly, five smaller panels were located in the coffers over the balcony.

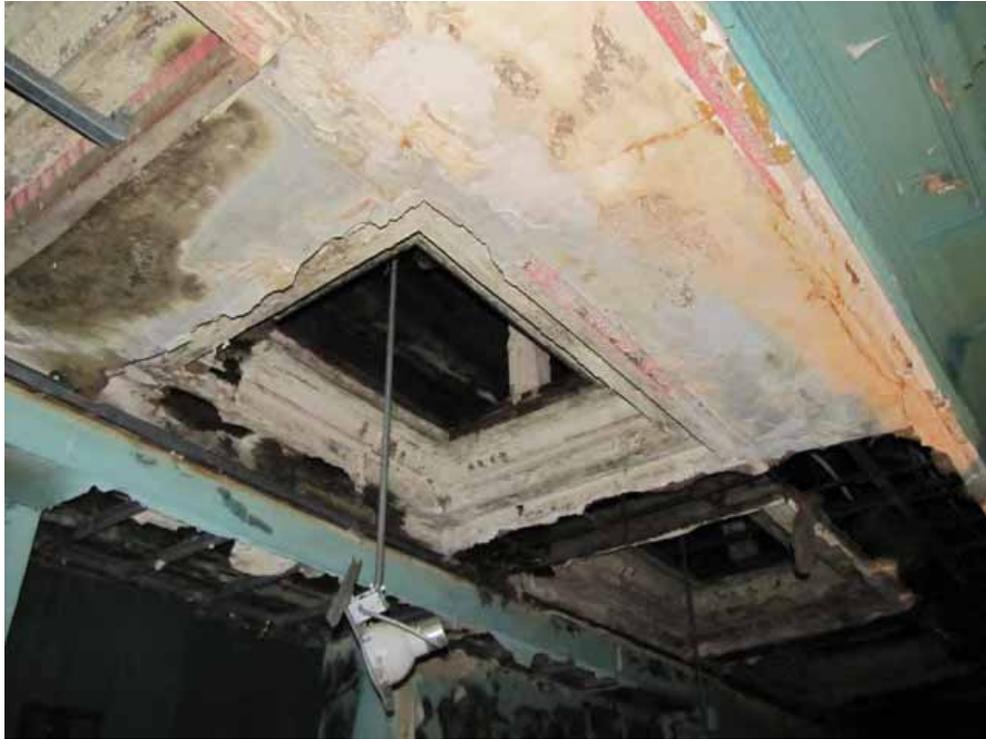
Figure: 112 Location: Foyer

Figure 111 shows illuminated panels originally located at the center of these coffers above the balcony.

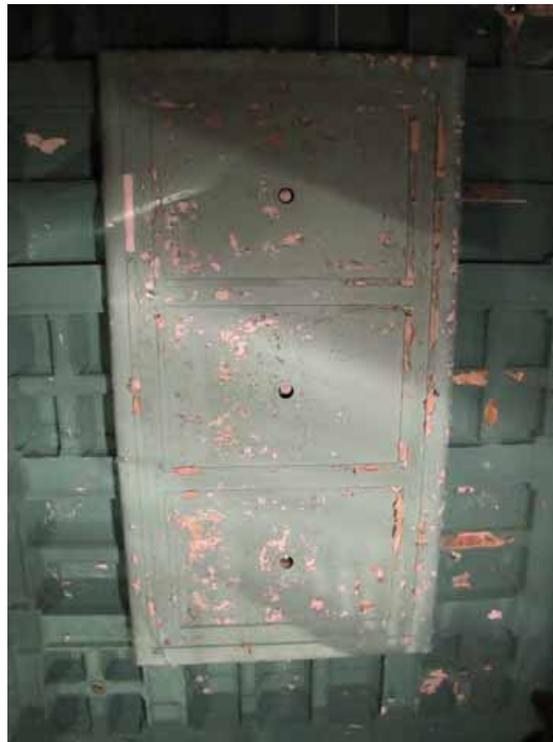
Figure: 113 Location: Foyer

The PACA report suggested the panel at the center of the ceiling was installed due to previous ceiling failure in this area.

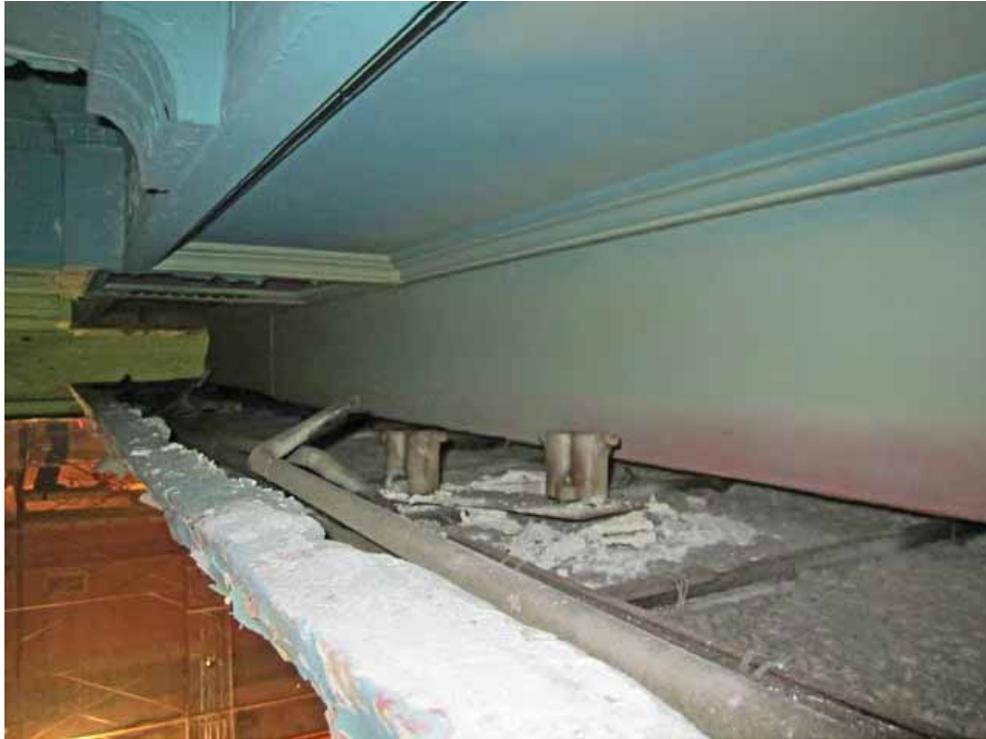
Figure: 114 Location: Foyer

The PACA report identified the large panel suspended from the center of the ceiling to be gypsum board. BCA Probe 2 revealed it to be plaster. The top edge of suspended panel is shown. The frieze between panel and coffered ceiling is visible.

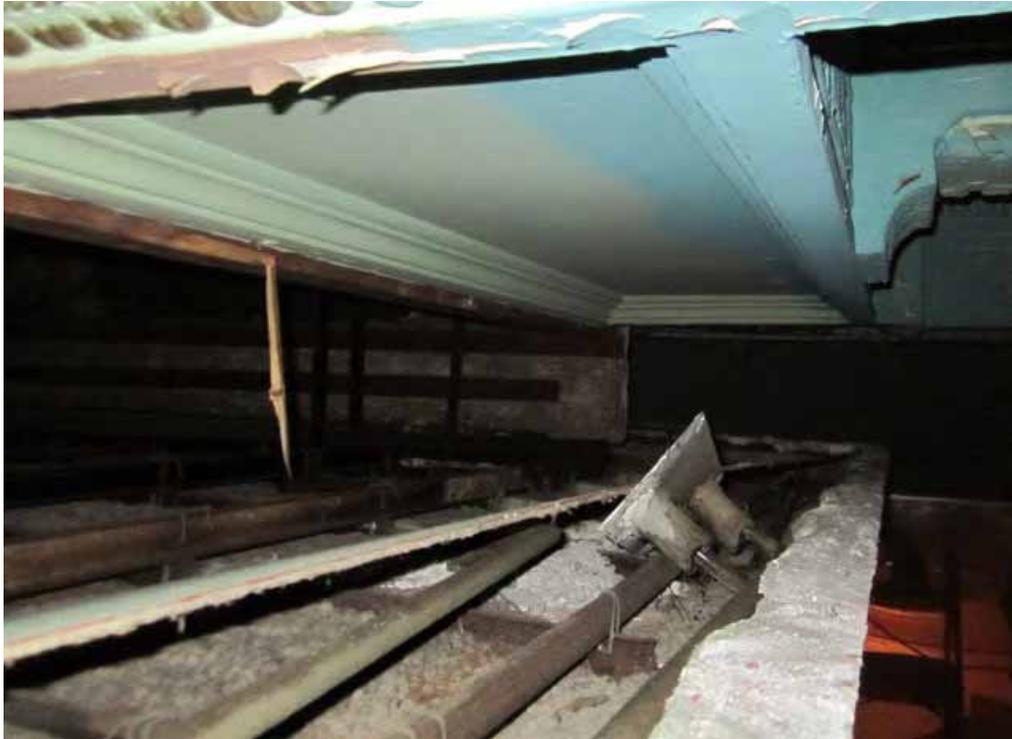
Figure: 115 Location: Foyer

Top edge of suspended plaster panel at center of ceiling. The frieze between panel and coffered ceiling is missing at the south edge, allowing a view of the interstitial space between the panel and ceiling.

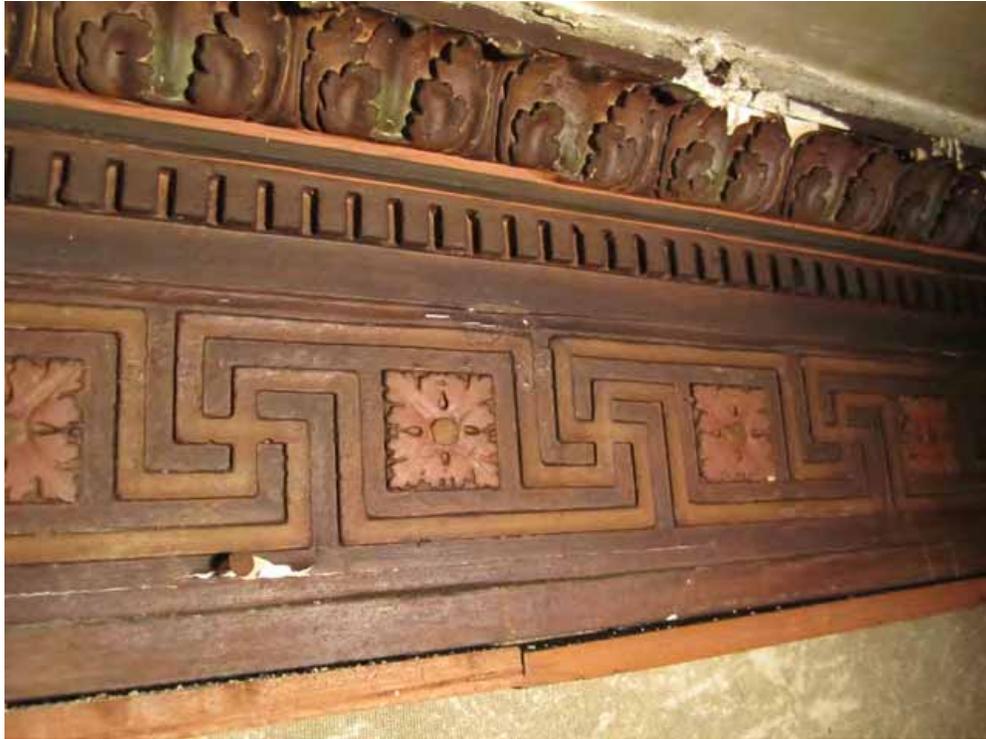
Figure: 116 Location: Foyer

BCA Probe 2 was located through the plaster panel at the center of the ceiling. This probe revealed what appears to be original faux wood finishes on plaster at the perimeter of the large suspended panel.

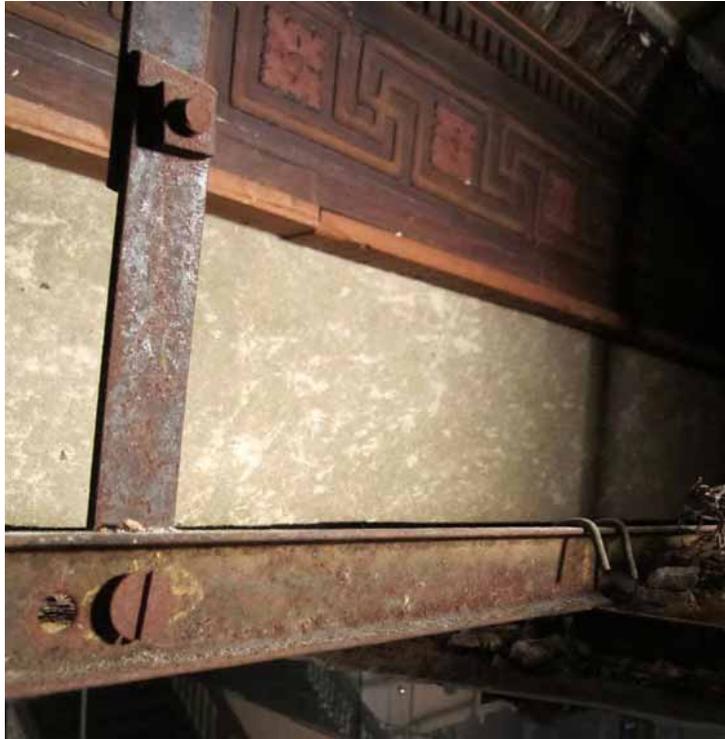
Figure: 117 Location: Foyer

The anchors supporting the plaster ceiling panel are corroding. The PACA report did not describe conditions above the panel.
