ALTERNATIVES ANALYSIS WITH BCA CONDITIONS ASSESSMENT UPDATE

**VICTORIA THEATER
235-237 WEST 125TH STREET
NEW YORK, NY
ALTERNATIVES ANALYSIS**

Conditions Assessment Update

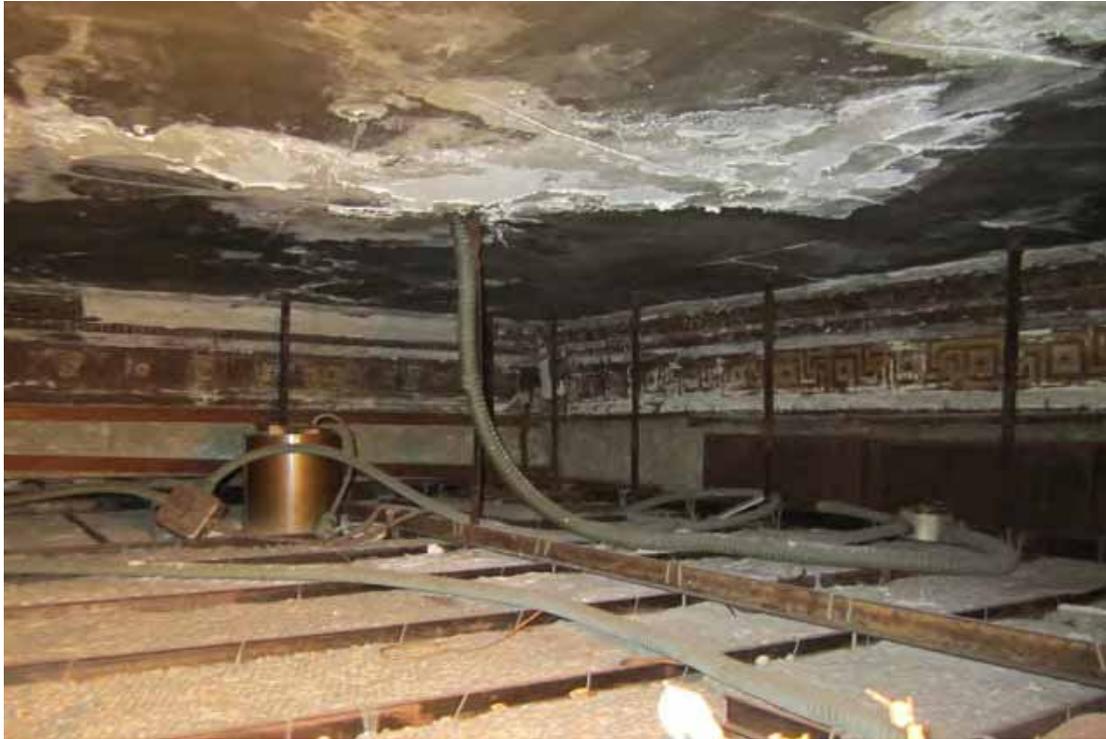
Figure: 118 Location: Foyer

The plaster above the suspended plaster panel exhibits water damage in the form of cracks and efflorescence. Water damage is also visible at the adjacent plaster cornice to the north, west, and east.

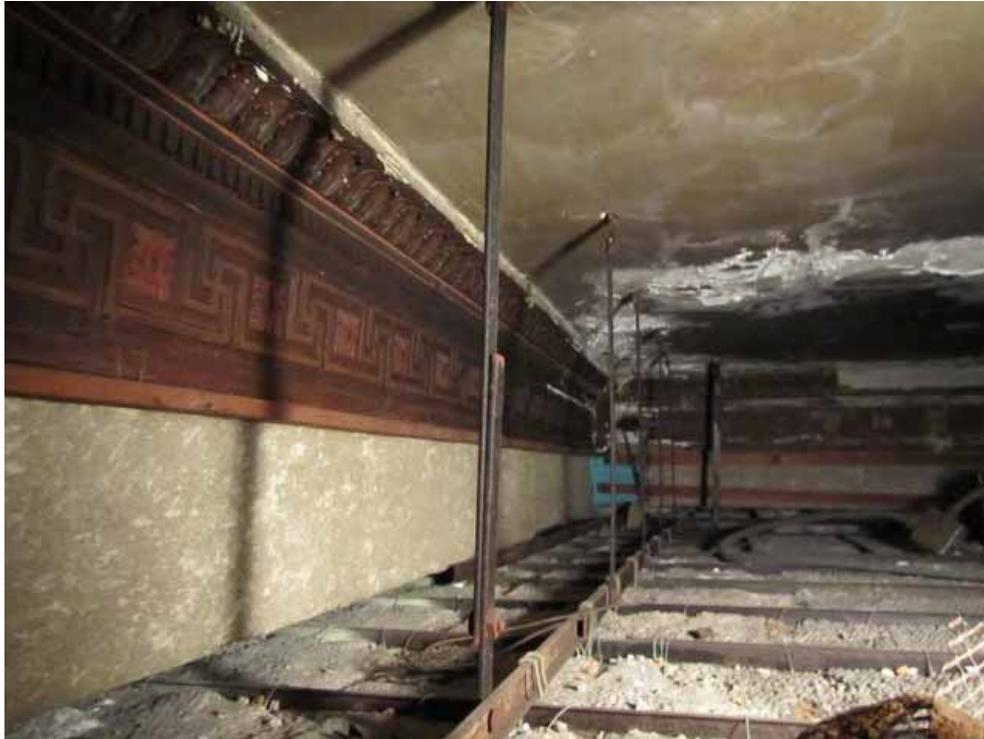
Figure: 119 Location: Foyer

Interstitial space above suspended ceiling panel at center of room. Note decorative faux-wood cornice, the back-side of the frieze between the suspended panel and coffered ceiling, and steel supports anchoring the panel to the structure above.

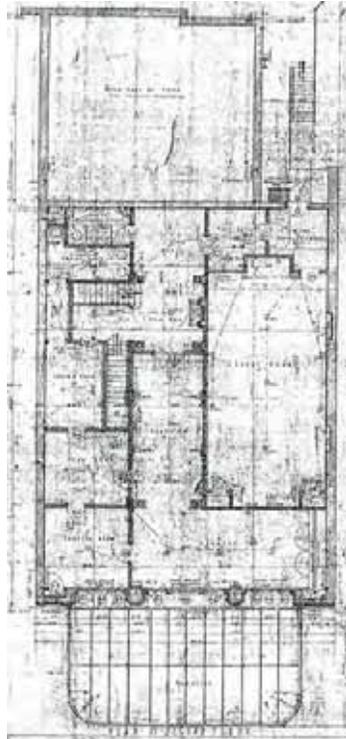
Figure: 120 Location: 2nd Floor

Archival plan of second floor, showing original wall configurations. Most of the partitions and finishes were removed during building alterations. The 2nd floor is now essentially one large room with restrooms and stairs in the northwest corner.

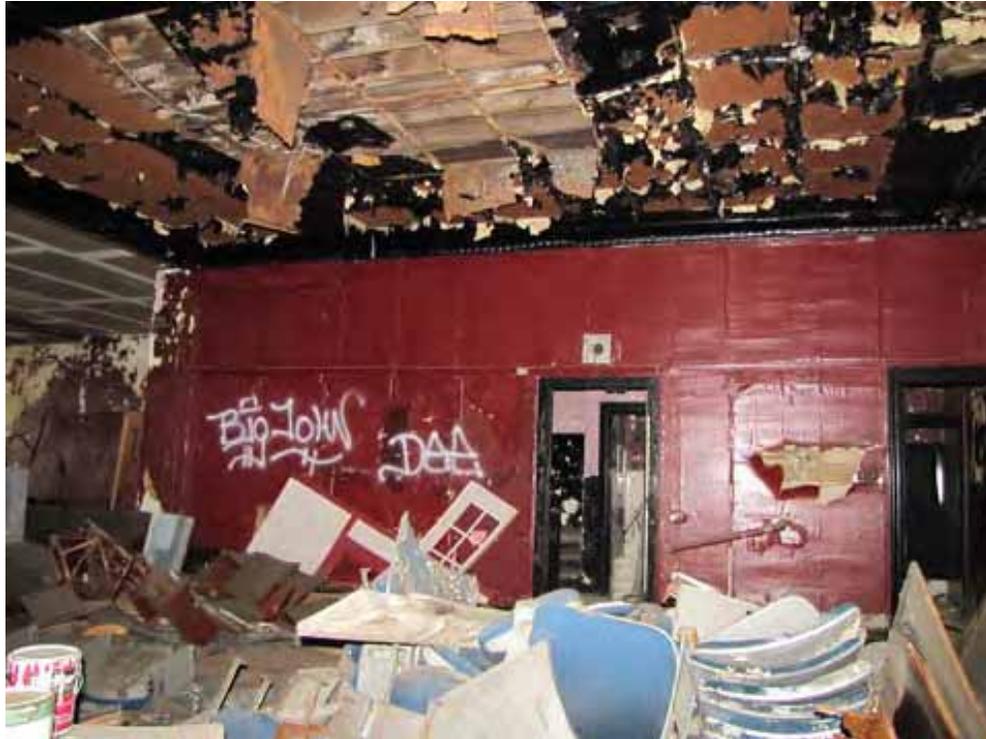
Figure: 121 Location: 2nd Floor

West elevation of the second floor. As noted in the PACA report, the tin ceiling has suffered severe water damage and the room is filled with discarded furniture, debris, and bird matter.

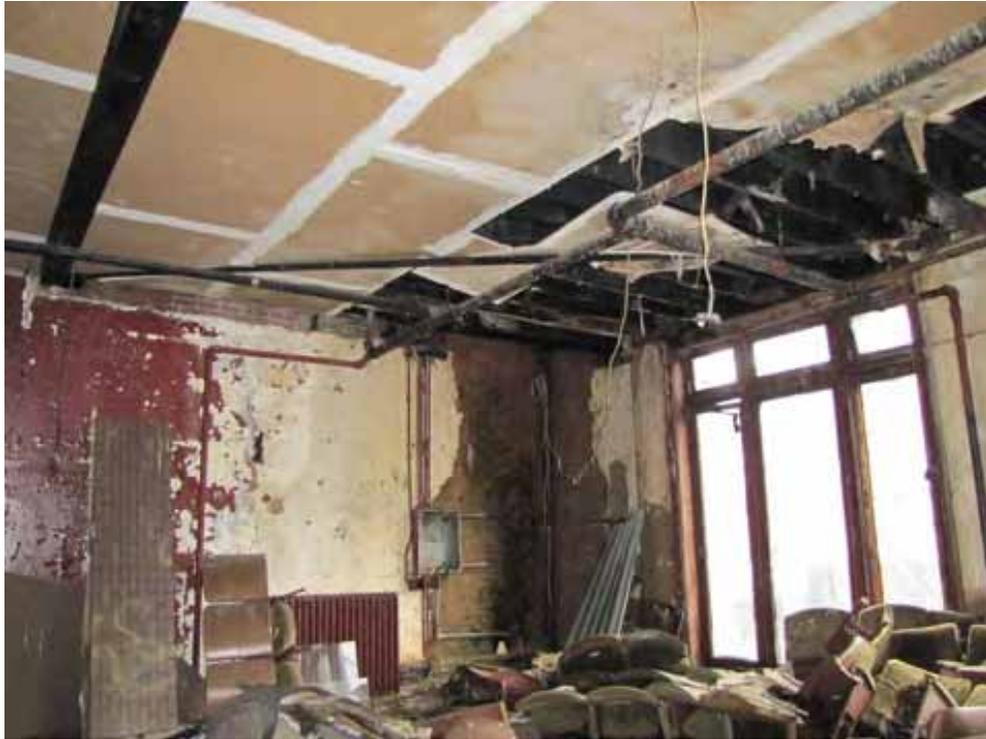
Figure: 122 Location: 2nd Floor

Southeast corner of the building. As noted in the PACA report, the rooms are in very poor condition and exhibit water damage. Water infiltration is ongoing at the four corners of the building.

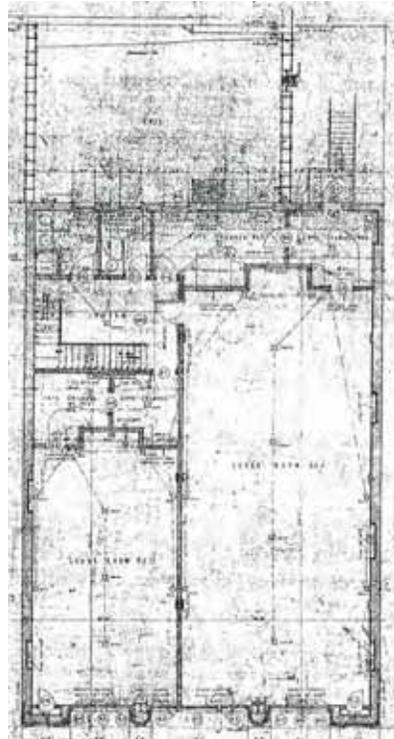
Figure: 123 Location: 3rd Floor

Archival plan of third floor showing original wall configurations. Most of the partitions and finishes were removed during building alterations.

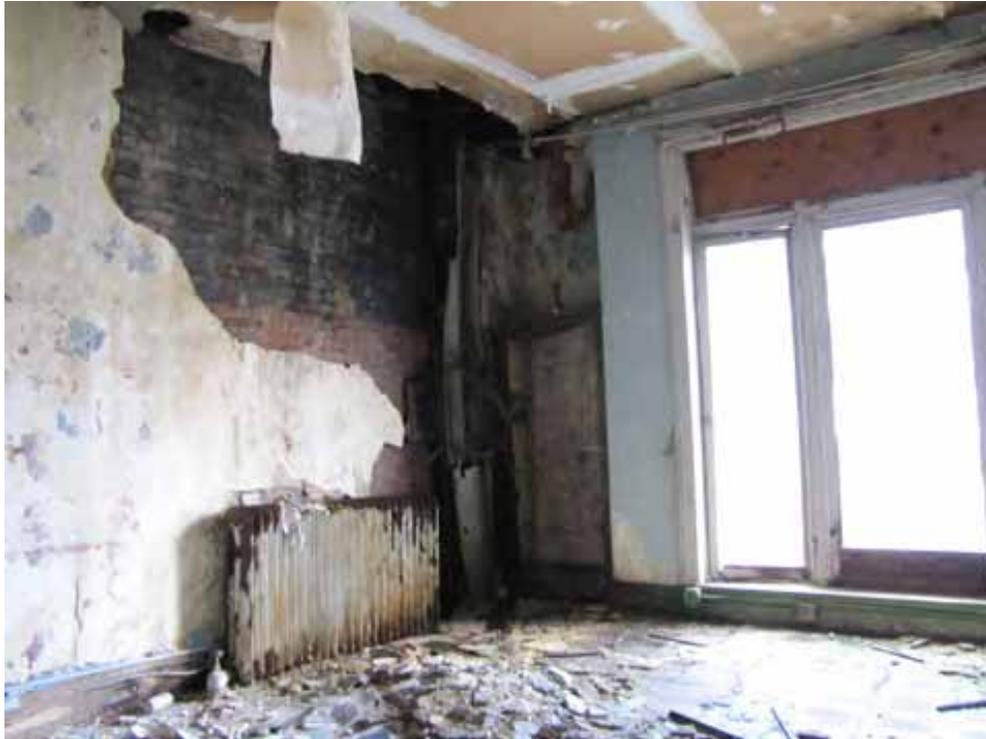
Figure: 124 Location: 3rd Floor

Southeast corner of the building. As noted in the PACA report, the rooms are in very poor condition and exhibit water damage. Water infiltration is ongoing at the four corners of the building.

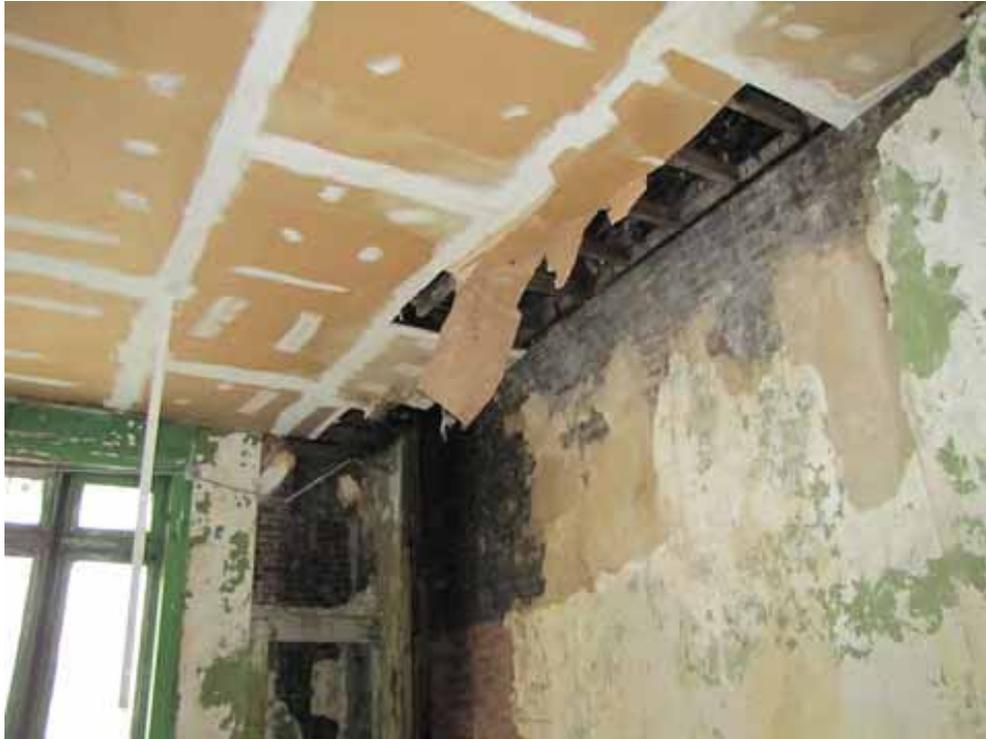
Figure: 125 Location: 3rd Floor

Southwest corner of the building. As noted in the PACA report, the rooms are in very poor condition and exhibit water damage. Water infiltration is ongoing at the four corners of the building.

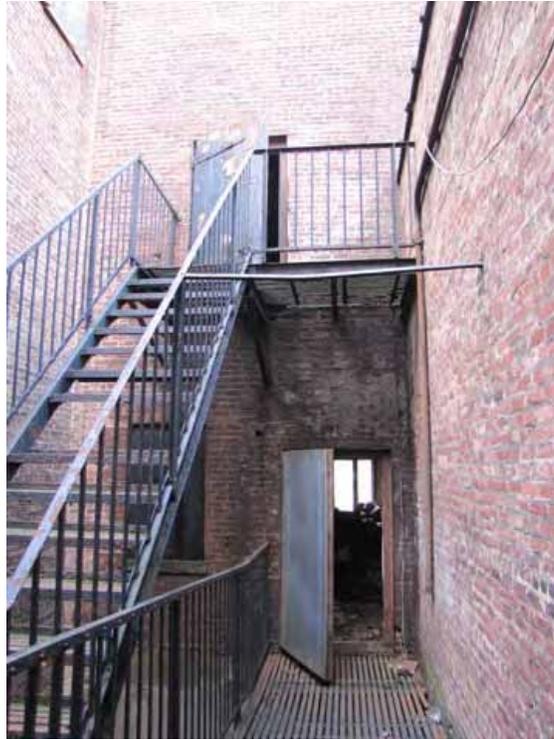
Figure: 126 Location: Interior Courtyard

The fire escape is corroding and is missing a tread at stairs leading to third floor. As noted in the PACA report, doors to the south building do not latch closed.

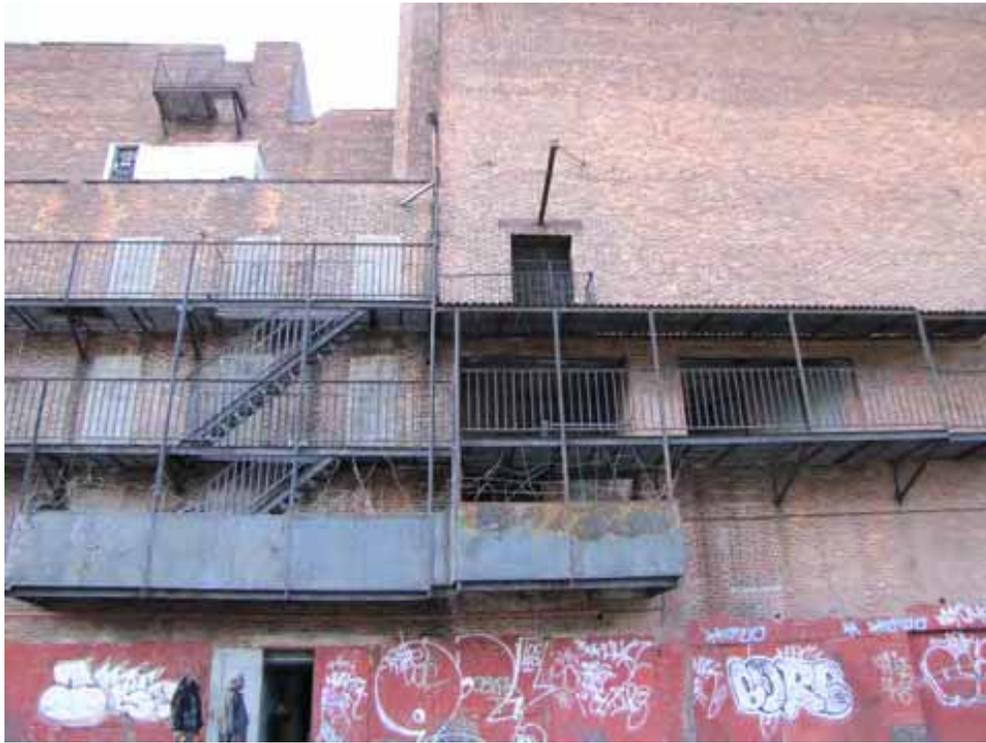
Figure: 127 Location: North Façade

As noted in the PACA report, the exit doors are difficult to open due to corrosion of the steel components, and window openings have been filled with concrete masonry units. The open door at the ground level is a non-original door opening.

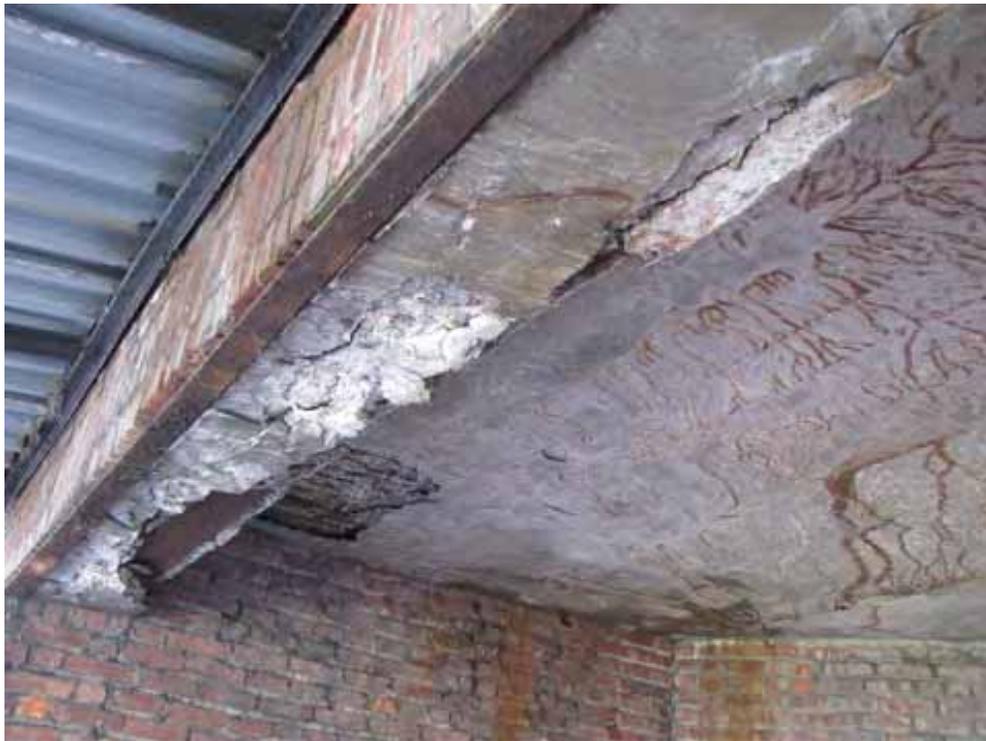
Figure: 128 Location: North Façade

The PACA report identified corroded steel units with hairline cracks in the adjacent masonry and mortar joints. Concrete is now spalling at corroded ferrous beams outside the emergency exits at the second level of the fire-escape.

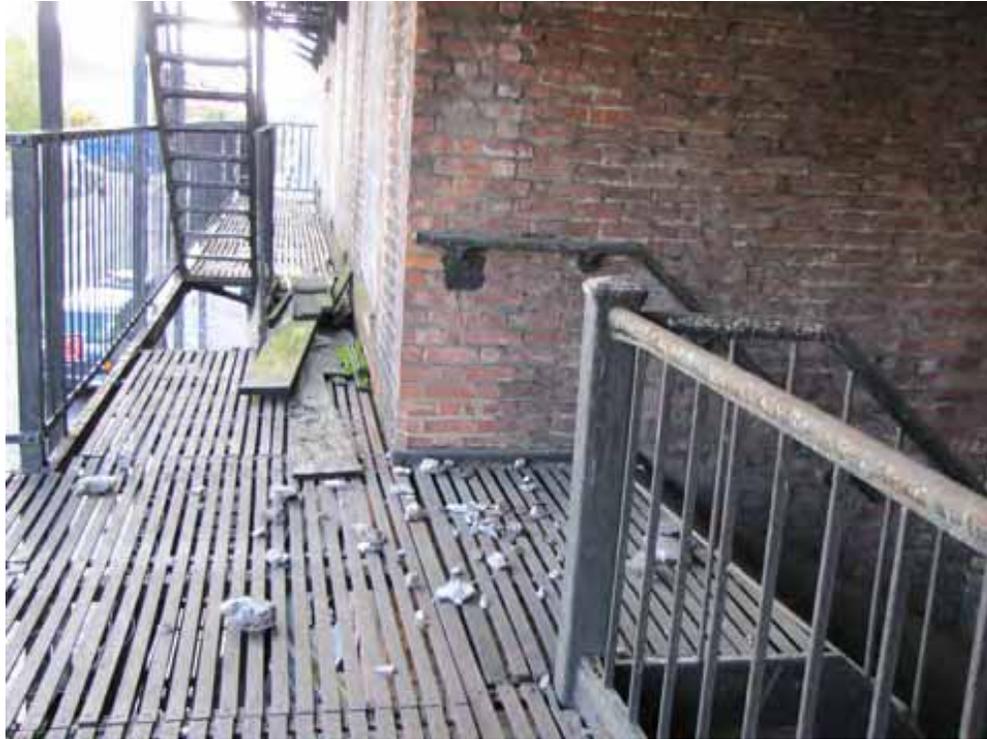
Figure: 129 Location: North Façade

Concrete at corroded ferrous beams has spalled and fallen onto the fire escape, outside the emergency exits at the second level of the fire-escape. The PACA report did not identify this condition.

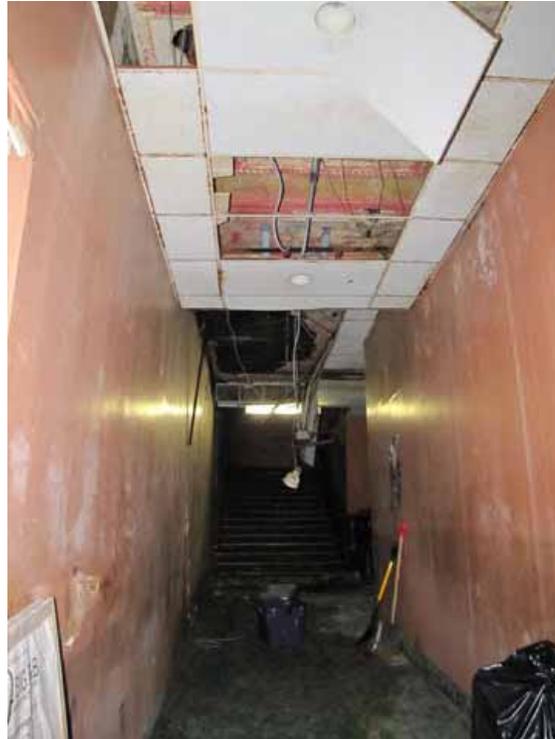
Figure: 130 Location: Orchestra Level: South Promenade

Ongoing water infiltration in the hall leading to the southwest stairs. Modern ceiling finishes have fallen, revealing sections of the damaged decorative plaster ceiling. Mold is visible on the walls. The PACA report did not identify damage in this area.

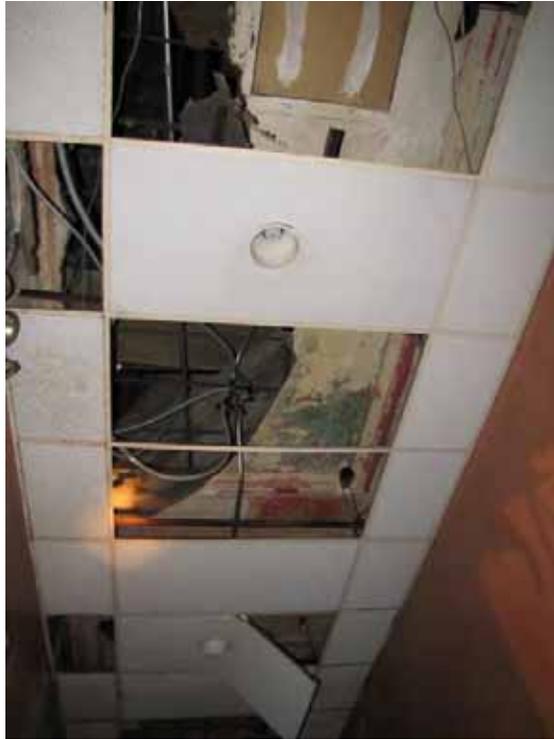
Figure: 131 Location: Orchestra Level: South Promenade

Original plaster ceiling above the drop ceiling exhibits large losses, water damage, and penetrations for the installation of the modern ceiling, ductwork, and conduits. The PACA report did not identify these conditions.

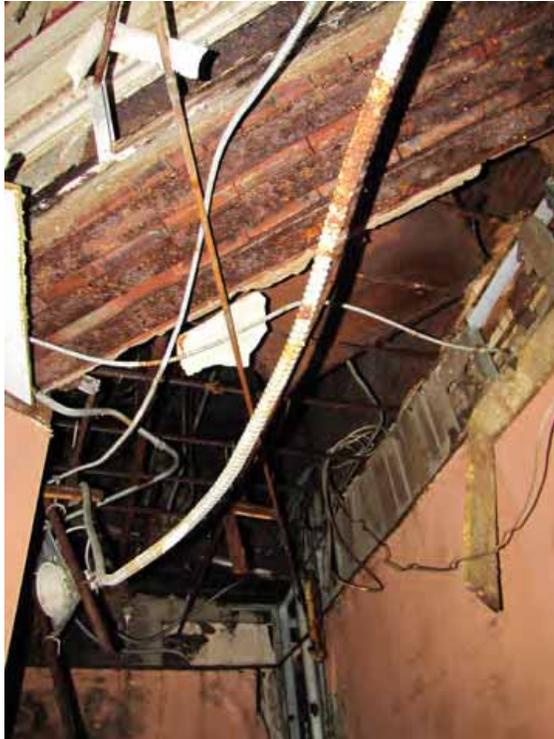
Figure: 132 Location: Orchestra Level: South Promenade

Ongoing water infiltration in the hall leading to theaters 1 and 5 from the foyer. Ceiling finishes have fallen, revealing corroded armatures. The PACA report did not identify damage in this area.

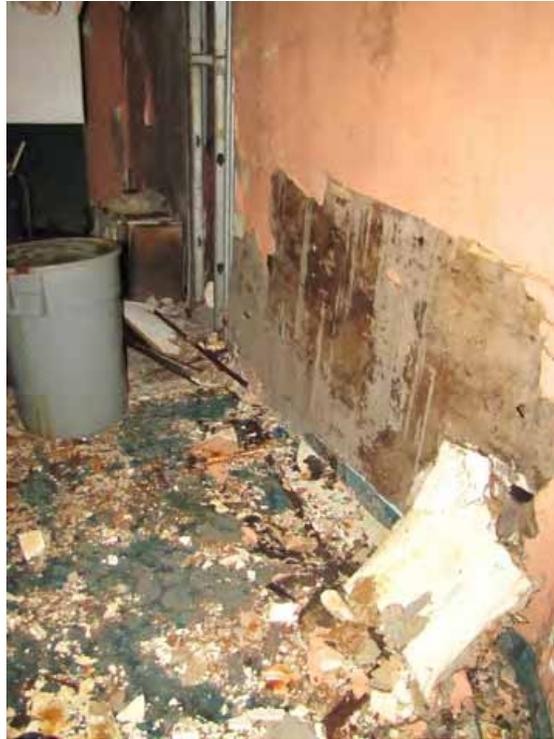
Figure: 133 Location: Orchestra Level: South Promenade

Debris from modern and original ceiling and wall finishes on wet floor in the hall leading to theater 1 and 5 from the foyer. See Figure 132 for condition of ceiling in this area. The PACA report did not identify damage in this area.

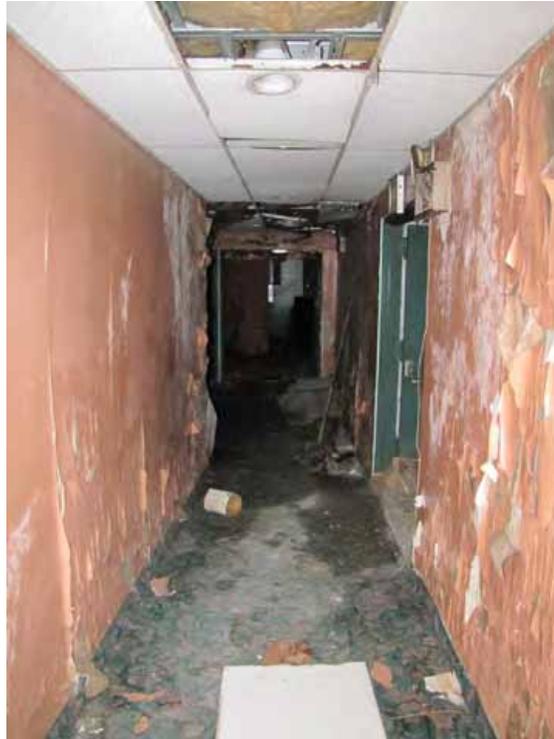
Figure: 134 Location: Orchestra Level: South Promenade

Ongoing water infiltration in the hall leading to theater 5 from the foyer. Deterioration is visible in the form of mold and flaking and peeling paint. The PACA report did not identify damage in this area.

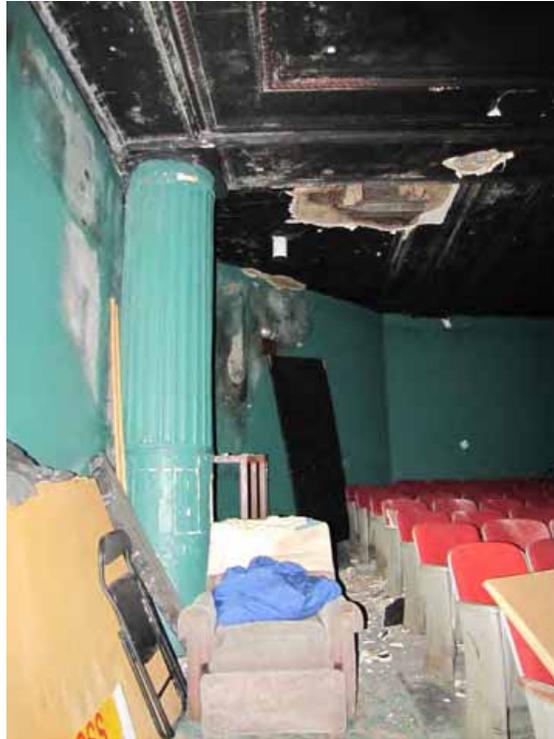
Figure: 135 Location: Orchestra Level: Theater 1

Ongoing water infiltration is visible along the south elevation of southwest theater. Deterioration is visible in the form of mold, flaking and peeling paint, and fallen original ceiling plaster. The PACA report did not identify damage in this area.

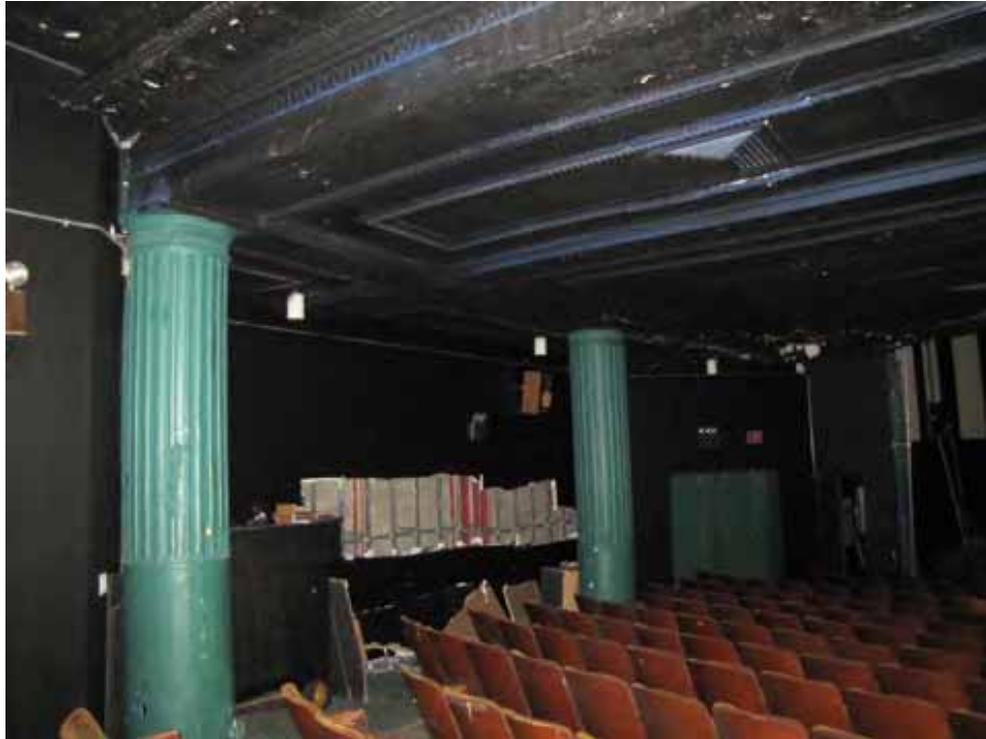
Figure: 136 Location: Orchestra Level: Theater 2

Archival drawings show columns at approximately the same locations and in the same style as those currently found in theaters 1 and 2.

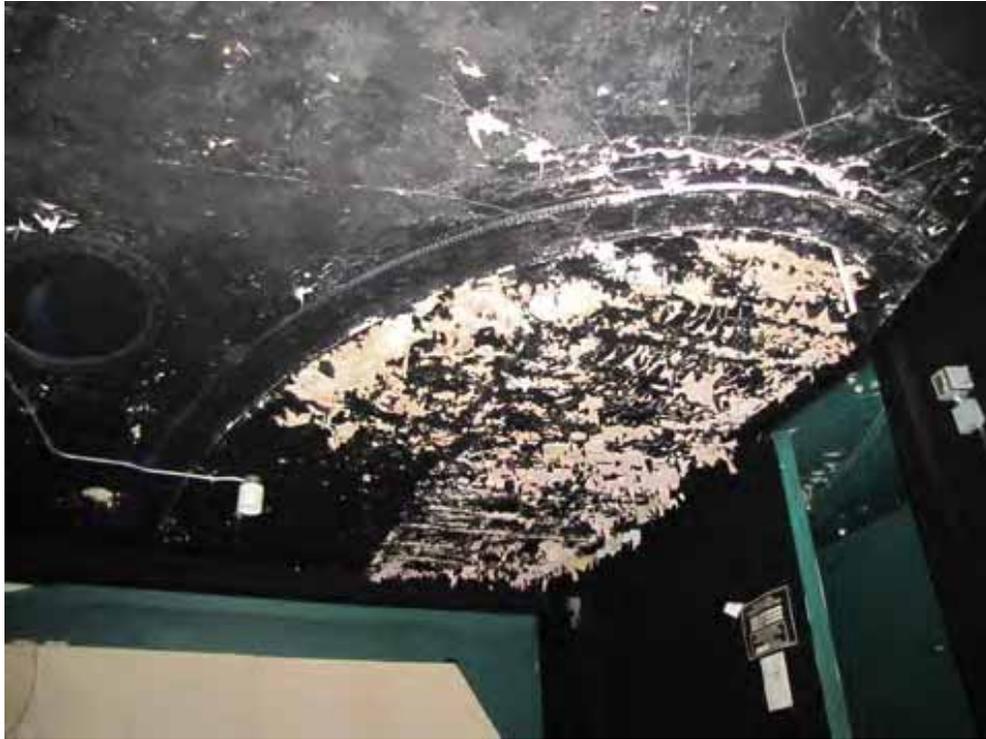
Figure: 137 Location: Orchestra Level: Theater 2

Flaking and peeling paint is visible at the southwest corner of the ceiling in the northwest theater. The PACA report identified the plaster ceilings under the balcony as stamped metal. The PACA report did not identify damage to the ceiling.

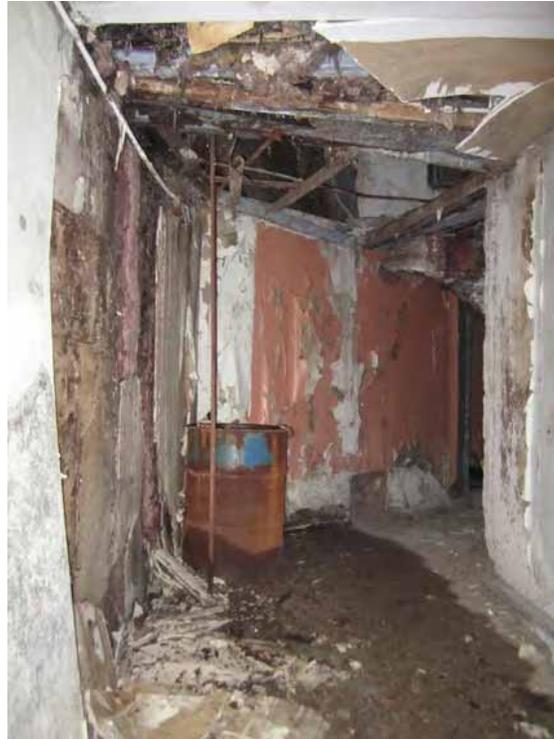
Figure: 138 Location: Orchestra Level: Between Theaters 2 and 5

Water infiltration is ongoing in the hall between the southwest and east theaters. Modern ceiling and wall finishes have fallen, exposing corroded armature. Mold is visible on the walls. The PACA report did not identify this damage.

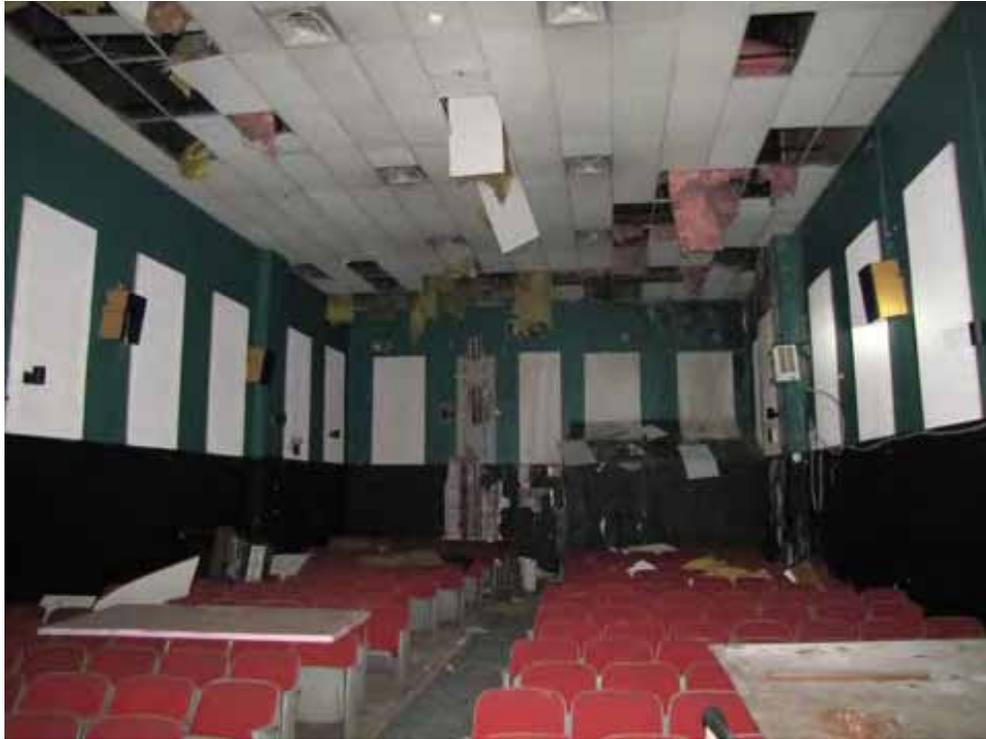
Figure: 139 Location: Stage & Backstage: Theater 5

Water infiltration is ongoing in the east theater, at the location of the original backstage area. The PACA report noted water damage at the east and south walls and the baseboard. Ceiling finishes have since fallen, exposing the steel framing high above.

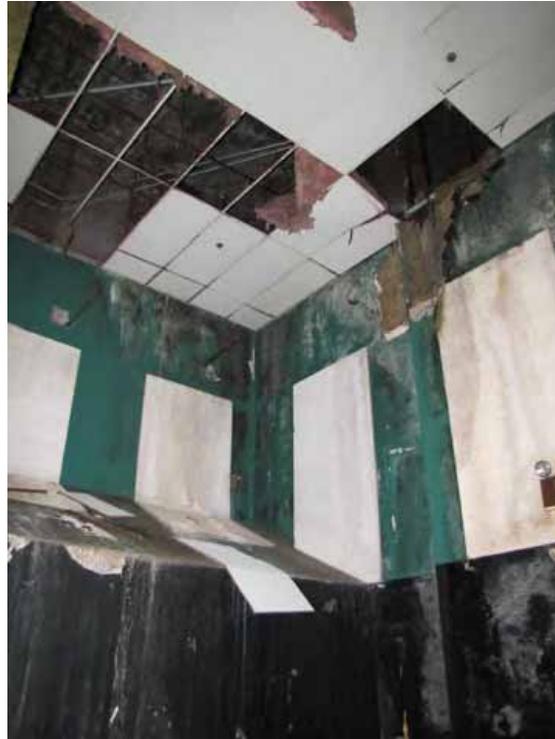
Figure: 140 Location: Stage & Backstage: Theater 5

The PACA report noted water damage at the east and south walls and the baseboard. BCA noted ongoing water infiltration in the southwest and northwest corners of the theater. The damage in the southwest corner is shown above.

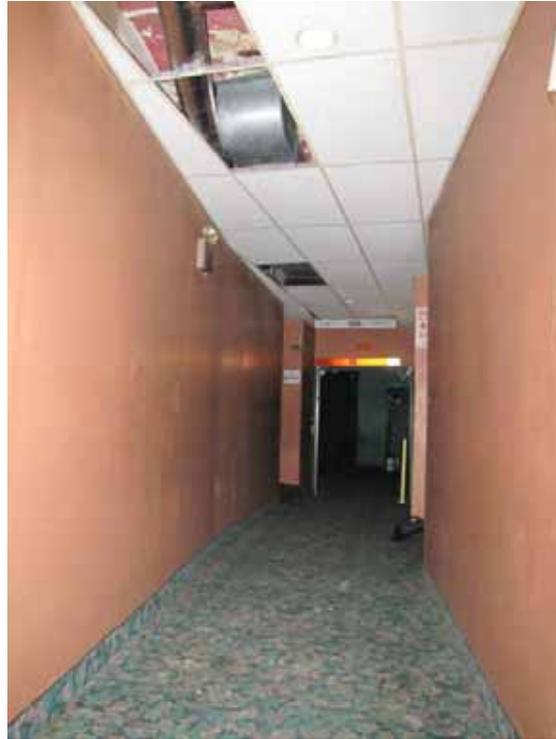
Figure: 141 Location: Orchestra Level: West Promenade

Historic plaster above modern drop ceiling has been damaged by the installation of ductwork, conduits, and anchors for the modern ceiling. The PACA report did not identify the presence of these historic finishes or their condition.

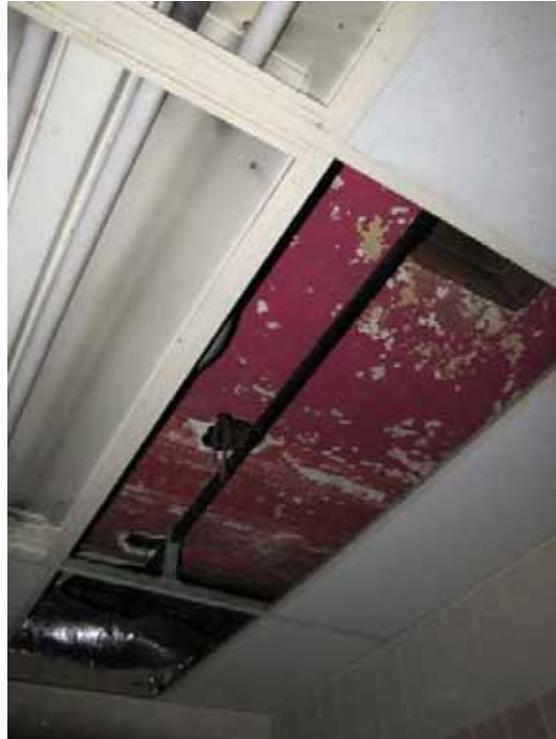
Figure: 142 Location: Orchestra Level: Women's Restroom

Historic plaster, visible above modern drop ceiling, has been damaged by the installation of ductwork, conduits, and anchors for the modern ceiling. The PACA report did not identify the presence of these historic finishes or their condition.

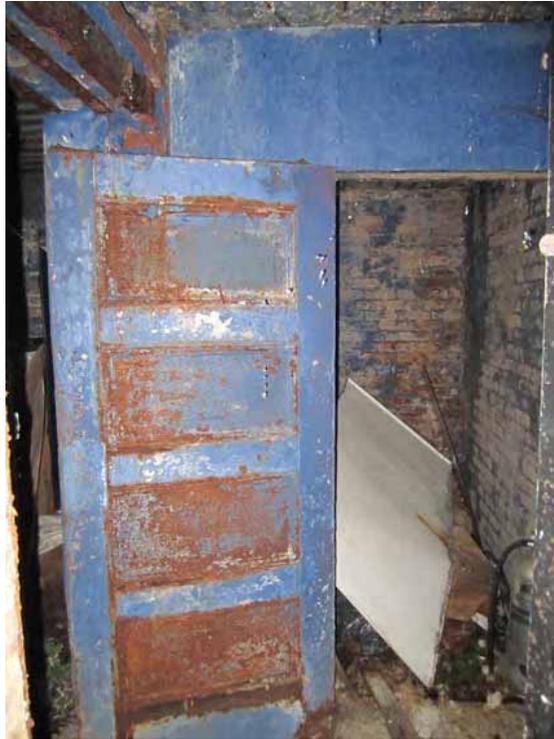
Figure: 143 Location: Orchestra Level: Southeast Corner

Water infiltration is ongoing at the southeast corner of the north building. These rooms are accessible at the south end of Theater 5. The steel doors and lintels in this area exhibit heavy corrosion. The PACA report noted damage in the adjacent theater.

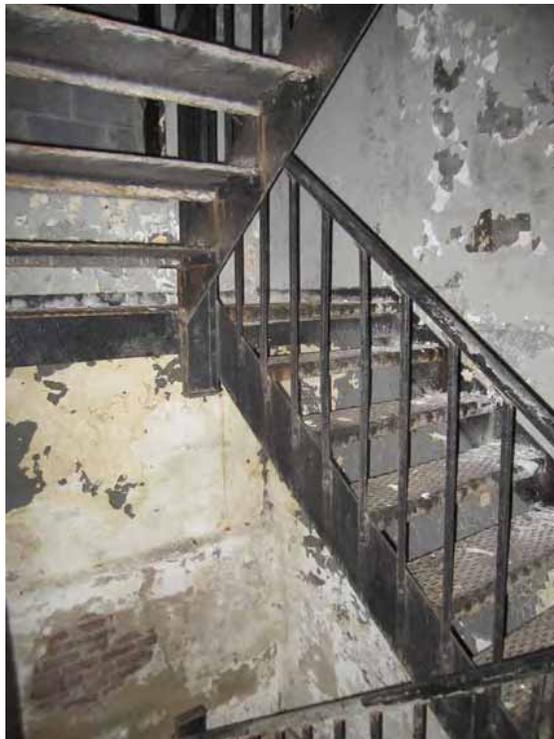
Figure: 144 Location: Orchestra Level: Northeast Corner

Water infiltration is ongoing at the northeast corner of the north building. The ferrous stairs in this area are corroded. The plaster finish has detached, exposing brick backup. The PACA report did not identify damage in this area.

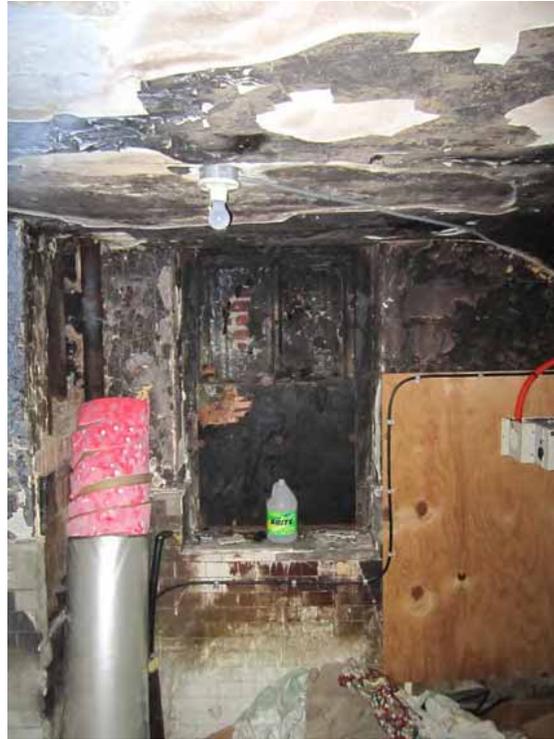
Figure: 145 Location: Northwest Stair

Below the northwest stairs is a small room with extensive water damage. The window in this room appears to be original, although it is badly damaged and sealed from the exterior with brick. The PACA report did not identify damage to this area.

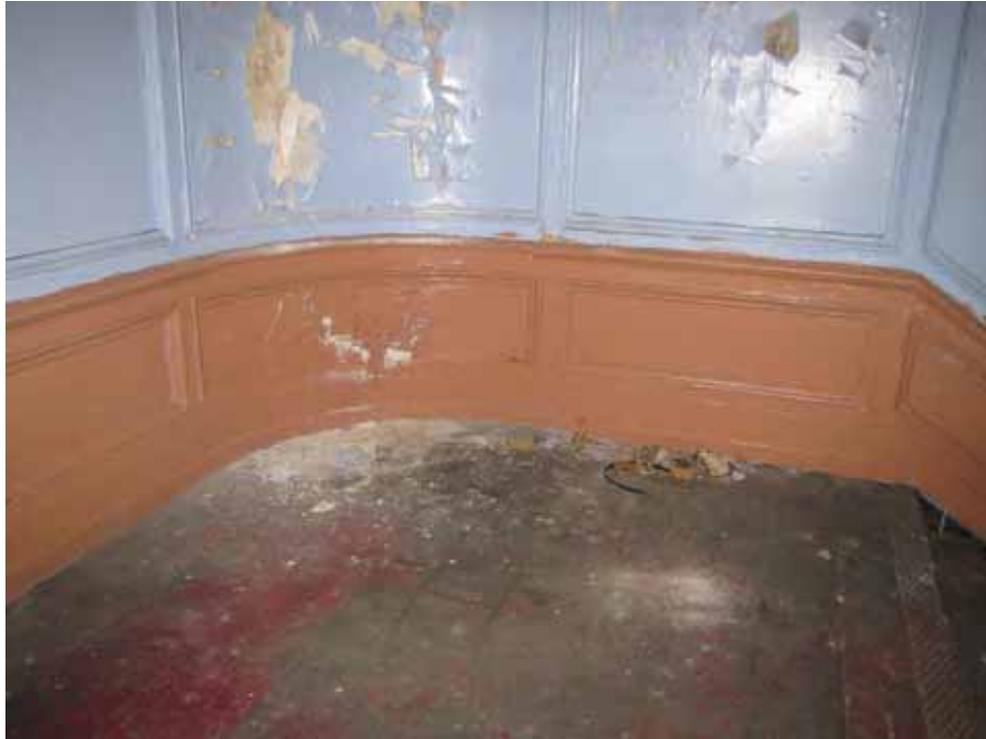
Figure: 146 Location: Northwest Stair

Water damage at northwest corner of stairs leading from first to second floor. The PACA report noted the plaster in this area was in good condition.

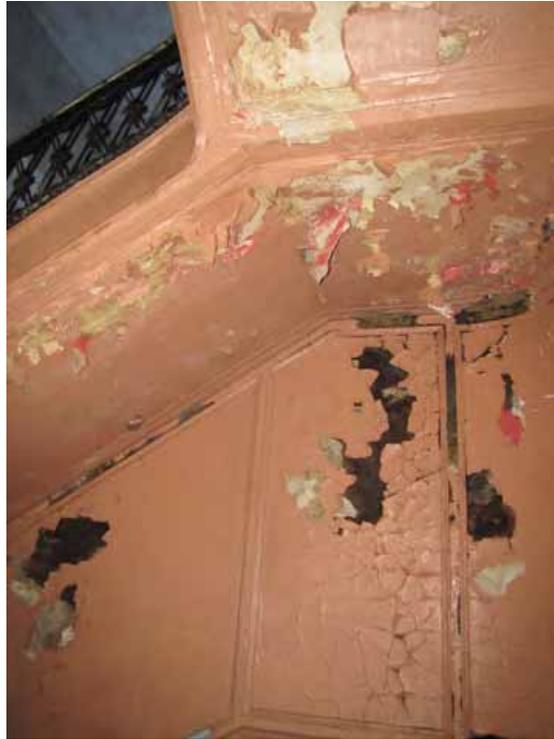
Figure: 147 Location: Southwest Stair

Water damage at the walls and soffit of the stairs leading from first to second floor. The balustrade in this area is corroding. The PACA report noted the plaster and railing in this area were in good condition.

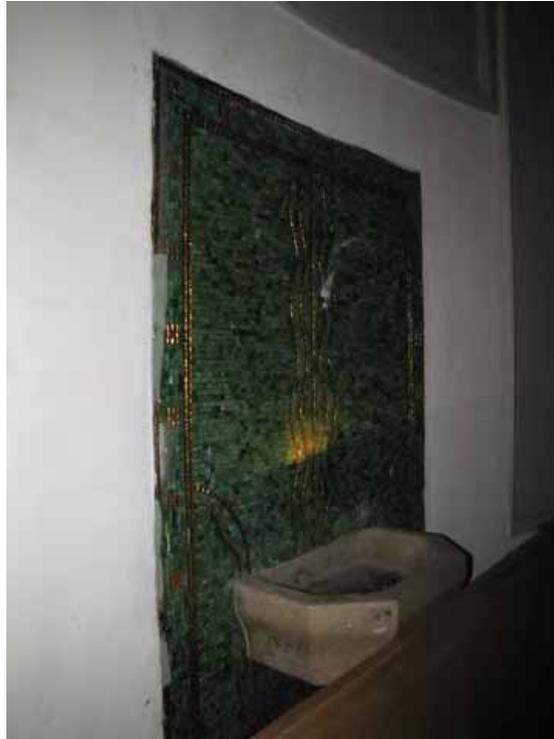
Figure: 148 Location: First Mezzanine: Northwest Anteroom

The PACA report noted the mosaic of a fountain was relocated from a niche in oval foyer and the existing basin was added. The mosaic is currently in good condition, except for paint on tiles in isolated areas.

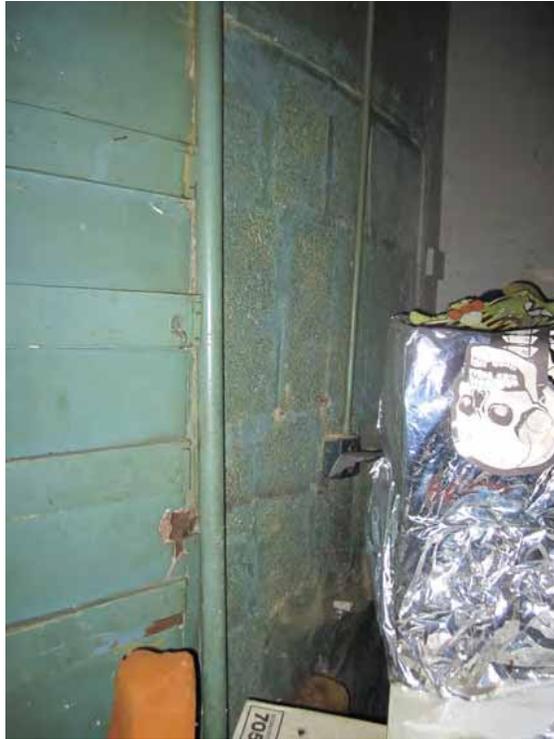
Figure: 149 Location: First Mezzanine: Northwest Anteroom

On the left of the above image is an abandoned door at the reverse side of existing mosaic in the north anteroom, as viewed from a closet at the northeast corner of the oval foyer.

BCA Probe 4A, adjacent to the top right corner of the mosaic on the east wall, revealed decorative paint on plaster in this area. This mosaic replaced an original door to a coat room. The opening behind the mosaic was filled with CMU (See figure 149).

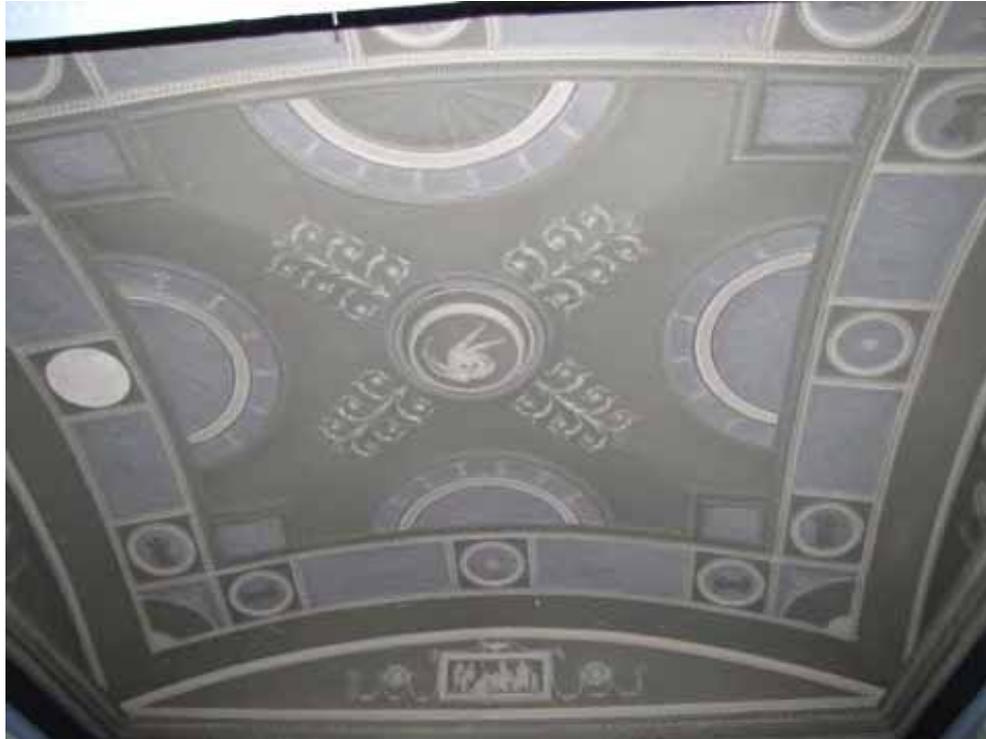
Figure: 150 Location: First Mezzanine: Northwest Anteroom

The ceiling at the north anteroom is in relatively good condition, with flaking and peeling paint but minimal mold or water damage. The PACA report did not describe the condition of this area.

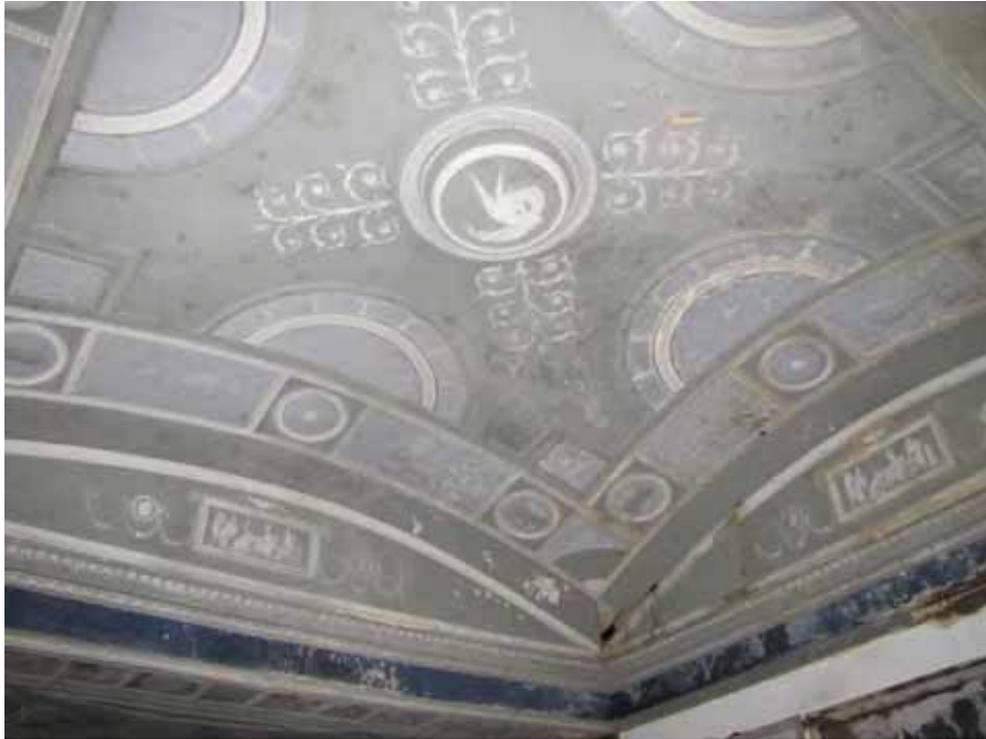
Figure: 151 Location: First Mezzanine: Southwest Anteroom

Significant mold accumulation is currently visible on the ceiling of the south anteroom. The PACA report did not identify damage in this area.

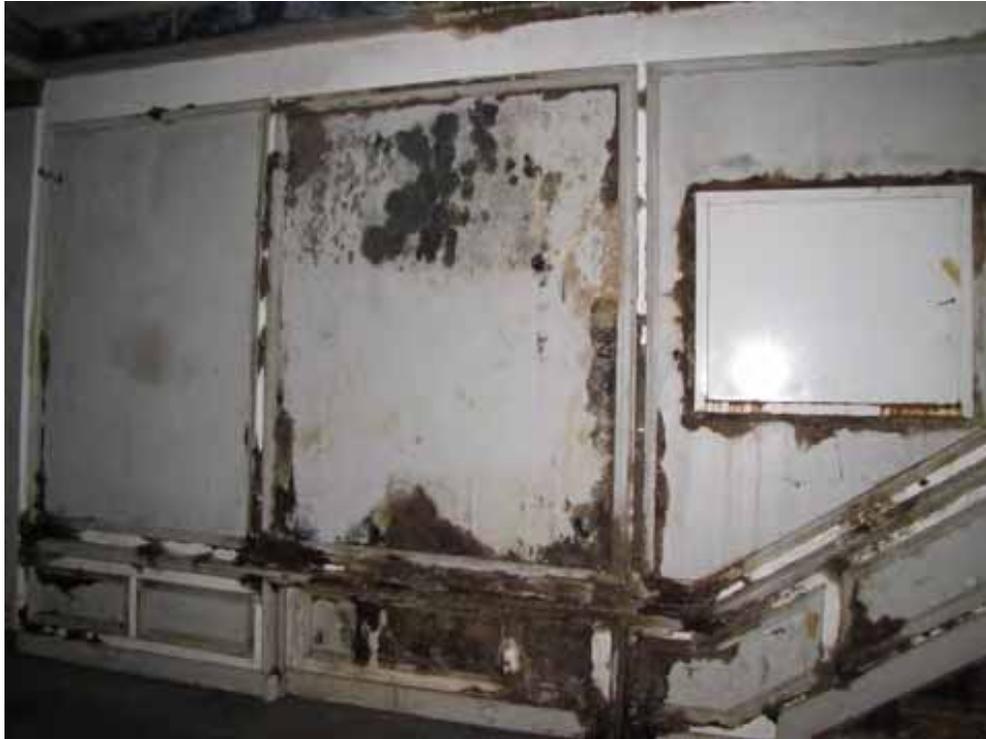
Figure: 152 Location: First Mezzanine: Southwest Anteroom

Significant mold accumulation is currently visible on the walls of the south anteroom. The PACA report did not identify damage in this area.

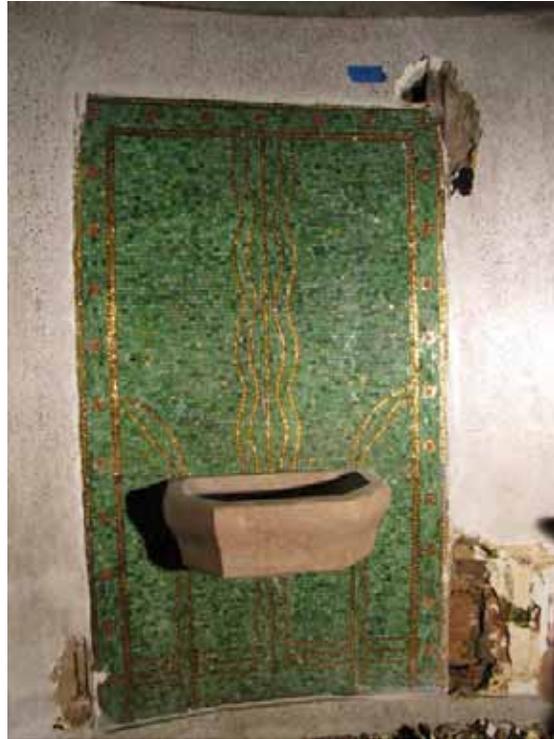
Figure: 153 Location: First Mezzanine: Southwest Anteroom

The bottoms of the mosaics in the first mezzanine anterooms do not have the same border as their top edges, suggesting that either the mosaics were truncated during their move or were originally designed to blend into the fountains at their base.

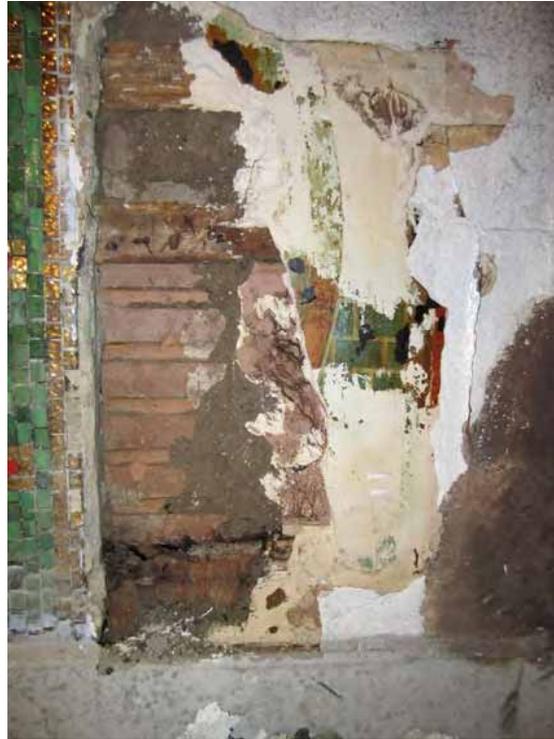
Figure: 155 Location: First Mezzanine: Southwest Anteroom

BCA Probe 4B, adjacent to the bottom right corner of the mosaic on the east wall, revealed decorative paint on plaster in this area. The adjacent plaster appeared to be cut for the installation of the mosaics, as no finished edge was found.
