ALTERNATIVES ANALYSIS WITH BCA CONDITIONS ASSESSMENT UPDATE

**VICTORIA THEATER
235-237 WEST 125TH STREET
NEW YORK, NY
ALTERNATIVES ANALYSIS**

Conditions Assessment Update

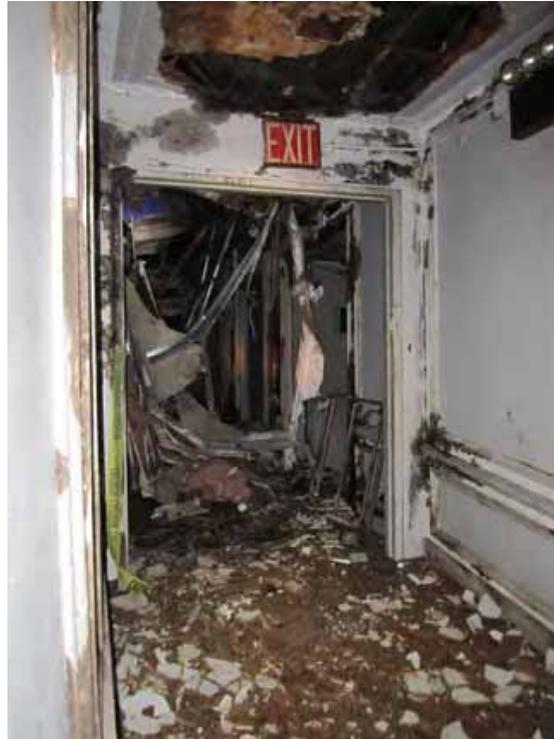
Figure: 156 Location: First Mezzanine: South Promenade

Water infiltration is ongoing in the south hall, where the buildings connect. Historic and modern finishes have fallen. The ferrous metal framing above exhibits corrosion. Mold is visible on the walls. The PACA report did not identify damage in this area.

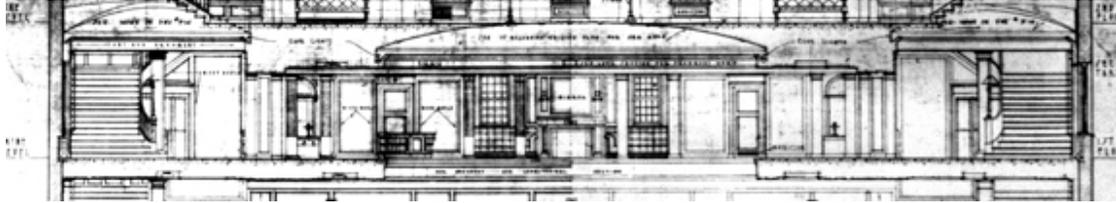
Figure: 157 Location: First Mezzanine: Oval Foyer

As noted in the PACA report, the center of the room was open to below, with a balustrade at the perimeter of the opening. Cove lighting was installed around the interior cornice of the oval ceiling; the fixtures are no longer extant.

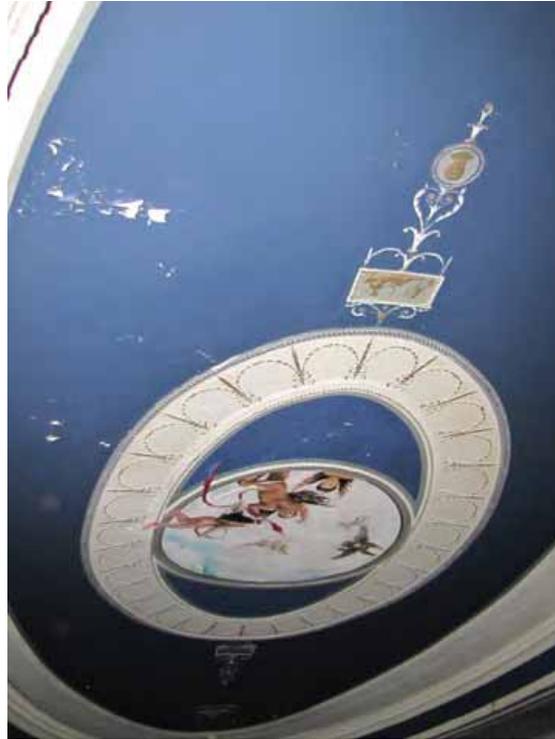
Figure: 159 Location: First Mezzanine: Oval Foyer

The PACA report noted that the central portrait covered the original ceiling medallion and decorative ventilation grille, however the flush nature of the existing portrait suggests the previous elements (shown in Figure 158) were removed.

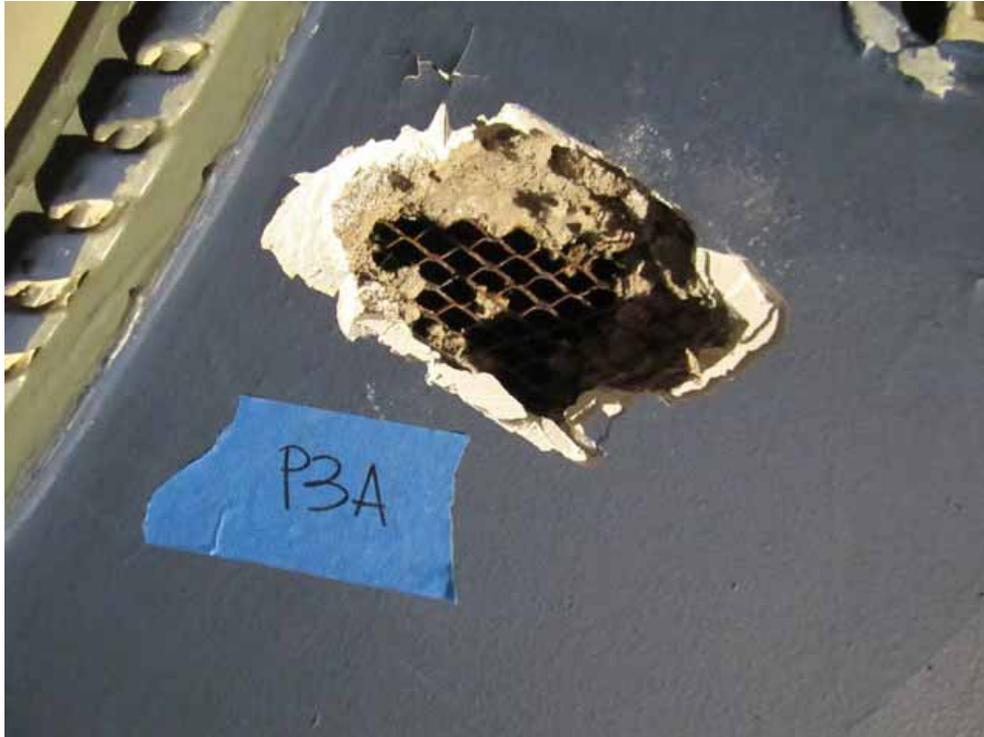
Figure: 160 Location: First Mezzanine: Oval Foyer

BCA Probe 3A, located near the center of the oval ceiling, revealed 1" thick plaster on expanded metal lath.

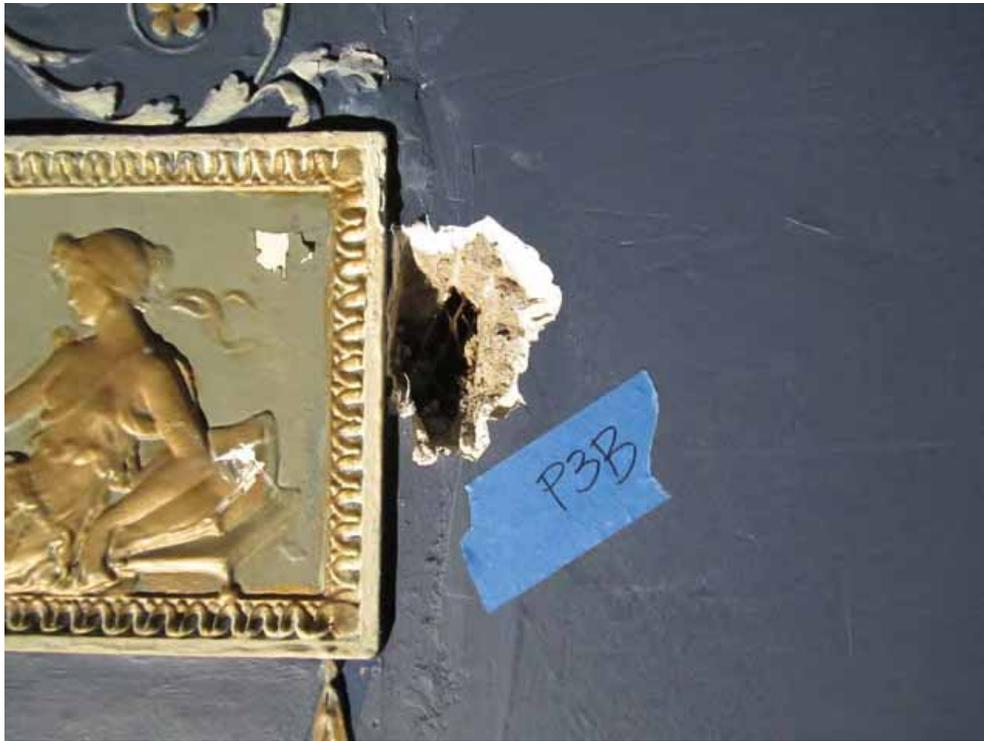
Figure: 161 Location: First Mezzanine: Oval Foyer
BCA Probe 3B, located near the center of the oval ceiling, revealed 1" thick plaster on expanded metal lath.

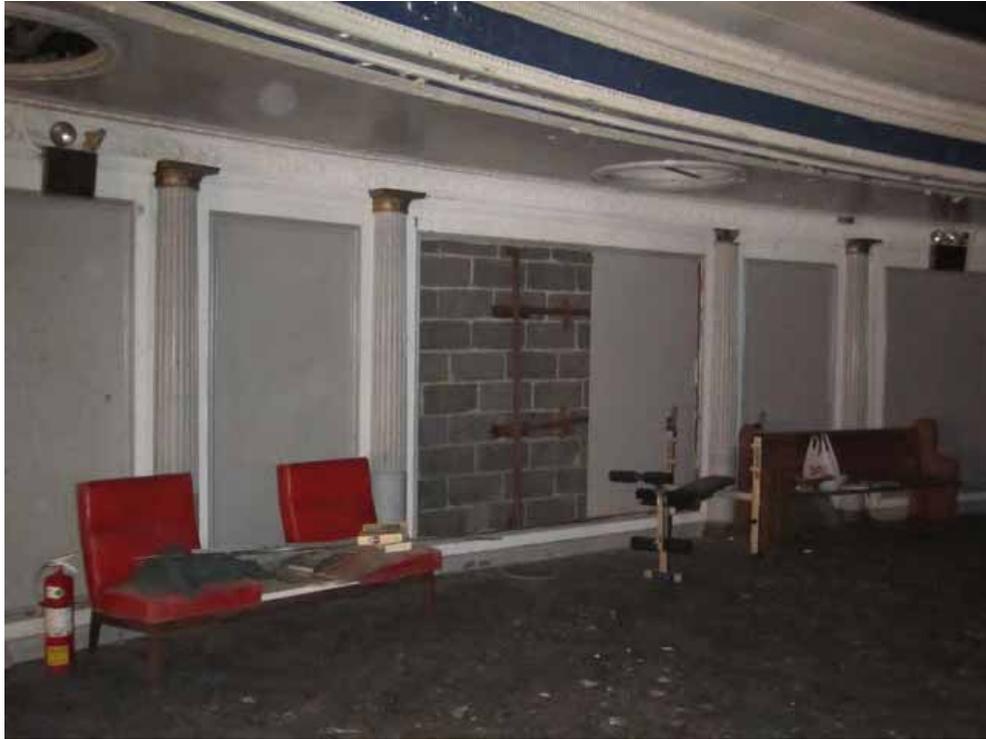
Figure: 165 Location: First Mezzanine: Oval Foyer

The openings between four columns, leading from the oval foyer to its west anteroom, were sealed with fire blocks and covered with wood panels. This allowed for expansion of the restrooms located behind the wall, along the west edge of the oval foyer.

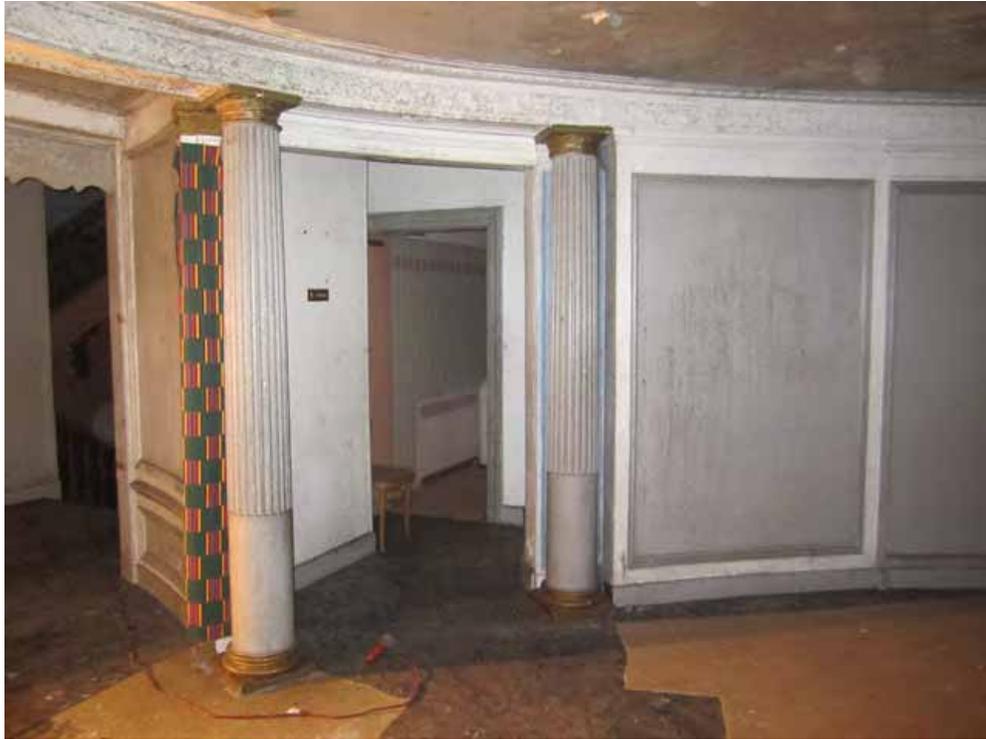
Figure: 167 Location: First Mezzanine: Oval Foyer

The restroom doors were relocated to adjacent the main east and west entrances to the room, where fountains were believed to have been previously located. The current door to the women's restroom is shown above.

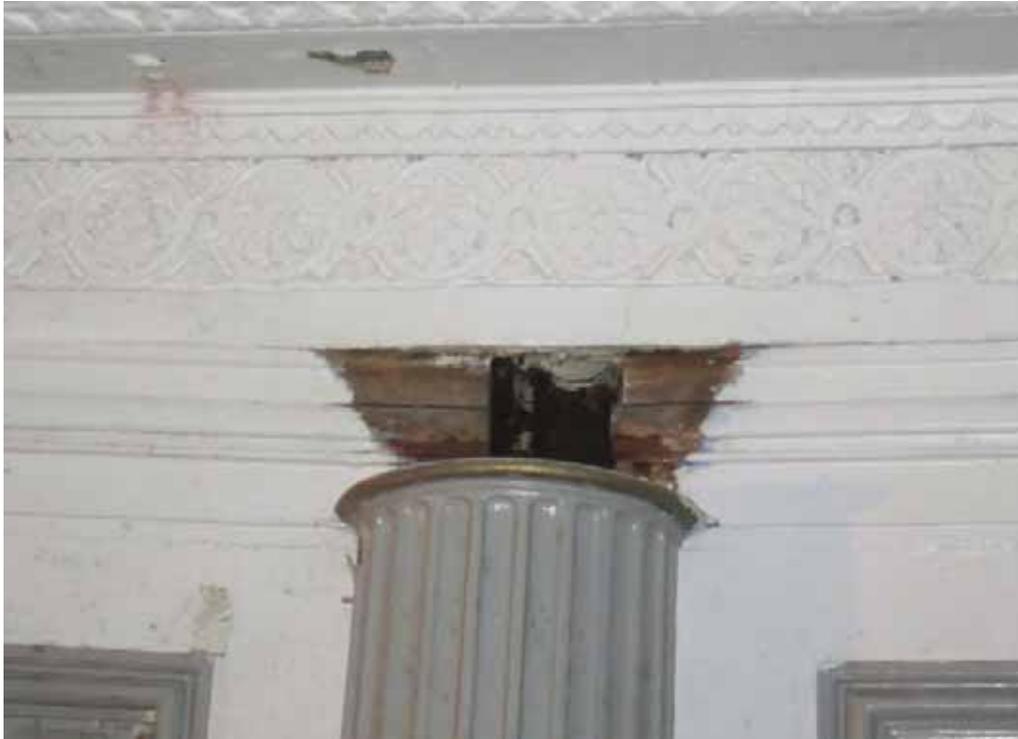
Figure: 168 Location: First Mezzanine: Oval Foyer

The original walls and columns at the perimeter of the room are wood. Unpainted wood is visible where a detached plaster capital was removed.

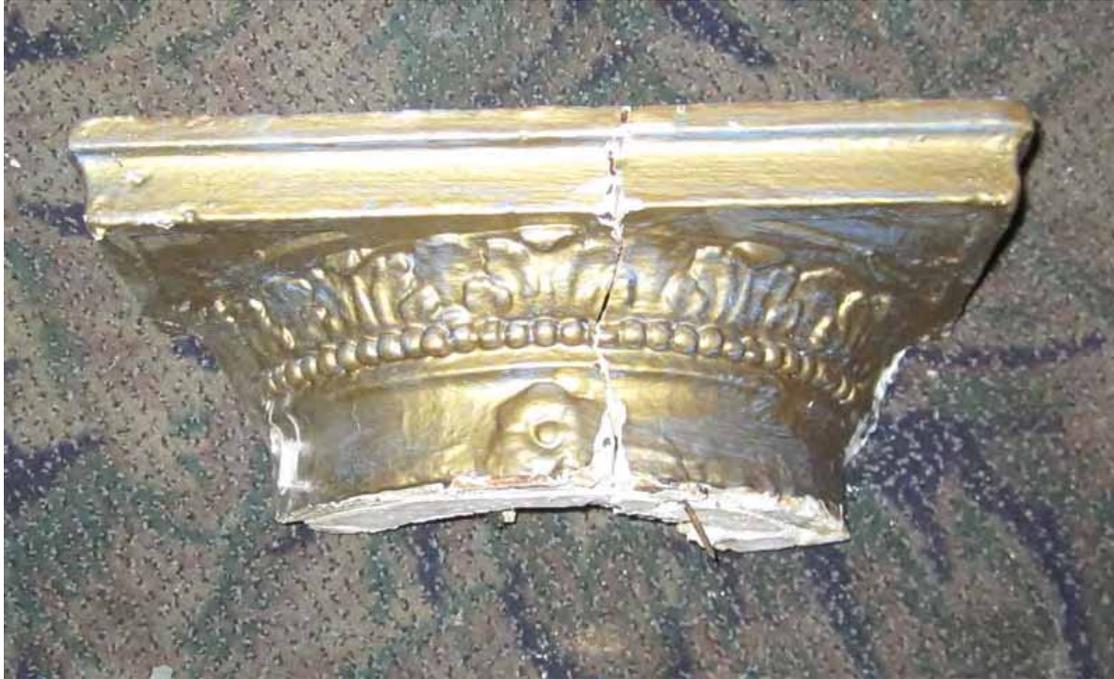
Figure: 169 Location: First Mezzanine: Oval Foyer
Detached plaster column capital removed from west elevation of the oval foyer.

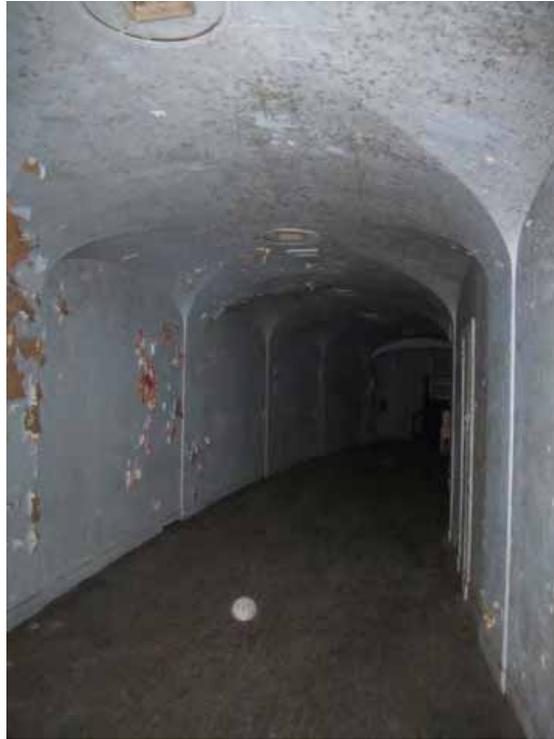
Figure: 173 Location: Second Mezzanine: West Promenade

Flaking and peeling paint are currently visible on the walls and ceiling in the west promenade, in addition to accumulations of mold. The PACA report did not identify damage in this hallway.

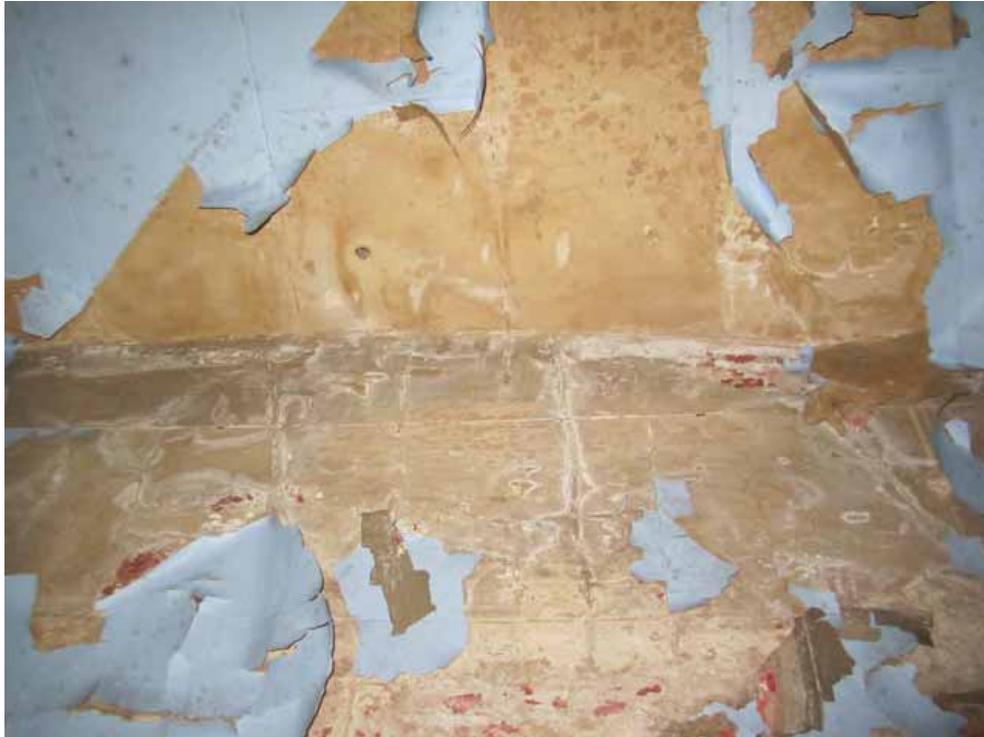
Figure: 174 Location: Second Mezzanine: West Promenade

The walls in this area were originally finished to resemble masonry. The faux joints are visible behind the existing paint finish. Water infiltration has resulted in flaking paint.

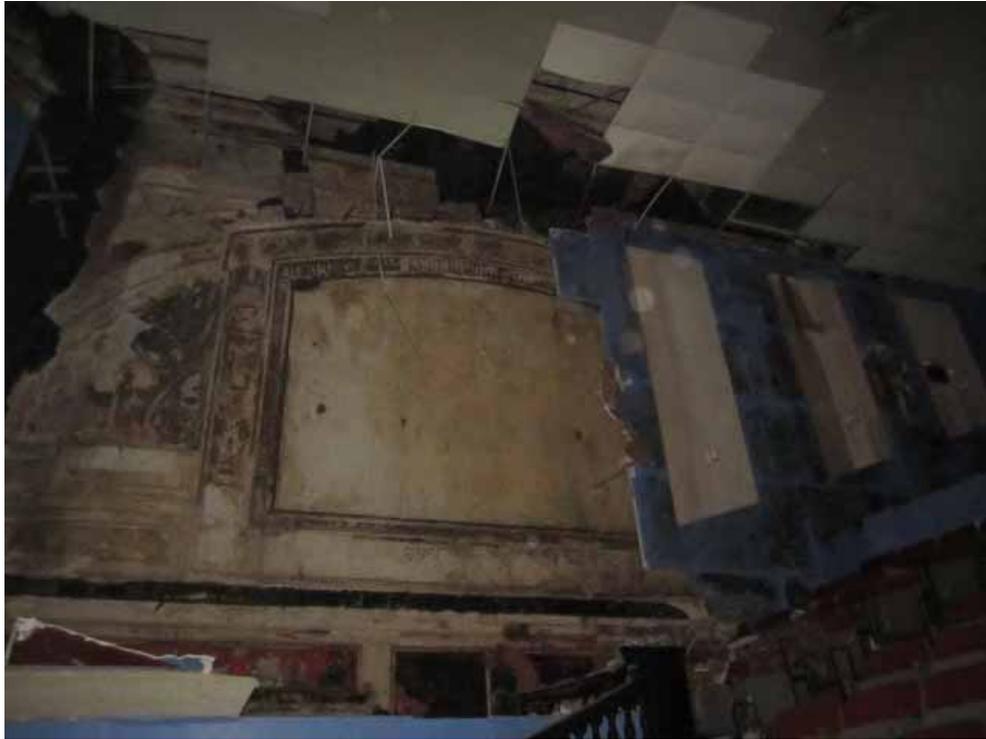
Figure: 175 Location: Balcony: Theater 3

Location of PACA Probe 14, at the south wall of Theater 3. Water infiltration is ongoing. A large section of wall and ceiling finishes have fallen since the PACA report. The mural was previously removed, probably during the 1986 renovations.

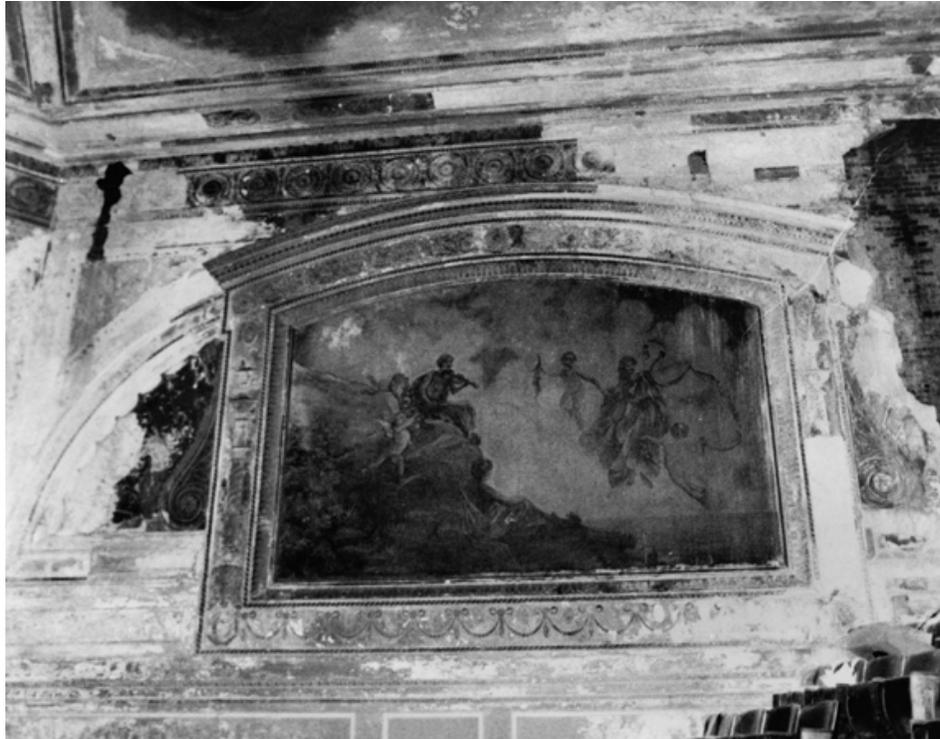
Figure: 176 Location: Balcony: Theater 3

Image of mural in south balcony theater c. 1985. Water damage was apparent at this wall before the installation of the gypsum wallboards. Note the missing plaster and exposed brick at the right of the image. The PACA report did not identify this damage.

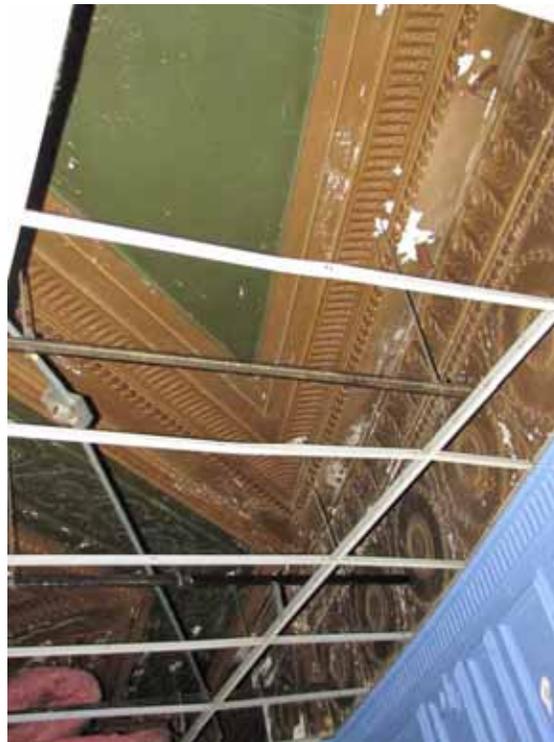
Figure: 178 Location: Balcony: Theater 4
As noted in the PACA report, the drop ceiling is anchored through historic plaster. Small plaster losses have occurred at the anchor points. The PACA report noted the anchors were found every 18 inches; BCA measured 48 inches between visible anchors.

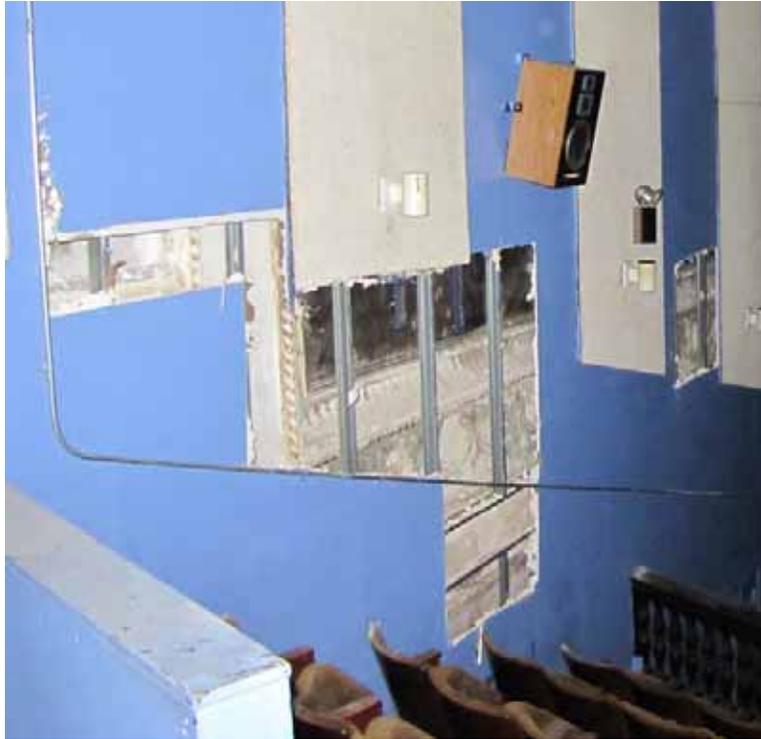
Figure: 179 Location: Balcony: Theater 4

Location of PACA probe 14. As noted in the PACA report, the gypsum board is attached to wall studs anchored through the painted canvas. The anchors are located approximately 48 inches o.c. horizontally (every other stud) and two anchors vertically.

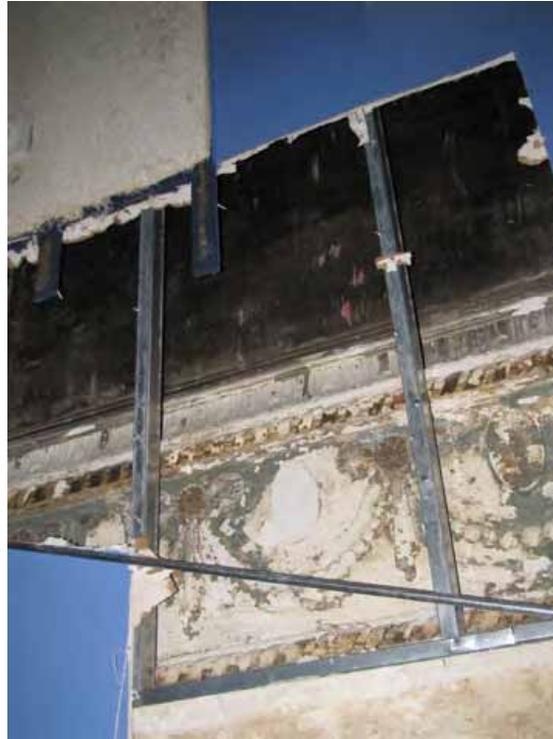
Figure: 180 Location: Balcony: Theater 4

Location of PACA Probe 14. As noted in the PACA report, the mural is obscured by heavy surface deposition and the canvas is sagging and has been punctured by the gypsum wallboard supports. BCA did not identify any active leaks in this area.

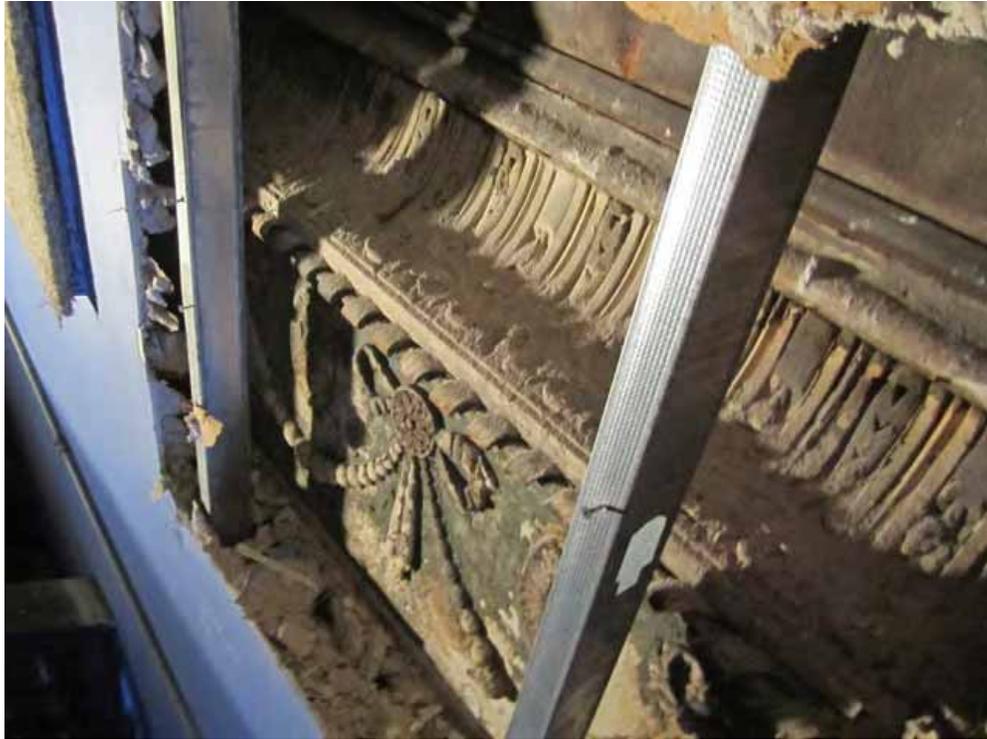
Figure: 181 Location: Balcony: Theater 4

BCA Probe 17 exposed decorative plaster at the base of the north balcony mural. As noted in the PACA report, the plaster surround is deteriorated. The plaster is friable and some ornament is missing. Paint is flaking and peeling.

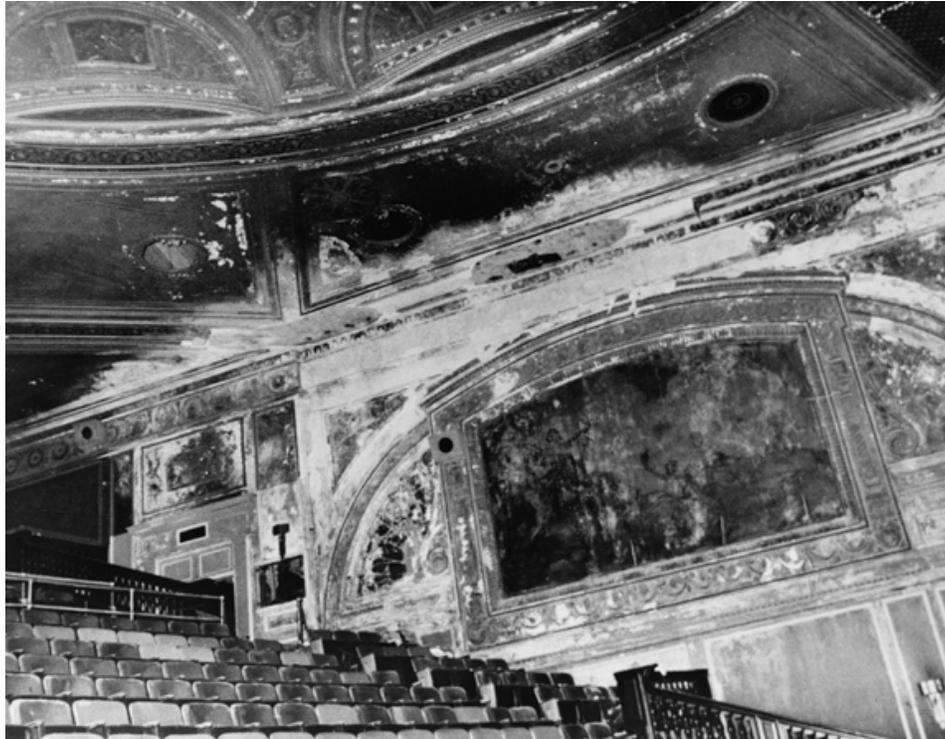
Figure: 182 Location: Balcony: Theater 4

Image of mural in north balcony theater c. 1985. Water damage was apparent at this wall before the installation of the gypsum wallboards.

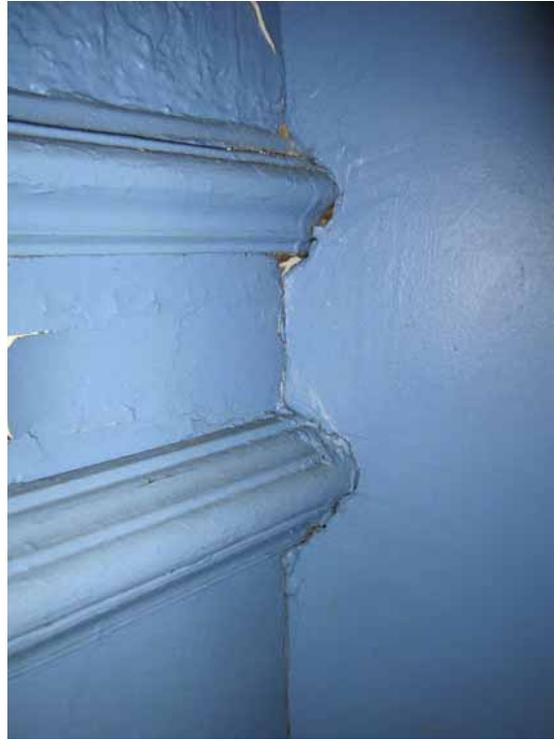
Figure: 183 Location: Balcony: Theater 4

At isolated locations, gypsum wallboard was installed so that it intersects exposed historic moldings. In some areas, such as that shown above, the wall board was cut to retain the profile of the adjacent wall moldings.

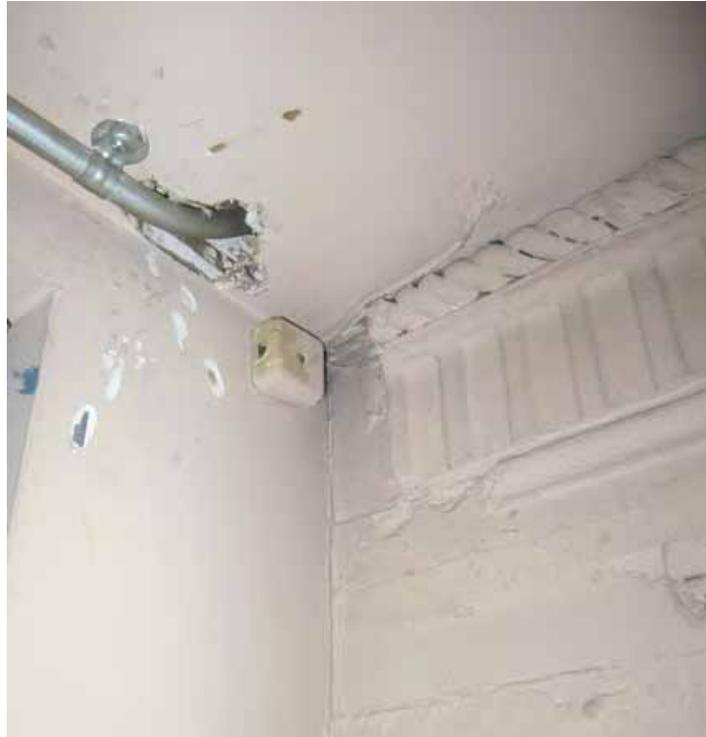
Figure: 184 Location: Balcony: Upper Projection Booth

At isolated locations, gypsum wallboard was installed so that it intersects exposed historic moldings. In some areas, such as that shown above, the decorative ornament was removed and the wallboard abuts the historic wall flush.

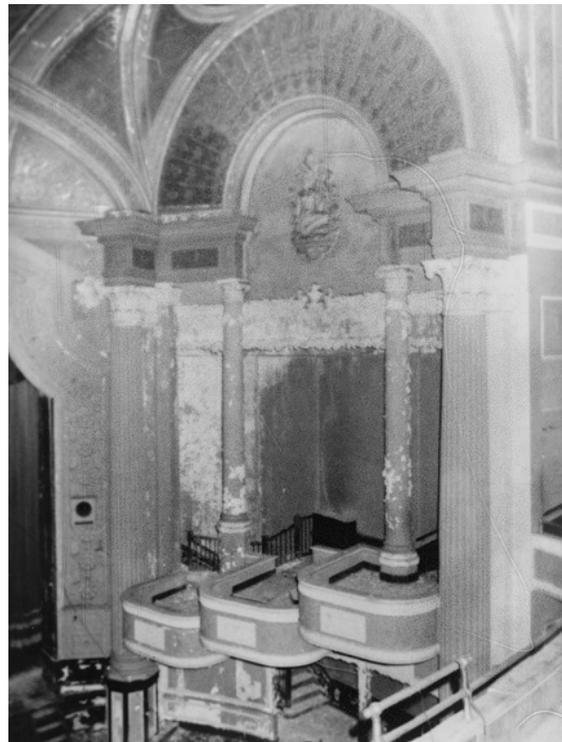
Figure: 186 Location: Balcony: Theater 3 - Projection Booth Closet
Archival image of theater boxes c.1985. Note change in paint scheme from the c.1918 image. Water damage was apparent at this wall before the demolition of the boxes.

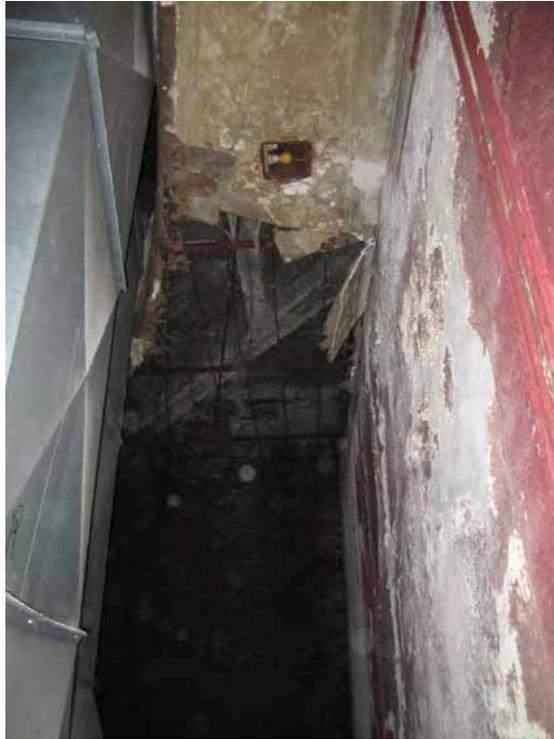
Figure: 187 Location: Balcony: Theater 3 - Projection Booth Closet

Ceiling above stairs leading to removed south theater boxes. As noted in the PACA report, the plaster is extremely damaged. Ceiling finishes in this area have collapsed, revealing corroded armature above. A small section of decorative plaster remains.

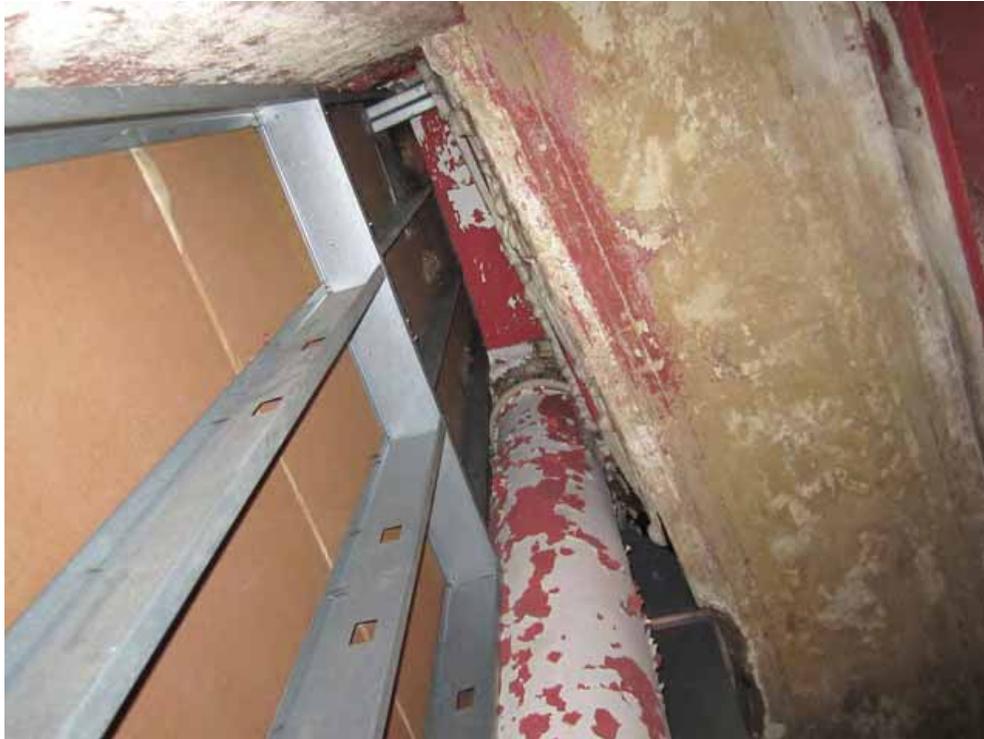
Figure: 188 Location: Balcony: Theater 3 - Projection Booth Closet

Location of PACA Probe 8A, through the east wall of a closet, exposed stairs leading to the location of removed theater boxes. Painted finishes remain on plaster at isolated locations, including extant columns and capitals.

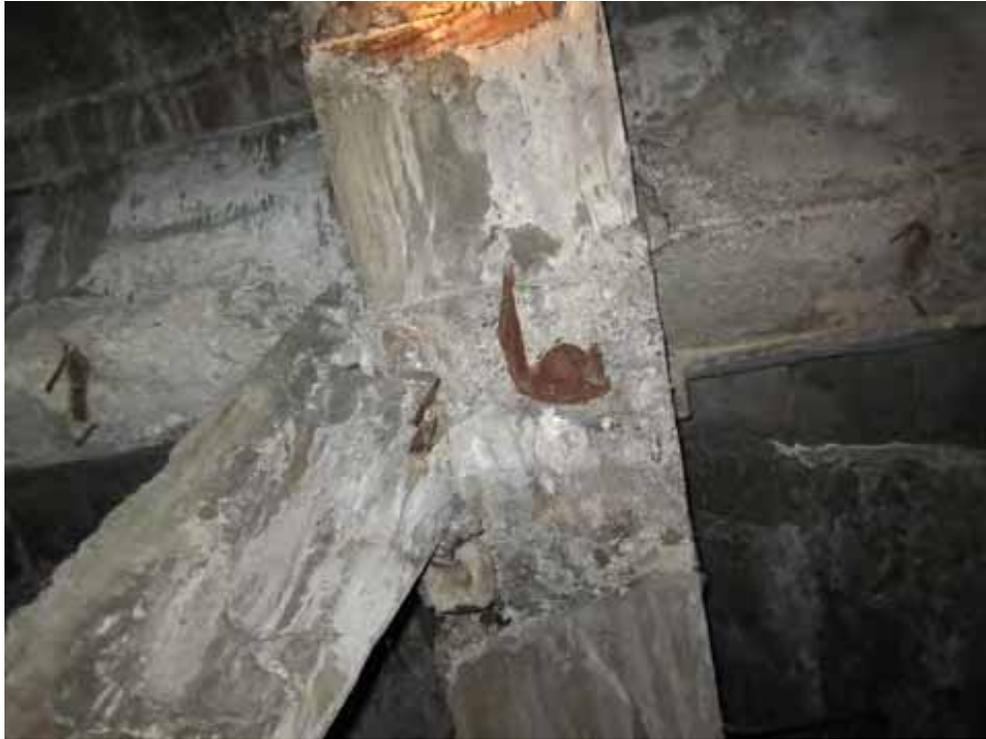
Figure: 189 Location: Attic

Small areas of corroding ferrous metal are visible at spalled sections of the reinforced concrete beams supporting the roof. The PACA report did not identify this condition.

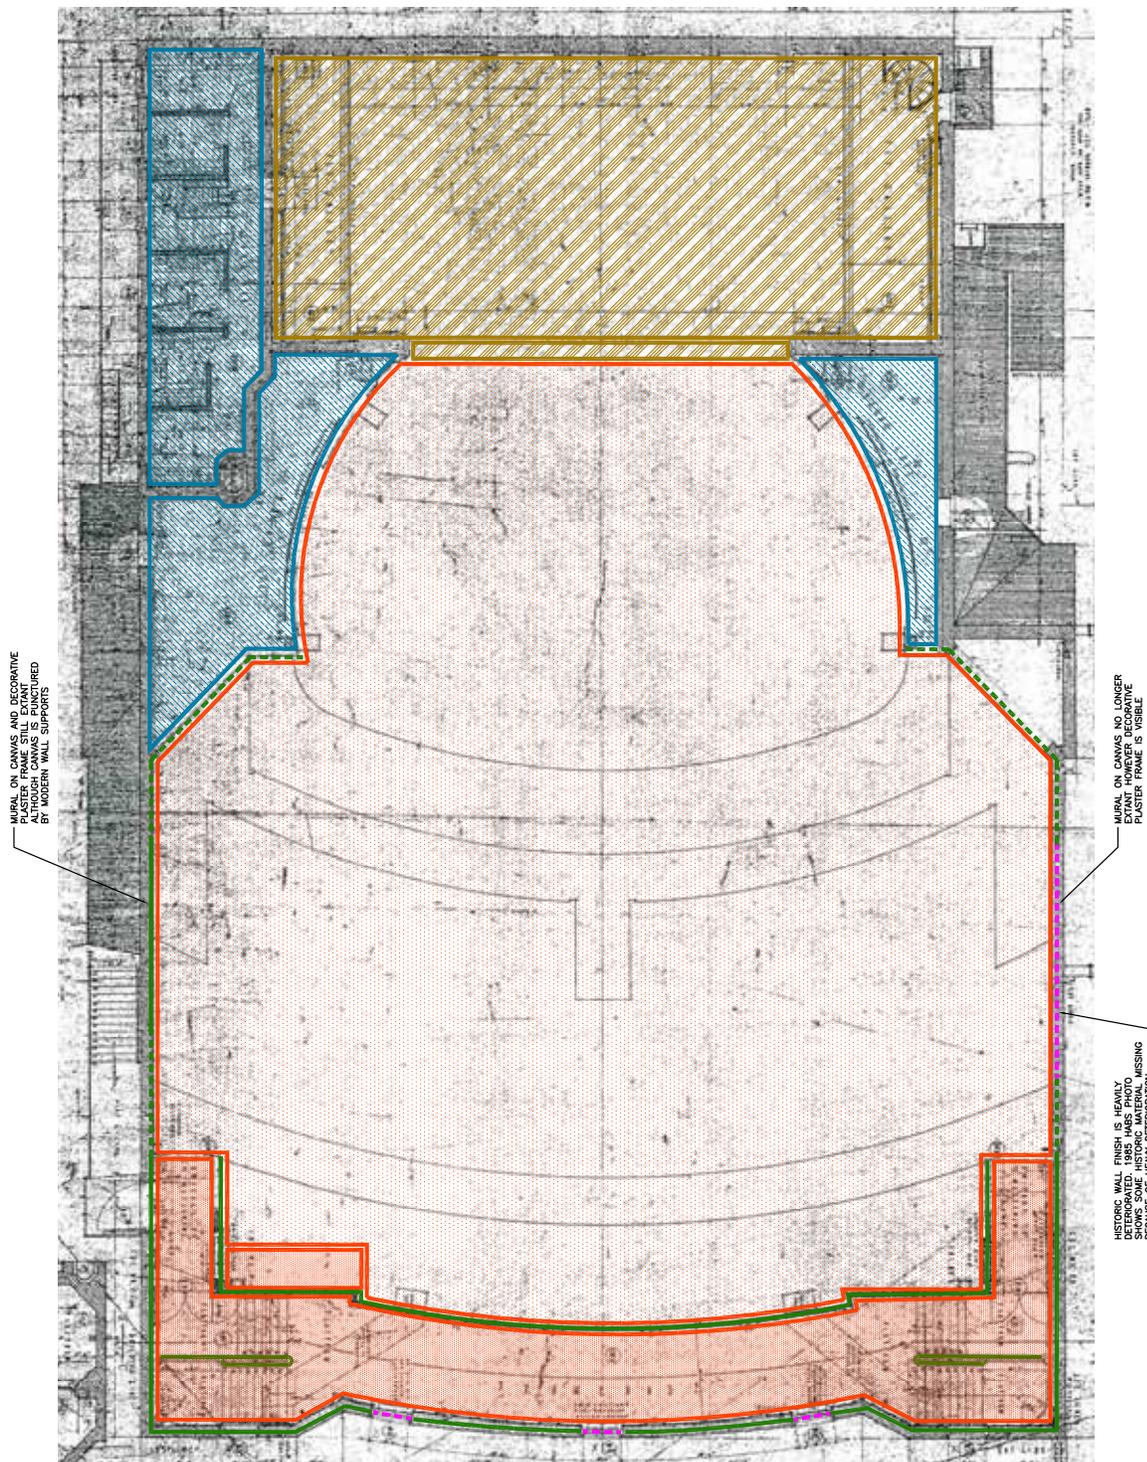
METAL ON CANVAS AND DECORATIVE PLASTER FROM 1917 PLAN STILL PRESENT ALTHOUGH CANVAS IS PUNCTURED BY MODERN WALL SUPPORTS

METAL ON CANVAS NO LONGER PRESENT AND DECORATIVE PLASTER FINISH IS VISIBLE

HISTORIC WALL FINISH IS HEAVILY DETERIORATED AND SHOWS SOME HISTORIC MATERIAL MISSING BECAUSE OF HEAVY DETERIORATION.

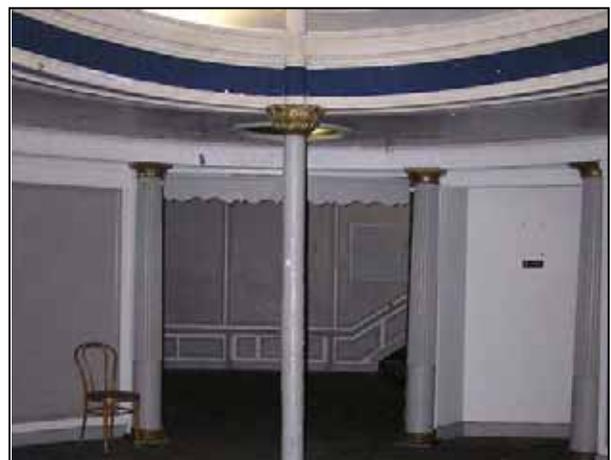
The only room in the North Building that remains, although altered, is the second floor foyer or former promenade (see photograph at right). The room is oval with a square anteroom at each side with staircases to access the different levels of the auditorium. Former seating areas have been removed and replaced with public toilets, and the opening in the floor has been filled in and covered over. The slender cast iron support columns remain at either side

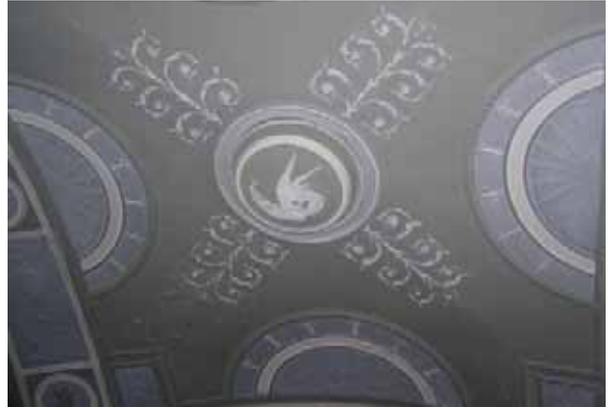
room which frame the openings to the stair wells, theater and current toilet areas. The other interesting feature is the suspended plaster promenade ceiling, which is ornamented in the Adam style with Greco-Roman applied ornamentation painted in pale grays and blues (see photograph at right). Missing components are the lighting and wall coverings. The center medallion and ventilation grille has been covered over with a contemporary painting.

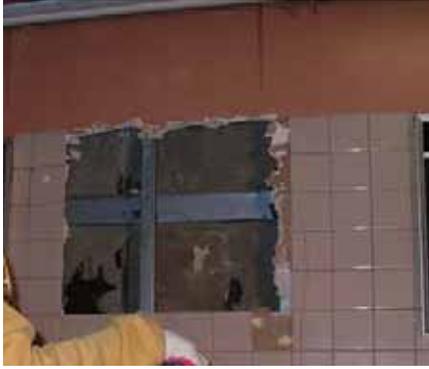
1.

Probe location was selected as original Lamb drawings indicate a fireplace surround as a feature for the double-height foyer.

A 2 ft. x 2 ft. probe hole was made through ceramic tile behind a food service center on the east wall of the foyer. Wall construction revealed contemporary metal studs supporting gypsum wall board, which conceals a cavity. No fireplace was found. Inspection of the cavity indicated that this space is used for distribution of new ductwork, electrical conduit and undefined cables.

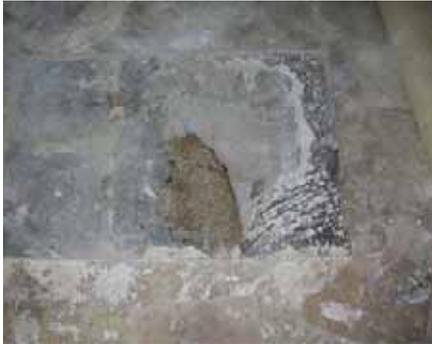
2.

Probe location was selected as original Lamb drawings indicate a decorative floor pattern, which appeared to be of a type of tile in the foyer.

A 2-ft. square of the existing carpet was cut out and removed to reveal the original Terrazzo floor. The floor was found to be in poor condition.

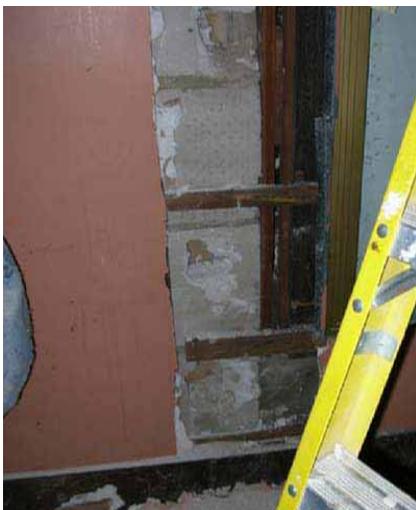
3.

Probe location was selected as original Lamb drawings indicate a marble finish on the foyer walls.

A probe was made on the east wall of the foyer. A 2-ft. wide section of the gypsum wallboard was removed exposing a layer of wood paneling with wood furring behind it placed over a layer of fire block. Portions of the original marble wall finish were found behind the fire block.

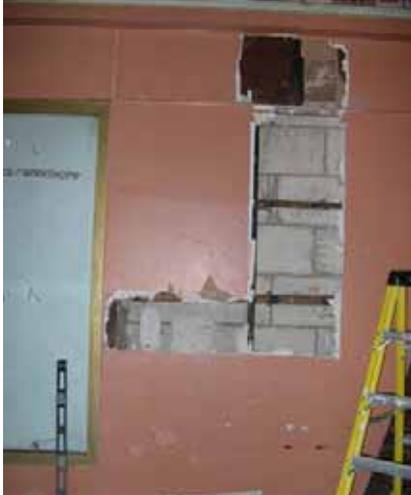
4.

Probe location was selected as original Lamb drawings indicate a marble finish on the foyer walls.

A probe was made on the west wall of the foyer. A 2 ft. x 6 ft. section of the gypsum wallboard was removed exposing a layer of wood paneling with wood furring behind it over a layer of fire block. Behind the fire block was a cavity and then a layer of fire brick. No marble finish was found at this location.

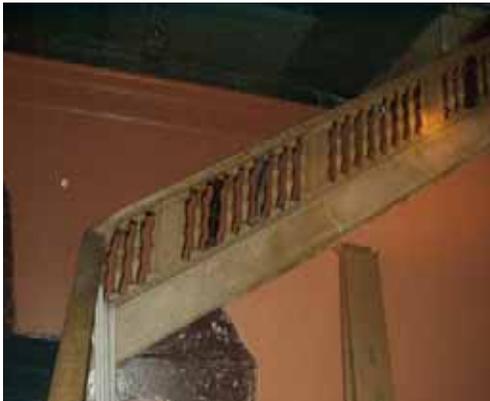
5.

Visual inspection was selected as original Lamb drawings indicate a marble railing at stairs leading to the mezzanine floor of the foyer and also leading across the mezzanine floor that overlooks the first floor.

The original marble railing remains, except for the lower section of the railing which was replaced with wood made to resemble the existing original marble railing.

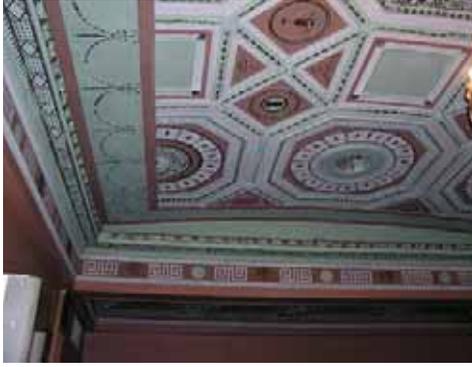
Ceiling at center of foyer

A visual inspection of the ceiling was conducted in the foyer. In the middle section of the foyer the original ornamented ceiling remains. There are visible areas of cracking and flaking paint. In the area above the stairs and mezzanine, the ceiling is covered with gypsum boards.

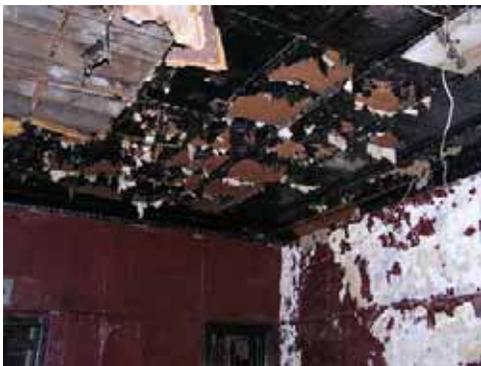
7.

Probe location was selected based on first-floor ceiling condition and investigation of second-floor ceiling condition.

A visual inspection was made of the second-floor ceiling at the south end of the building. It was apparent that sections of the original tin ceiling remained, however, the ceiling is in a state of deterioration beyond repair.

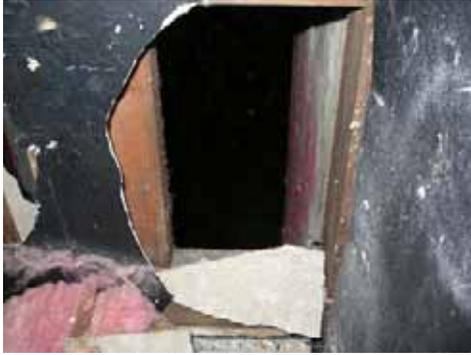
8.

A. Probe at southern balcony

A probe hole approximately covering a 4 ft. x 5 ft. section of the gypsum wall board was made on the southern side of the theater where one half of the box balconies originally were located. Behind the gypsum wall were stairs leading down to the balcony. The stairs were covered with plywood and could not be determined as original. The balcony platform remains but not the balcony boxes. This area is currently used for HVAC equipment. The decorative plaster ceiling remains but in an extremely deteriorated condition.

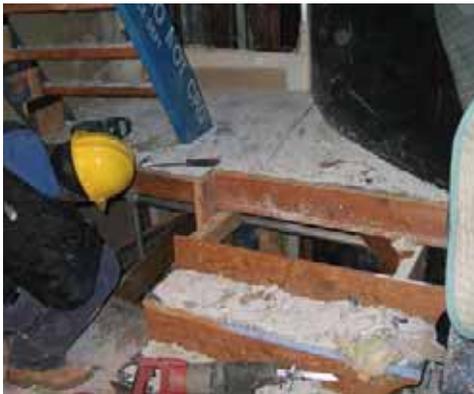
8B.

B. Probe at northern balcony. Note entrance to balcony below new stairs

A probe hole approximately covering a 4 ft. x 4 ft. section of the plywood wall was made on the northern side of the theater where one half of the box balconies originally were located. A storage area with stairs was built in the location of the entrance to the balcony. Behind the stairs and behind the plywood remained only the balcony platform with a section of the railing attached at the edge. The balcony boxes, the stairs leading down to the balcony platform, and the rest of the railings are no longer there. The decorative plaster ceiling remains, but in a heavily deteriorated condition.

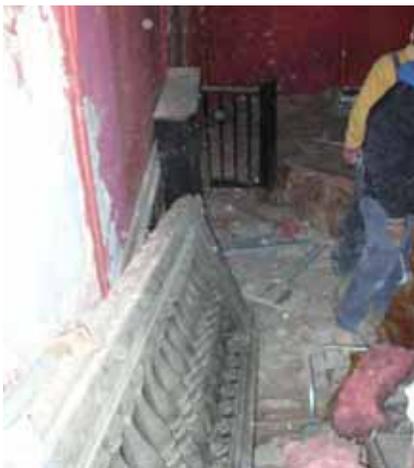
B. Northern balcony. Note that the only remaining piece is the platform with attached railing at edge.

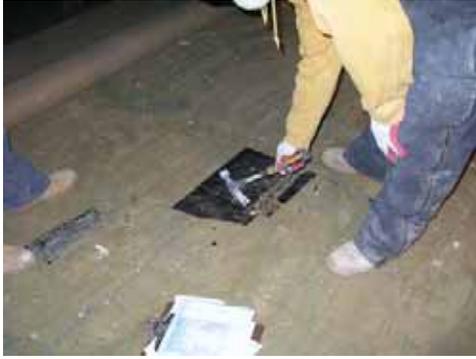
9.

The foyer on the second floor of the theater on the west end of the building is covered with carpet. A section of the carpet was rolled up and a 1 ft. x 1 ft. probe was made removing the padding and revealing original marble floor tile.

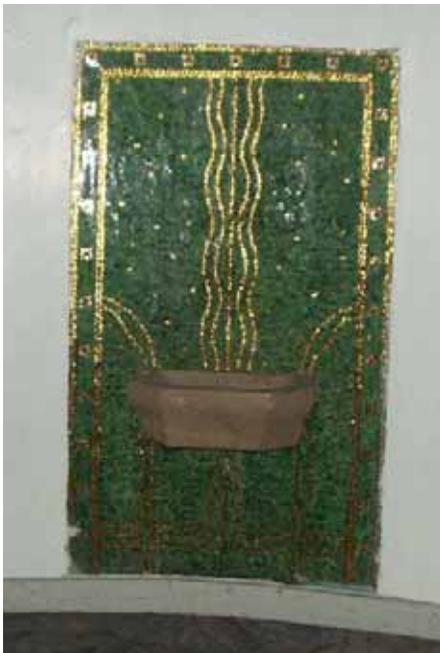
10.

The original drinking fountains with mosaic tile surround remain flanking the outer areas of the second floor theater foyer. The tiles surrounding the fountains as well as the fountains are in good condition.

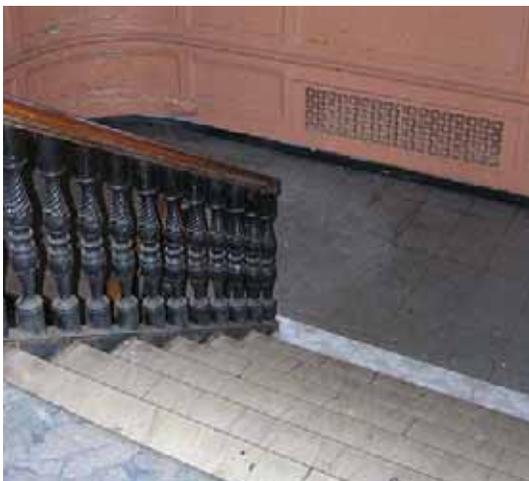
11.

The marble stairs and cast iron railings remain on both ends of the west end of the building. They appear in good condition.

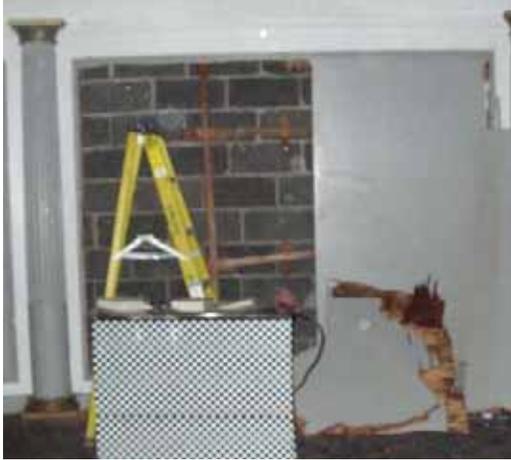
12.

First probe done at west foyer wall

The first probe was made on the western wall of the second floor foyer where the original drawings showed a passage way to the fireplace. Removing the plywood revealed a CMU wall covering the passage way. Behind the CMU wall were the restrooms.

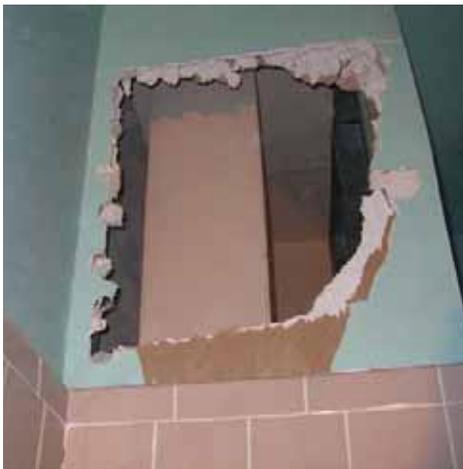
Second probe done at south wall of restroom behind CMU wall

Second probe to locate the fireplace was made in the men's restroom. The second probe was made cutting a 2 ft. x2 ft. hole into the south wall of the restroom behind the CMU wall which would be the passage way. The probe revealed steel framed construction supporting gypsum wall board. Within the wall was a cavity with ducts. No passage way was found.
