ALTERNATIVES ANALYSIS WITH BCA CONDITIONS ASSESSMENT UPDATE

**VICTORIA THEATER
235-237 WEST 125TH STREET
NEW YORK, NY
ALTERNATIVES ANALYSIS**

Conditions Assessment Update

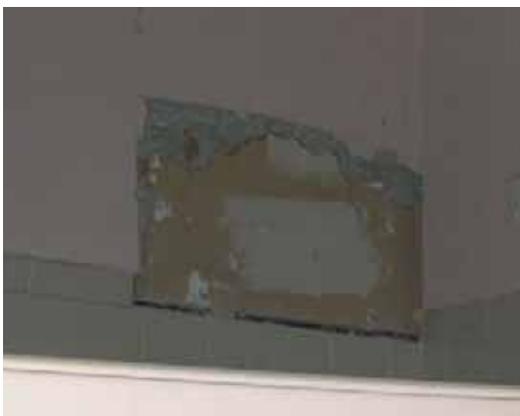
Third probe done at west wall of restroom at interior of exterior west wall

The third probe to locate the fireplace was made in the women's restroom. The third probe was made cutting a 2 ft. x2 ft. hole into the west wall of the restroom. There was a layer of plaster followed by concrete. No fireplace remains.

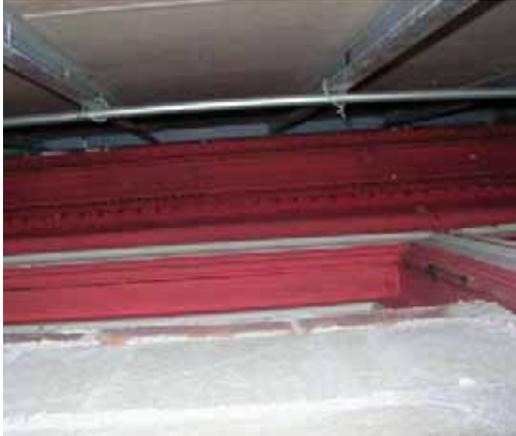
13.

Three 4 ft. x 2 ft. probe holes were made at the north wall of the theater. Each probe hole was situated at the location where the fire doors once were. Behind the gypsum wall board and metal stud framing were the original wood door trims painted red and the openings, now filled in with fire block.

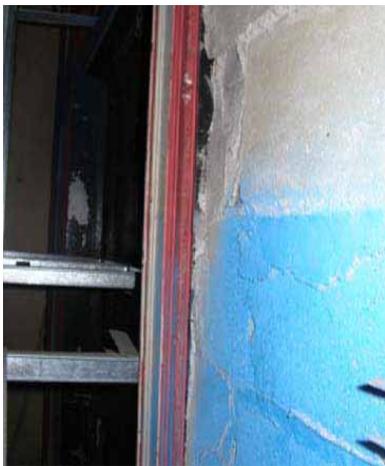
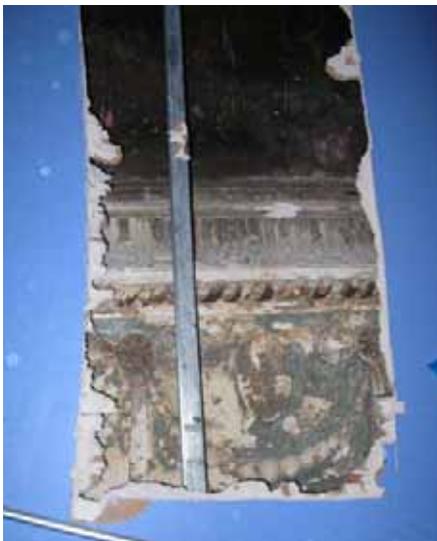
14.

North wall mural and trim with metal stud wall support spanning across mural

A 4 ft. x 4 ft. probe was made through the existing gypsum wall board and acoustic panel at the lower east portion of the north wall in the main north theater. Wall construction consisted of gypsum wall board, acoustical paneling, and metal stud work. The original mural screen and plaster surround still remain. Missing portions of the plaster ornamentation is evident. The mural has been damaged with the stabilization of the furred out gypsum board. The approximate size of the mural and trim is 30 ft. x 15 ft.

- Where the wall painting located on the north wall was encapsulated, there is water damage, which has blistered and lifted the canvas. The plaster substrate has deteriorated by expansion and has torn the rotted canvas in various locations. The plaster frame that surrounds the large canvas has also deteriorated from excessive water damage over time. Mold and mildew have compromised the majority of the painting.

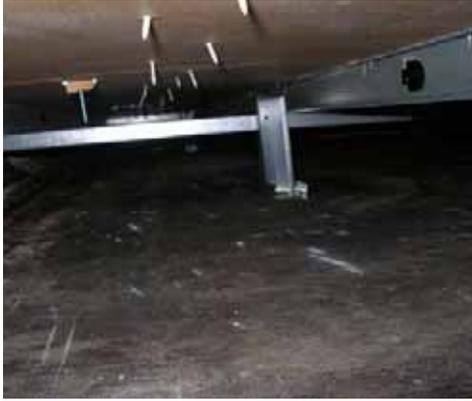
North wall mural, note metal studs piercing through mural fabric

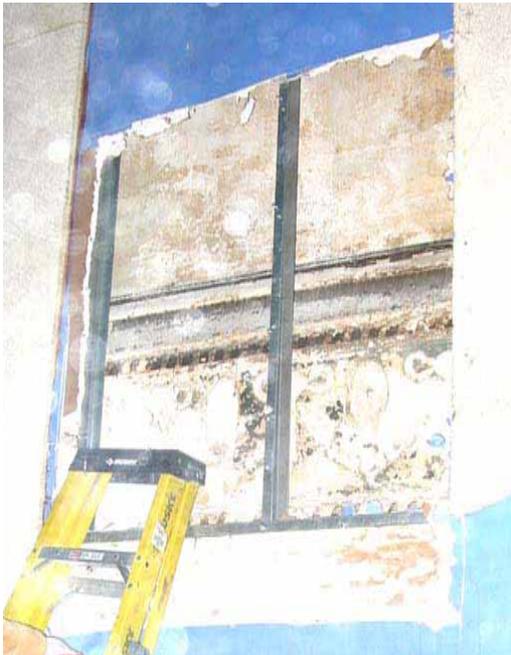
A 4 ft. x 4 ft. probe was made through the existing gypsum wall board and acoustic panel at the lower west portion of the south wall in the main south theater. Wall construction consisted of gypsum wall board, acoustical paneling, and metal stud work. The original mural screen was not found, however the plaster surround still remains. Missing portions of the plaster ornamentation is evident. The approximate size of the trim is 30 ft. x 15 ft., the same as the North side.

South wall mural trim with metal stud wall support spanning across area. No mural found at this location.
