Block I 129, Lot 49

Location, Use, Zoning, and Ownership

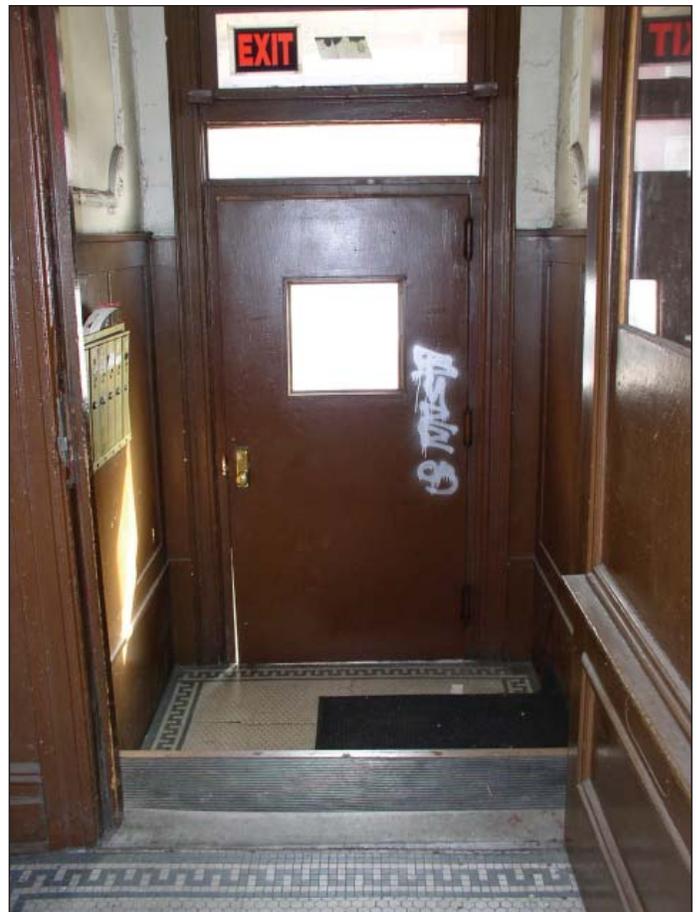
Photograph 1129-49-H

AYDC has maintained lot 49 in substantially the same condition it was in when the property was purchased in April 2005. Apart from some graffiti painted on the door of the building on lot 49 (see Photograph I), the building's exterior appears to be in fair condition. However, as shown in Photographs B through H, the building's interior is in a state of disrepair. Severe water damage is evident on several walls and ceilings. Mold is visible in many areas of the building (see Photographs C and F) and pools of moisture within portions of the walls and ceilings have caused the paint to bubble and peel (see Photographs C, D, and E). In some areas, entire layers of drywall are peeling off the walls (see Photograph B). As shown in Photograph G, paint is peeling from the ceiling surrounding the skylight in the stairwell. This is most likely a result of water leaking into the building from the rooftop. And as shown in Photograph H, graffiti has been painted on the inside of the building's front door.
