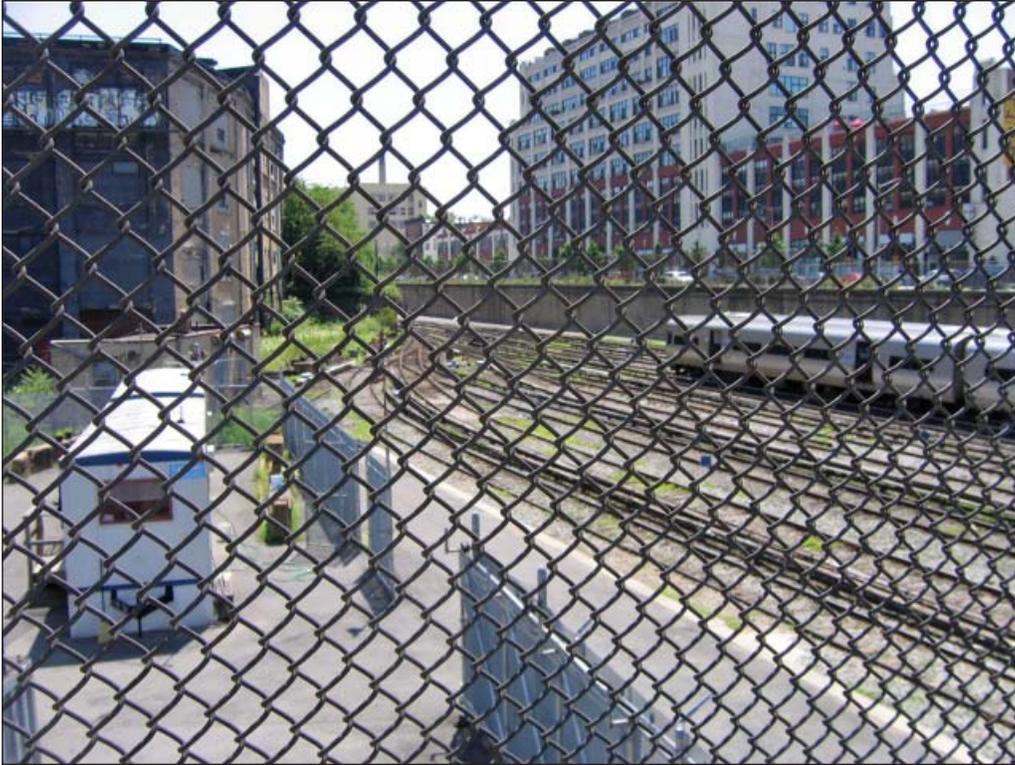
Photograph I 120-I-A

Lot 1 occupies over 75 percent of the block bounded by Atlantic Avenue on the north, Carlton Avenue on the east, Pacific Street on the south, and 6th Avenue on the west. The lot accommodates the middle portion of the 8-acre below-grade rail yard, which is used for the storage and servicing of LIRR commuter rail trains (see Photograph A).

Current conditions on lot 1 are shown in Photographs A through G. Similar to the eastern portion of the rail yard (Block 1121, lot 1) this middle section is located entirely below-grade and is surrounded by a chain link fence, sections of which are topped in barbed wire. As shown in Photographs B through G, portions of the yard itself are overgrown with vegetation and littered with trash and debris. Metal beams are stored in the open yard and several small storage structures and interior walls are painted with graffiti. The sidewalks surrounding lot 1 on Atlantic, 6th, and Carlton Avenues are also in a condition of disrepair. As shown in Photograph H, tall weeds grow along the fence facing Atlantic Avenue, and the sidewalk area—similar to the sidewalk along the Atlantic Avenue portion of Block 1121—is strewn with trash and only partially paved.

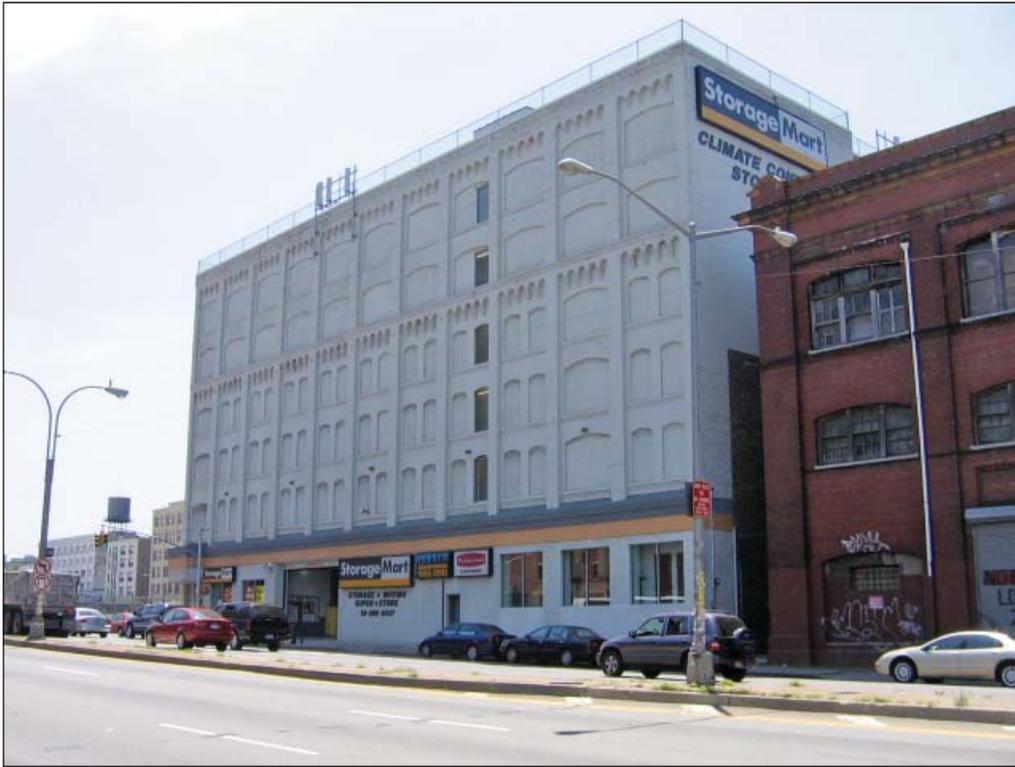
Photograph I 120-28-A

Lot 28 is located at 728 Atlantic Avenue, between 6th and Carlton Avenues. The lot hosts a six-story, 72,990 gsf warehouse building (see Photograph A) occupied by a self storage business. Lot 28 is located in an M1-1 zoning district. M1 districts allow high-performance light manufacturing uses and often serve as buffers to adjacent residential or commercial districts. M1-1 districts have an FAR of 1.0. According to the New York City Department of Finance, lot 28 is owned by WSMP-MW-EAST, L.P.

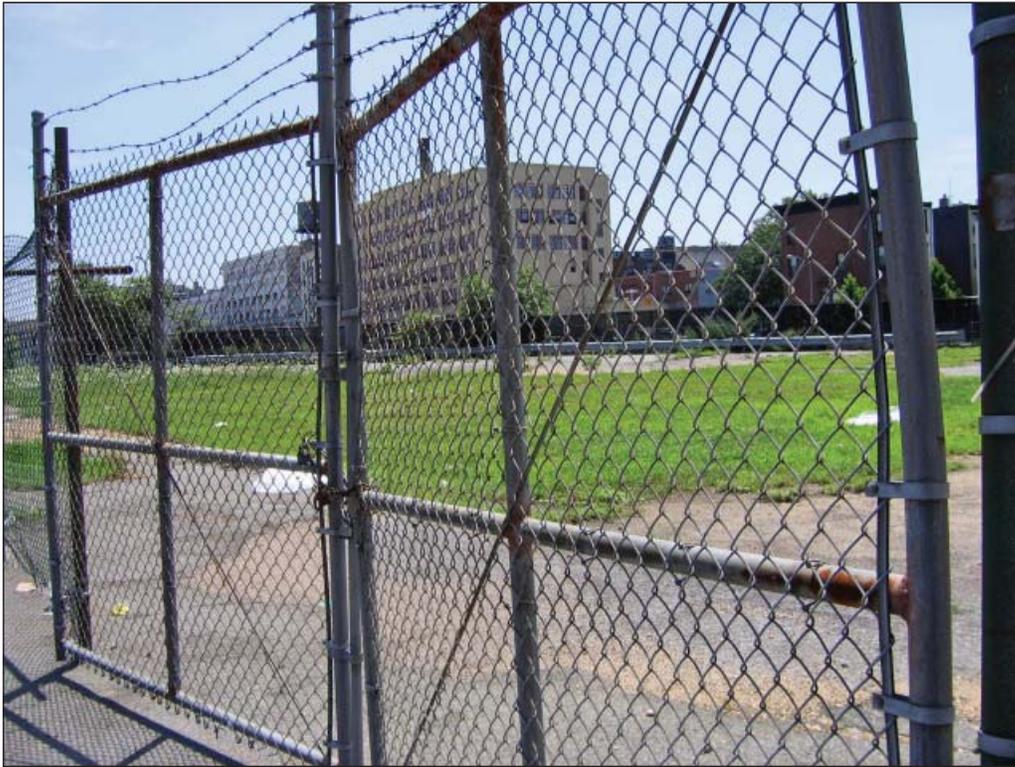
Photograph I 120-35-A

Lot 35 is located on Atlantic Avenue, on the eastern portion of the block bounded by Atlantic Avenue on the north, Carlton Avenue on the east, Pacific Street on the south, and 6th Avenue on the west. The lot is vacant (see Photograph A). Lot 35 is located in an M1-1 zoning district. M1 districts allow high-performance light manufacturing uses and often serve as buffers to adjacent residential or commercial districts. M1-1 districts have an FAR of 1.0. According to the New York City Department of Finance, lot 35 is owned by 730 Equity Corporation. In Fall 2005, AYDC assumed the ground lease for the property.

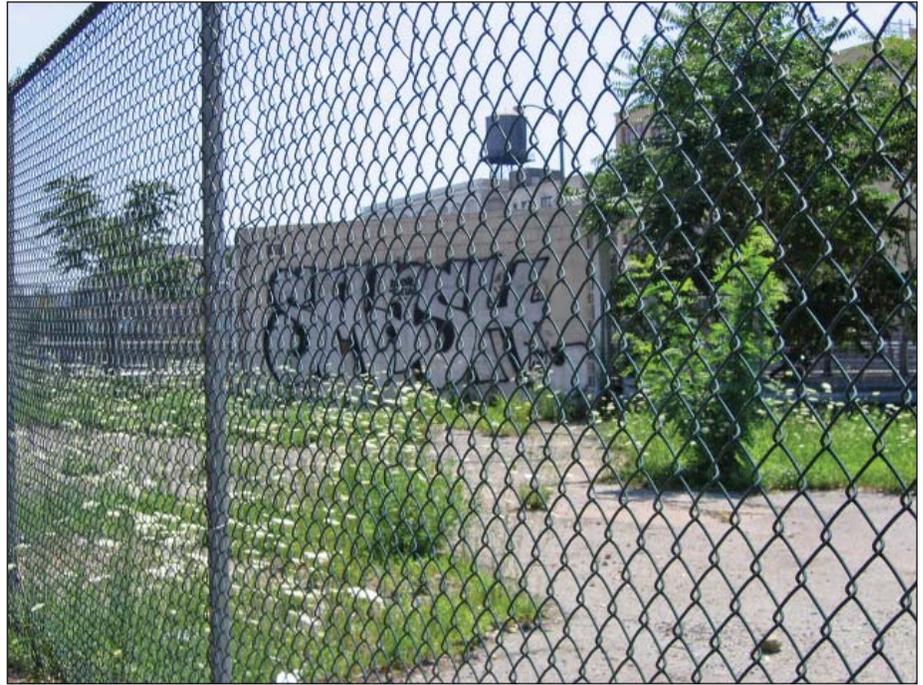
Photograph I 120-35-C

As shown in Photograph B, lot 35 is surrounded by a chain-link fence, portions of which are covered with barbed wire and sections of which are no longer standing upright. The lot itself is overgrown with weeds and the brick wall facing into the lot on the eastern portion of the lot is painted with graffiti (see Photograph C). In addition, as shown in Photographs B and D, the sidewalk along Atlantic Avenue is cracked and uneven and weeds have grown up through most of the cracks and along the curb.
