## Block I 127, Lot 20

### Location, Use, Zoning, and Ownership

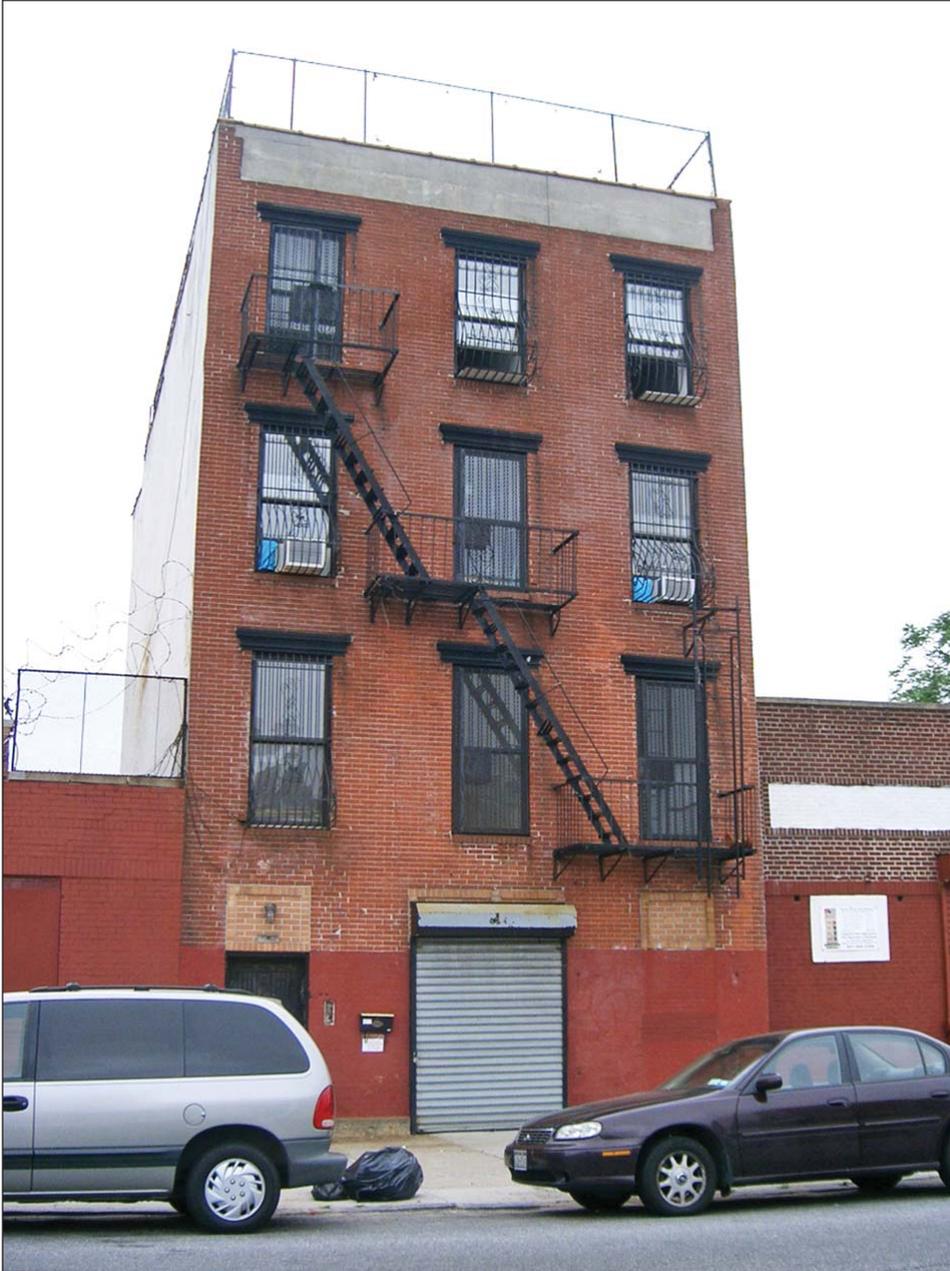
**Photograph 1127-21-A**

Lot 21 is located at 624 Pacific Street, between 5th and 6th Avenues. The lot is occupied by a 5,000 gsf, four-story residential building with ground floor commercial space (see Photograph A). Lot 21 is located in an R7A zoning district with a C2-4 overlay. R7A districts permit medium-density housing with a maximum FAR of 4.0. C2-4 districts accommodate retail and personal service shops needed in residential neighborhoods. When mapped in R7 districts, the maximum commercial FAR in C2-4 districts is 2.0. Lot 21 is owned by AYDC, which purchased the property in July 2004.

No unsanitary or unsafe conditions were identified as part of the visual assessment.

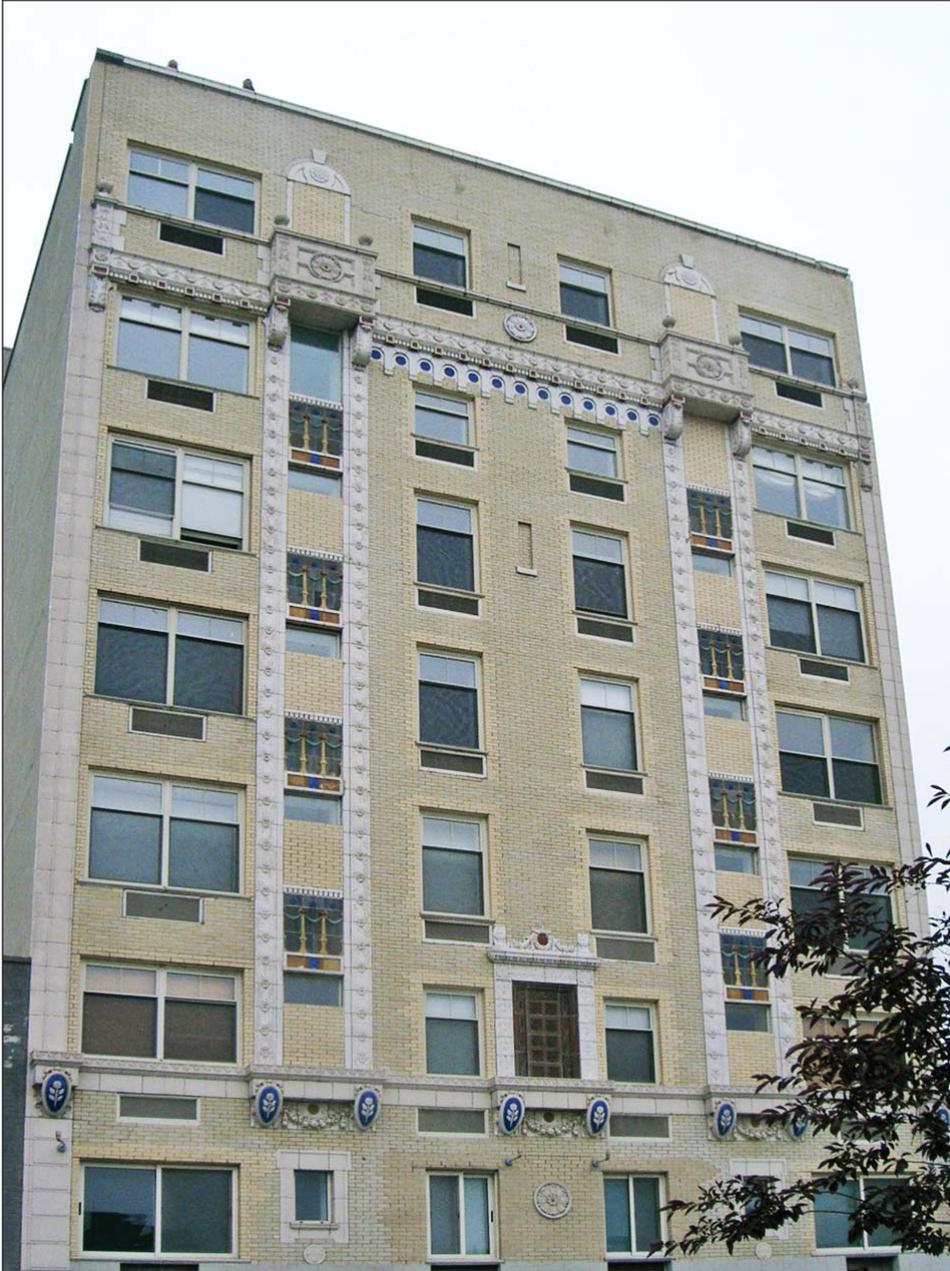
**Photograph 1127-1101-1131-A**

Lots 1101-1131 (also referred to as lot 27, the lot number assigned to the lot prior to its division into condominium units) are located at 636 Pacific Street, between 5th and 6th Avenues. The parcel is occupied by a 38,750 gsf, eight-story residential condominium building (see Photograph A). Lots 1101-1131 are located in a C4-4A zoning district. C4 districts are located in major commercial centers outside the central business district and allow department stores, theaters, and other commercial uses that serve a larger area. C4-4A districts have a maximum commercial FAR of 4.0. AYDC owns all but one of the 31 condominium units in the building on the lot. The units were purchased by AYDC in November 2004.

No unsanitary or unsafe conditions were identified as part of the visual assessment, and no thorough engineering inspection report has been done for this property. However, according to documents obtained from the former president of the 636 Pacific Street Condominium Association, numerous aspects of the building's renovation and conversion were performed poorly by the condominium sponsor and have required significant and repeated repairs or replacements since the owners first occupied the building in 2003. The problems were so numerous that the owners filed a complaint against the building sponsor with the Office of the Attorney General in August 2003, retained legal counsel to represent them, and hired an architecture firm (loci architecture pc) to write a report documenting the many problems with the building. Among the concerns listed by the residents were: basement flooding, faulty electrical wiring, missing plaster on the southwest building façade, prevalence of flies and other insects (which the owners speculated may have stemmed from "additional decomposing rodents in walls/basement"), floors buckling from water damage, active water/ceiling leaks in individual apartments, and mold growing in first floor apartments. The report prepared by loci architecture in January 2004 indicated that the building continued to experience a variety of problems, including substantial water damage due to poor weatherproofing, inadequate courtyard pitching, and insufficient caulking and flashing on the exterior façade, balcony doors, window frames, and roof.

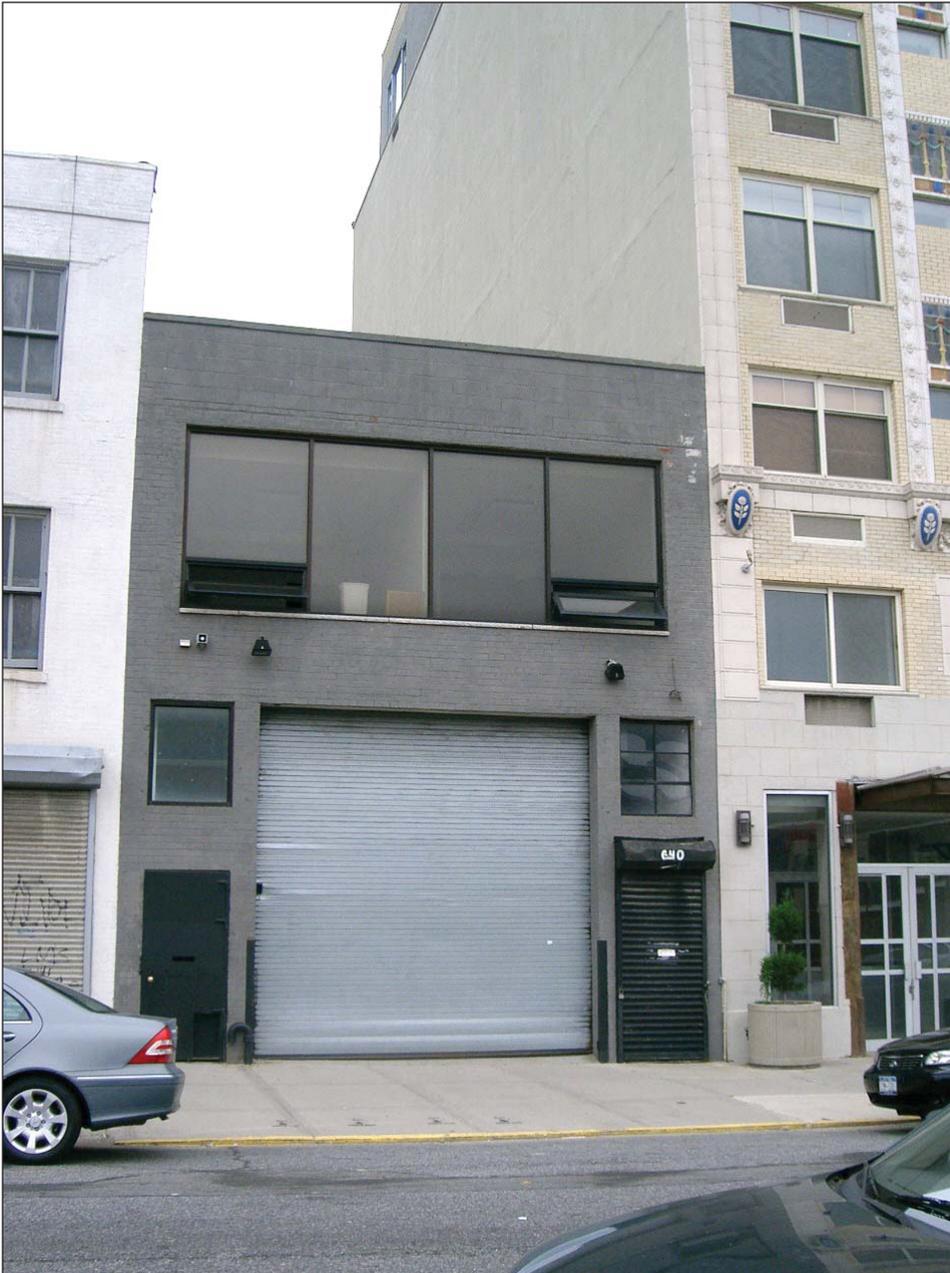
**Photograph I 127-29-A**

Lot 29 is located at 640 Pacific Street, between 5th and 6th Avenues. The lot is occupied by a 2,750 gsf building containing a garage with office space above (see Photograph A). Lot 29 is located in a C4-4A zoning district. C4 districts are located in major commercial centers outside the central business district and allow department stores, theaters, and other commercial uses that serve a larger area. C4-4A districts have a maximum commercial FAR of 4.0. Lot 29 is owned by AYDC, which purchased the property in November 2004.

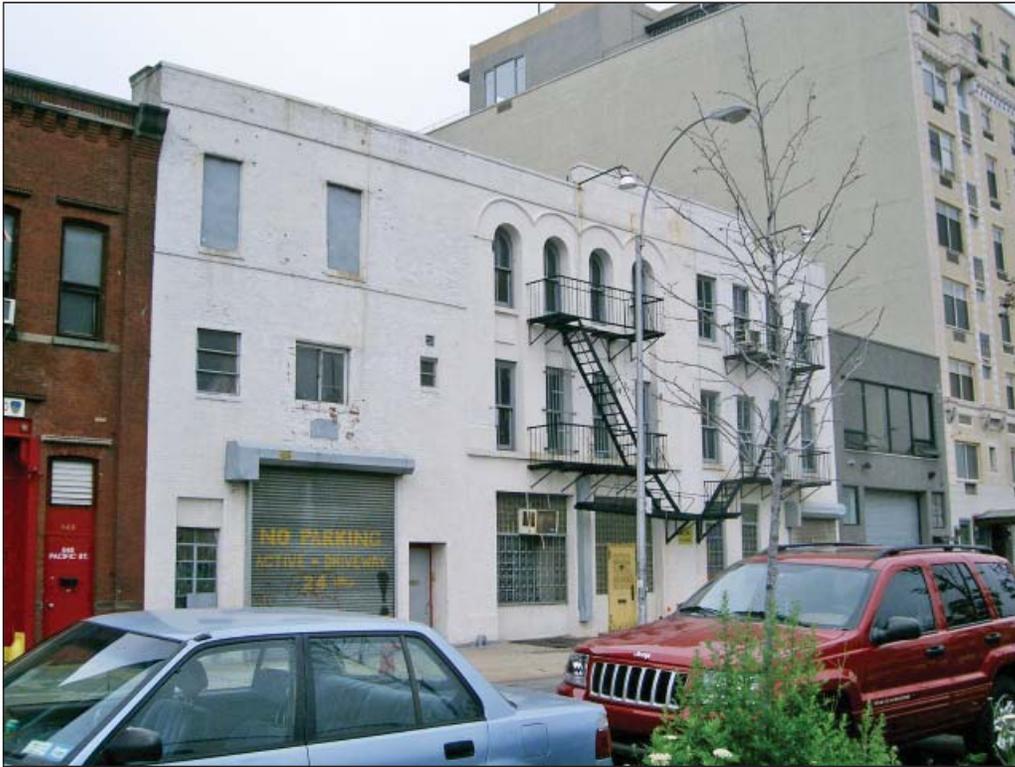
**Photograph I 127-30-A**

Lot 30 is located at 642-646 Pacific Street, between 5th and 6th Avenues. The lot is occupied by a vacant 19,679 gsf, three-story mixed use residential and commercial building (see Photograph A). Lot 30 is located in a C4-4A zoning district. C4 districts are located in major commercial centers outside the central business district and allow department stores, theaters, and other commercial uses that serve a larger area. C4-4A districts have a maximum commercial FAR of 4.0. Lot 30 is owned by AYDC, which purchased the property in April 2005.

The façade of the building on lot 30 is generally in fair condition. However, the building's garage door and adjacent window are painted with graffiti, one of the building's windows is cracked, and the paint is flaking off portions of the building's façade (see Photographs B and C). In addition, as shown in Photograph D, the sidewalk in front of the building is heavily cracked, the curb is deteriorating, and weeds grow through many of the cracks.

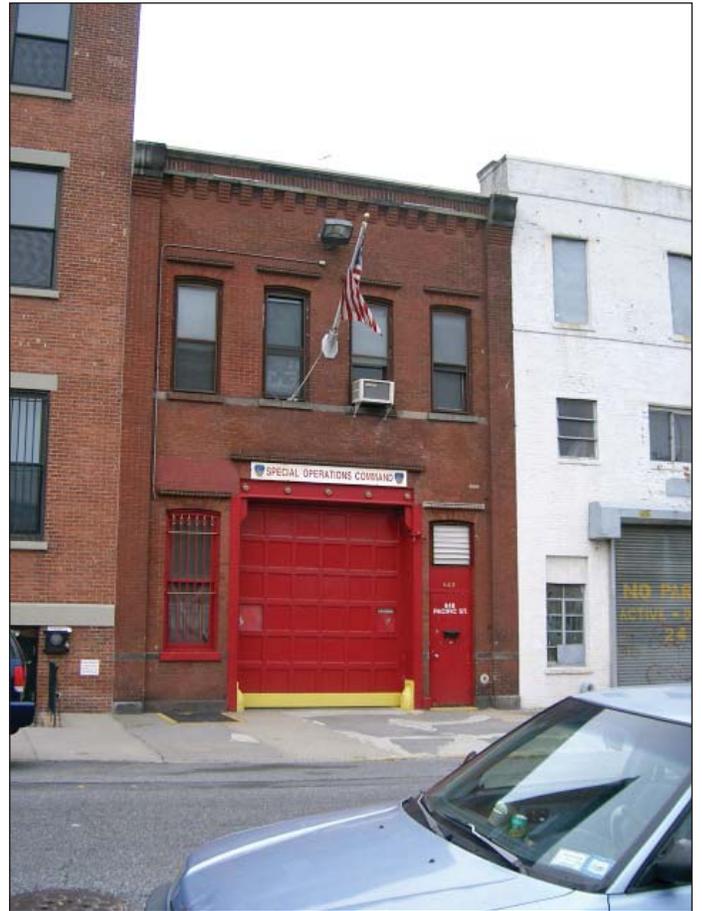
**Photograph I 127-33-A**

Lot 33 is located at 648 Pacific Street, near the corner of 6th Avenue and Pacific Street. The lot is occupied by a 2,750 gsf, two-story building used by the New York City Fire Department (FDNY) as an equipment cleaning and storage facility (see Photograph A). Lot 33 is located in a C4-4A zoning district. C4 districts are located in major commercial centers outside the central business district and allow department stores, theaters, and other commercial uses that serve a larger area. C4-4A districts have a maximum commercial FAR of 4.0. Lot 33 is currently owned by the City.

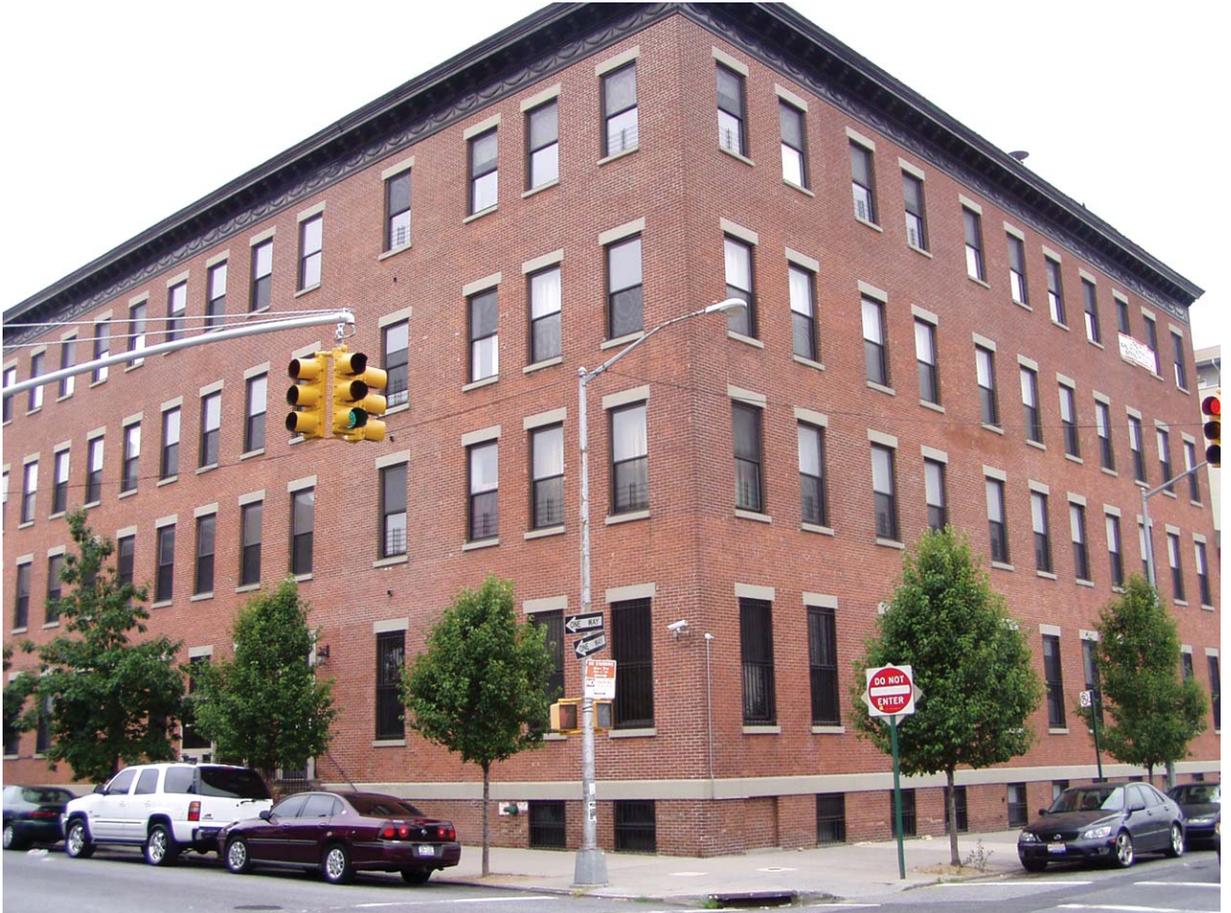
**Photograph 1127-1001-1021-A**

Lots 1001-1021 (also referred to as lot 35, the number assigned to the lot prior to its division into condominium units) are located at 24 6th Avenue on the corner of 6th Avenue and Pacific Street. The parcel is occupied by a 29,736 gsf, five-story residential condominium building (see Photograph A). Lots 1001-1021 are located in a C4-4A zoning district. C4 districts are located in major commercial centers outside the central business district and allow department stores, theaters, and other commercial uses that serve a larger area. C4-4A districts have a maximum commercial FAR of 4.0. AYDC owns 19 of the 21 condominium units located in the building, and is currently under contract to purchase the remaining two units.

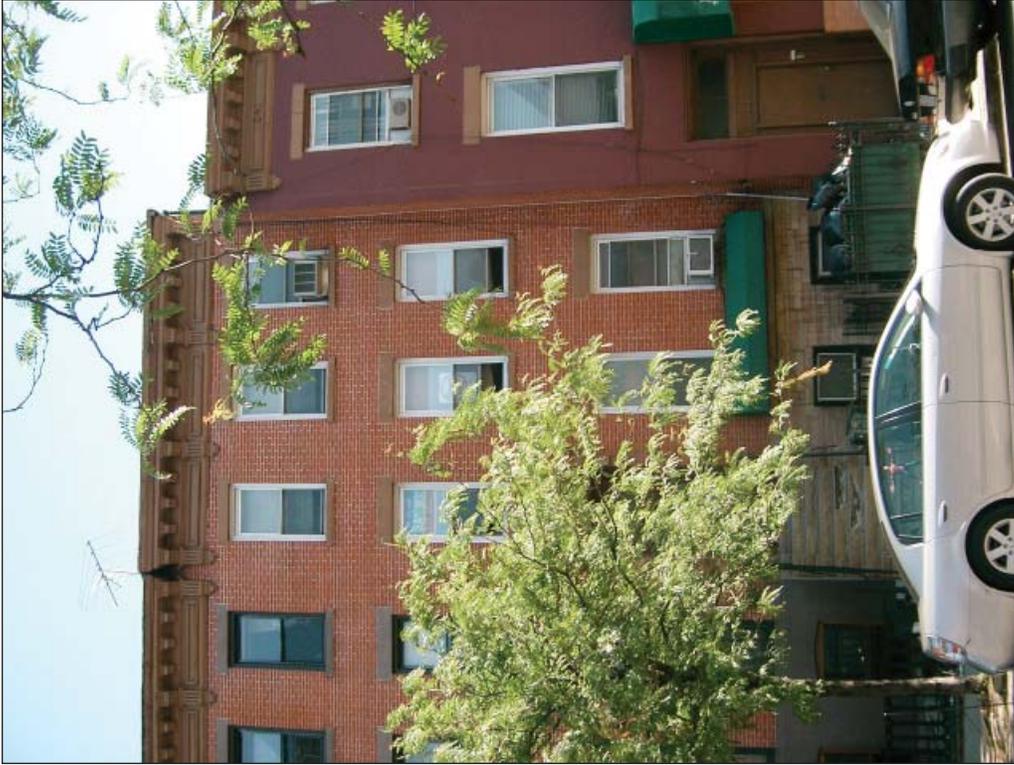
**Photograph I 127-43-B**

Lot 43 is located at 483-485 Dean Street, on the corner of 6th Avenue and Dean Street. The eastern portion of the lot is occupied by a 4,686 gsf, three-story residential building with ground floor commercial (see Photograph A) and the western portion of the block is occupied by a three story residential building (see Photograph B). Lot 43 is located in an R6B zoning district. With an FAR of 2.0, R6B districts are generally characterized by shorter, four-story rowhouses or apartment buildings. Both buildings on lot 43 are owned by AYDC, which purchased them in August 2005.

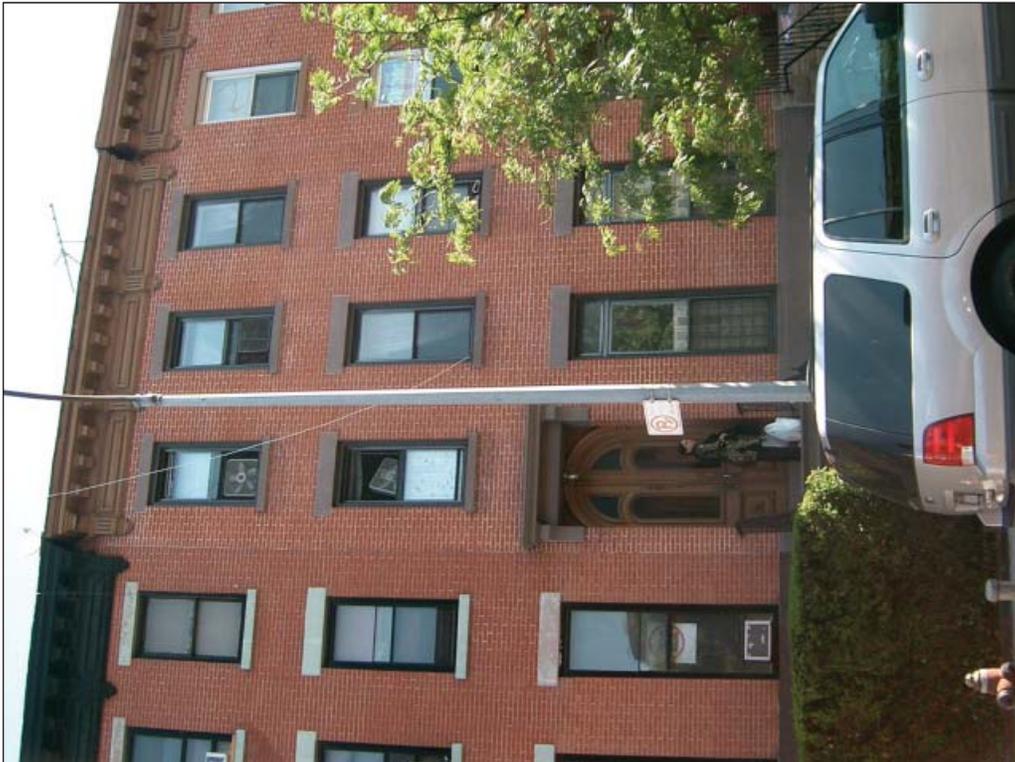
**Photograph I 127-45-A**

Lot 45 is located at 481 Dean Street, between Flatbush and 6th Avenues. The lot is occupied by a 2,400 gsf, three-story residential building (see Photograph A). Lot 45 is located in an R6B zoning district. With an FAR of 2.0, R6B districts are generally characterized by shorter, four-story rowhouses or apartment buildings. According to the New York City Department of Finance, lot 45 is owned by Nasser Ahmed.

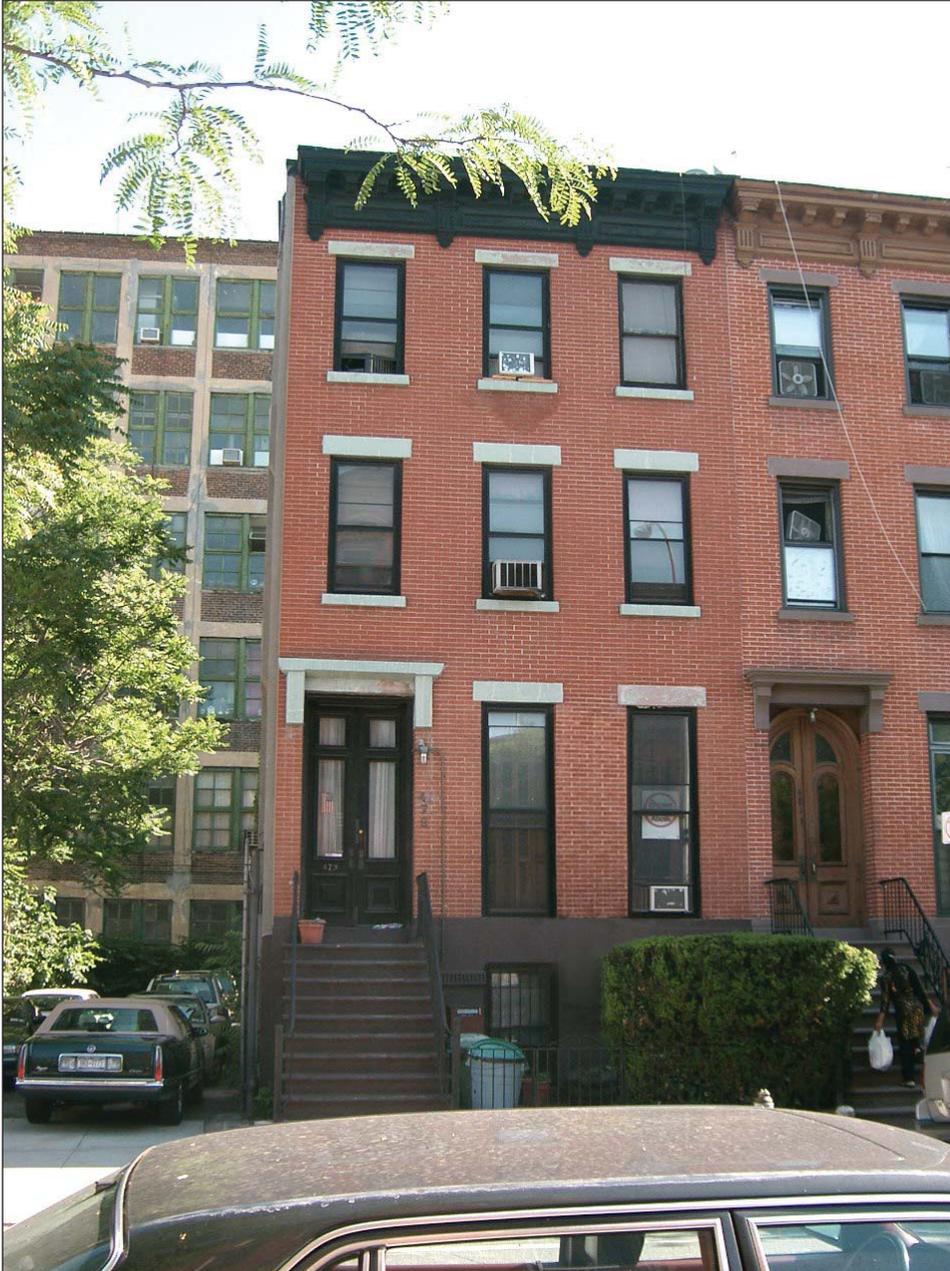
**Photograph I 127-46-A**

Lot 46 is located at 479 Dean Street, between Flatbush and 6th Avenues. The lot is occupied by a 2,400 gsf, three-story residential building (see Photograph A). Lot 46 is located in an R6B zoning district. With an FAR of 2.0, R6B districts are generally characterized by shorter, four-story rowhouses or apartment buildings. Lot 46 is owned by AYDC, which purchased the property in May 2006.
